Shearography non-destructive testing of a composite ship hull section subjected to multiple impacts

Proceedings of the 20th European Conference on Composite Materials: Composites Meet Sustainability

An overview of the composite ship hull section is shown in Fig. 1. The dimensions are about 6 meters in height and 2.3 meters in width. The structure is made from FRP laminate skins and foam cores. The composite ship hull section is a RAMSSES demonstrator [11,12] at Damen Shipyards. Before shearography inspection, multiple impact tests (https://vimeo.com/522716506) surpassing helicopter emergency landing loads have been performed on the hull shell and its composite helicopter deck for proving the resilience of composites to harsh marine environments. The impacted area on the hull shell is shown in Fig. 1(c).

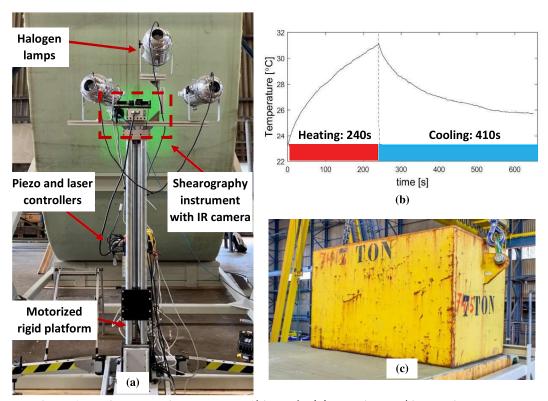
Figure 2 Testing campaign at Damen Shipyards: (a) Experimental inspection system. (b) Average temperature profile from thermal loading. (c) Applying mechanical loading.

The hull shell was illuminated with a Torus 532 laser source (optical power of 500 mW and wavelength of 532 nm) through a beam expander [Fig. 2(a)]. The formed speckle image was captured by a Pilot piA2400 camera with Linos MeVis-C 1.6/25 imaging lens and a Thorlabs bandpass filter through a Michelson interferometer. A piezo-electric actuator PSH 4z from Piezosystem Jena was used to enable temporal phase-shifting (three-step, 2.8 s per phase-shifting cycle). The shearing distance is about 9 mm (~34 pixels) in the vertical direction, which was determined experimentally to produce reliable phase maps for defect detection. During the testing, the shearography instrument was fixed on a motorized rigid platform. By adjusting the rigid platform, scanning in both horizontal and vertical directions can be achieved, enabling a large-area inspection.

Thermal loading was performed by three halogen lamps, each operating at full electrical power (1000W) [Fig. 2(a)]. During heating and cooling, the surface temperature of the hull shell was monitored with a FLIR A655 thermal infrared (IR) camera. The fields of view (FOVs) were inspected by repeating the same thermal loading [Fig. 2(b), 240s of heating], while the average temperature increase of the heated area was about 8 °C. Mechanical loading was done by

placing a 7-ton metal block on the structure [Fig.2(c)], which corresponds to the landing of a medium-sized helicopter.
