Health condition monitoring of insulated joints based on axle box acceleration measurements

Engineering Structures

Health Condition Monitoring of Insulated Joints based on Axle Box Acceleration Measurements

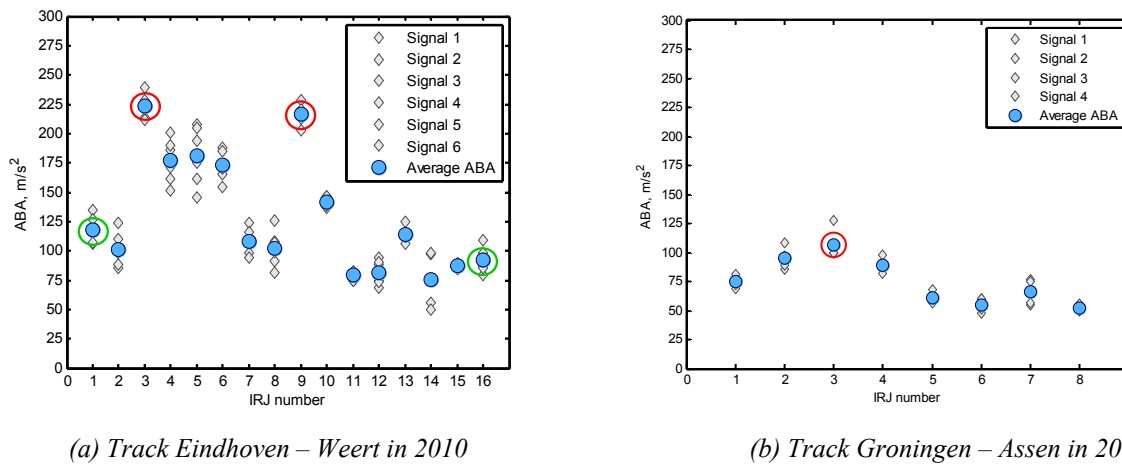
Figure 4: Local maxima of ABA at IRJs. Blue circles indicate average local maxima, grey diamonds denotes the maximum of each ABA measurement.

To study the relationships between the state of IRJs and ABA values we compared two IRJ with high ABA magnitude (IRJs number 3 and number 9 indicated with red circles in Figure 4a) and two IRJs with comparatively low ABA magnitude (IRJs number 1 and number 16 indicated with green circles in Figure 4a). As it appeared from the visual inspection of the IRJs, the two IRJs with high ABA magnitudes (above 200 m/s^2) were indeed in a deteriorated condition: the IRJ number 3 had plastic deformation D_1 on the rail surface caused by the impact at the endpost (Figure 5c) and the IRJ number 9 had a crack in the fastener D_2 (Figure 5g-h). As for the IRJs with comparatively low ABA magnitude (below 150 m/s^2), the IRJ number 1 may be considered as in a good condition (Figure 5a), since only light deformation of the rail surface is visible. While the IRJ number 16 had a significant gap between the two pieces of the rail, as a result of the loss of insulation material D_3 (Figure 5j). Thus, the ABA magnitude at IRJs cannot be an indication of D_3 . Therefore, further investigation of the frequency content of ABA is presented in the next section.

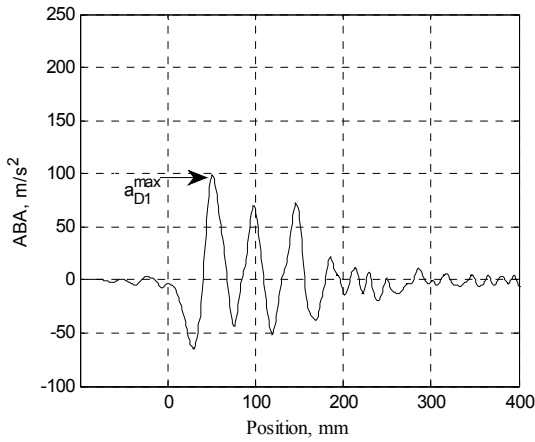
Figure 6c presents the ABA measured at IRJs 3 from the track Groningen – Assen (G-A), see photo in Figure 5l. The ABA signal at this IRJs had a wavelength of about 50 mm. The local maximum ABA was $a_{D1}^{max} = 100 \text{ m/s}^2$, which is quite close to the normal condition ($a_N^{max} = 91 \text{ m/s}^2$). The PSD at these IRJs is shown in Figure 6d. There major peaks for this IRJ are 90 Hz, 350 Hz and 570 Hz, which is consistent with the frequencies in Figure 6b.

(c) ABA at IRJs with plastic deformation (G-A)

(d) PSD at IRJs with plastic deformation (G-A)

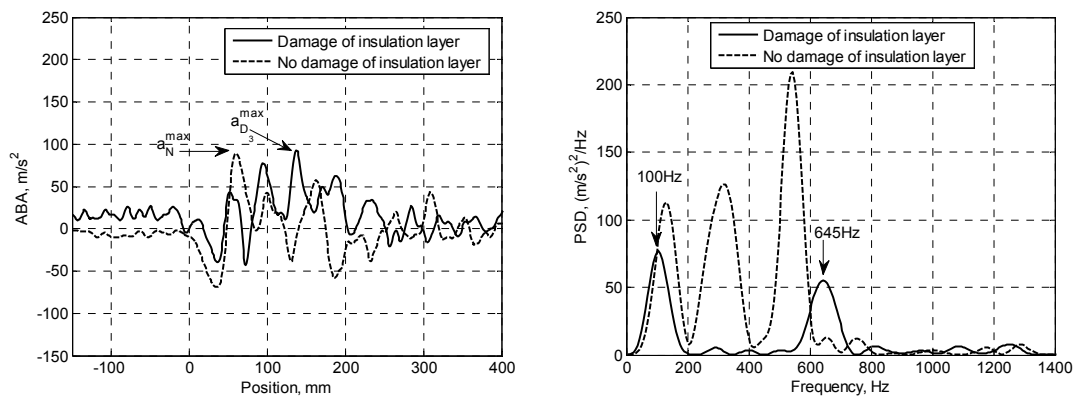
The ABA at this IRJ is shown in Figure 7a with a solid line. The ABA magnitude at this IRJ is comparable to the reference IRJ ($a_{D_3}^{max}=86 \text{ m/s}^2$), but the wavelength is shorter than that of the reference signal. The PSD at the IRJ with the damaged insulation layer is shown in Figure 7b. The major two frequencies for this IRJ are 100 Hz and 645 Hz.

(a) ABA at an IRJ with damaged insulation layer (2010) (b) PSD at an IRJ with damaged insulation layer(2010)

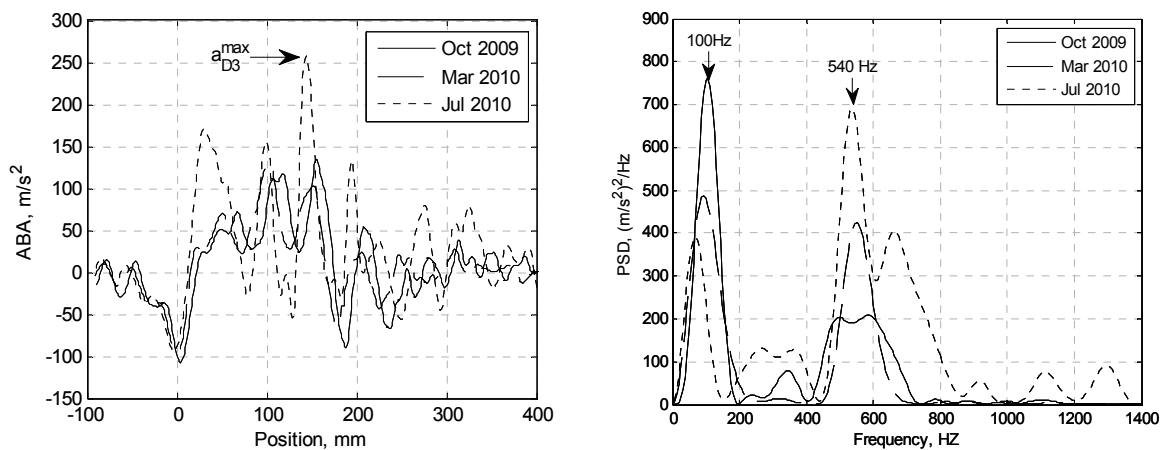
From these data it is impossible to extract the information about the health state of the IRJ due to low ABA magnitude and PSD. Thus, the retrospective analysis of the ABA measurements was performed to obtain more information. Figure 7c presents the ABA signals measured in October 2009 – July 2010. The ABA magnitude at this IRJ in October 2009 was $a_{D_3}^{max}=134 \text{ m/s}^2$, in March 2010 was $a_{D_3}^{max}=129 \text{ m/s}^2$, and in July 2010 was $a_{D_3}^{max}=257 \text{ m/s}^2$.

The major two frequencies in the PSD for this IRJ are 100 Hz and 540 Hz (Figure 7d). The frequency of 100 Hz is close to the frequency of 70 Hz obtained by the analysis of Figure 6f and must be related to the crack in the fastener. As for the damage of the insulation layer, it was difficult to see in these data any specific features related to this phenomenon.

(c) ABA trends at an IRJ with damaged insulation layer (d) PSD trends at an IRJ with damaged insulation layer

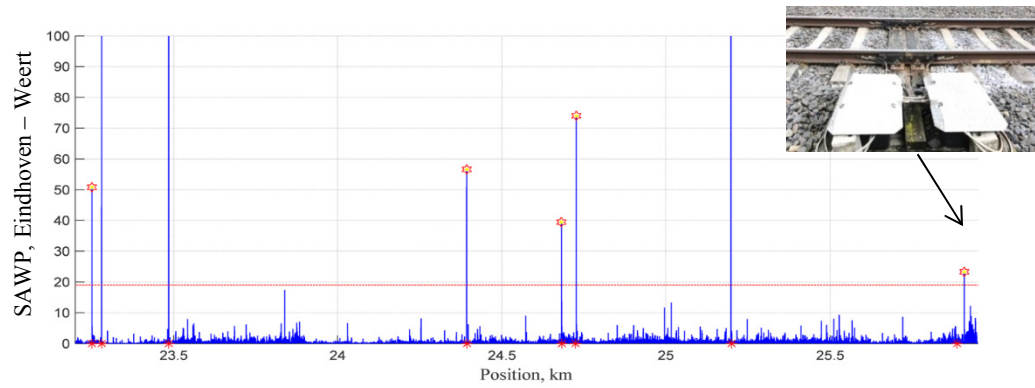
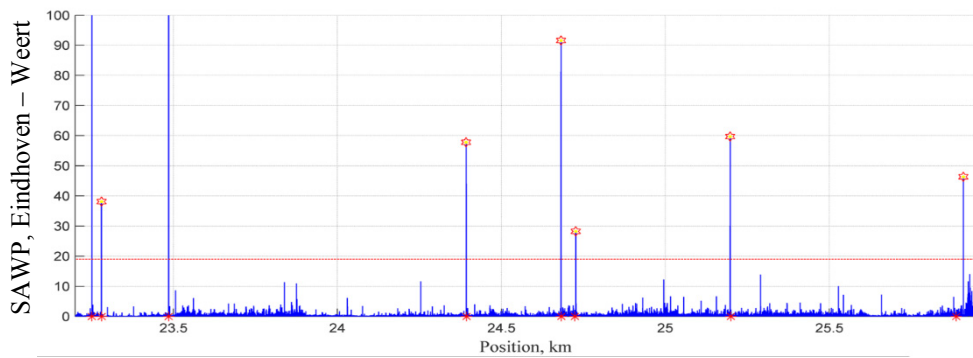
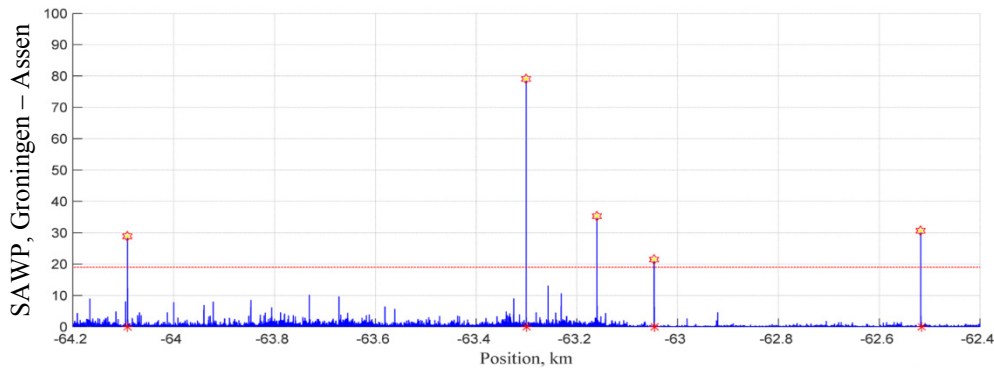
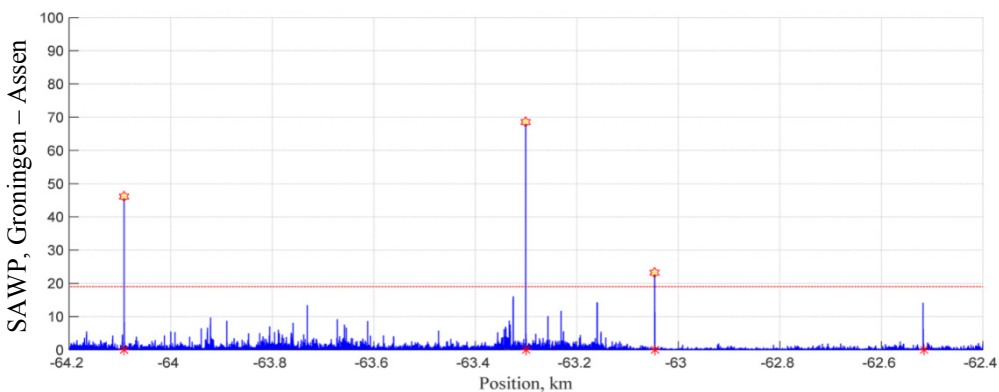
Figure 10: Detection of IRJs.

Figure 10a-b shows the calculated SAWP functions for right and left rails on a section of this track with 8 IRJ's locations, marked with red asterisks. The detection resulted in 77 predicted locations, with 62 of them being correct; 13 locations have been missed and 15 locations were falsely predicted. The hit rate of this detection is 83% and the false alarm rate is 19%.

Figure 10c-d presents the prediction for another track, Groningen – Assen. The length of the investigated track was 2.2 km with 4 IRJ's locations in total. One of the IRJs at position - 62.5km on the left rail was missed by the automatic detection. However, this location was detected from the signal on the other rail, and thus, by combination of the signals from both rails all the IRJs can be detected. In Figure 10c there is also one rail defect at -63.160 km.
