Surface characterization and microstructural evolution of railway rails in a medium-wide curve after preventive grinding

B. Schotsman ^{a,b}, M.J. Santofimia ^a, R.H. Petrov ^{a,c}, J. Sietsma ^a

Rail grinding
Preventive maintenance
Premium rail steel
Track test
Crack initiation

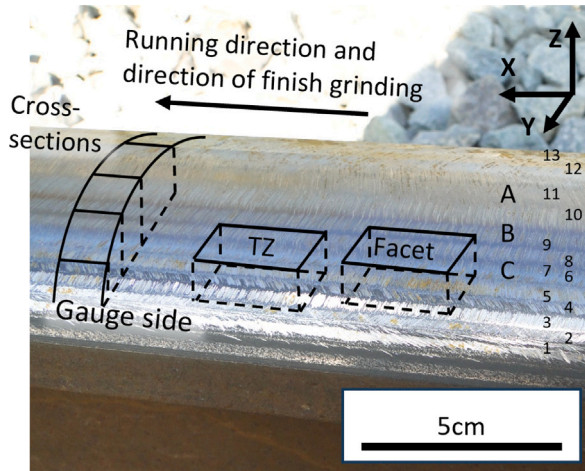
Fig. 2. Image of the ground in-service rail. At the rail surface are indicated: (1) Visually distinguishable ground facets (1–13). (2) Measurement positions for hardness and surface roughness measurements, A, B, and C. (3) The position of the metallographic sections: sections along the running direction at the facet and at the facet transition zone (TZ), and cross-sections.

The grinding pattern applied in the current study resulted in the presence of 13 observable facets on the final surface, as shown in Fig. 1, although in the grinding design even more facets are identified. The large number of facets requires a small grinding depth and results in even lower removal, and hence lower roughness, in the transition zones.

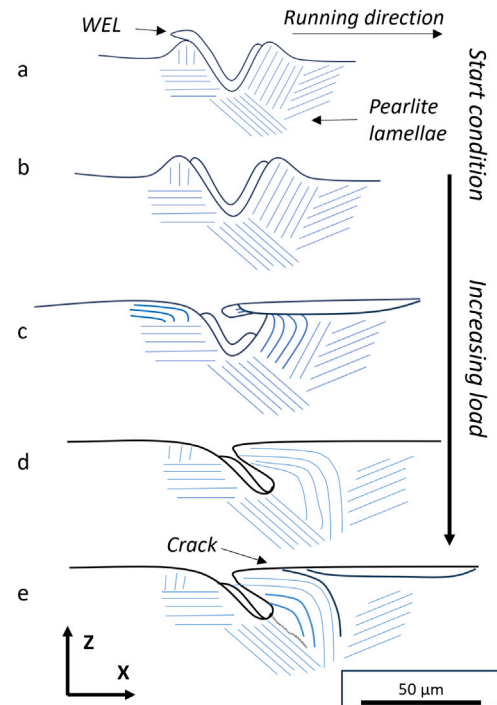
Fig. 10. Schematic model describing roughness reduction, and WEL removal, re-appearance and submerging of the freshly ground surface.

Fig. 10b represents the second stage. The majority of extruded slivers and semi-detached WEL patches are fractured and removed from the surface.
