# Demonstration of the Structural Resiliency of Damaged Sentryglas Laminated Heat Strengthened Glass Fins in Full Scale Testing

**Abstract:** A unique structural design was made for the glass façade of the Co-Creation Center building in Delft. The roof is completely carried by the glass fins. The fins are laterally stabilized by being included in the triple glazed façade. To certify the safety of the design full scale tests on the fins were done at Delft University of Technology. Due to a transportation accident the fins were damaged at one end. This allowed an additional study into the effect of this pre-test damage on the residual compressive stresses induced by the tempering. It was found that the residual stresses were not significantly affected by the damage. During the compression tests no cracks developed at the damaged ends. A load of 200 kN, more than double the maximum design load did not produce failure in the prototypes. After intentionally seriously damaging all plies of the fins, the fins could still carry the 200 kN load for 30 min without buckling or other failures being noted. Measurement of the residual stress in the outer plies of the fins after damage showed th

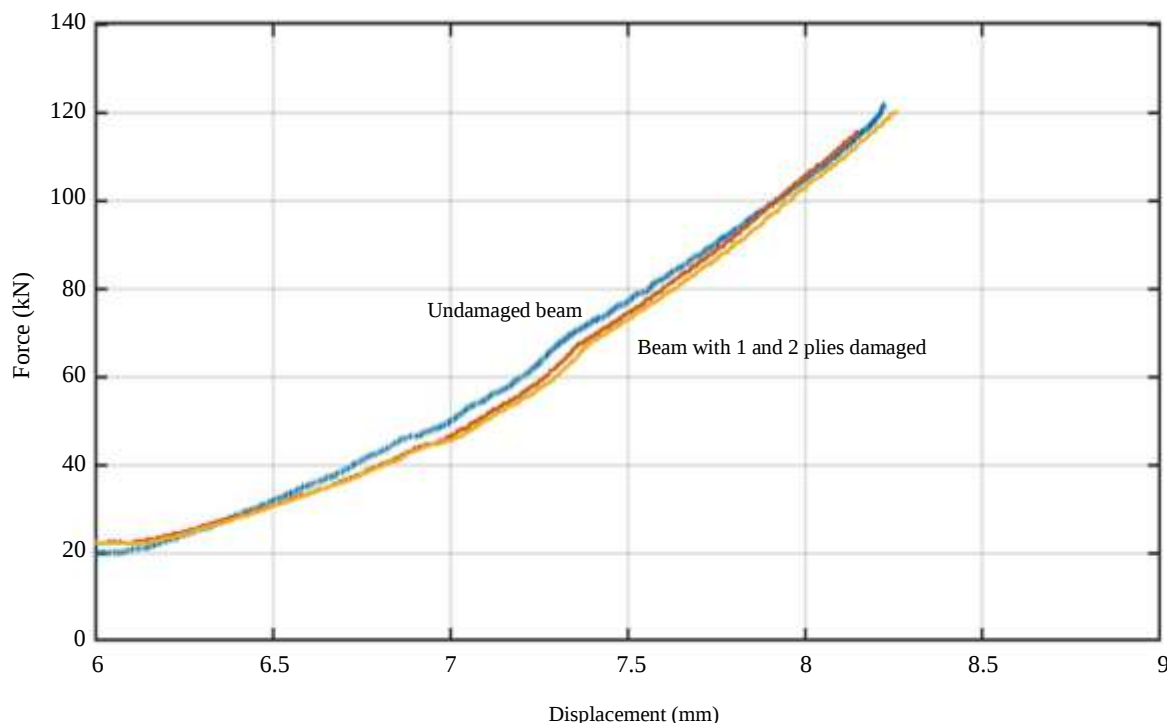
Fig. 10: Load displacement behaviour of specimen 1

There was no failure of the glass fin under loading. Both the undamaged and damaged specimens were capable of dealing with a load at least double the maximum load expected in service. Figure 10 shows the load/displacement behaviour of the tests on specimen 1. Figure 11 shows the load displacement behaviour of specimen 2. The initial non-linearity of the load displacement curves in Fig. 10 and 11 is the result of movement in the steel top connection, which requires some displacement before the load is fully

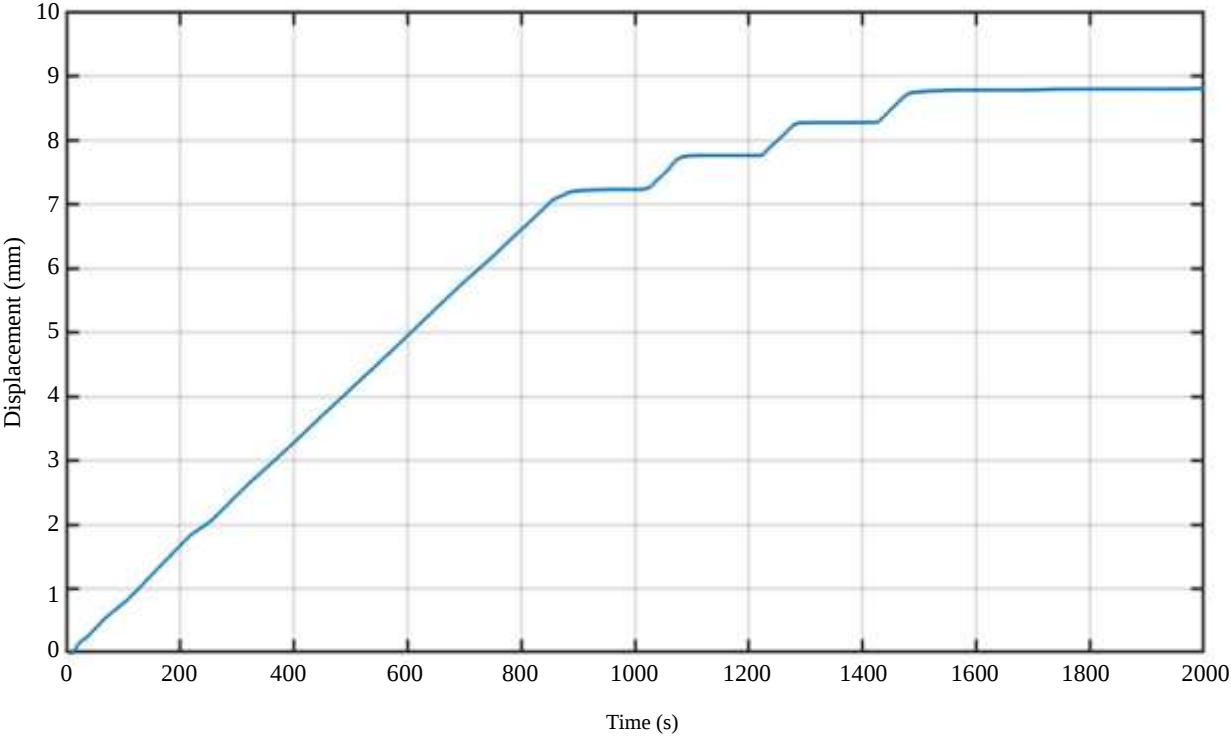
**Fig. 12:** Displacement time behaviour of the test on the 2 ply damaged specimen 1

The damage did not result in short term creep, as is shown in Fig. 12, as holding the load constant did not result in additional displacement. Considering the significant levels of damage inflicted on the specimens, as shown in Fig. 13, this result is significant as the interlayer plays a significant role in transmitting forces in damaged specimen.
