## Monitoring Pilot Study of Temporary Permeable Structures for Mangrove Restoration

Water

# Monitoring Pilot Study of Temporary Permeable Structures for Mangrove Restoration

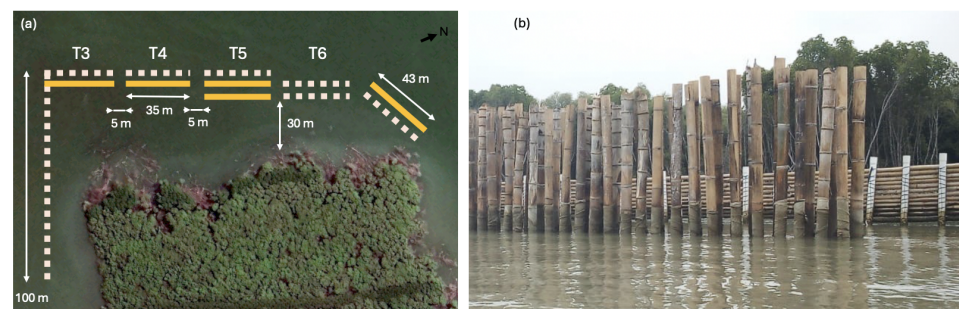
**Figure 2.** Layout of the structures built in the pilot project. (a) Overview of the arrangement of structures consisting of rows of vertical bamboo poles (white dotted lines), and horizontal bamboo beams attached to PVC poles filled with concrete (yellow lines). (b) Close-up details of a row of vertical bamboo poles (front) and row of horizontal bamboo beams attached to vertical PVC pipes (back).

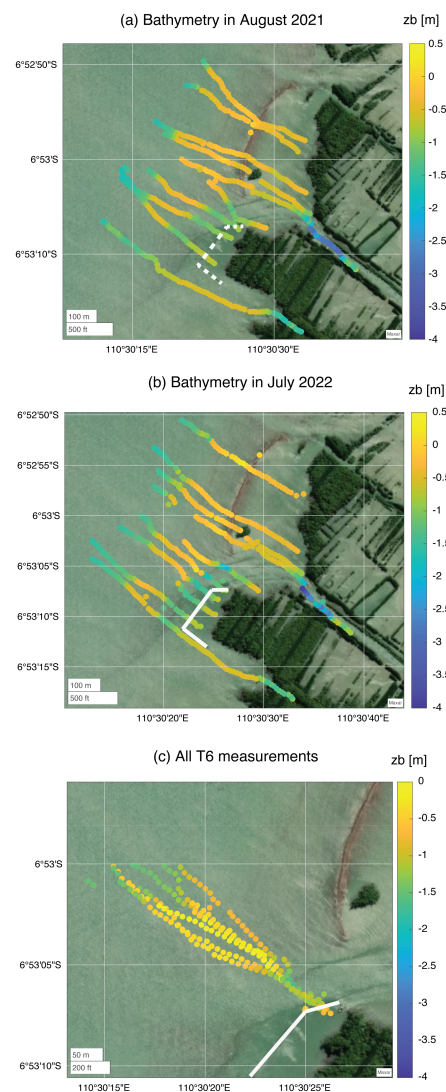
The bathymetry reveals two prominent features: a submerged chenier, represented by shallow (yellow) areas in Figure 4, and the drainage creeks extending from the mangrove stands, shown by blue-green dots. Between August 2021 (Figure 4a) and July 2022 (Figure 4b), the most significant large-scale changes include the deepening of several drainage channels and an increase in the crest height of the chenier, which rose above mean sea level, as it migrated onshore. The progression of these features over time is further illustrated in Figure 5, which provides a detailed view of the profile evolution over 10 months after structure construction. The bathymetry also shows that the structures aligned with the edge of an already present drainage channel, which deepened between August 2021 and July 2022 (Figure 4a,b).

**Figure 4.** Bathymetric profiles along monitoring transects, where  $z_b$  represents the seabed elevation relative to mean sea level (MSL) in meters. (a) Bathymetric profiles in August 2021, before the construction of the structures. (b) Bathymetric profiles from July 2022, showing the seabed elevation 10 months after structure construction. (c) Bathymetric profiles from all time measurements at transect T6, highlighting lateral variability and misalignment among measurements due to spatial differences in transect positioning. The location of the structures is indicated by white lines. In plot (a), a dashed white line is used to indicate that the structure had not yet been constructed at that time.

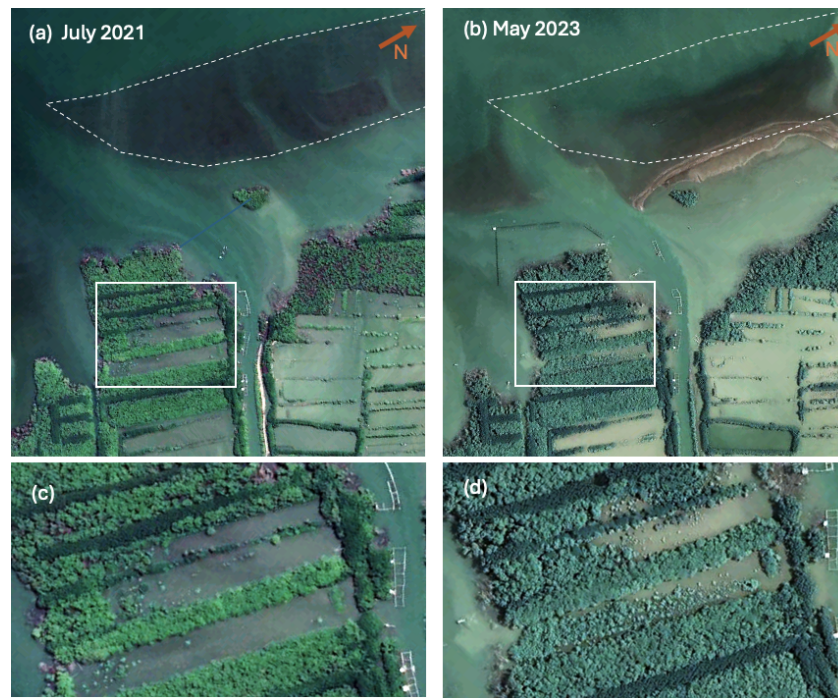
**Figure 6.** Satellite imagery from Google Earth depicting the study area in (a) July 2021, and (b) May 2023. The chenier outline from (a) is overlaid as a white dashed line in (b) for comparison. The landward migration of the chenier can be observed between (a,b). The white rectangles enclose areas with increase in mangrove cover between 2021–2023, with close ups for (c) July 2021 and (d) May 2023.

Despite the challenges faced by seaward mangrove fringes, mangrove establishment has been locally observed along the coast over the past decade. In Demak, Google Earth imagery reveals long-term mangrove colonization and growth at the seaward edge behind a stable chenier that has persisted in front of the coastline since 2015 (2 km north of Timbulsloko village), as well as behind a concrete seawall constructed in 2012 in Timbulsloko. These observations demonstrate the feasibility of mangrove restoration on subsiding

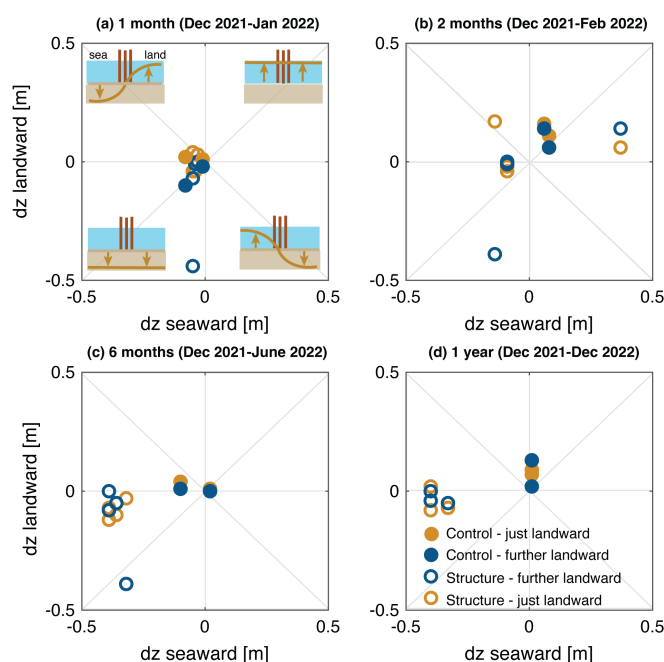
Seaward erosion occurred mainly within the first two months (Figure 8a,b), continuing into subsequent months as the area deepened significantly by June (Figure 8c) before stabilizing between June and December (see Figure 9). Behind T3 and T4, mild erosion persisted throughout the year. At T5, the bed level raised by 0.1 m between January and February 2022, perhaps due to sedimentation during storms within this period (see consecutive storms in January in Figure 3) but this sediment had eroded again by June. At T6, significant erosion occurred at the most landward point during the first month (Figure 8a), while bed level changes elsewhere were minor. The severe erosion observed at the seaward pole of T6 appears influenced by creek development, supported by the deepening of creek C3 in December 2021 (Figure 5e).

The control transect, where the chenier height was larger, exhibited complex dynamics: erosion in December, significant accretion in January, followed by erosion in February, minimal changes until June, and further accretion (up to 0.08 m) from June to December, when wave conditions were relatively milder (Figure 3). Accretion during calm wave conditions may have occurred in periods of elevated tidal levels, when submersion of the chenier top enables even small waves to generate significant morphodynamic changes [16]. The time series of a structure transect and a control transect are shown in Figure A1 of the Appendix A.

**Figure 9.** Seabed level changes (dz in meters) measured both landward (vertical axis) and seaward (horizontal axis) of a temporary permeable structure (empty dots), and at a control transect (filled dots) across four different time periods. The diagonal represents equal magnitude of the changes in the seaward and landward points. (a) December 2021–January 2022, representing one month during the Northwest monsoon season; (b) December 2021–February 2022, covering two months of the Northwest monsoon season; (c) December 2021–June 2022, representing a six-month period; and (d) December 2021–December 2022, capturing a full year. These plots illustrate sediment accumulation or erosion patterns in proximity to the temporary permeable structures compared to sites without structures. Sketches illustrating the erosion patterns for different combinations of bed level changes seaward and landward are shown in plot (a).

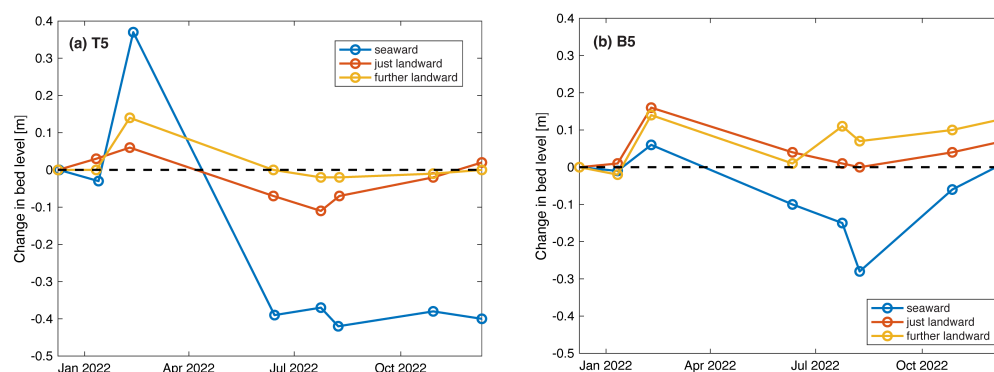
The time series of bed level changes for the structure transect T5 and the control transect B5 are shown in Figure A1.

**Figure A1.** Time series of bed level changes from monitoring poles at T5 (a) and B5 (b). Each subplot shows three lines representing measurements taken at different locations: seaward, landward, and further landward.
