## Microstructural investigation into the damage mechanism of short pitch rail corrugation

Zhang, Pan; Li, Shaoguang; Ren, Fang; Hajizad, Omid; Dollevoet, Rolf; Li, Zili

Engineering Failure Analysis

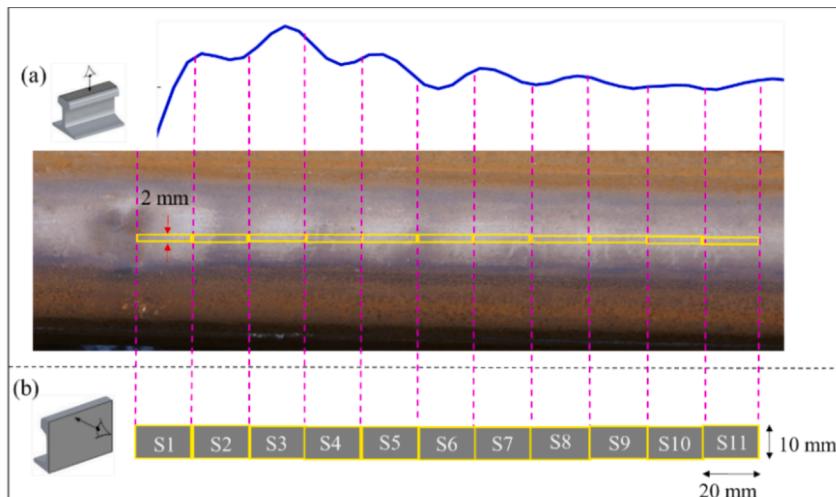
**Fig. 2.** The cutting scheme of eleven longitudinal-vertical specimens from the corrugated rail sample.

To investigate the microstructural alterations and damage mechanisms of rail corrugation, eleven longitudinal-vertical specimens (S1, S2, ..., S11) were prepared by cutting the rail sample along the center of the running band, as shown in [Fig. 2](#). The dimensions of each specimen are 20 mm × 10 mm × 2 mm in the longitudinal (rolling), vertical and lateral directions, respectively. Based on their loading conditions, these specimens are categorized into three groups: the first group is located within the corrugation zone and is significantly influenced by impact loads from squats (e.g., S1 and S2); the second group is within the corrugation zone but is only slightly affected by squats (e.g., S5 and S6); and the third group is in the non-corrugation zone (e.g., S10 and S11). Specimen preparation followed standard metallographic procedures, including sectioning, embedding, polishing, and etching with a 3 % Nital solution.

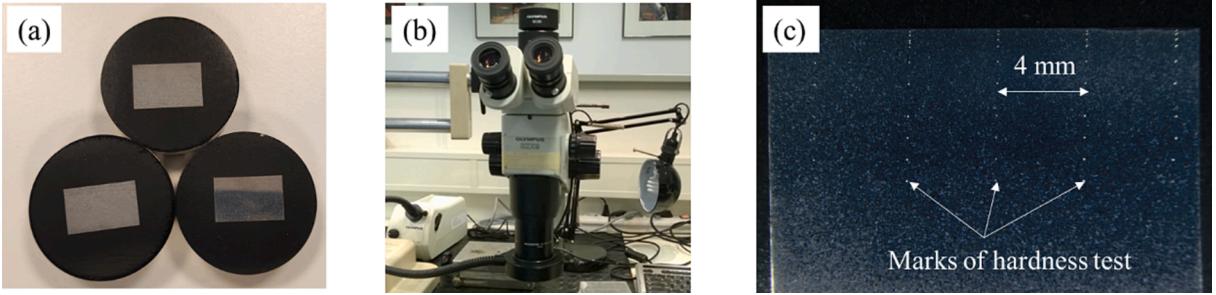
**Fig. 3.** Rail specimens and test methods. (a) rail specimens; (b) LOM; (c) micro-hardness test with remaining indentation marks in the specimen.

The microstructures of each specimen were examined and recorded along the longitudinal direction at intervals of about 0.66 mm (corresponding to one image size) using an Olympus BH-2 light optical microscope (LOM), as shown in [Fig. 3b](#). To investigate the mechanical properties of corrugated rail materials, micro-hardness tests were performed on each specimen at intervals of approximately 4 mm, at different depths: 0.1 mm, 0.25 mm, 0.5 mm, 1.0 mm, 2.0 mm, 3.0 mm, 7.0 mm, as shown in [Fig. 3c](#). The testing device
