# Assessing Salt-Induced Degradation in Historic Timber-Masonry Buildings Using Micro-Drilling: A Dutch Soda Factory Case Study

The timber elements of the monumental Sodafactory building in Schiedam, the Netherlands, were investigated to assess the extent of salt-induced degradation. The damage was primarily caused by defibration, a chemical process caused by salt crystallization within the wood structure, which separates the wood cells, induces mechanical rupture, and ultimately results in a complete loss of strength. While the damage is visually detectable, it is difficult to quantify reliably. To address this, micro-drilling measurements were performed in radial and tangential direction on eight wooden beams, which appeared to be severely defibrated. Micro-drilling proved effective for quantitative measurements of decay, supported by a TU-Delft developed algorithm to scientifically determine decay from micro-drilling signals. Results showed that, beneath the layer of defibrated wood, the beams generally remained structurally sound. Only two of the eight beams were found to be severely decayed, with less than 50% of their original cross-section remaining intact. Microscopic anal

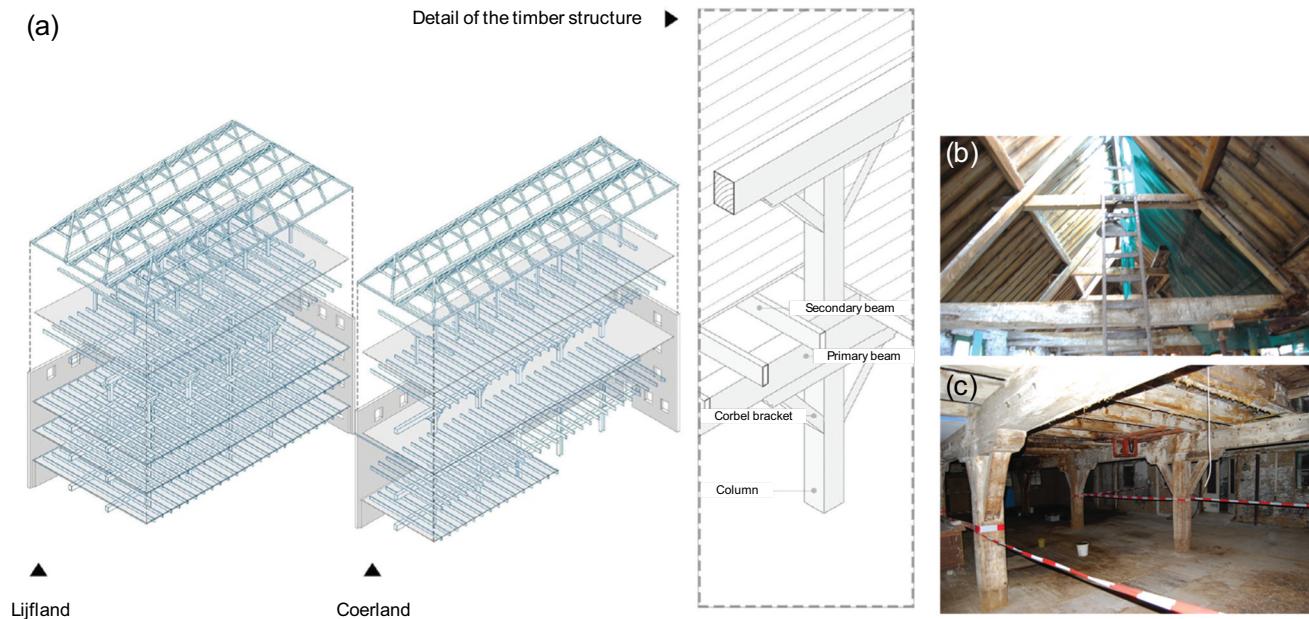
**Figure 2.** (a) The Lijfland and Coerland building parts of soda factory: timber elements are highlighted in blue (Adaptation from Van der Weele et al. 2020); (b) Roof structure and (c) internal timber structure in Coerland.

excluding the masonry building envelope, consists of wooden elements. Over time, these wooden components have experienced deterioration, leading to physical damage from chemical processes of salts generated by the soda production. Salts, in combination with moisture, have caused extensive, visible defibration damage throughout the building. The salt on the timber surface creates visibly white deposits known as salt efflorescence (Johnson, Ibach, and Baker 1992; Ortiz et al. 2014; Blanchette, Held, and Farrell 2002). Dissolved salts penetrate the wood, and when the wood dries, the salts crystallize inside it (Mi et al. 2020; Oren 2008). This crystallization breaks open the wood fibers (defibration), forming a “fuzzy” surface layer (Figure 3). Strong alkalis can degrade wood in a way that visually resembles fungal decay (white and bleached appearance). Initially, the damage mainly affects the surface, while the core of the wood often remains in good condition. In time, the progression of the crystallization can lead to a thinner load-bearing core of the beam, ultimately leading to failure (Figure 3b). The repeated dissolving and crystallizing process caused extensive damage also to the masonry walls of the Sodafabriek (Brocken and Nijland 2004; Sharma et al. 2025). However, this study focuses primarily on timber damage.

The second floor of the Lijfland building was used to store soda in containers, allowing it to dry and crystallize. It is highly likely that this process was the primary cause of degradation observed in the wooden elements. Water, rendered alkaline by the presence of sodium carbonate, could come into contact with the wooden beams, leading to chemical damage and accelerated deterioration of the wood. This theory helps to pinpoint a specific salt source in the building, useful for identifying the cause of the damage. Based on this assumption, selected primary and secondary beams on the ground, first, and second floors of the Lijfland building were investigated (see Chapter 2: Materials), with the choice

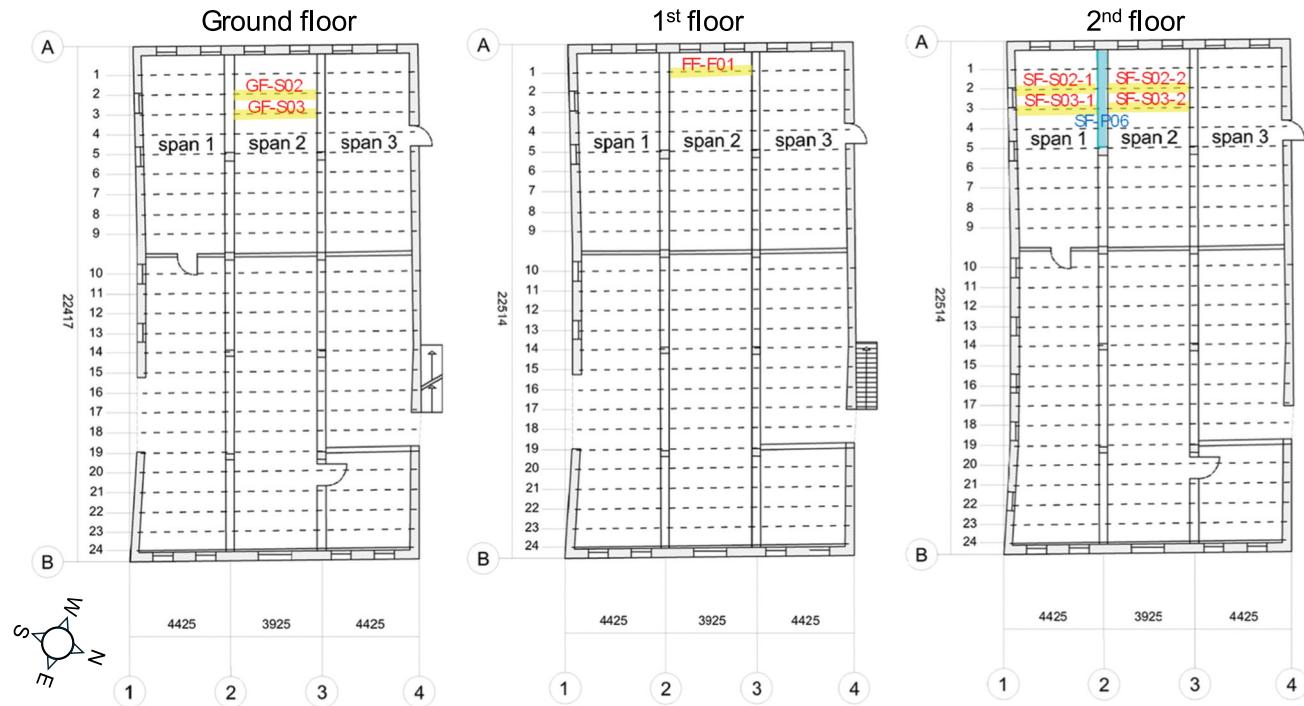
The investigation focused on the primary and secondary spruce (*Picea abies*) beams located in three rooms within the Lijfland building (See Figure 4), which exhibited severe decay and raised concern about the safety of the building. The rationale behind this choice is supported by a preliminary investigation carried out using visual inspection and simple tools (chisels and screwdrivers) to remove the layer of fuzzy, decayed wood and gain a qualitative understanding of the damage severity. The selection of the analysed beams is based on the observation that the most severely deteriorated elements were located in the western part of the building (Figure 4), directly beneath the bays where the storage tanks had been placed.

**Figure 4.** Plan of the ground, 1st and 2nd floors in Lijfland building, divided into 3 main spans. The beams investigated are highlighted and coded. The measurements are expressed in millimeters. The beam sections highlighted in the figure represent the original cross section without decay as listed in Table 1.

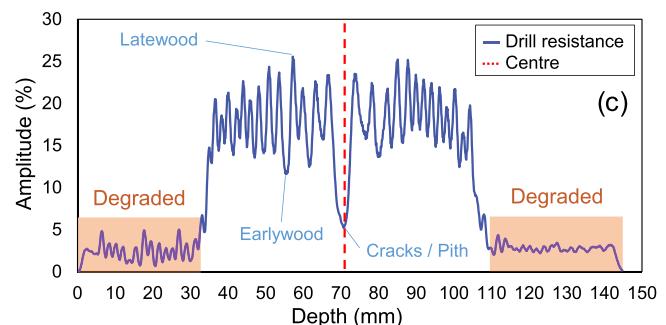
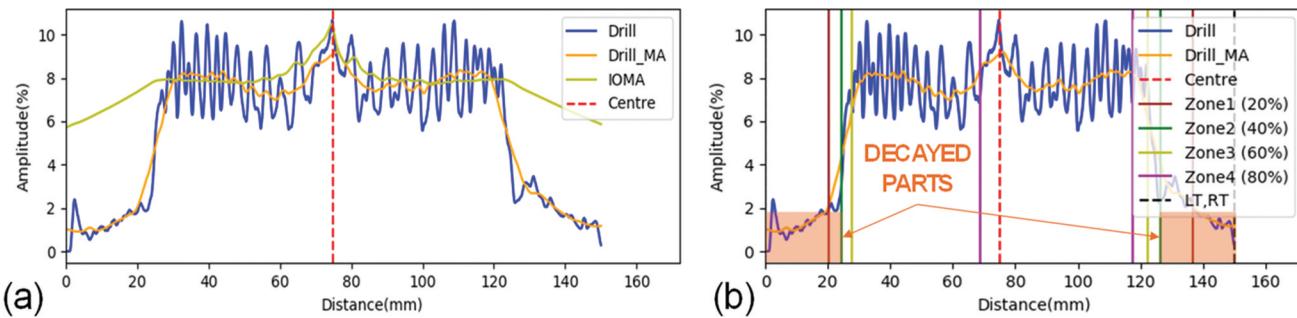
**Figure 6.** Example of the analysis of the drilling signal (Drill B) for a decayed spruce round wood: a) drilling moving average (Drill\_ma) and IOMA from which the zones are calculated; (b) 4 zones and decayed parts (soft shell) associated to zones 1 and 2.

(2024). Both soft shell depths (right and left) are measured. An example is shown in Figure 6.
