Confirming Debonding of Non-Metallic Inclusions as an Important Factor in Damage Initiation in Bearing Steel

Nikolic, Ksenija; De Wispelaere, Jelle; Ravi, Gopalakrishnan; Hertelé, Stijn; Depover, Tom; Verbeken, Kim; Petrov, Roumen H.

In this work, we investigated a failed tapered roller bearing that operated in a wind turbine. The bearing was removed from the gearbox following the formation of an axial crack. All specimens were extracted from the inner ring. The specimens are made of AISI 52100 martensitic steel and have a chemical composition as shown in Table 1. The resulting microstructure consists of tempered martensite, spheroidal carbides homogeneously distributed in the martensitic matrix, and transition carbides [42]. Transition carbides are precipitates formed during tempering treatment from supersaturated martensite; they include η and ϵ carbides [46]. To examine the presence of non-metallic inclusions (NMIs) and any associated damage in the bearing, 4 samples were cut from the zone of interest along circumferential and axial planes in the loaded zone (Figure 1). Samples were prepared for metallographic observation using a Struers (Struers, Ballerup, Denmark) type 50A15

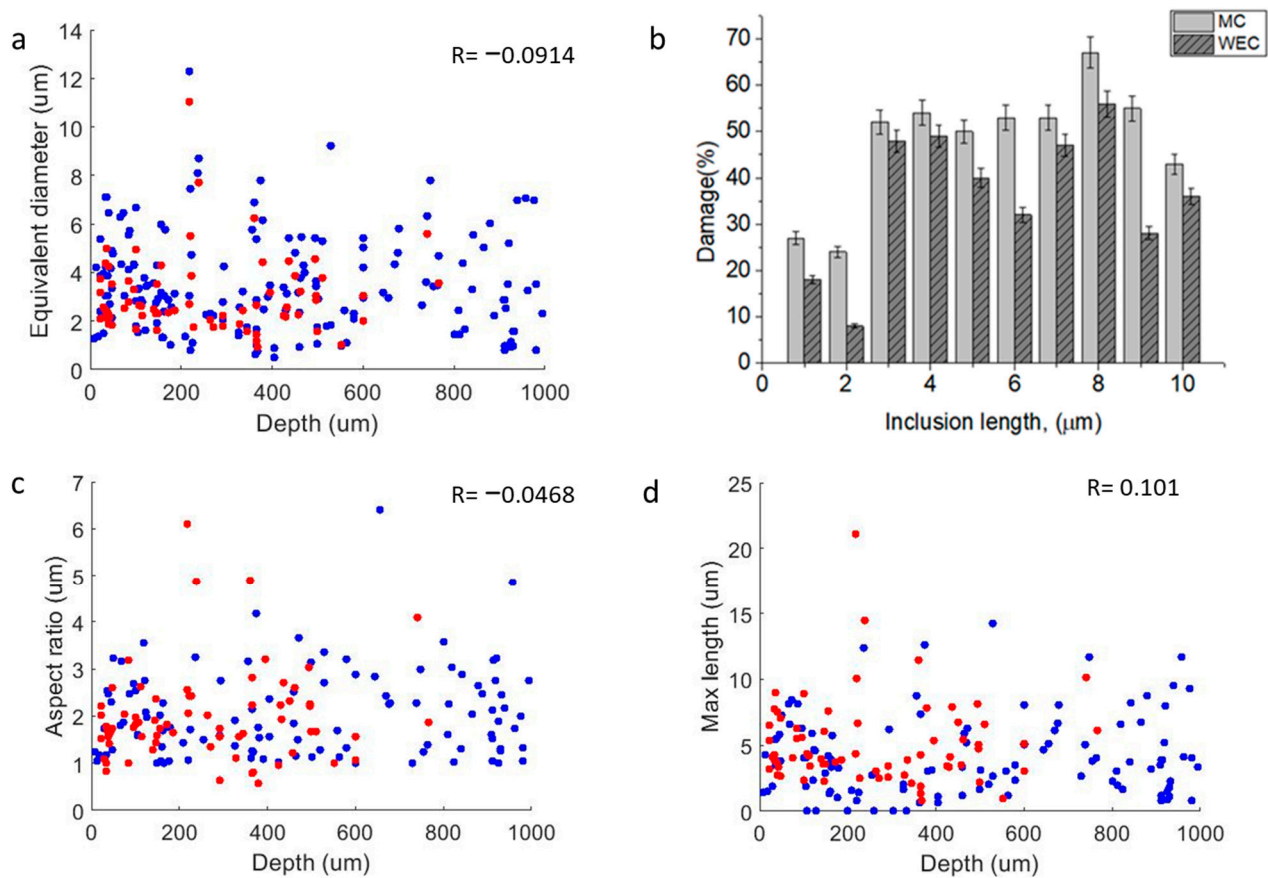
with the observations in [24,26]. Figure 8 shows the depth versus size, aspect ratios, and max length of the inclusions; red dots are the inclusions that initiated damage, and blue inclusions are without damage. The equivalent diameter of the inclusions across depth suggests that they are randomly distributed throughout the sample (cf. Figure 8a). In Figure 8b, we observe the relationship between inclusion length and the percentage of initiated MCs and WECs. The damage percentage was determined by categorizing all non-metallic inclusions in the loaded zone based on their size per 1 micron, such as 0–1 micron intervals, 1–2 microns, 2–3 microns, and so on. Subsequently, the total number of non-metallic inclusions in the specific zone and the count of damage initiated by these inclusions were established. Inclusions measuring up to 2 μm exhibit a low probability of damage, less than 30%. However, as the inclusion length reaches 3 μm and beyond, there is a significant rise in damage initiation. The greatest percentages of damage occur at inclusion lengths of 8 μm , with 66% for MC and 56% for WEC. A similar observation as in Figure 8a is valid for the aspect ratio, maximum length of the inclusions (cf. Figure 8c), and maximum length across the depth of the sample (cf. Figure 8d).

Figure 8. (a) Distribution of inclusion size across depth. (b) Percentage of initiated MCs/WECs in correspondence with inclusion length. (c) Maximum length of inclusions across depth. (d) Aspect ratio across the depth. Red represents inclusions that initiated damage, and blue indicates inclusions without damage.

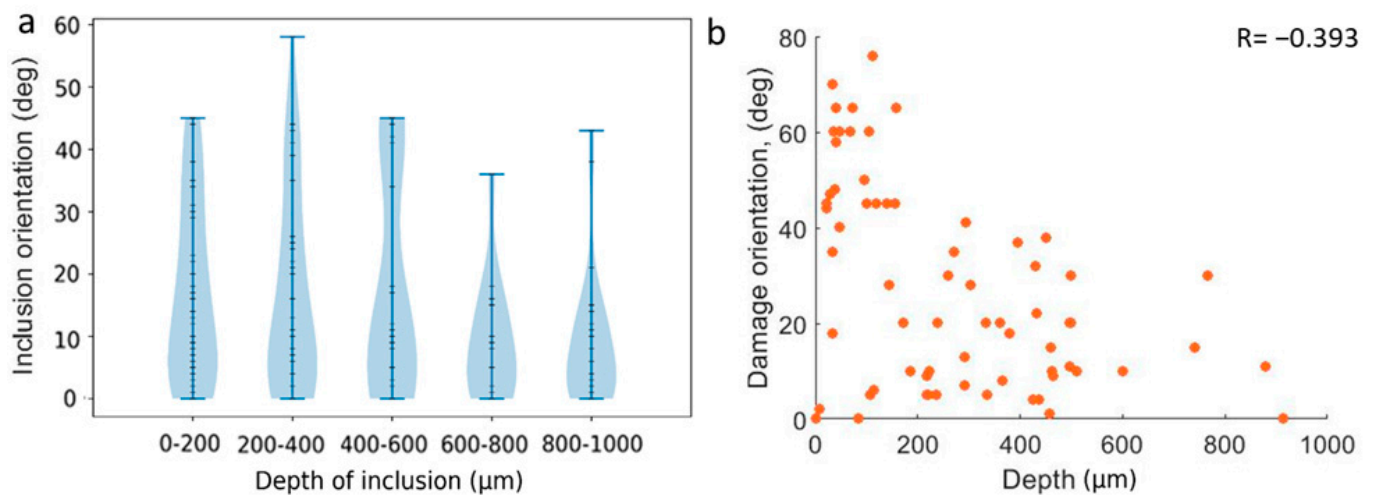
In this section, the microstructural features of butterfly wings and white etching cracks were evaluated. Some authors referred to both as a non-linked phenomenon [23], while others see the BWs as a precursor for WECs [26,35,47,48]. It is reported that WECs appear to develop in parallel or branching patterns without following any particular maximum shear stress directions [49]. In this study, BWs were found down to 200 μm below the surface, with the majority of them being closer than 100 μm to the surface. The inclusions leading to WECs were located within a band of 200–500 μm below the surface, which is assumed to be the zone that experienced high rolling contact stresses. It is widely accepted that BWs initiate within the angle of 45 degrees with respect to the over-rolling surface. Moreover, given the depth below the surface, WECs cannot initiate at these angles as the shear stresses are not the same as in the zone up to 200 μm . Of course, these numbers correspond to this particular bearing, given its particular loading history. The orientation of the inclusions in relation to the distance below the surface is presented in Figure 9a. Inclusions tend to have a lower orientation angle smaller than 30 degrees. The orientations of microstructural alterations across the depth of the sample are presented in Figure 9b. Most of the alterations up to 200 μm are oriented close to 45 degrees, and the angles become shallower as the inclusion depth increases.

Figure 9. (a) Inclusion orientation across the depth. (b) Average angle of damage in relation to depth.

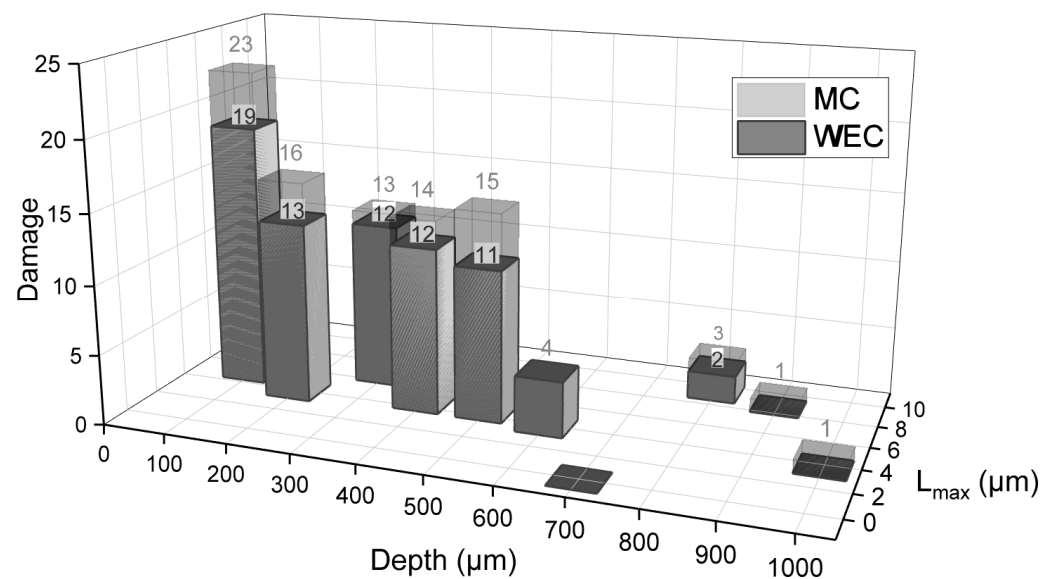
Figure 11 shows the occurrence of white etching cracks and matrix cracks across the depth of the sample and their corresponding length. The average value of multiple inclusions length per 100 μm is shown. A clear trend can be observed with a high number of cracks (matrix cracks and white etching cracks) up to 500 microns, followed by a steep decline, with only one matrix crack present at a distance between 900 and 1000 μm . Moreover, the average length of inclusions varied from 4 to 6.5 μm , up to 500 μm below the raceway surface, and at distances greater than 500 μm longer (around 9 μm), inclusions initiated a matrix crack. Furthermore, the size of white etching areas changes as the distance from the raceway surface increases. Within a range from the raceway surface up to 200 μm , the length of the white etching varies from 10 to 30 μm , with one exception where a length of 100 μm was measured. The longest white etching cracks (in a range of 100 μm) were found in a zone between 200 and 500 μm . At larger distances within the range of 500–1000 μm , shorter white etching cracks with an average length of 30 microns were observed. This indicates the influence of stresses, i.e., at greater distances (>500 μm), longer inclusions are required for damage initiation.

Figure 11. WEC and matrix crack initiation in relation to inclusion size and distance from the raceway surface.

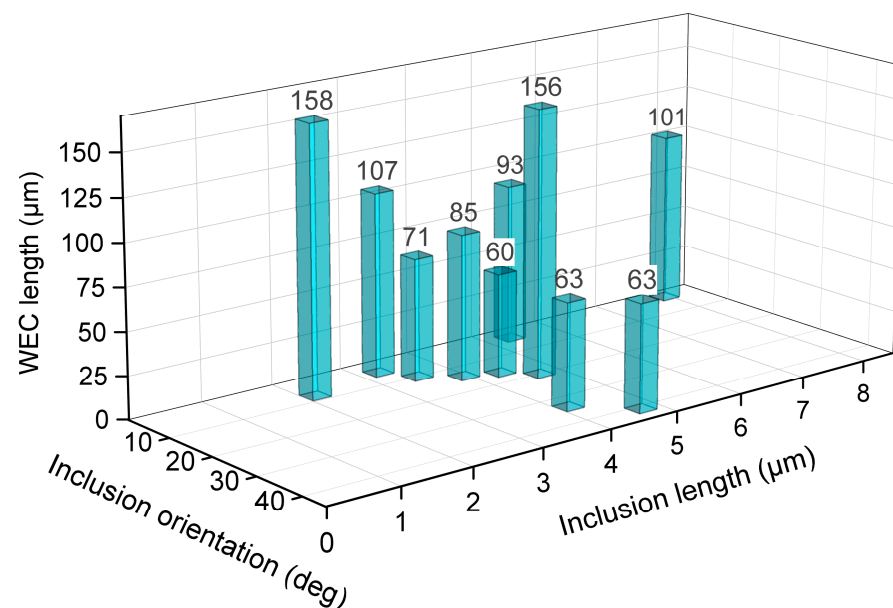
In this section, the lengths of the inclusions that caused the longest WECs in this bearing were analyzed to disclose the main factor for the damage initiation from the size, shape, angle, or debonding. However, it is important to note that all observations were conducted in two-dimensional sections. WEC networks were relatively short (up to 160 μm)—as such, the inclusions related to WECs were considered to be the initiation locations of WECs rather than the propagating WECs being incidentally connected to the inclusion. Figure 12 shows the length of WECs, the length of inclusions, and the orientation of the inclusions to the raceway surface. The lengths of the inclusions that initiated the longest WECs were in the range of 2–5 μm ; most of them (90%) ranged from 350–500 μm below the raceway surface. The orientations of the inclusions varied from 3 to 44 degrees with respect to the over-rolling direction, suggesting that there is no strong link between the inclusion orientation and the initiation of damage. The majority (85%) of inclusions showing WECs were debonded from the steel matrix. In this case, the shape was not considered because most inclusions (85%) in the studied bearing were globular. The chemical composition of the inclusions that initiated long WECs was, in most cases, (87.5%) pure manganese sulfide without the addition of calcium, magnesium, or alumina. It should be noted that the percentage of so-called multi-phase inclusions was low throughout the bearing at only 23%. Based on this observation, it is suggested that small (2–5 μm) debonded MnS inclusions caused damage initiation.

Figure 12. Overview of the longest WECs observed in the studied bearing. The length of WECs was plotted to the corresponding length of the inclusion that initiated WEC and the inclusion orientation to the over-rolling direction.

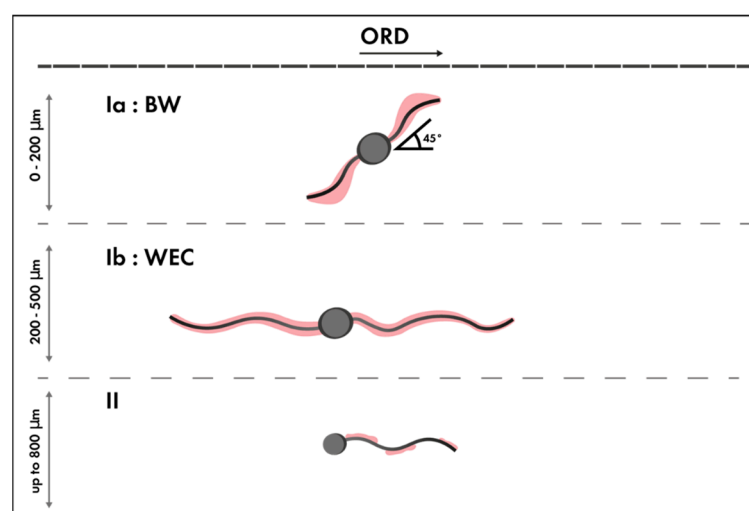
Comparing the microstructural alterations in different zones, earlier postulated mechanisms about crack rubbing and severe plastic deformation can be confirmed. A graphical representation of the proposed hypothesis is shown in Figure 14. In zone Ia, only individually present BWs were observed, which had a typical 45-degree propagation on either side of the non-metallic inclusion. In zone Ib of Figure 14, most of the WECs consisted of cracks propagating left and right from the non-metallic inclusions with a significantly thick WEA developed in the vicinity of the WEC. In zone II, most cracks appear only on one side of the non-metallic inclusions and the accompanying WEA was thinner than in zone Ib. These findings are in line with the previously proposed mechanism [35,52]. Indications of severe plastic deformation can be derived by comparing zones Ib and II. Zone II (where the stresses due to over-rolling contact are less pronounced) had a less deformed area around the WEC. Lower stresses mean that crack face rubbing is less intense; consequently, less WEAs are formed.

Figure 14. Schematic representation of the appearance of microstructural alteration with respect to the angle of initiation and depth below the raceway surface.
