## Unravelling corrosion degradation of aged aircraft components protected by chromate-based coatings

2024

Engineering Failure Analysis

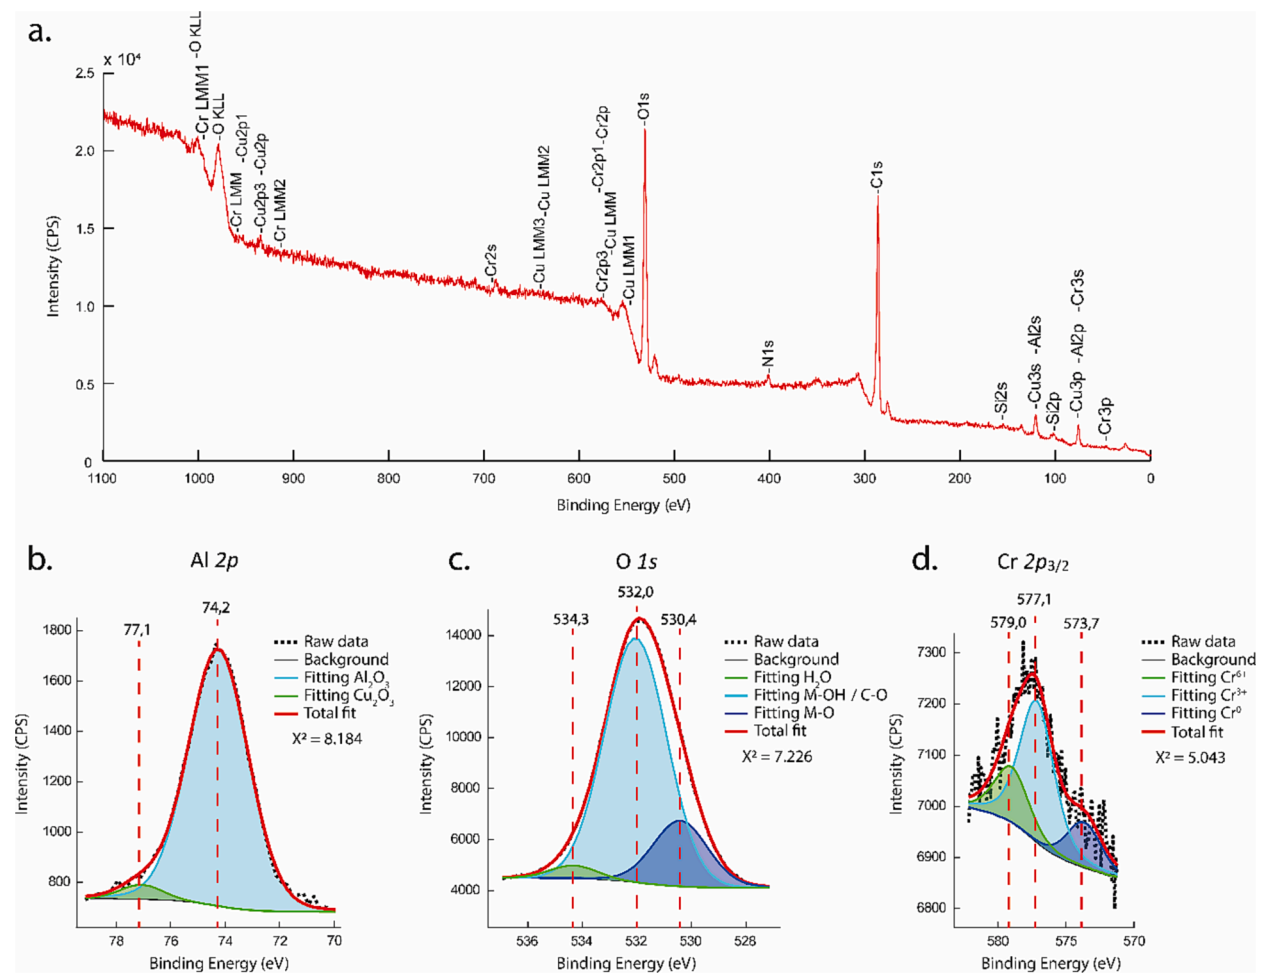
The high-resolution spectra, depicted in Fig. 5, reveals distinctive peaks corresponding to the elements of aluminium (Al 2p), oxygen (O 1s) and chromium (Cr 2p<sub>3/2</sub>). Fitting and analysis of the obtained spectra provides valuable insights. The aluminium spectrum (Fig. 5b) indicates the primary presence of aluminium- and copper-oxide, confirming the presence of the aluminium alloy

**Fig. 5.** XPS survey spectrum (a), including fitted outcomes in the high resolution spectra, obtained from the region at the tip of the investigated aircraft component, elucidating the elements (b) aluminium, (c) oxygen, and (d) chromium.

AA2024-T62 in the bare aluminium regions [36–38]. The broad Al 2p spectrum also encompasses contributions from aluminium hydroxides (Al(OH)<sub>3</sub> and AlO(OH)) [37]. To gain a deeper understanding of the varying amounts of metal oxides and hydroxides, the oxygen spectrum is further analysed.

The fitted oxygen spectrum (Fig. 5c) reveals the presence of H<sub>2</sub>O, metal hydroxides (e.g., aluminium and chromium hydroxides), and metal oxides [37,39–41]. The heightened concentration of aluminium oxide is attributed to the damaged anodized oxide layer as observed in the bare aluminium surfaces (Fig. 3e). The presence of metal hydroxide bonds can be ascribed to the corrosion of the aluminium alloy and the sealing treatment after anodizing, both resulting in aluminium hydroxide. The metal hydroxide bonds can further be attributed to chromium hydroxide, as indicated by the distinctive chromium peak in the Cr 2p<sub>3/2</sub> spectrum, as depicted in Fig. 5d.
