# Geotechnical Hazards | Geological Considerations in Dams Failure

Teodora Barbuntoiu

A Thesis in the Field of GeoEngineering  
For the Degree of Bachelor of Applied Earth Science

Delft University of Technology

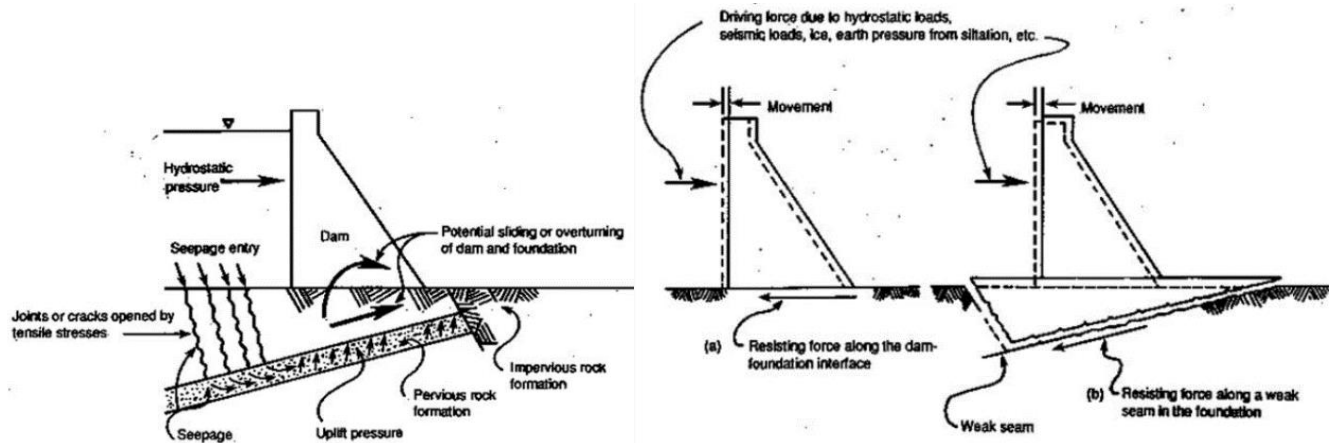
Figure 2: Uplift pressure in a dam (left) and sliding failure (right) (Empson, 2013)

Figure 2, left sketch, illustrates the effects of the uplift pressure present in the cracks within a dam but also in the pores and joints of the foundation rock. Figure 2, right sketch, puts emphasis on the devastating effect of sliding if the driving force is greater than the resisting force. Both uplift and sliding are drivers of instability for dams and can lead to failure, as exemplified in Table 2.

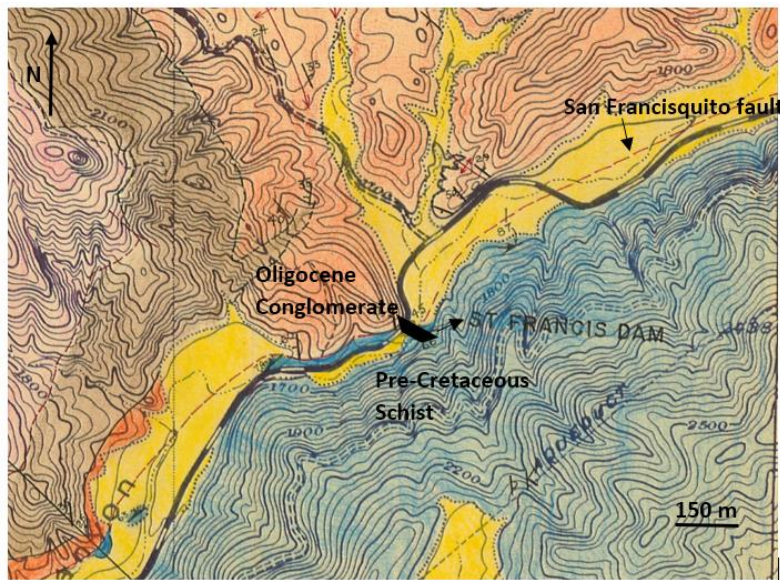
Figure 5: Geological map of the San Francisquito Creek (Ruiz-Elizondo, 1953)

The two meter wide Francisquito fault is filled with gravelly clay gauge (Stapledon, 1976) of comminuted schist which is hard when dry and oily when wet. The fault lays halfway the abutment and has a strike parallel with the course of the canyon (ICOLD, 1974). The strike-slip fault juxtaposes high-grade Pelona Schist on the south with non-metamorphosed Mesozoic rock units on the north such as the Sespe Formation (Bunker, 2001). The fault can be seen also a dotted red line in Figure 5 in the geological map, creating a clear boundary between Sespe and Pelona Formation.

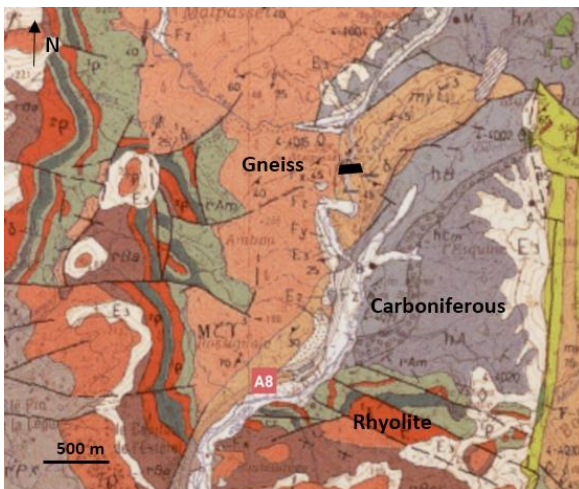
This major dam hazard is due almost entirely on geological causes (Walters, 1962). As a result of this, special attention will be given to the geology of the area in order to clarify what went wrong and how a more thorough site investigation could have prevented this collapse. From the regional geology, it is known that the dam is situated in the Provence Alps, in a synclinal Carboniferous zone enclosed by metamorphic horizons of the base of Massif de l' Esterel (Walters, 1962), an area with intense tectonic movement. The geological map enclosed in Figure 12 shows that the dam was founded in an area of Rhyolite flows and Carboniferous rocks, known as the Houiller du Reyran formation. The gneiss formation (Gneiss du Tanneron) overlies much of the site merges with the carboniferous sediments downstream in the valley (Jaeger, 1979).

Figure 12: Geological Map in the part of the Provence Alps, where the Malpasset Dam is located ("BRGM | FRENCH GEOLOGICAL SURVEY," n.d.)

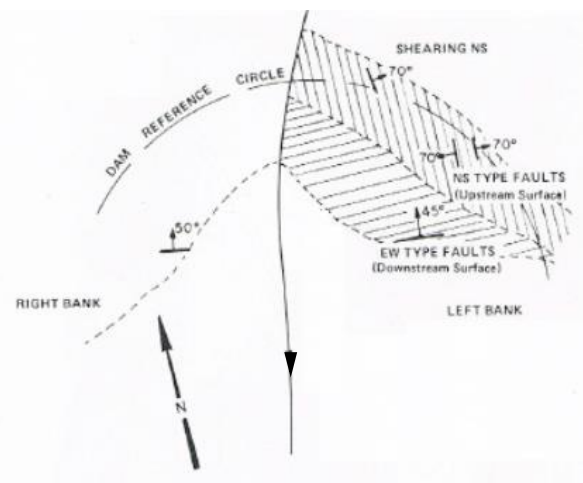
Figure 13: Geological Sketch of dam area (Goodman 2013)

Local geology comes with a comprehensive description of the rocks at the site. In general, banded gneiss and schist of Pliocene age are exposed at surface at the site location and the primary rock present is augen gneiss, phyllite rich, poor in feldspar and with a schistose structure. The schist is prominent on the left bank and lower part of the right side with the foliation dipping downstream 40 degrees into the right abutment. The rocks exhibit minerals such as sericite and chlorite (Goodman, 2013), which decreases the mechanical strength of the rock. The sericite schist has unconfined compressive strength tested in laboratory ranging from 30 to 50 MPa in contrast to the in-situ measurements of 1 MPa rock mass strength (Thomas, 1979). This difference can be

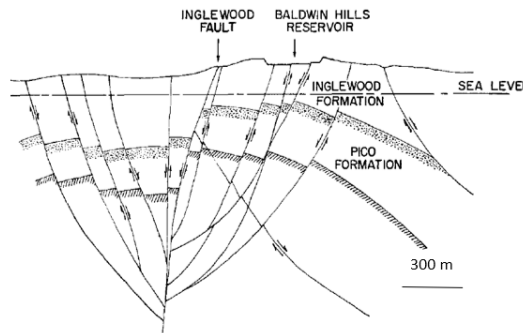
Figure 19 shows the geological cross-section which illustrates the stratigraphy in the Baldwin Hills. At the surface, the soil mantle is clayey silt for less 1 m, overlaying another thin layer of alluvium layer, a mixture of silt, clay, sand and gravel. The first formation encountered is the Palos Verde from upper Pleistocene, about 20 m thick, fine to coarse sands occasional interbedded with silts or soft sandstone (Hudson & Scott, 1965). It is highly erodible, proof given by the deep gullies found next to the reservoir (ICOLD, 1974). Below Palos Verde lays Inglewood Formation which dates from lower Pleistocene. It is 30 m thick and is composed of thick fine sands, interbedded with silts and clays (Hudson & Scott, 1965). This formation ranges from hard rock to loose, as shown by the powdery sands and silts which were eroded and exposed at failure (ICOLD, 1974). The deepest formation is Pico Formation dating from upper Pliocene which is the thickest (more than 500 m) and composed of silt, very fine sands and clay interbedded with soft siltstone (Hudson & Scott, 1965). It is more massive than the overlying formations and less erodible than Inglewood formation (ICOLD, 1974).

Figure 19: Geological Cross section in the Baldwin Hills region (Hudson & Scott, 1965)

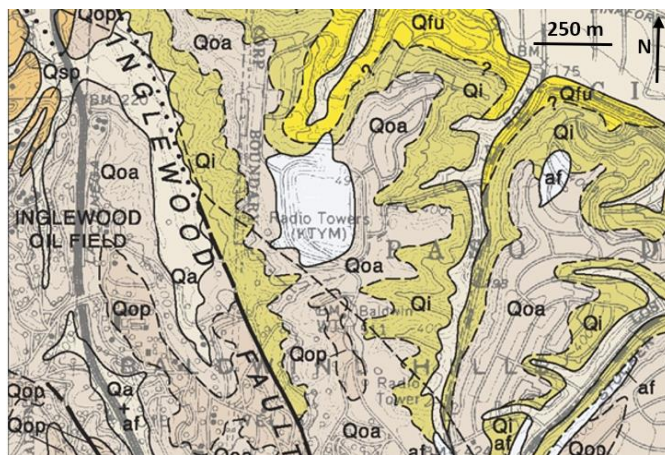
The interpretation of the layers in the Baldwin Hills area is confirmed by looking at the geologic map administered by the U.S Geological Survey (USGS) in Figure 20. We can identify the 'Qoa' to be the Palos Verde formation, upper Pleistocene, slightly consolidated and very erodible. The Inglewood Formation is exposed at the surface near the site and it is depicted as 'Qi' in the geological map. The last layer that the reservoir encounters on the northern face is 'Qfu', which is described by the USGS as the Upper Fernando Formation. From literature, we know that the upper Fernando formation is from the same age as the Pico formation, Pliocene and Pleistocene (Blake, 1991), thus it can be assumed that both the cross section and the geologic map may refer to the same layer. Moreover, Blake (1991) provides numerous cross sections with the stratigraphy in the Los Angeles Basin and it is clear to see that around Inglewood fault (referred to as the Newport Inglewood fault), the material found at the surface is composed of Quaternary sediments overlaying the Pico formation. The other interpretation would be to assume that the Upper Fernando Formation is part of Inglewood, thus only Quaternary material is exposed at the surface in the northern embankment of the Baldwin Hills reservoir.

Figure 20: Geological Map of the area near the Baldwin Hills reservoir situated in the center (Dibblee & Ehrenspeck, 1991)
