# Investigation on Manufacturing Defects

in CFRP T-stiffened co-cured Single Aisle flap skin panels

A.S. Wulfers, B.Sc.

Faculty of Aerospace Engineering · Delft University of Technology

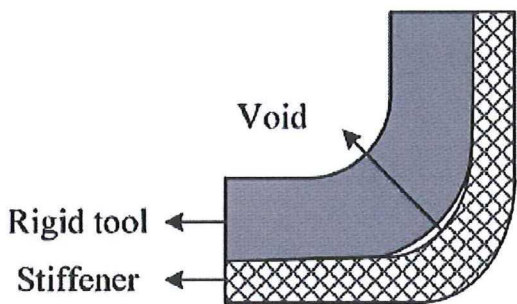
One of the other problems that arises with the hard tooling is that a void could be present in the corner of the stiffener as shown in Figure 2.2 [27].

**Figure 2.2:** Void in the corner of the stiffener

This void will either fill up with resin or plies start to shift due to the empty space. Therefore it is of key importance that the tool matches with the final panel in terms of the outer radius of the tool and the inner corner radius of the part [14, 28].

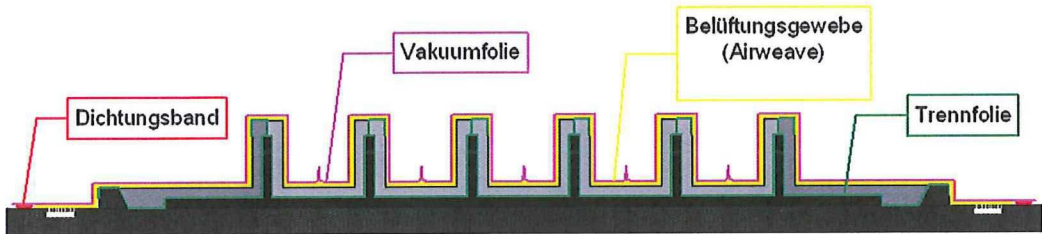
As can be seen from Figure 3.3, the two halves of the cores makes contact at the top of the stiffener web. This could also be a reason on why the plies of the stiffener show signs of slippage. If the two tools do not match up properly, resin and fibres can slip through an opening between the two tools.

Figure 3.3: Autoclave build-up

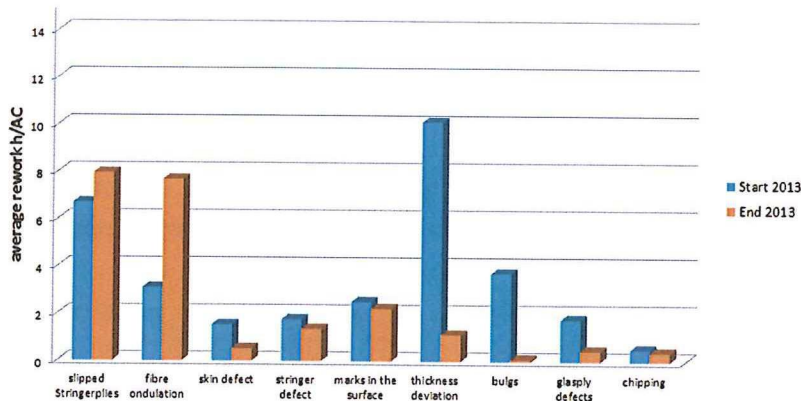
As a start, the defects in the current panels are examined. An overview of the amount of rework that had to be done per aircraft due to different defects can be seen in figure 4.2

Figure 4.2: Amount of rework done per aircraft due to different defects

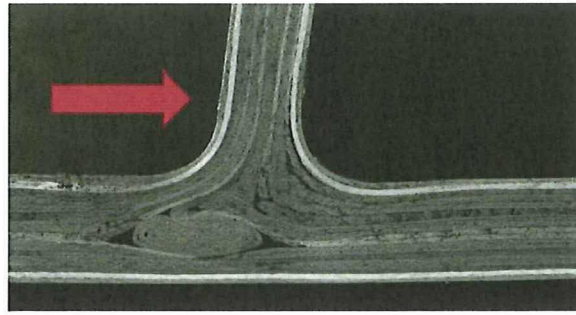
One of the defects that is clearly noticeable from the cross sectional images is the misalignment of the filler material. An example of this can be seen in figure 4.4. When comparing this image to that of figure 4.1, it can be clearly seen that the filler material is not in the centre of the intersection of the two stringer halves and the skin itself.

As explained in chapter 3, the filler material is placed between the two halves of the U-Profiles that form the stringer. This is done after the preforming when the stringers are compacted and still upside down before the rotation phase. It is noticed, by monitoring the actual production process, that the filler is always placed perfectly in the centre of the gap. Even with placement by hand, the accuracy is very high and it is assumed that the misalignment of the filler material in the cured panel is not due to the placement by hand. If the filler material is in the right place of the final cured panel it is located in the centre with an equal amount of filler material

**Figure 4.4:** Filler misalignment

When examining figure 4.4, it can be seen that there appears to be a sideward movement acting in the translational direction of the stringer that is indicated by the red arrow. The resulting force seems to shift the complete stringer away from its original location or constrains the movement of the stringer in relation to the movement of the filler and skin. The conclusion is therefore that either there is a force pushing the stringer sideways or that the skin and filler material have moved sideways. In addition, the left of the stringer corner appears to be stretched out since the thickness is smaller of the stringer above the filler material. Also the fold above the filler material of the right stringer half gives the impression the stringer is pushed over the filler material and that some layers of the right stringer half are stuck between the left half and the filler material. The movement between of the stringer and the skin would then be around 1,9 mm if the centre of the stringer would coincide with the centre line of the filler.

Another possible cause for the misalignment of the filler materials is that either the wrong size or shape is used or that the filler material itself is unsuitable. When looking at an example from literature, shown in figure 4.5, the misalignment of the filler material from figure 4.4 shows

An easier solution to this problem would be to use more constraints to perfectly align the skin and stringers by giving them less freedom to move individually. Next to constraining the tools, it would also be a solution to realign the tools with respect to each other if they do not line up properly. The possible cause of the misalignment of the filler material could also be because of the movement and misalignment of the tools in the autoclave and autoclave build-up step. If the tools are not constrained enough when the panel is in the autoclave, the applied pressure and the fact that the resin becomes liquid, it could happen that the cores start moving over the filler material. Additionally, the cores can also slide during the handling and transportation of the assembly. A solution for this problem would be to automate the process more to avoid manual handling or to setup new regulations for manual handling.

The filler material in photo 4.5b has shifted more to the left side of the stringer and allows the layers on the right side of the filler to increase in volume because there is more room for resin on that side. This is also the case for the misalignment of the filler in the stringer flaps. A solution to this would obviously be to increase the amount of filler material.

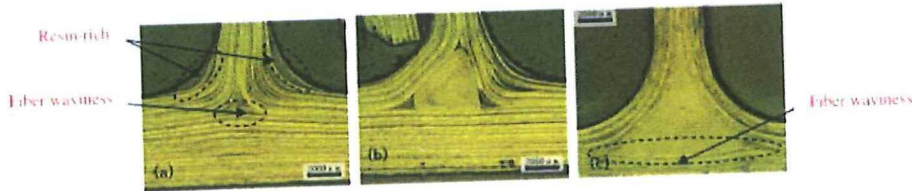
similarity with that of photo 4.5b where not enough filler material is used in the intersection.

**Figure 4.5:** Filler misalignment comparison

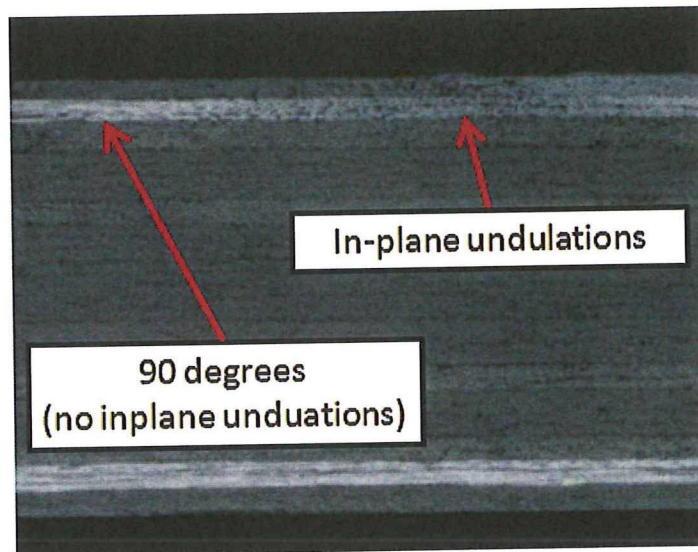
be seen that the second layer (90 degree layer) changes from a light grey color on the left to a darker grey color in the centre. Here, the color matches the first layer from the top in terms of grey scale.

**Figure 4.8:** Laminate cross section with in-plane undulations in the top and second layer

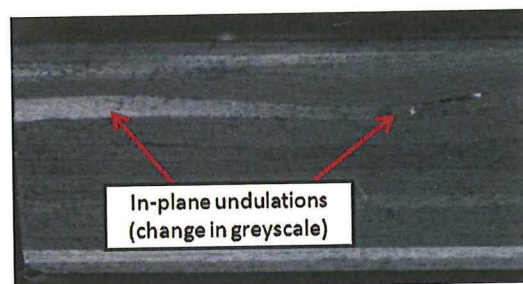
A more severe in-plane undulations, including out-of plane undulations, and change in grey scale is seen in figure 4.9.

**Figure 4.9:** Laminate cross section with more severe undulations

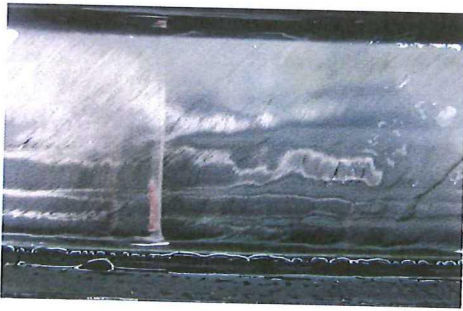
In figure 4.10 it can be seen that the individual fibres change orientation from their original 45 degrees to almost 90 degrees in some areas. The waviness seems to originate from the corner section of the stringer and skin at the bottom of the picture and propagates towards the top side. In the top section, the waviness is vanished and the fibres have their original orientation of 45 degrees again. From a structural point of view, a change of orientation could influence the load carrying capabilities of the part. If the fibre changes orientation, the laminate can carry less load in the specified direction. This could lead to premature failure of the panel below the

**Figure 4.10:** In-plane fibre waviness (undulations) on the surface

designed ultimate load.

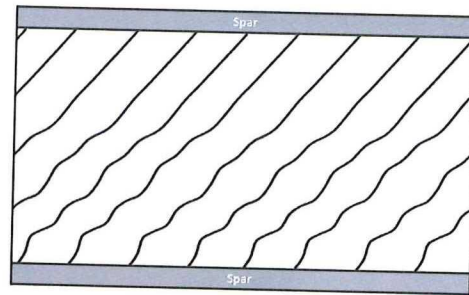
**Figure 4.11:** In-plane fibre waviness (undulations), schematically

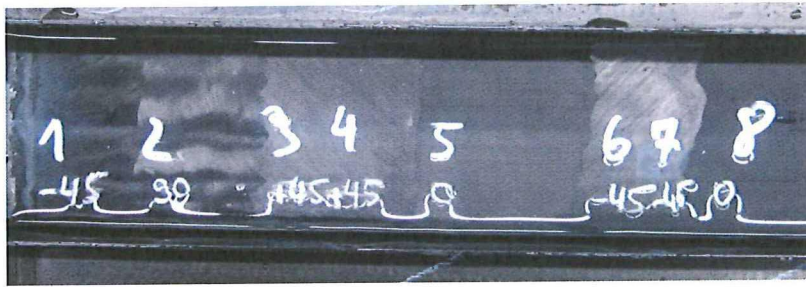
The fact that the waviness is not random and seems to originate from the corner sections suggests that the cause of it would be in the manufacturing of the panel and that it for instance is not a standard defect in the prepreg material. The waviness depends also on the fibre orientation. In figure 4.13, which indicates the ramp section, it can be seen that the presence of the waviness is not in every layer and direction. It thus also depends on the location of the layer in the layup and maybe also on the orientation itself. However, the in-plane undulations in other layers than the top layer cannot be observed from the outside. Only an assumption can be done if there are in-plane undulations present in the outer layer that they could also be present in other layers. If there are not in-plane waves present in the outer layer, the chance is low, although still present, that they are present in the other layers.

**Figure 4.13:** In-plane waviness depending on the fibre orientation

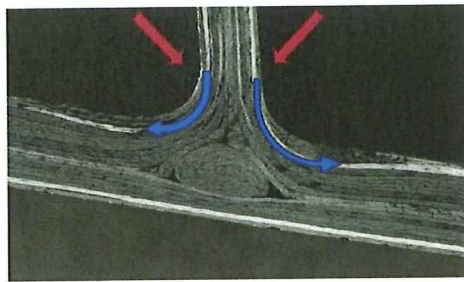
In cross sections of other stringers, the defect of resin rich areas can be observed. Resin rich areas occur in the corner section between the laminate and the stringer. The outer layer is over saturated with resin, which causes the carbon fibre layer to expand in thickness. This defect is almost the same as the wrinkles, with the difference that the whole stringer seems to be pushed down without the outer layer moving separately from the other layers. In this case, no fold of only the outer layer of the laminate will occur. In figure 4.19, the resin rich areas can be seen

**Figure 4.19:** Resin rich area in the corner section

In the figure 4.19, the blue arrows indicate the internal forces and the red arrows the external forces. The outer layers of the laminate in the corners are oversaturated with resin, because the whole layer pack is pushed down leaving a cavity in the corner section. This cavity starts to fill up with resin and causes the outer layer to ‘soak up’ the excess resin. For these resin rich areas the same causes are assumed as for the wrinkles.

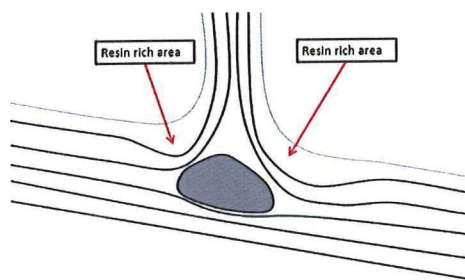
**Figure 4.20:** Resin rich area in the corner section, schematically

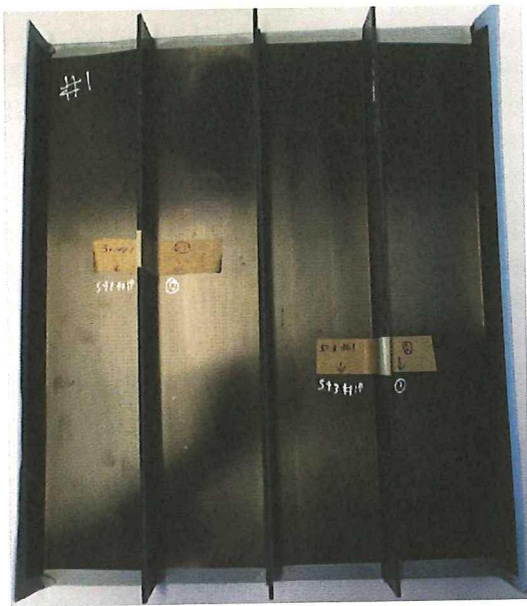
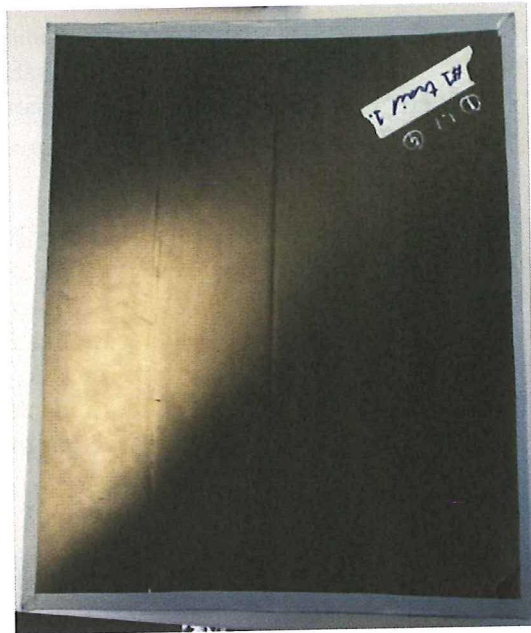
By visual inspection, the following defects are observed:

- In-plane waviness (to a small degree)

- Out-of-plane waviness (to a small degree at the filler location in the skin)
- Enclosed release film in the resin
- Filler indentations on the back
- Dry spots
- Curved plate

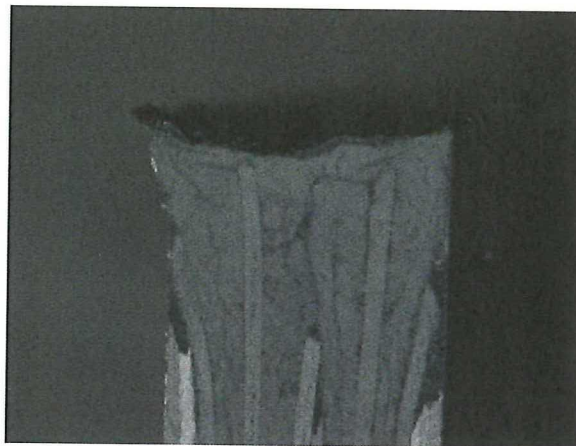
The preforming is not done properly where the laminate is located above the core after compressing, followed by the placement of the filler as can be seen above. In the preforming, the laminate does not follow the contour of the outer surface of the steel cores. Then, as soon as the skin is placed on the web of the U-profile laminates or if the pack is placed on the skin, there is extra material in the corner sections known as bulging. The filler material sticks to the skin and the stringer. As soon as the autoclave pressure is applied and the temperature is increased, the stringer plies together with the filler and skin start to move upwards due to the decreased viscosity of the resin. The end result is that the filler is not located at the original cross section anymore. Also, the skin underneath the filler shows a large out-of-plane wave that follows the contour of the stringers and filler on one side and the flat ground plate on the other side. This is also visible on the visual inspection as the filler indentation on the skin, the waviness next to the indentations and the enclosed release film. This in-plane waviness is also visible next to the indentation in the cross section with the slight colour change in grey scale. This indication is based on experience in examining the cross sections. In the cross sectional image it can also be seen that the enclosed release film is only in the resin and not in between the fibres. The enclosing of the film could be due to the fact that the pack was also compressed after the skin was placed on, creating wrinkles in the release film. When the resin turns liquid, it flows between the release film, enclosing it with resin.

There is a gap between the stringer and the top of the core which in the end is filled with the carbon fibre material. The 0 degree plies in the depth direction of the cross section (darker layers) shift up more than the 90 degree plies (lighter almost outer layers), which is logical since individual fibres in the 0 degree plies are more easy to move away from one another due to the liquid resin. For the 90 degree plies to fill the cavity, the fibres themselves would need to elongate. This elongation is almost zero because of the high stiffness of the fibres. From the outside, the top of the stringers seems to show slipped stringer plies, while in fact the inner layers moved up instead of the outer layers moving down. The top of stringer 3 with the elongated layers is shown in figure 6.9.

**Figure 6.9:** Cross section of the top of the stringer with the moved up layers

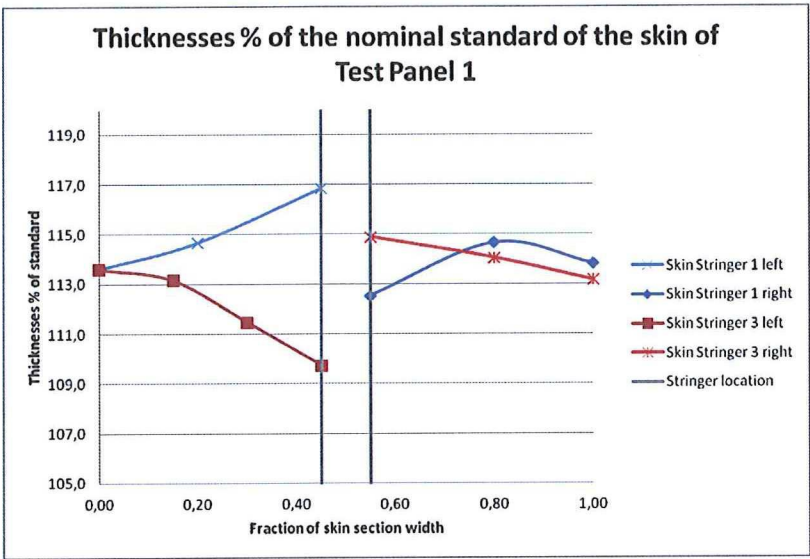
In addition to the defects in the cross sectional images, it can also be noticed that there is a significant thickness deviation in the stringer thickness. The thicknesses of the skin and stringers are displayed below in figure 6.10 and figure 6.11. Here, the actual measured thickness is portrayed as a percentage of the nominal thickness that the laminate should have. This is namely the cured thickness of a single layer multiplied by the number of layers in the laminate. The total number of layers is 18 and the thickness of one ply is 0,125 mm, resulting in a total

thickness of 2,250 mm. This was also explained in chapter 5. A smaller actual measured thickness means that the laminate is over pressurized and will have a higher fibre volume content. This is because, the resin is squeezed out more out of this measured region while the fibres remain in place. When the laminate has a larger actual measured thickness it means that either more resin is present in this section or that there are more fibres present, e.g. by forming wrinkles or waves. If there are no wrinkles or waves present, it means that the laminate is under pressurized. Since not all measurement points are taken at the same locations for the different test panels and since that the cross sections do not have precisely the same length, the thickness percentages are displayed as a rough fraction of the total cross section length. The graphs give an overview of the general shape of the cross section by using the measured data points and show the comparison between the different cross sections in the panels. In figure 6.57, the fraction of the stringer height at value 0 is the skin and at value 1 is the top of the stringer.

Figure 6.10: Panel 1: Thickness percentage of the nominal of the skin

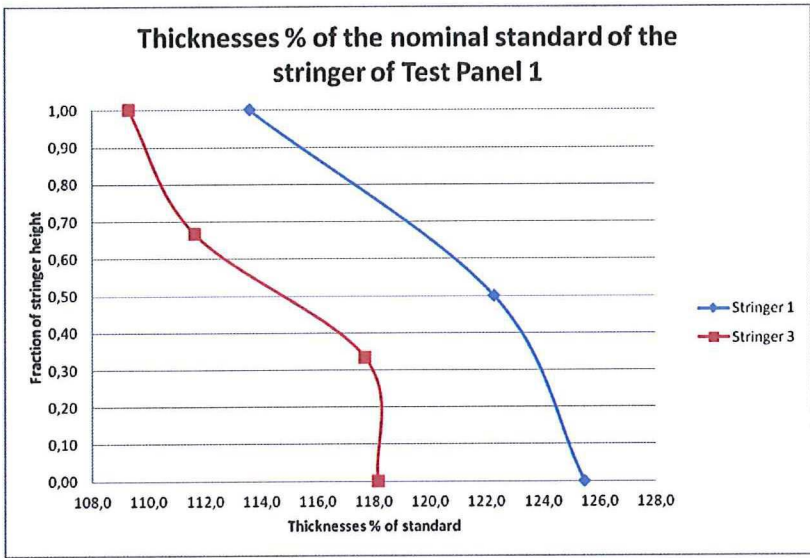
Figure 6.11: Panel 1: Thickness percentage of the nominal of the stringers

In addition to the defects mentioned above, the thickness differences of the stringer is explained by the shifting of the filler material, the unclamped edge bar and that the stringer laminate was 5 mm shorter than the core. Also the skin is slightly under pressurized.

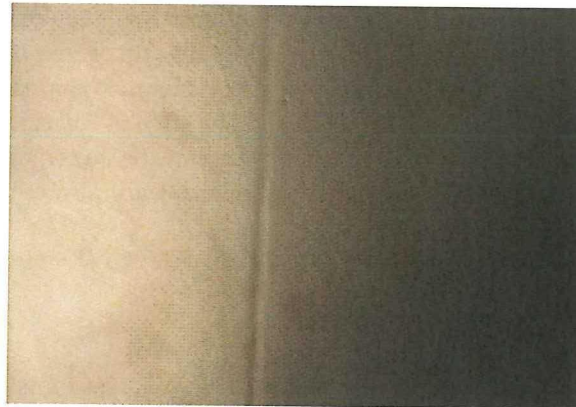
The small in-plane waviness is exactly the same as in test panel 1 and is assumed to be present in the prepreg material already. Differently, when compared to test panel 1, no dry spots are present, so the evacuation of air was done properly. Also, the plate was not curved, because the correct lay-up was done. However, the filler indentations are still present only to a smaller degree. An important difference is that the release film is not enclosed by the resin in this panel at the filler location. That is probably because the pack was already sufficiently compressed before the skin was placed on. No wrinkles were formed in the release film for that resin and it could not be enclosed like in panel 1. Also, no waviness is seen around the filler indentations. A close up of the filler indentation is shown in figure 6.14.

**Figure 6.14:** Filler indentation on the back of the skin of the part

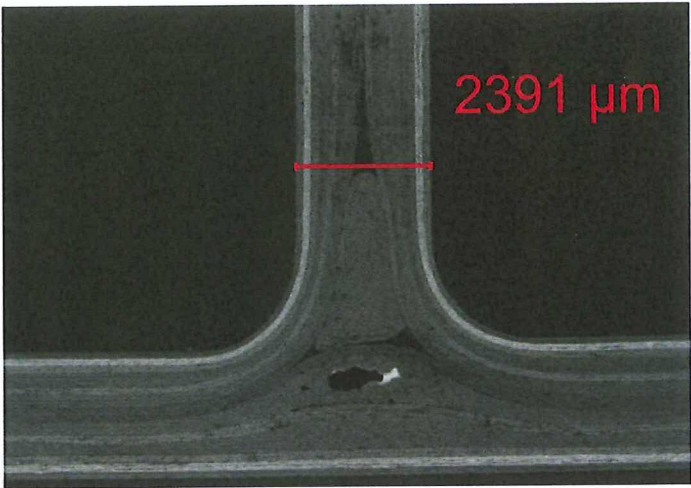
The main defect that is observed is the vertical filler movement. This defect can be seen in figure 6.15, which is cross section 3 at stringer 3.

Figure 6.15: Vertical filler movement in stringer 3

With this panel it can be concluded that improper preforming, when the laminate is not fully attached to the core, can lead to filler material shifting upwards. By visual inspection an indication for the filler movement is given by the indentations at the filler locations in the skin.

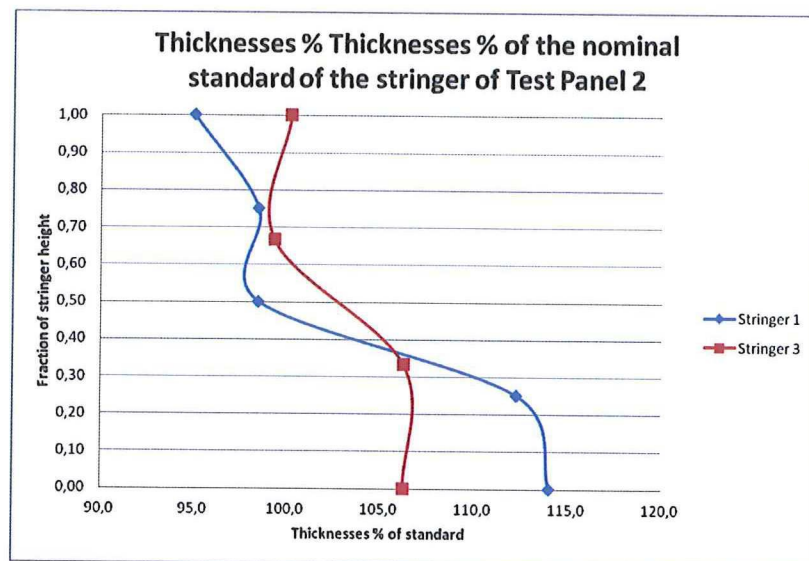
For stringer 1, the thickness is 2,566 mm or 114% at the bottom and at the top 2,138 mm or

Figure 6.17: Panel 2: Thickness percentage of the nominal of the stringers

95% which is a difference of 0,428 mm. The thickness measurements can be seen in appendix D and the deviations from the tolerances in appendix E. At stringer 3 there is also a thickness difference for the top and bottom of the stringer where it is 2,391 mm or 106% at the bottom and 2,255 mm or 100% at the top and does not make the difference of 0,166 mm too significant. All the values of this panel are however within the tolerances and from a quality point of view this panel would still be acceptable.

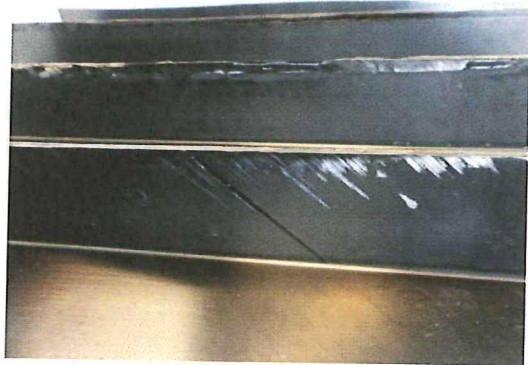
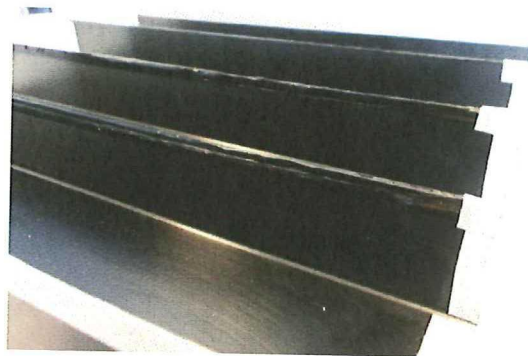
The main defect that can be noticed from the visual inspection is the large number and size of dry spots. They are located on all the stringers on the top and are most severe in the centre of the stringer and are absent at the two ends of the stringer. An overview of these dry spots can be seen in figure 6.23 and 6.24.

Figure 6.23: Dry spots in the stringers

Figure 6.24: Dry spots in the stringers

These dry spots can be easily explained by the mistake to fully enclose the panel with release film and tape so that the panel is closed of airtight and locations where it should not be. That way, there was no possibility for the entrapped air to escape which remained in the panel. All the air gathered in the middle at the top of the stringer, because the pressure that is exerted on the laminate is higher in the web, because of the weight of the core. The air is pushed up to the stringer until it reaches the top and accumulates in the centre of the stringer. From the visual inspection it can be seen that the dry spots in the stringers with the exact height are on the surface and in between the fibres. However, for the stringer with a lower height, the outer layers are lower and have the entrapped air above it, while the centre plies of the stringer moved up to fill the rest of the cavity. A close-up of the difference can be seen in figure 6.25 and 6.26.

For the next panels the alteration is done not to fully enclose the top and sides of the panel with tape and release film, but to close off the top at the top of the stringers and the cores and to enclose the skin together with the outside of the flanges of the outer stringers. The tape on the two longitudinal ends of the panel will not be present anymore so that the air can evacuate through those sides.

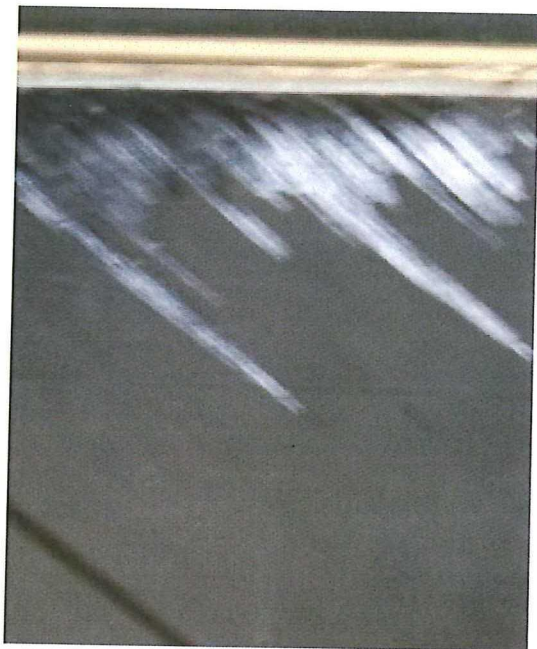
Figure 6.25: Dry spots in the stringers close-up

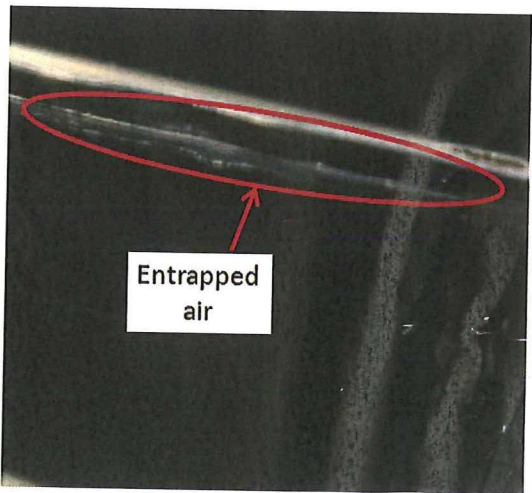
Figure 6.26: Entrapped air above the stringers close-up

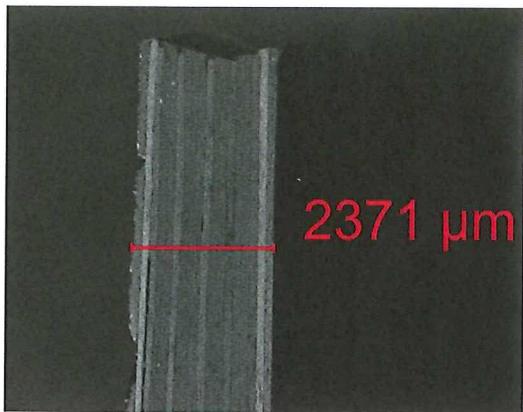
When looking at the top of the stringer of the cross section, a difference is noticed between the stringer 1 with an exact height and stringer 3 with an 8 mm lower flange. As described in the outer quality section, the dry spots in the stringer with the exact height are on the surface and in between the fibres. The stringer with a lower height has less high outer layers and has the entrapped air above it, while the centre plies of the stringer moved up to fill the rest of the cavity. This can be seen clearly in the cross sections in figures 6.28 and 6.29.

Figure 6.28: Stringer 1 without a cavity, but with dry spots on the left of the stringer

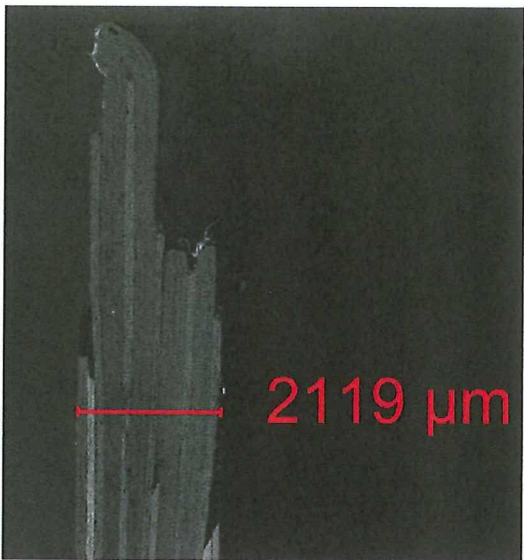
Figure 6.29: Stringer 3 where, the centre plies fill the cavity above the stringer

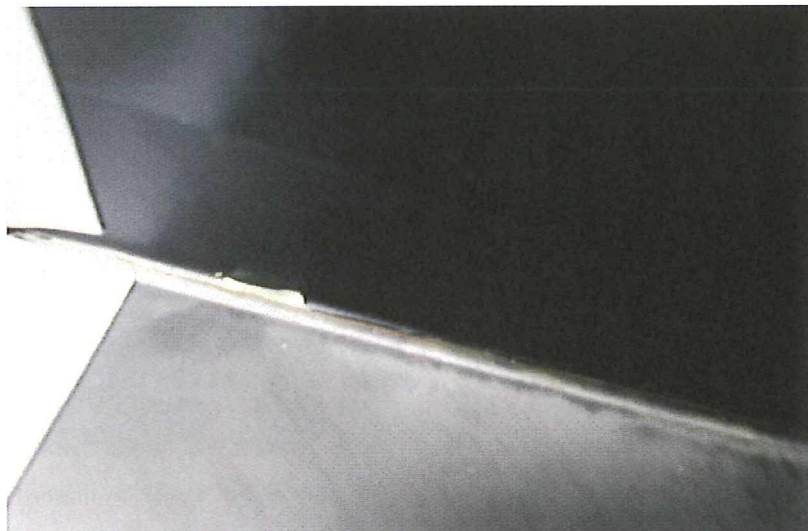
The waviness is present to a larger degree than in test panel 3. In addition to the waviness in the corner sections, there is also release film enclosed in the corners of cores 2, 3, and 4. In core 2, the release film is still present and irremovable. The enclosed release film can be seen in figure 6.36.

**Figure 6.36:** Enclosed release film in the corner section

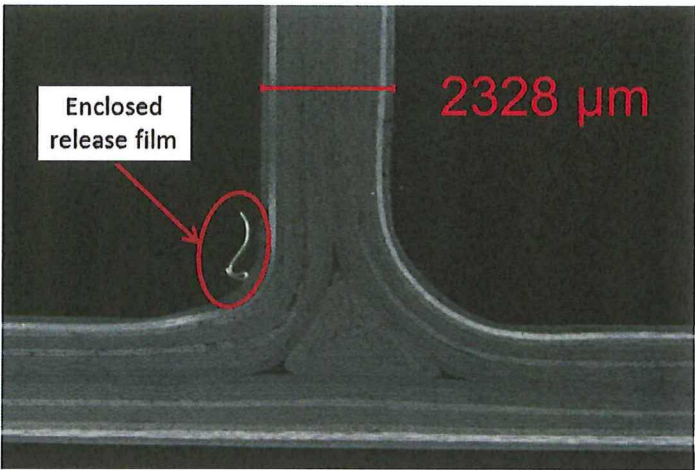
Cross section 6 at stringer 2 was taken at the location where the release film was enclosed in the corner section that is shown in figure 6.36. Looking at the cross section, it is interesting to notice that the release film is not enclosed in a wrinkle of the prepreg, but in the resin that accumulated on top of the laminates corner. The cross section can be seen in figure 6.37.

Figure 6.37: Enclosed release film in the corner section

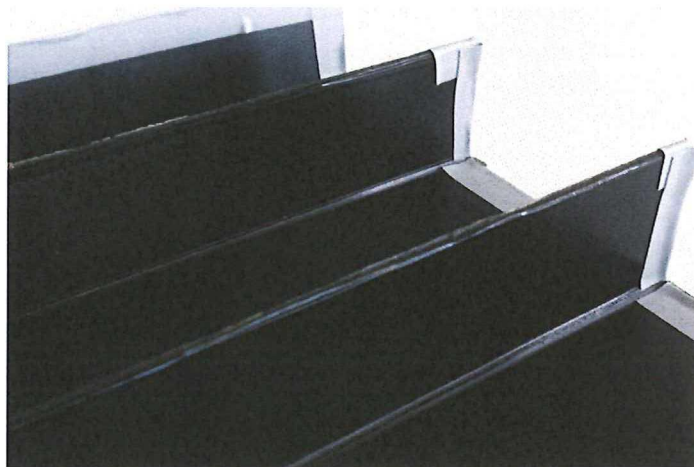
autoclave cores are bigger than the preform cores, they don't fit properly on the skin. They are resting on the corner sections and as soon as the panel goes in the autoclave, the cores are pressed down, dragging the outer plies with them. This is similar to the 'hanging core' principle of panel 6 and 6. Therefore, also slipped stringer plies can be seen, although they are less severe than those of the previously manufactured panels. The slippage distance is about 2-3 mm for the inside of the flanges of the stringer sides adjacent to core 2 and 3. The slipped stringer plies are shown in figure 6.45.

**Figure 6.45:** Slipped stringer plies in stringer 2 and 3

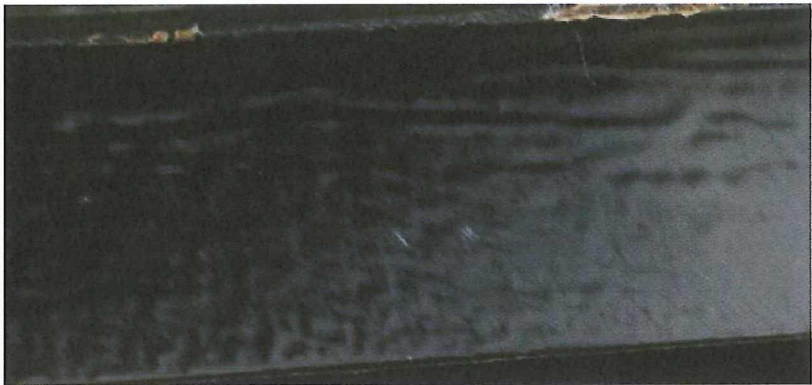
A difference to the undulations is that they are more strongly present on one side of the core than on the other side. This could originate from the order in which the cores are placed. As soon as the first core is placed, it pushes the stringer outwards, because of the width mismatch. This also goes for the next cores. When the stringer is shifted sideways, it is likely that undulations start to form on the convex side of the moved stringer due to the pressurization of the corner section. On the concave side, the corner is stretched out, resulting in fewer undulations. This would also indicate that the filler material might have shifted sideways. The in-plane waviness

**Figure 6.46:** In-plane waviness in the skin on the inner mould line at core 2

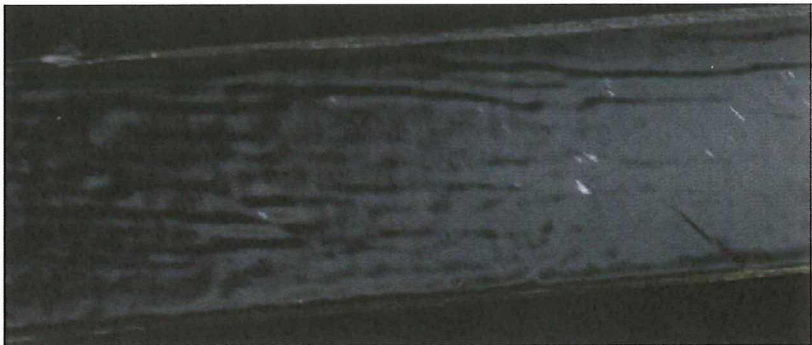
**Figure 6.47:** In-plane waviness in the skin on the inner mould line at core 3

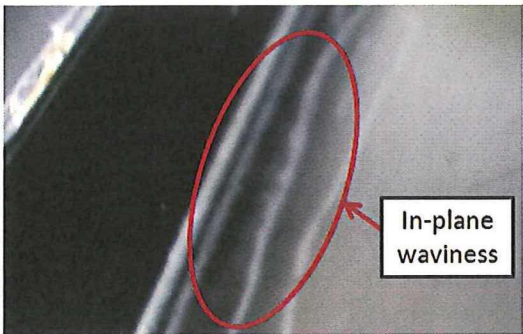
When turning the part, the out-of plane undulations can be seen better due to a different deflection of the light and they correspond also to the in-plane undulations. They can be seen in figure 6.48 and figure 6.49.

**Figure 6.48:** Out-of-plane undulations near the corner sections of core 2

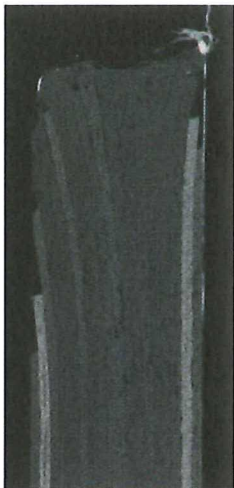
In that figure, also the in- and out-of-plane waves are observed, which originate from the corner sections. The in-plane waves are depicted as the colour change of the layers to a different grey scale. There is a lot of in-plane waviness in the middle of the laminate in the corner section, with around a 45 degree ply change orientation in some of the individual plies in the right corner section of figure 6.50. This indication is based on experience in examining the cross sections and is indicative only. On the concave side of the stringer intersection, slipped stringer plies of 3 mm are present on one side of the stringer, namely on the core 2 side. The slipped stringer plies in the stringer are shown in figure 6.51.

**Figure 6.51:** Slipped stringer plies in stringer 1 on the side of core 2

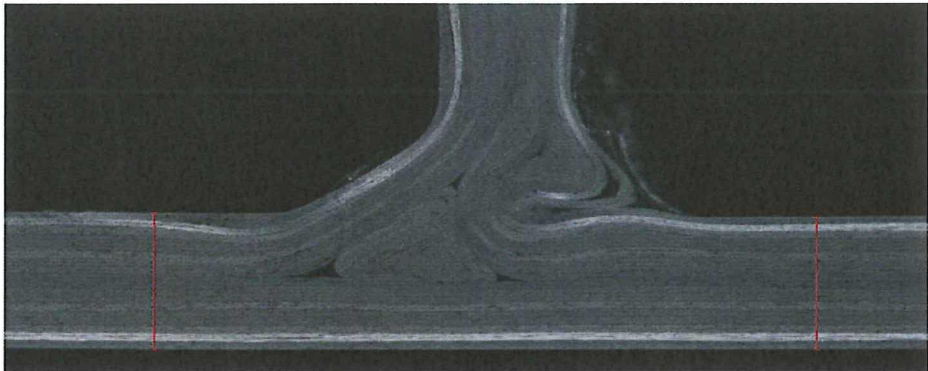
In stringer 2 there is a combination of the core width differences on both sides of the stringer. By looking at the intersection of the stringer and skin, more extreme waves and wrinkles and misalignment of the stringer can be seen when comparing to stringer 1. The wrinkles and shifting of the stringer is in the same direction as in stringer 1. This means that the whole core shifted in the direction of core 1. The fact that this stringer has shifted more, and that an extreme wrinkle is present on the side of core 2, corresponds with the fact that core 3 has a larger width than core 2. Core 3 pushed stringer 3 further away from its intended position. The cross section of stringer 2 is shown in figure 6.52.

**Figure 6.52:** In- and out-of-plane undulations and wrinkle in the right corner section in stringer 2

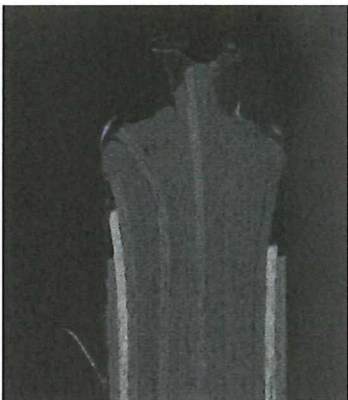
Next to the larger wrinkle and misalignment of the filler, also in-and-out of plane undulations can be seen in both the corner sections as well as in the skin. When looking at the top of the stringer, the slipped stringer plies can clearly be identified on both sides of the stringer with a slippage of about 2 mm on each side. This is shown in figure 6.53.

**Figure 6.53:** Slipped stringer plies on both side of stringer 2

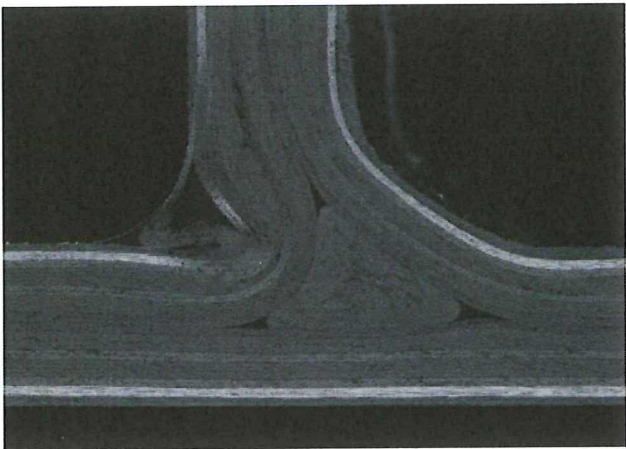
In stringer 3, the wrinkle and filler misalignment is to the other side compared to stringer 1 and 2. The wrinkle and undulations are less severe compared to the ones in stringer 1 and 2, but still present, see figure 6.54. Interesting to see is that the slipped stringer plies of 3 mm are on the other side of the stringer on the side of the core, see figure 6.55.

An explanation for this could be that the core 4 was pushed upwards when the other cores were pressed in. This can also be seen in figure 6.42 on the left side of the image that core 4 is not touching the skin of the laminate. In the autoclave, the outer ply is then pushed downwards,

Figure 6.54: Wrinkle and undulations around stringer 3

creating the wrinkle in the corner section. This shows the interaction between the cores. If one core moves in a direction less or more than the width difference that is present between preform core and autoclave core, it will influence the shifting distance and direction of the other cores.

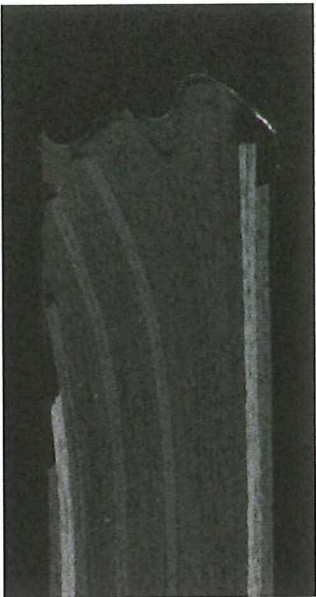
Figure 6.55: Slipped stringer plies in stringer 3 on the side of core 3

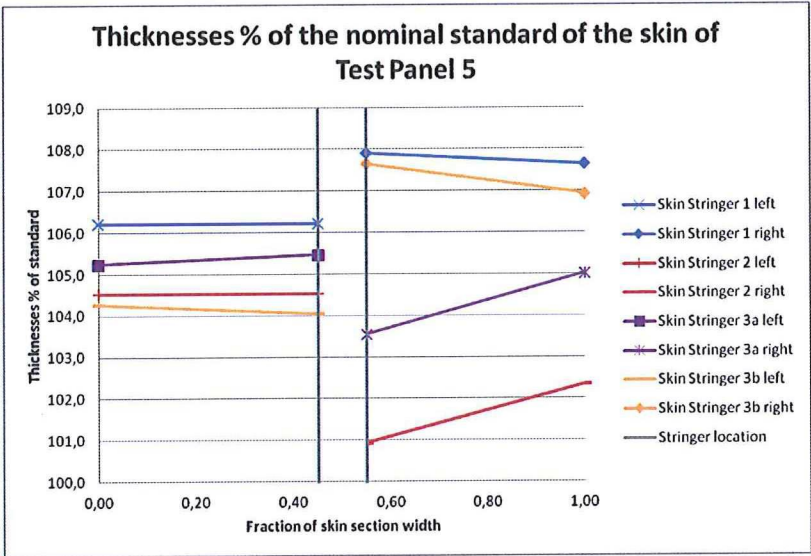
Figure 6.56: Panel 5: Thickness percentage of the nominal of the skin

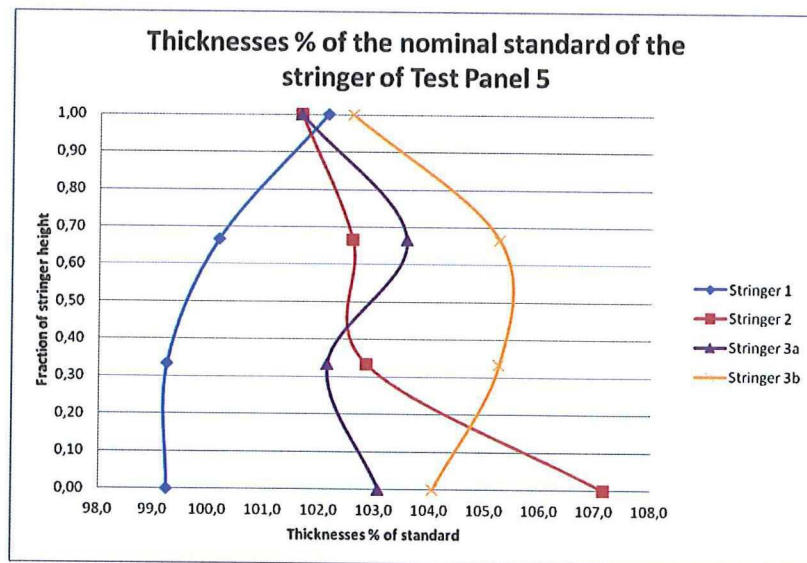
Figure 6.57: Panel 5: Thickness percentage of the nominal of the stringers

In this part, the autoclave core 2, between stringer 1 and 2, is 0,92 mm wider than the preform core and core 3, between stringer 2 and 3, is 1,84 mm wider. For stringer 1, the stringer gets thicker at the top side of the stringer compared to the bottom side. By looking at the skin thickness of the right of stringer 1 and the left side of stringer 2 it is seen that the skin is thicker on the right side of stringer 1. This means that the core has rotated clockwise which also resulted in the thicker stringer at the top.

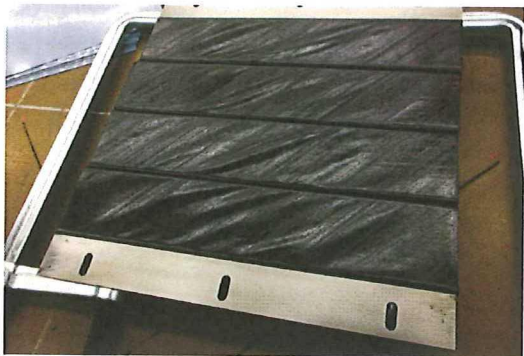
During the manufacturing, the whole pack of stringers is compressed. During this step of the manufacturing process, the web of the U-profile laminates started to show waves. These waves formed when the preform cores were still inside the laminate, so the width dimensions of the laminate match the preform core widths. The reason for the waviness is probably that the clamps were not turned with equal speed, compressing one half first followed by the other. It could have also been because the cores were not lined up properly. The waviness was also clearly visible after turning when the preform cores were removed. At this point, the skin and filler were already stuck on stringer pack. The waves on the in- and outside of the stringer webs can be seen in figure 6.58 and figure 6.59.

**Figure 6.58:** Waviness of the uncured stringer laminate on the outside of the stringer pack before turning

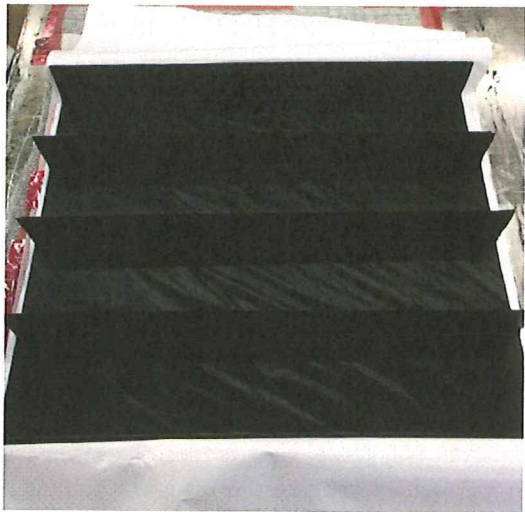
**Figure 6.59:** Waviness of the uncured stringer laminate on the inside of the stringer pack after turning

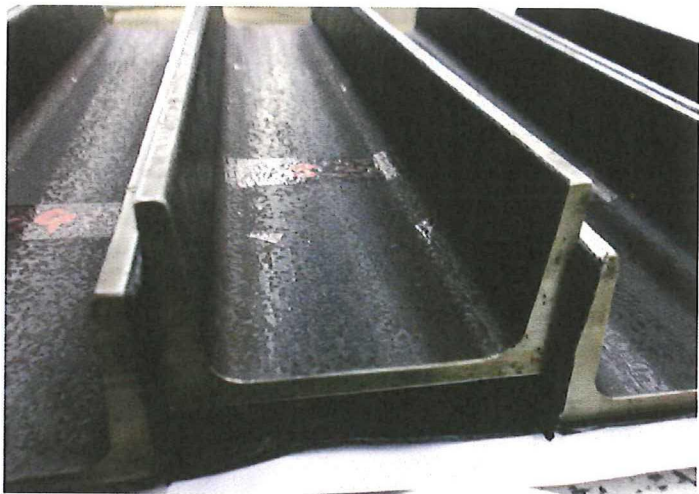
The core was hanging with a highest distance of 15 mm above the web of the U-profiles laminate. When examining the pictures, it can be seen that small waves are starting to form in the skin. The core end with the smallest distance from the web was fully pushed down, as soon as the vacuum bag was closed and the vacuum was applied. The side with the largest distance still

**Figure 6.61:** Hanging core on one side of the core with a height of 15 mm

had a gap underneath it, even with the vacuum applied. By looking at the finished panel and the presence of the defects, it is clear that the gap is still present when the autoclave pressure is applied. As soon as the resin becomes liquid, the core is pressed down and the gap is closed.

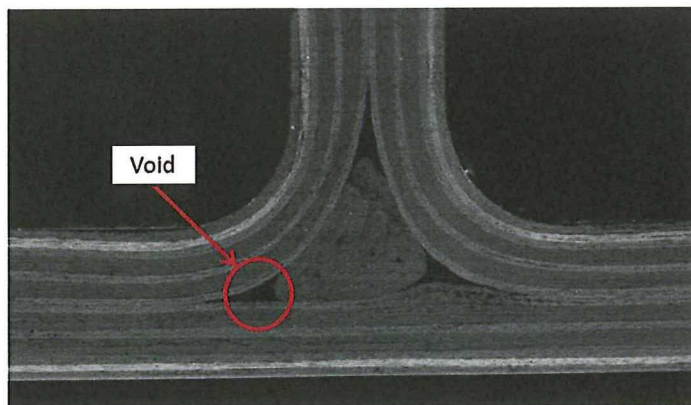
**Figure 6.68:** Cross section of the intersection of stringer 1 as a reference without the hanging core

The filler is in the correct location in the centre of the intersection. However, a small void can be seen on the left corner side of the filler. Apart from the void, the panel quality of stringer 1 is good, with no other defects. The reason of the presence of the void is most likely caused by the entrapment of air when the filler was placed on the pack and covered by the skin. The void is considered to be accidental and not representative of the overall stringer quality. On the other side of the cross section, there is no void present and it therefore considered to be a local phenomenon.

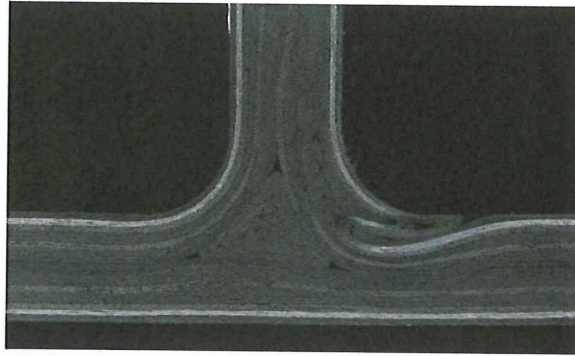
When the cross section of core 3 is examined on the side where the core was hanging, defects in the form of slipped stringer plies, stronger out-of-plane undulations and wrinkles in the corner section on both sides of the core in stringer 2 and 3 can be observed. These defects are shown in figures 6.69-6.71.

**Figure 6.69:** Wrinkle/fold in the corner section of stringer 2 where the hanging core was present

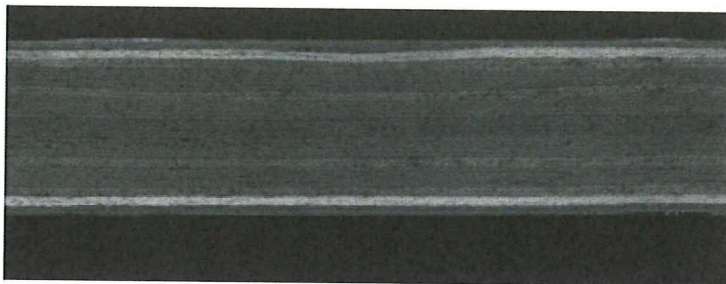
**Figure 6.70:** In- and out-of-plane waviness in the top layers of core 3 with the hanging core

In figure 6.70, both the in- and out-of-plane undulations are present, where the in-plane waves are visible by the grey scale change in the top outer layer. The waviness in the panel is noticeable, but does not have a strong influence on the panel quality. Out-of-plane waviness does become a problem when the orientation of the plies greatly changes. As soon as forces are applied, the

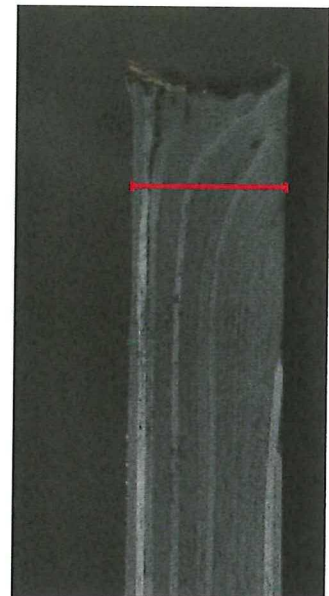
**Figure 6.71:** Slipped stringer plies of 6 mm in stringer 2 with the hanging core

In the figure with the slipped stringer plies (figure 6.71), it can be seen that the outer two plies slipped the most. The slippage of the plies is directly translated in wrinkles and undulations, because the material needs to go somewhere. The explanation of the cause of the defects is explained in the outer quality section.

plies cannot take up the loads properly, since they are not loaded in tension directly. Then, delaminations can then occur due to the inter laminar forces. The red line in figure 6.71 was used for the thickness measurement at that location

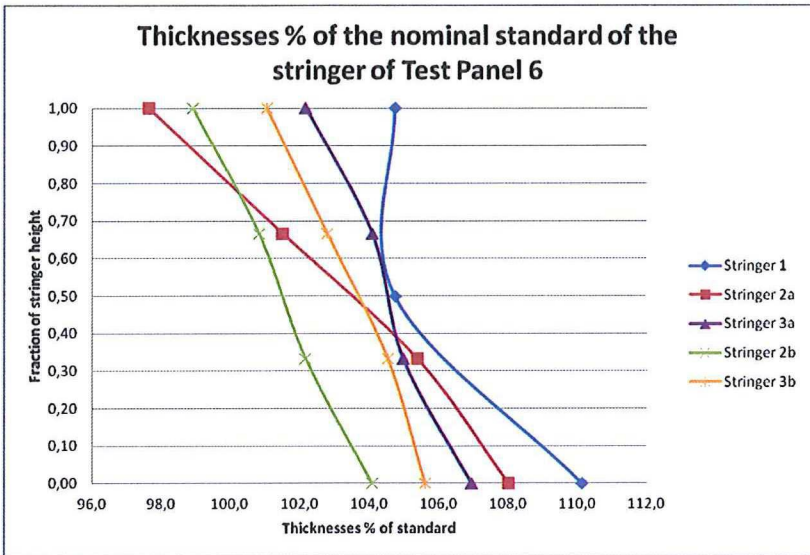
Figure 6.73: Panel 6: Thickness percentage of the nominal of the stringers

As can be seen in figure 6.73, the stringers all are thicker on the bottom than on the top. The cores have the perfect shape before the autoclave with 90 degree angles in the corner section. However, the panel takes over the same shape as the core, because the core gives the outer shape to the part. From the observations that are made in the previous sentences, the core could not be rotated around the x-axis, because the corner sections on both sides of the core are pressing the skin in the corners and under pressing in the middle. Therefore, the conclusion is made that the shape of the cores changes in the autoclave either due to the increased temperature or due to the high pressure of 7 bars. As soon as the resin becomes liquid, the core is able to deform to a certain degree. If pressure is acting on the flanges of the core, they will rotate outwards, bending the web of the core. Due to the autoclave pressure that is also acting on the web, the core is pushed down in the corner section, resulting in a lower thickness. The cores have by then obtained a W-shape due to the finite stiffness of the cores. From here onwards, this effect is referred to as the W-effect and can be seen in figure 6.74.

different effects and severity of the deformation will occur. To monitor the W-effect and the severity of it, the recommendation is to do further testing with these and the actual carbon fibre cores

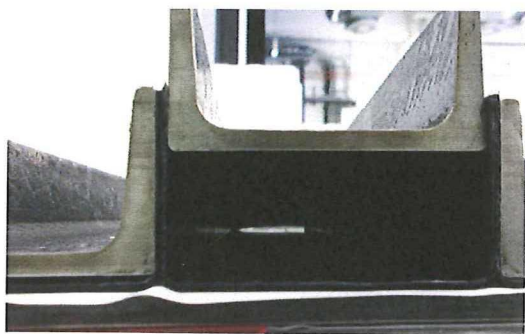
**Figure 6.75:** Hanging core with a height of 24 mm, front view

In figure 6.75 it can be seen that core 2 on the left is not completely touching the skin of the laminate, due to the lack of available space for the core to fit completely.

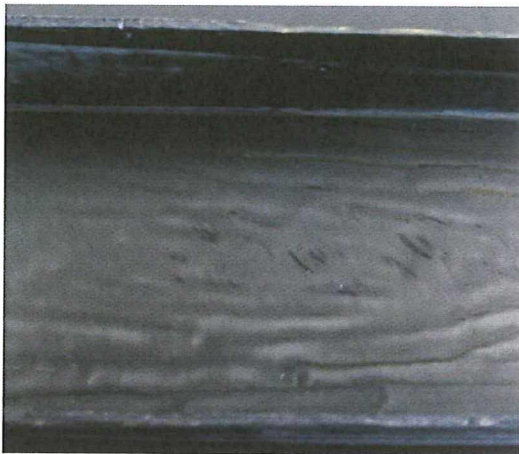
The in-plane undulations are better visible in figure 6.80 and the out-of plane undulations in figure 6.81. The undulations are more intense near the corner sections of the stringer than in the centre and the dry spots are located more in the centre of the laminate.

**Figure 6.80:** In-plane, undulations and the dry spots in the web of the stringer at core 3 where the hanging core was present

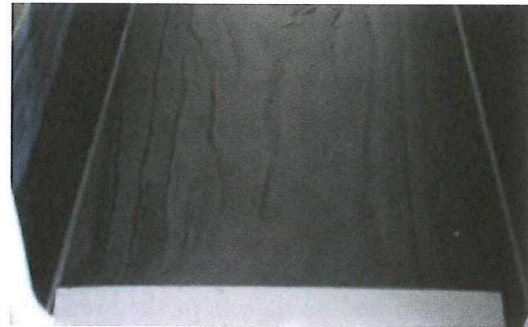
**Figure 6.81:** Out-of-plane undulations and the dry spots in the web of the stringer at core 3 where the hanging core was present

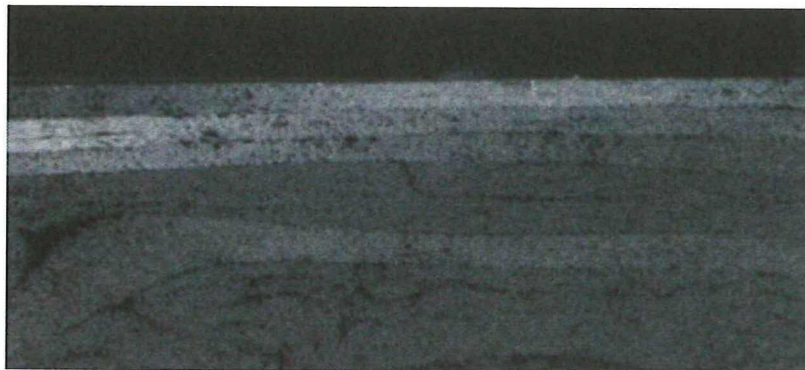
**Figure 6.82:** In-plane undulations in the layers

The top layer is changing from a 45 degree layer to a 90 degree layer by looking at the change of colour from dark grey to very light grey. The reverse happens in the second layer, where the 90 degree layer changes either to - or + 45 degrees. The layers thereafter are also changing to a different orientation. This indication is based on experience in examining the cross sections.
