# Investigation on Manufacturing Defects

in CFRP T-stiffened co-cured Single Aisle flap skin panels

A.S. Wulfers, B.Sc.

Faculty of Aerospace Engineering · Delft University of Technology

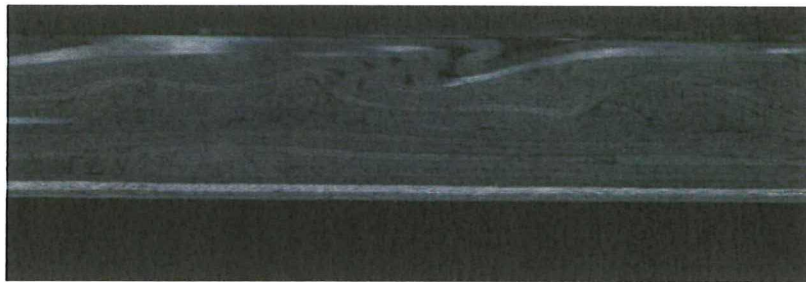
The out-of-plane undulations are dominant throughout the skin and even form wrinkles in some locations. The undulations are however only present in the top half of the skin laminate which was previously the web of the U-profile and not the skin laminate (bottom 9 layers). That is logical since the plies of the stringer are being forced down, creating the undulations, and the skin remains unaffected. The skin laminate is however compressed less or more depending on the location across the width of the part. The out-of-plane, together with in-plane undulations are shown in figure 6.83.

**Figure 6.83:** In- and out-of-plane undulations in the layers

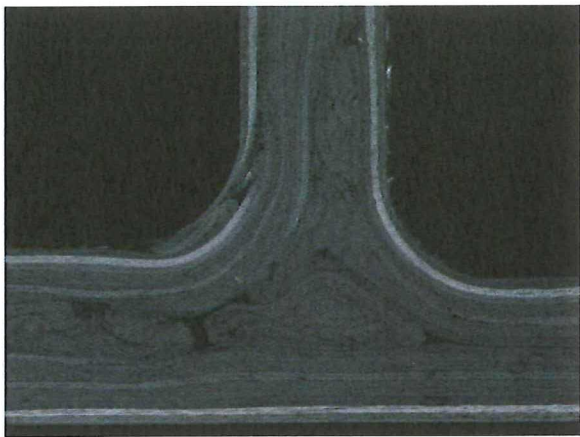
corner sections. As can be seen in figure 6.85, not only wrinkles are formed with the outer plies, but also the quality of the inner plies is affected. Large internal undulations are observed in the centre of both the stringer and the web of the U-profile.

Figure 6.85: Wrinkles and large internal undulations present in the intersection of stringer 3

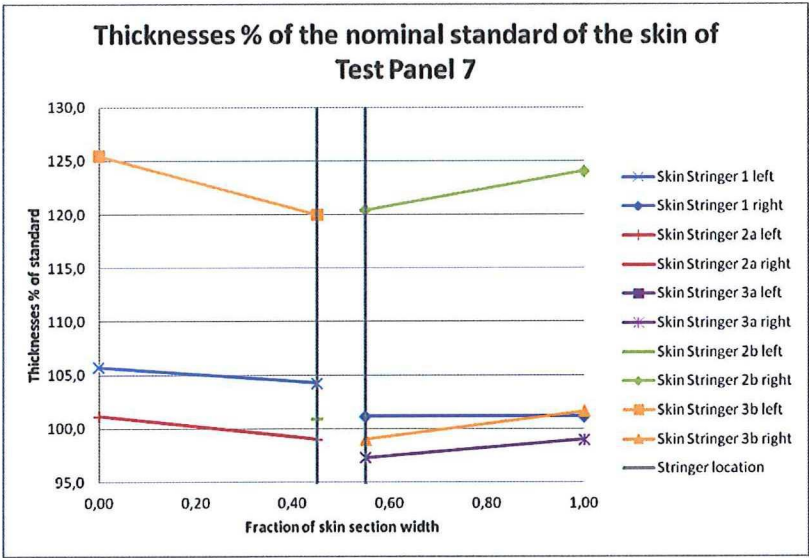
Figure 6.86: Panel 7: Thickness percentage of the nominal of the skin

Comparing stringer 2a with 2b and 3a with 3b, it is seen that the thickness of the skin on average is much higher on the right side of 2b and the left side of 3b compared to the same locations in 2a and 3a. This is an identical behaviour as for panel 6, but with a larger thickness between the hanging side of the core and the non-hanging side. The highest thickness is in the skin on the left of 3b of 2,823 mm or 125,5% compared to the same location in 3a of 2,276 mm or 101,2%. This is a difference of 0,547 mm. The extra thickness is a result from the hanging core and the extra plies that are present in the skin in the form of wrinkles and large out-of-plane undulations. Also the two stringers at locations 2b and 3b are much thinner on average compared to 2a and 3a. This can be explained by the slipped stringer plies, which causes thinner stringers due to less material present. In core 3, the W-effect is also observed since the core presses down in the corner section and is thicker in the centre of the skin.

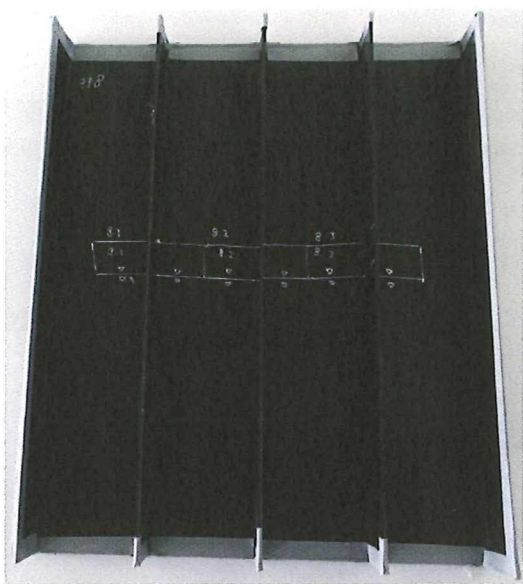
**Figure 6.90:** Panel 8: finished panel front view

In the bottom skin of the panel, it can be seen that there are slight dents along the length of the filler location which are shown in figure 6.92.

This could indicate that the filler material has shifted upwards, because the indentations look similar to the indentations seen in test panels 1 and 2.

The locations of the cross sections are indicated in figure 6.90. Looking at the cross sectional image it can be seen that the filler material has shifted upwards. This happens for a similar reason as for test panels 1 and 2. As soon as the autoclave pressure is applied and the temperature is increased, the stringers will be pressed together to fill the cavity between laminate and core. The stringer plies together with the filler and skin start to move upwards due to the decreased viscosity of the resin as was explained as the cause of the in-plane waviness in the stringers in the outer quality section. The end result is that the filler is not located at its intended position anymore. Also, the skin underneath the filler shows an extreme wave that follows the contour of the stringers and filler on one side and the flat ground plate on the other side. This can also be seen clearly from the visual inspection as the filler indentation on the skin. This is explained graphically in figure 6.89 and the cross section of the shifted filler material in stringer 3 in figure 6.95.

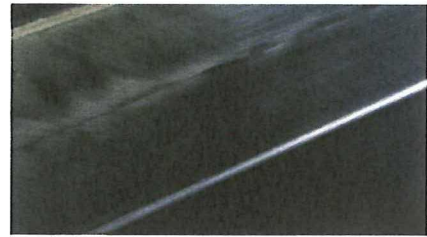
**Figure 6.94:** In-plane waviness in stringer 3

Similar to test panel 12 with the pushing down of the stringer, in-plane undulations are observed in the stringers instead of the skin. The presence of the undulations can be explained by the fact that the preform core is larger than the autoclave core. From figure 6.89, it is visualised that with the cavity present and the autoclave pressure pushing from the right side, panel of the skin laminate, filler and the stringer want to be pushed to the left. As soon as the width difference  $w$  is 0 mm, the skin, filler and stringer material is pushed upwards. By the movement of the fibres from the skin into the stringer, the amount of fibres starts to build up. Since it is constrained from movement on the top and the movement of fibres upward, they start to show waviness. The waviness is stronger for the stringer 1 with the width difference  $w$  of 1 mm, compared to stringer 3 with the width difference  $w$  of 2 mm. Both stringers and their corresponding waviness are shown in figure 6.93 and figure 6.94.

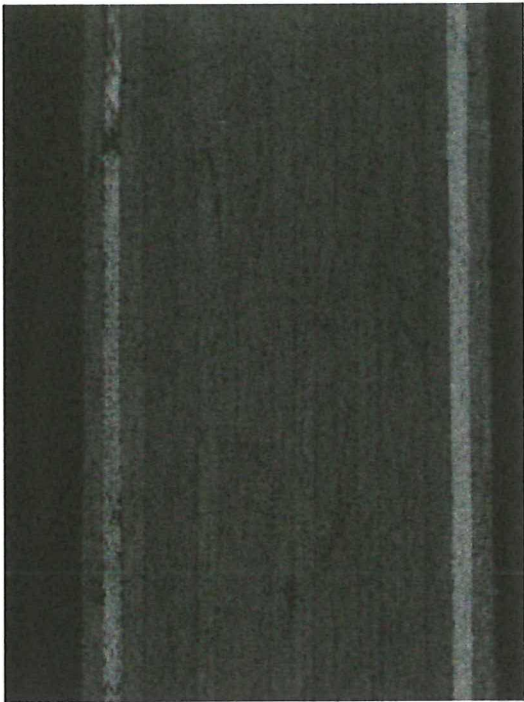
Figure 6.97: In-plane waviness in stringer 3 seen from the cross section

Examining the cross sections of the stringers, the in-plane waviness is observed in the outer ply. This is similar as for test panel 12, where the stringer is pushed down. In this case the stringer is pushed up with extra material from the skin because of the width difference between

the cores, but the compressive forces are the same. The cross sectional images of the stringer and the corresponding waviness are shown in figure 6.96 and figure 6.97.

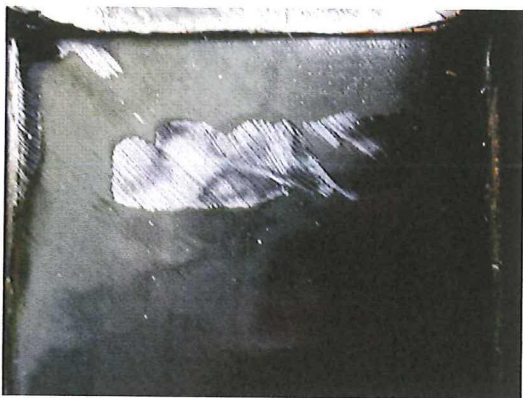
Figure 6.110: Dry spots at location 1 in core 4

The increase in thickness leads to an increase in fibre undulations and dry spots. The dry spots start occurring in the stringer in core 3 and to a small degree in the ramp section with the cavity. In core 4, the dry spots are also present on the end of the core in addition to large dry spots in the ramp section. The dry spots in core 3 and 4 are shown in figure 6.109 - figure 6.111.

A cavity is present on one side of the ramp at location 4 and 5, so the core will rotate down until it rests on the laminate. This leads to a cavity on the other side of the mould, resulting in dry spots and undulations. These in-plane undulations can also be seen in figure 6.110. It is also noticed that the ramp with the cavity becomes darker brown for an increasing shifting distance of the respective cores, see figure 6.112. Cured resin has a brown colour, so a darker brown colour means that there is more resin present in that area, which corresponds to the fact that the resin is filling the cavity.

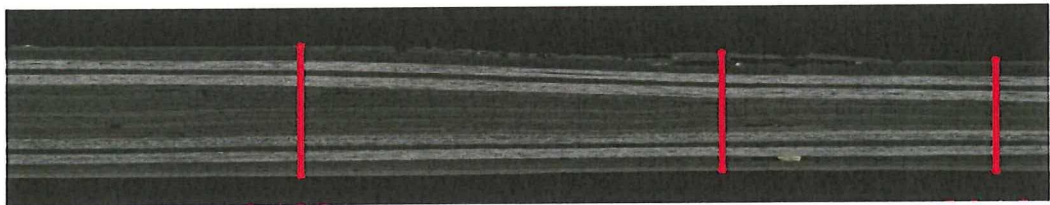
Figure 6.115: Dry spots visible at the cross section at location 4 in core 4

In addition to these undulations, the dry spots in the top layers as well as cavities in the deeper layers are present by looking at these cross sectional images. Interesting to see is that there are not only surface dry spots, but that the lack of pressure also leads to cavities in the rest of the laminate. These dry spots and cavities are present in location 4 of core 3 and 4 and in location 1 of core 4. Location 4 of core 4 is shown as an example in figure 6.115.

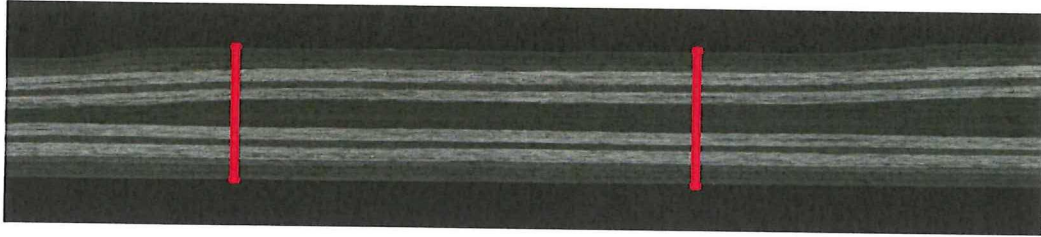
**Figure 6.116:** Matching ply step and tooling ramp locations in core 1

Core 1 is the reference core which should serve as a benchmark for the other cores since no shifting of the cores takes place. Nevertheless, some quality issues are present in these sections. On points 1, 2 and 3, the ramp locations of the tooling matches perfectly with each other as can be seen in figure 6.116.

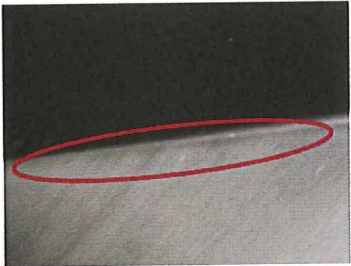
The only observed defect is that there are small undulations present in the skin in the corner sections of the stringer. This could indicate that the filler material has shifted. For the rest, the panel has an expectable quality according to the visual inspection. The small in-plane waviness in the corner section of, in this case stringer 2 core 3, is shown in figure 6.129.

**Figure 6.133:** In-plane waviness in the corner section in stringer 2

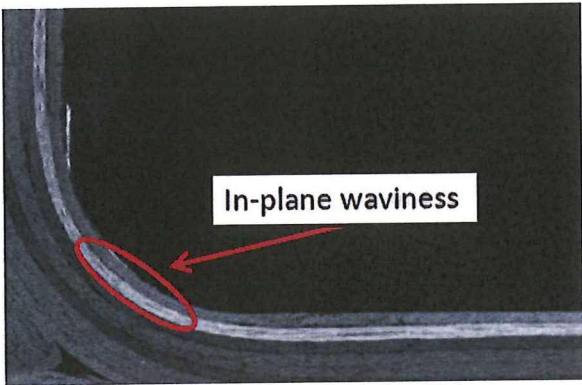
The first defect that is observed by looking at the cross sections is the in-plane waviness in the skin near the corner sections. As an example, the waviness at stringer 2 at location a on the top of the panel, on the right side where core 3 is present is shown in figure 6.134.

The colour change of the top layer from darker grey in the stringer, to light grey in the skin, indicates the change of fibre orientation in that layer from 45 degrees to almost 90 degrees. This indication is based on experience in examining the cross sections. In stringer 1 at location a, at the top side of the panel, a resin rich area is identified on the right side of the stringer on the

**Figure 6.134:** Cross sectional image of the in-plane waviness in the corner section in stringer 2

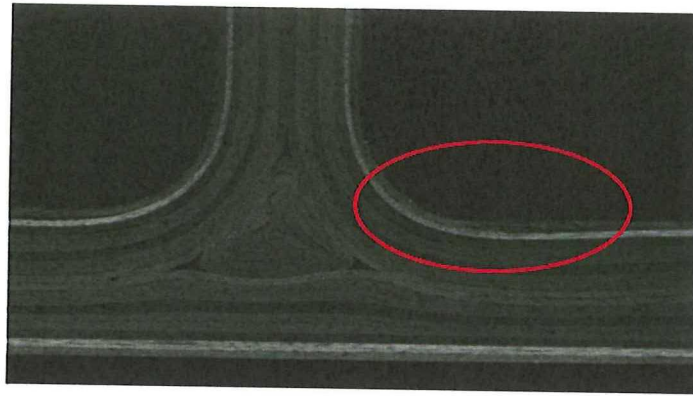
**Figure 6.135:** Resin rich area on the right side of stringer 1

The shape of the resin rich area further propagates to the layers below it and gives the indented shape of the other layers, compared to the left hand side. The resin rich area indicates that the core pack has indeed rotated.

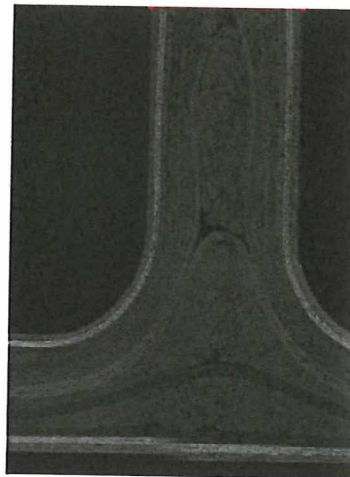
Other, unexpected defects are also present in this part. For cross sections at location b in stringers 1 and 2 at the bottom of the panel where the cavity was present, the filler has shifted upwards significantly. For stringer 2 in cross section location b in stringer 2, the upward shifting of the filler material is as much as 4,5 mm. This intersection with the filler material shifting is shown in figure 6.136.

**Figure 6.136:** Vertical filler movement in stringer 2

The shifting of the filler material in stringer 1 and 2 occurs in the side of the panel where the gap of 3 mm was present. Together with the thickness analysis that is further explained in the next section, it can be concluded the laminate was local lack of pressure on that side of the part. First of all a gap of 3 mm was present, which the expansion block was supposed to fill by pushing the core pack into the gap. The theory is that the expansion block did expand, but not enough to completely pressurize the laminate at the end. This led to the filler material moving upwards instead of the expected sideways movement, since there was space available for the stringer to expand dragging the filler material along with it. To monitor the effect of the rotating cores, only the one side with the good compression is taken into account. This can also be seen from the thickness measurements. The panel that is not under enough pressure is

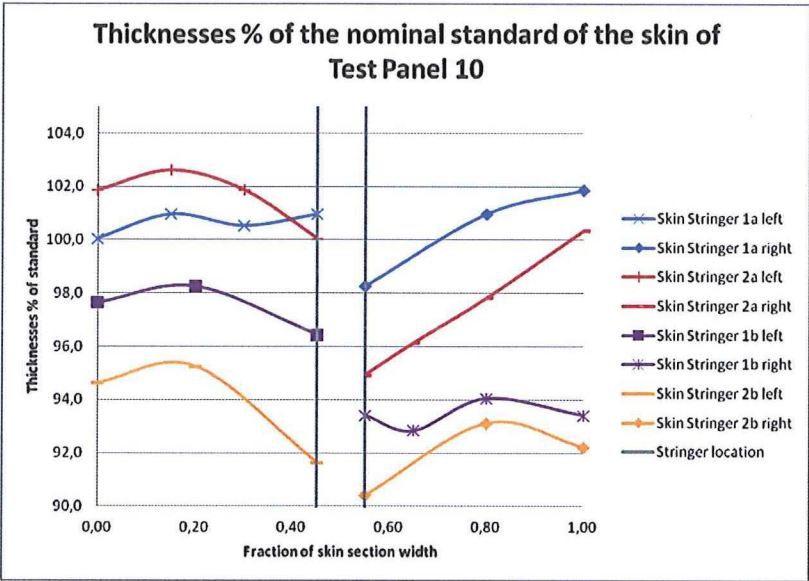
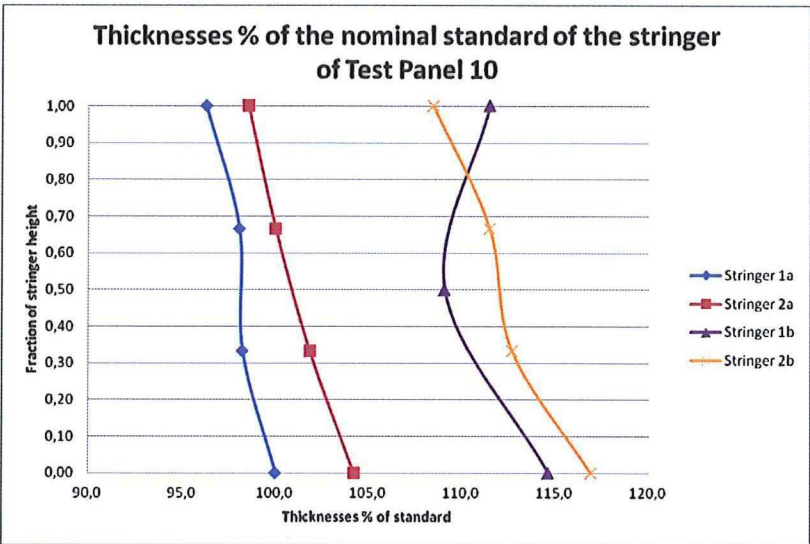
The thicknesses in the skin are close to the nominal value. In this section, 1a is the location a in stringer 1 on the top of the panel and 1b location b on the bottom side of the panel where also the gap is present (see figure 6.127). This is the same for 2a and 2b, but then for stringer 2. The skin at stringer 1b and 2b, which are located on the side of the panel where the gap was

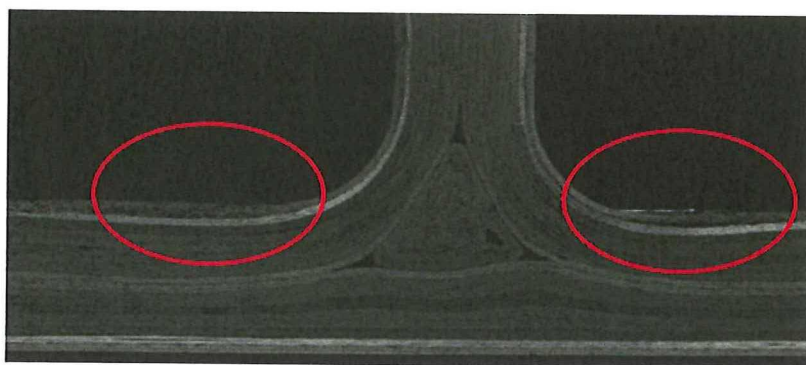
fibre orientation in that layer from 45 degrees to almost 90 degrees. This indication is based on experience in examining the cross sections. Also a resin rich area is identified at this location on the right side of the stringer on the side where the core pushes the stringer to the left. In the other cross section of stringer 1 at location b at the bottom of the panel, two resin rich areas are present on both sides of the stringer. The cores were pushed from right to left and it is shown in figure 6.147.

**Figure 6.147:** Resin rich areas in the corner sections of stringer 1

The shape of the resin rich area further propagates to the layers below it on the right side of the stringer just like in test panel 10 and gives the indented shape of the other layers, compared to the left hand side.

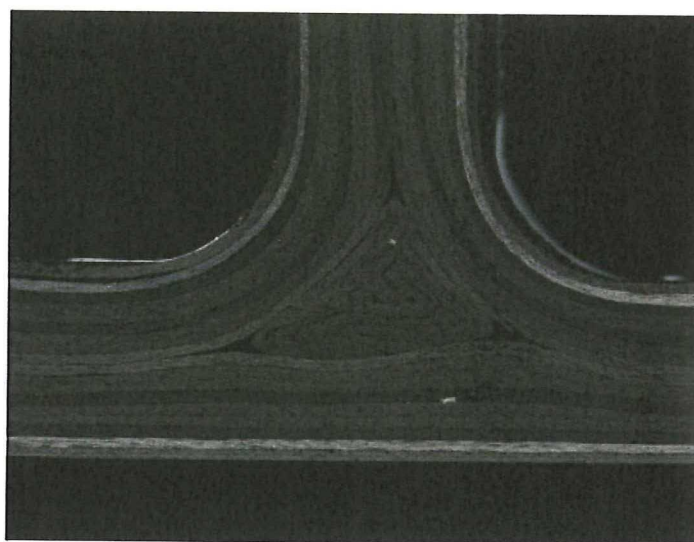
In addition to the in-plane waviness and resin rich areas, filler material has also shifted 0,5 mm in stringer 2 at the top side of the panel. The filler misalignment is shown in figure 6.148.

**Figure 6.148:** Horizontal filler misalignment in stringer 2

The core is pushing from the right side, so there is a force acting on the stringer and filler material that pushes them to the left. The filler material is compressed on the right hand side due to this force and pressed between the stringer web and skin laminate on the left side. This is a completely different situation for the shifting of the filler material than when the autoclave core is bigger than the preform core in test panel 5 (section 6.2.2). In that situation the force is acting more from above pressing the stringer more outwards and over the filler material, followed by exerting pressure on the filler material. In the case of the shifting of the cores however, the

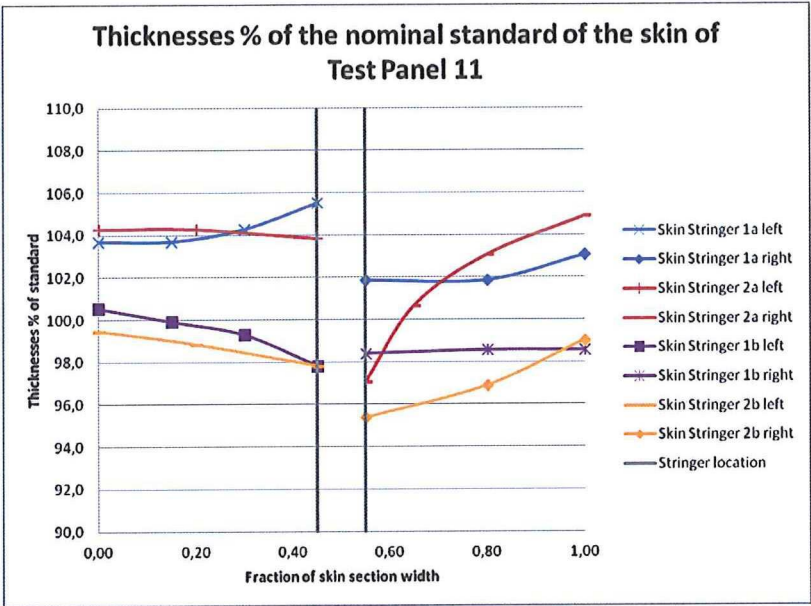
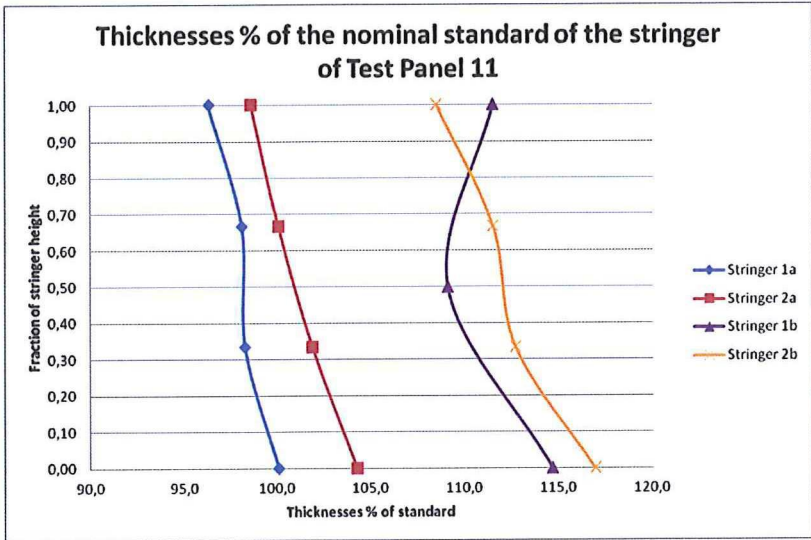
The thicknesses of the skin in stringer panels 1a and 2a (on the top of the panel) are on average

higher than of 1b and 2b (on the bottom of the panel). In stringers 1a and 2a, there is a more significant presence of the resin rich areas compared to 1b and 2b. This means that there is more resin in the skin present, which explains the increased thickness. The thicknesses of the skin and stringers 2a and 2b match quite well and show a similar shape. Core 2 and 3 are slightly rotated inwards with core 2 having a clockwise rotation and core 3 a counter clockwise. This inward rotation causes the stringer to be thicker at the bottom and thinner at the top. For stringers 1a and 1b there is on the other hand a difference between the shapes of the stringers and the thicknesses of the skins. The left panel of the skin is higher near the stringer for panel 1a, implying that the core is rotated slightly counter clockwise. The corresponding stringer is almost perfectly straight with a width at the bottom of 2,262 mm or 103,7% of the nominal and 2,262 mm as well at the top. On the other hand, at the other side of stringer 1 at location 1b, the skin is increasing in thickness on the left side of the stringer. The stringer is increasing in thickness with a width of 2,231mm or 99,2% at the bottom and 2,384 mm at the top or 106,0%. The width difference is 0,153 in this case. The reason for these differences within the same stringer could be that the lateral movement also involved a slight rotation in the xy-plane. This would give rise to the possibility that the stringer cavity is larger at the top, explaining the width difference in the stringer. Other explanations would be that the core changes shape to a small extent in the autoclave due to temperature or pressure or that the shape of the core is not precise. This was previously referred to as the W-effect in test panel 4. In order for the last explanations to be true, a precise measurement of the core and its behaviour in the autoclave needs to be done.

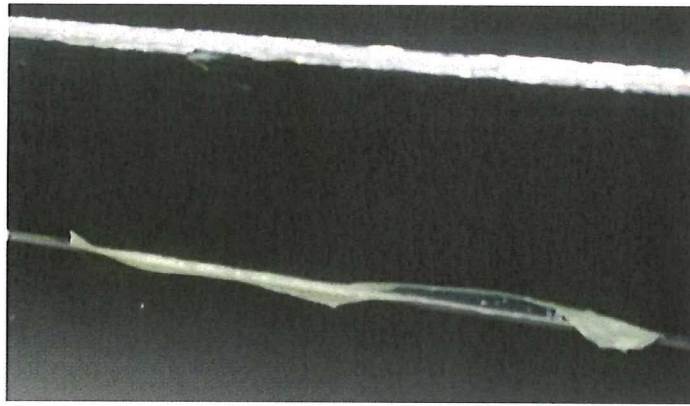
Release film was present on the laminate to allow for easy removal of the prepreg and cork support material. The foil was enclosed in the corner sections of all stringers, but could be removed from the cores 1 and 2. At cores 3 and 4, the foil is still enclosed and could not be removed. This indicates that the stringer with the largest height is pushed down more than the stringer with the smaller height. The pushing down of the stringer results in an open space in the corner section, which will fill with resin and encloses the release film. The enclosed release film is shown in figure 6.158.

**Figure 6.158:** Enclosed release film in the corner section of stringer 3

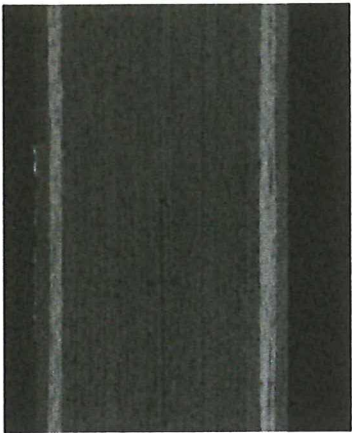
In the stringer, the in-plane undulations are present on the same side where also the release film was enclosed in figure 6.161. The outer layer changes from a 45 degree orientation to almost a 90 degree orientation, by looking at the change of grey scale of the outer layer. This indication is based on experience in examining the cross sections.

**Figure 6.161:** In-plane waviness in stringer 3

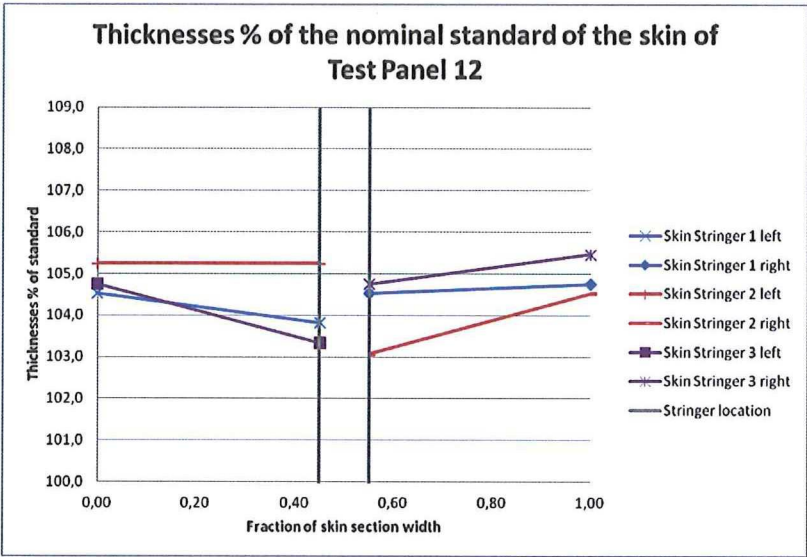
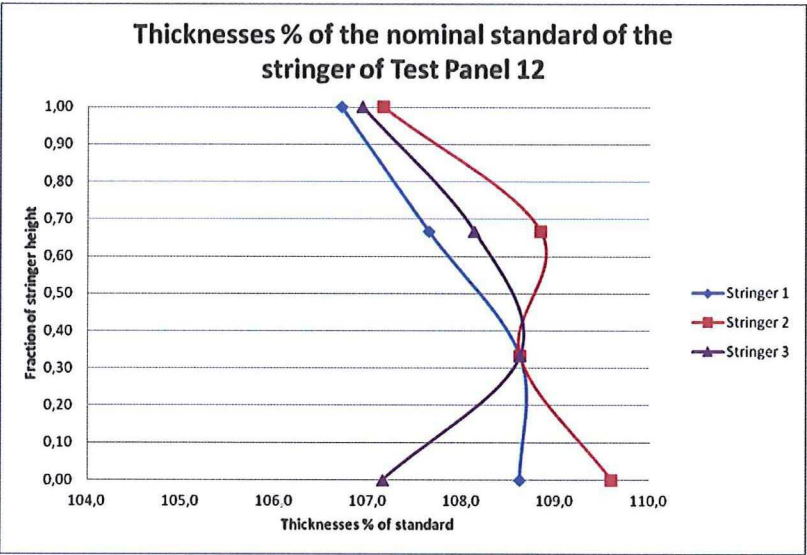
The thicknesses of the skin and stringers are displayed below in figure 6.162 and figure 6.163. The thickness measurements can be seen in appendix D and the deviations from the tolerances in appendix E. In this panel the cores 1 and 2 were hanging 1 mm above the skin of the laminate and core 3 and 4 2 mm. This results in that stringer 1 is 1 mm too high for the cavity, stringer two a combination of 1 and 2 mm and stringer 3 2 mm too high. The thicknesses of the skin section are almost similar for all the three stringers. In core 3, the W-effect can be seen, since on the right side of the skin of stringer 2 and on the left side of stringer 3 are pressing in the corner section more and less in the middle of the skin. Of main interest for this process alteration are

the stringer thicknesses in specific stringer 1 and 3. Stringer 1 is slightly thicker at the bottom of the stringer with a thickness of 2,444 mm or 108,6% compared to the top with a thickness of 2,401 or 107,1%. This is a difference of 0,043 mm. At stringer 3, there is only a 0,005 mm difference. However, the stringer is a bit thicker in the centre where the stringer is 0,036 mm thicker compared to the bottom. The assumption is that the stringer is compressed from the top, due to the higher stringers than the height of the cavity, resulting in the compaction of the stringer in the centre. This results in the undulations in the stringer that were observed as well as the increase in thickness in the centre for a larger stringer height difference.

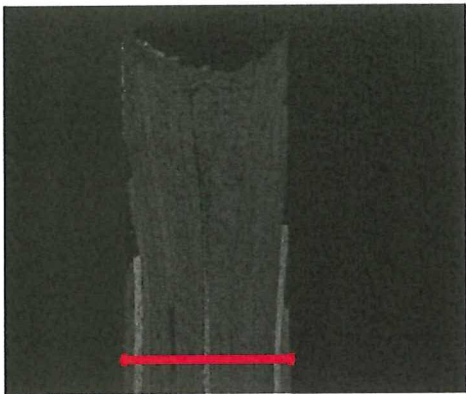
In addition to the manufacturing defects, the slipped stringer plies can be observed clearly and are directly linked to the stringer height. These slipped stringer plies are seen as a defect, resulting from the stringer height difference. As an example, the top of stringer 3 with the slipped stringer plies is shown in figure 6.171.

Figure 6.171: Slipped stringer plies on the top of stringer 3

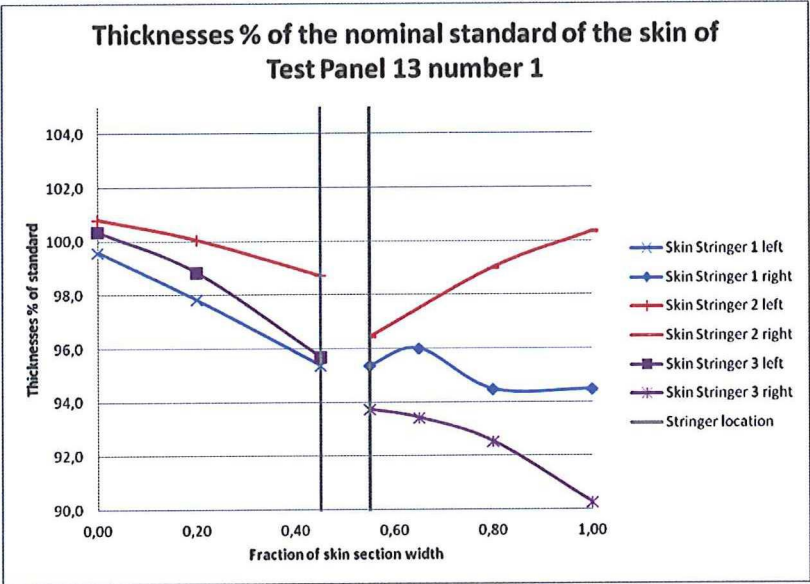
Figure 6.172: Panel 13.1: Thickness percentage of the nominal of the skin

The skins next to the stringers are all very thin compared to the nominal with at the right of stringer 3 a thickness of 2,031 mm or 90,3%. Comparing the thickness of the skin to the thickness of the stringer, it is concluded that the resin from the skin is pushed out into the stringers. The reason that the resin is pressed out of the skin is that the resin was free to move into the stringer, since it was needed to fill the cavity. The stringers are out of tolerances with stringer 1, being the thickest with a thickness at the bottom of 2,865 mm or 127,3%. All the stringers are thinner at the top, which is logical due to the presence of the cavity above the

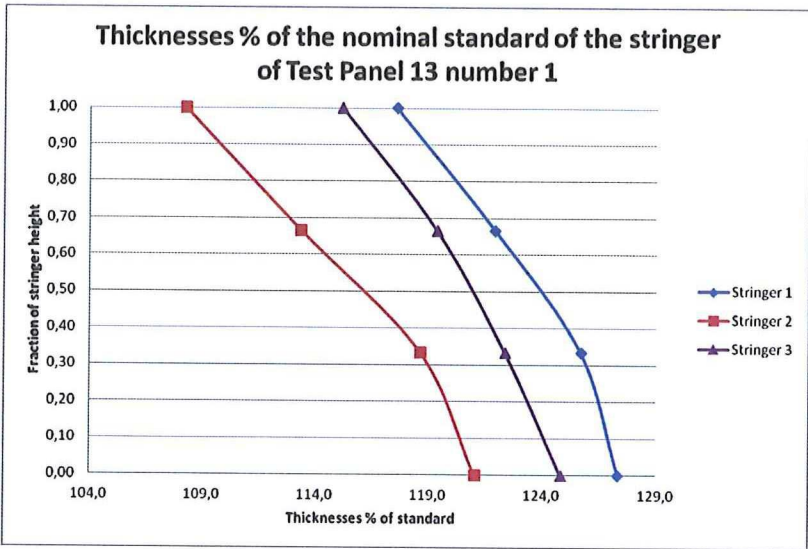
Figure 6.173: Panel 13.1: Thickness percentage of the nominal of the stringers

stringers, with for example for stringer 1 with a thickness of 2,645 mm or 117,6% This is a difference with the bottom of 0,220 mm. Even at the top of the stringer, the thickness is still very large and close to the maximal allowed value. Also, the W-effect, which was explained in panel 4, is slightly present when looking at core 2 between stringer 1 and 2. The thickness is lower at the stringer on the right side of stringer 1 and on the left side of stringer 2 and larger in the middle.

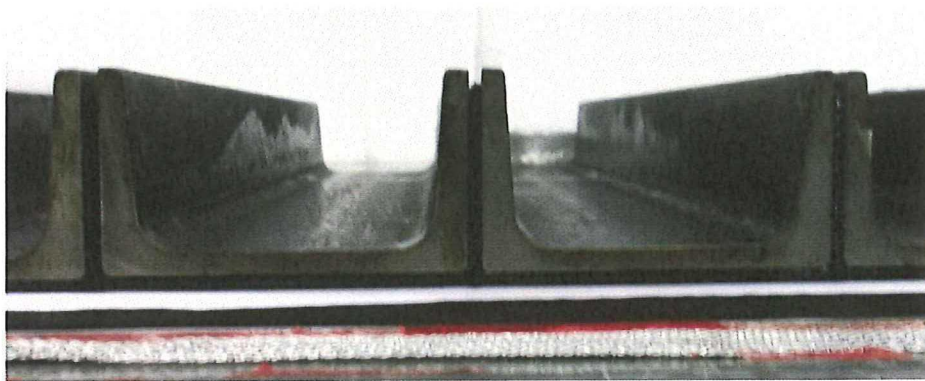
The cut off stringers with the cores for this part, with stringer 1 on the left and stringer 3 on the right, are shown in figure 6.174.

**Figure 6.174:** Shorter stringers than the cores with stringer 1 on the left

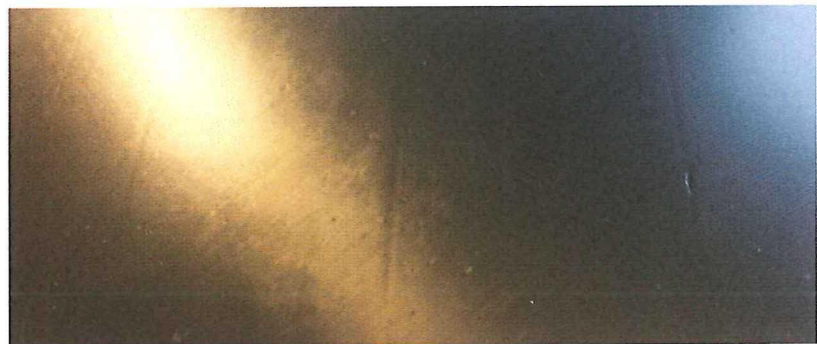
The corresponding explanations for the different sizes of resin stains and slipped stringer plies are given in section 6.4.2. This time, the filler indentations are also present on the back, but to a smaller extent than for 13.1. This could indicate that the filler movement is less than in panel 13.1 or not even be present at all. The filler indentations are shown in figure 6.179.

**Figure 6.179:** Filler indentations on the outer mould line

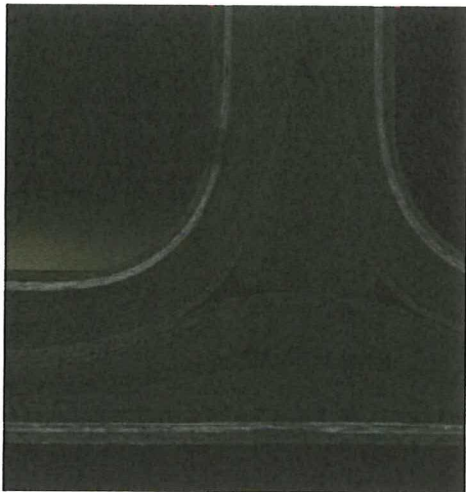
The first observation is that the filler material in all the stringers has moved up slightly. However, the distance that the filler material moved upwards is almost the same for all stringers ranging from 1,5 - 2,0 mm for the all three stringers. As explained in the thickness section, the panel was not under pressurized before the autoclave. The assumption is that as soon as the resin is moving upwards to fill the cavity, the stringer is stuck between the two halves of the stringer laminate flanges. The filler is firmly wedged between the two halves and cannot move up further, because the space within the stringer for the filler material to move upwards is smaller due to proper pressure. As an example, the intersection with the filler material of stringer 3 is shown in figure 6.180.

Figure 6.180: Wedging of the filler material between the two stringers halves in stringer 3

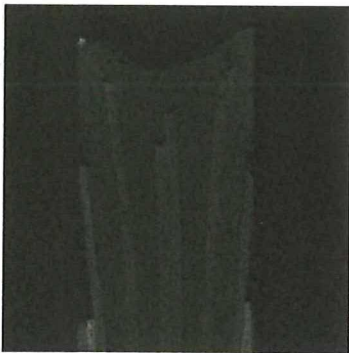
In addition to the filler material, the slippage of the stringer plies is observed clearly. The outer plies show the least movement upwards, followed by the  $\pm 45$  degree plies. The, darker, 0 degree plies fill the most panel of the cavity. As an example, the top of panel of the slipped stringer plies of stringer 2 are shown in figure 6.181.

Figure 6.181: Slipped stringer plies in stringer 2

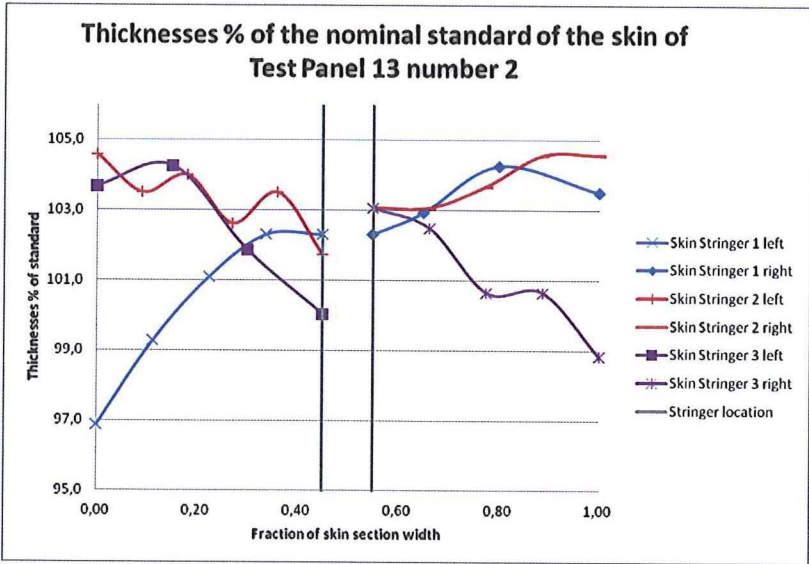
Figure 6.182: Panel 13.2: Thickness percentage of the nominal of the skin

The skins thicknesses are all very close to the nominal of what the thickness should be. The two outer cores are rotated away from the stringer with core 1 rotating counter clockwise and

core 4 rotating clockwise. However, the thickness differences are close to each other, so this is not clearly proven.

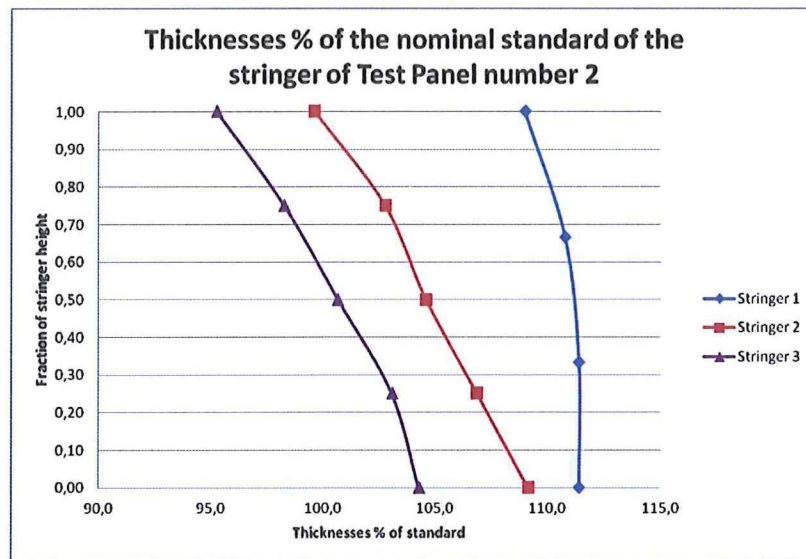
Figure 6.183: Panel 13.2: Thickness percentage of the nominal of the stringers

The difference between the 2 mm and the 4 mm shorter stringer is on the other hand identical between the calculated area, actual area and the bottom of the stringer and the top of the stringer. This is also observed from figure 6.183 where the stringers 2 and 3 have an almost identical shape, with the difference that stringer 3 is shifted to the left. The difference in calculated area to nominal before curing and the actual area after curing difference between stringer 1 and 2 is therefore only due to the higher thickness of stringer 1 at the top.

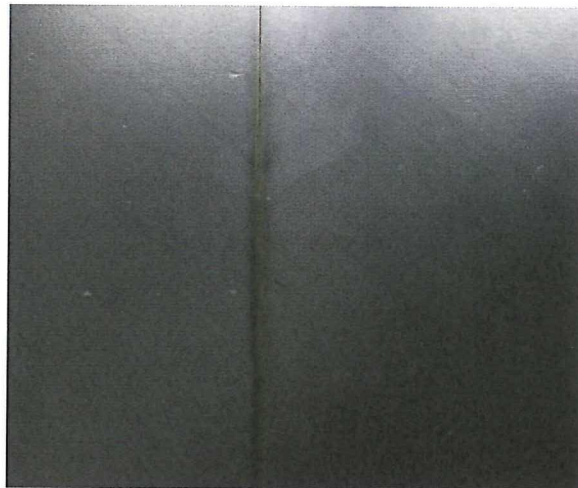
On the back of the panel on the skin, filler indentations with out of plane waviness in the form of a wrinkle are present below stringer 1. This is the stringer with the 50% filler material. This indicates that either the filler material, due to an insufficient cross section, was not able to fill the intersection properly or that it moved upwards or that the resin flow from the material to the intersection was insufficient, so that the skin leaves an out-of-plane wave. The filler indentations on the back of stringer 1 are shown in figure 6.190.

**Figure 6.190:** Filler indentation for stringer 1 on the outer mould line

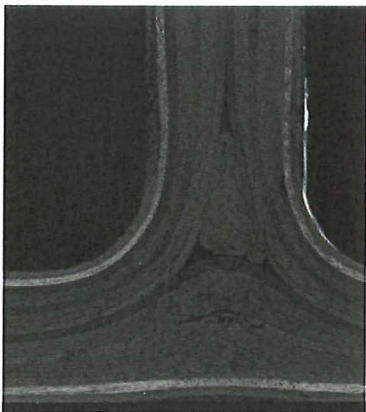
From these images, the influence of the different filler sizes and material is seen clearly. The 50% filler in stringer 1 moved completely up the stringer with a distance of 2 mm, due to its insufficient size. As a result, the fibres in the skin filled the intersection, creating a large wave in the skin. This consequently leads to the wrinkles at the bottom surface of the skin. For the 150% filler material in stringer 2, the laminate in the stringer is completely compressed. This can be seen from comparing the thickness of the laminate of the stringer halves next to the filler material with that of stringer 1. The filler material also moved up slightly with a distance of 0,7 mm. In stringer 3, the filler material also moved upwards, in this case with a distance of 0,5 mm. Comparing stringer 2 and 3, it is seen that the triangular filler material fills the intersection better with fibres with almost no pure resin spots. Also the triangular filler material has more material than the 150% filler.

Figure 6.192: 50% filler material in the intersection of stringer 1

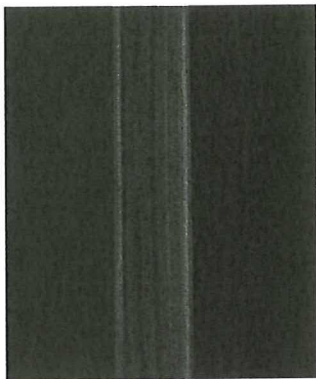
The origin of the undulations is explained in the evaluation of the cross sections section and they are caused by the W-effect and can be seen in the stringers in figure 6.191.

**Figure 6.195:** In-plane undulation in stringer 1

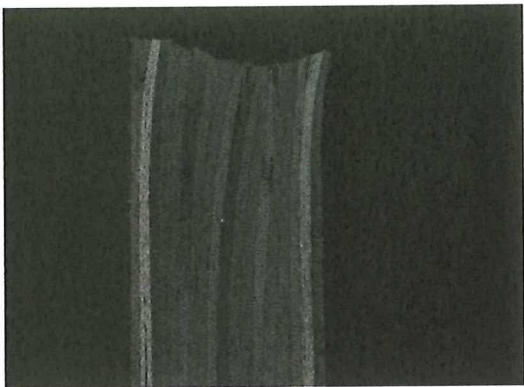
the bottom of the stringer by the so-called W-effect. The top of the stringer is then compressed from the top by the autoclave pressure and because the stringer is pushed upwards, resulting in the compression of the stringer in axial direction. When examining the top of the stringer, it can indeed be concluded that the stringer was compressed on the top, due to the deflection of the layers to the left. This is the result from an axial compression. As an example, the out-and-in-plane undulations of stringer 1 are shown in figure 6.195 as well as the top of the stringer in figure 6.196. More on the axial compression of the stringer is explained in the thickness measurement section.

**Figure 6.196:** Top of stringer 1

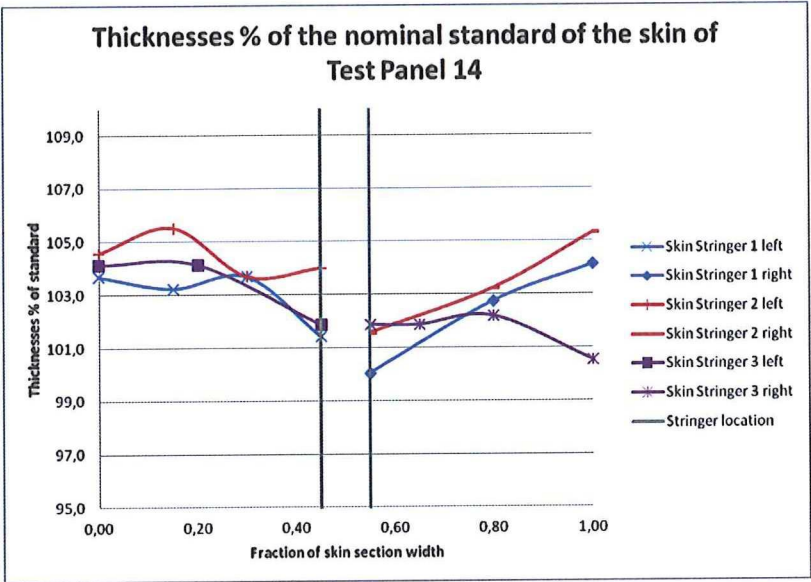
**Figure 6.197:** Panel 14: Thickness percentage of the nominal of the skin

The thicknesses of the skin and stringers are displayed below in figure 6.197 and figure 6.198. The skins thicknesses are all close to the nominal of what the thickness should be. Interesting to see is that the skins have globally the same shape for all the skins on the right side and all

the skins on the left side. The panel has the same contour as the outer contour of the core, so with a core with a perfect straight web, these results would not be possible. Core 2 for example is pressing down on the right side of stringer 1 and the pressure decreases, closer to the centre of the core. After that, the core again exerts more pressure near the corner of stringer 2, resulting in a thinner skin. By looking at the stringer thicknesses, they are all thicker at the bottom than at the top. The conclusion from this is that the steel cores deform slightly due to the autoclave pressure in the way as described in test panel 4 as the W-effect. The fact that the undulations occur is due to the autoclave pressure that is exerted in the top, the bottom of the stringer is pushed upwards by the filler and the clamping on the bottom due to the filler in figure 6.199.

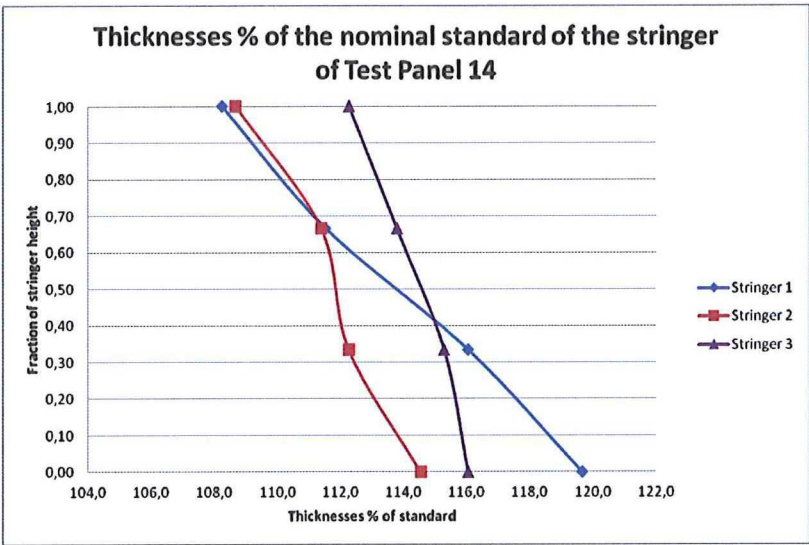
Figure 6.198: Panel 14: Thickness percentage of the nominal of the stringers

By looking at the thickness differences of the individual stringers with respect to each other, it is seen that stringer 1 is the thickest at the bottom with a thickness of 2,692 mm or 119,6% with respect to the nominal. The filler material of 50% cross section is pushed all the way up the stringer, due smaller size of the filler. This leads to the local thickness increase at the bottom and also to a large thickness difference with the top of 0,257 mm. Stringer 2 has the smallest thickness at the bottom of 2,577 mm or 114,5%. In figure 6.193 it can be seen that the laminate is pressurized a lot between the filler material and the core and it also leads to a smaller total stringer thickness. More fibre material in the bottom suggests that the deformation of the core is less, which also corresponds to a smaller width difference compared to the top of 0,132 mm. The same is true for stringer 3.

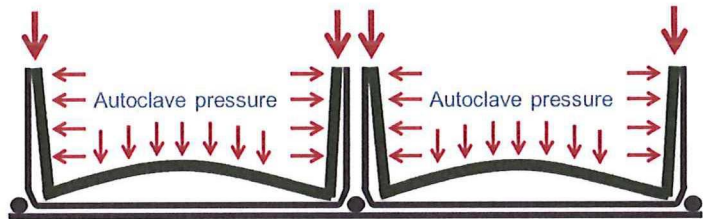
This deformation would explain the thickness differences as well as the shifting of the filler material upwards for all three stringers. As soon as the stringer gets stuck between the cores, the laminate becomes clamped between the filler and the cores. On the top of the stringers, there is a layer of release film, the airweave and the vacuum bag. These layers are pressed onto the stringers and create a flat surface. As soon as the core flanges are pressed inwards, the ancillary material at the top of the core will move with it. This leads to that the release film for

Figure 6.199: Cause of in-plane waviness in the stringers

instance is not completely straight in tension above the top, but that it is slacking due to the pressurization. This gives the option for the autoclave pressure to push directly on the top of the stringer laminate instead of that the pressure it taken up mostly by the tension in the release film above it. With the pressure exerted on the laminate from the top and the laminate clamped below, the fibres start to deform into undulations. This last panel is in the real production not possible, since the cores are closed off at the top, so the pressure cannot be exerted directly onto the laminate. However, the carbon fibre core can deform due to the pressure, so the thickness variations can occur.
