ELASTOCOAST PILOTS IN THE NETHERLANDS
STORM SEASON 2007/2008

ELASTOGRAN GMBH

15 September 2008

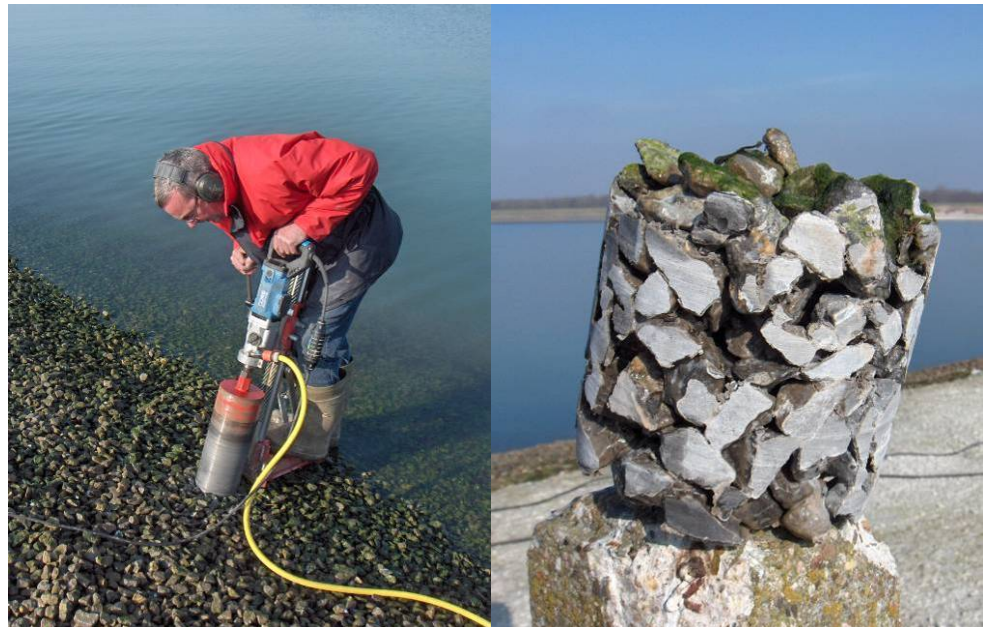
Figure 2.7

Five months after construction, core samples were taken at the Zuidbout to verify the structural integrity over the layer thickness. The Elastocoast structure was very well capable of withstanding the mechanical forces of the drilling process and produced cylindrical samples that were completely intact from top to bottom.

Core drilling process (left) and the resulting cylindrical sample of Elastocoast.

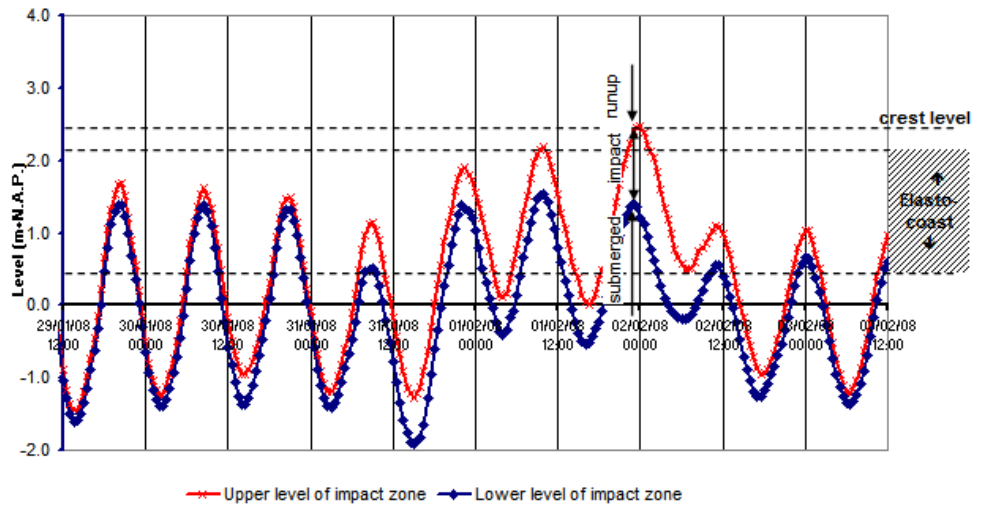
Figure 2.20
Position of upper and lower level of the impact zone.

The graph shows that the Elastocoast structure has suffered from all load cases during the storm. Comparison to the observed wave conditions shows that a persistent heavy wave attack was present from February 1st 23:00 PM to February 2nd 05:00 AM. Therefore, all load cases have occurred in combination with heavy wave attack.

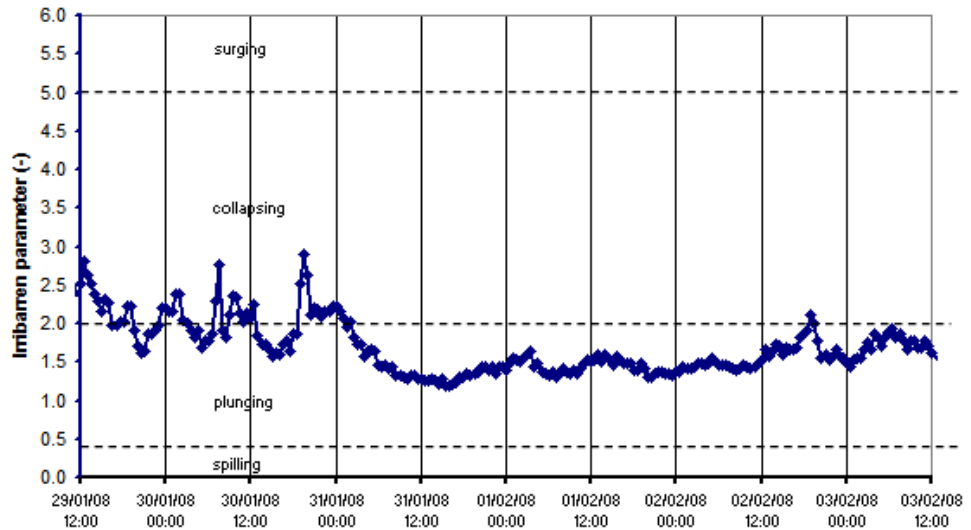
The graph below shows the Irribarren-parameter at the Zuidbout during the storm and the corresponding breaker type. During the storm, the Elastocoast layer was persistently subjected to breaking waves in the plunging regime.

Figure 2.21
Breaker types that occurred at the Zuidbout during the storm of February 2nd.

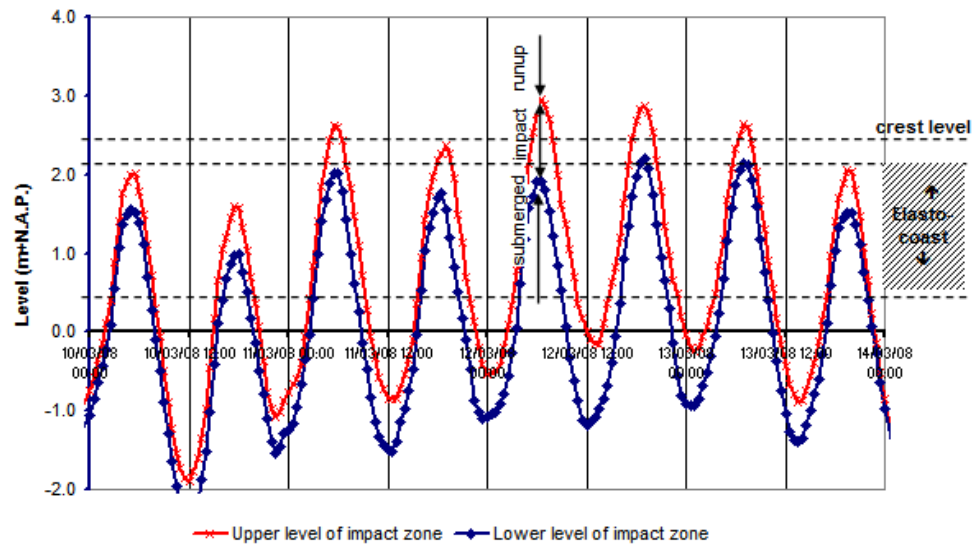
Figure 2.26
Position of upper and lower level of the wave impact zone.

The graph shows that the Elastocoast structure has suffered mostly from the impact and submerged load cases during the storm. Comparison to the observed wave conditions shows that a persistent heavy wave attack was present on March 12th from 6:00 AM to 15:00 PM. Due to the high water level, loading by wave run-up took place above the Elastocoast structure.

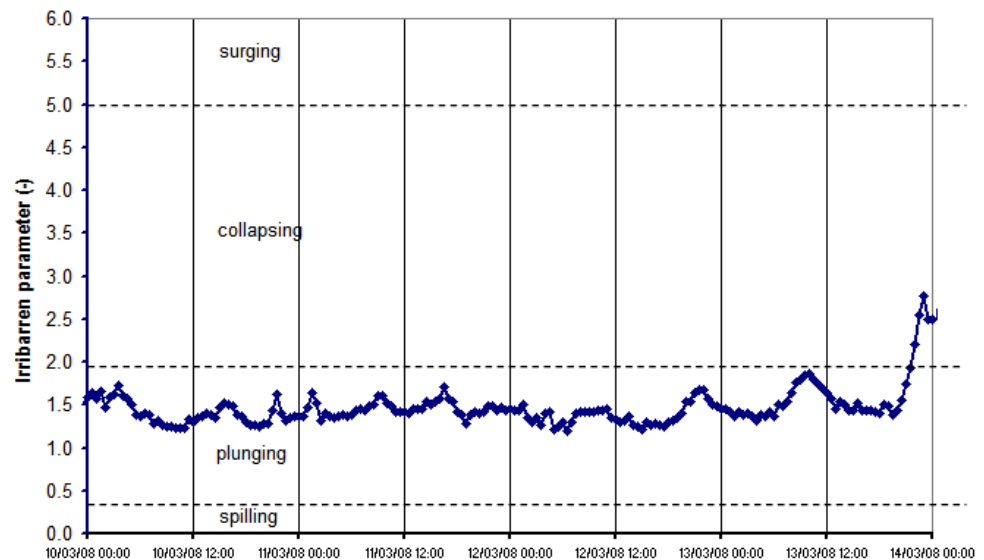
The graph below shows the Irribarren-parameter at the Zuidbout during the storm and the corresponding breaker type. During the storm, the Elastocoast layer was persistently subjected to breaking waves in the plunging regime.

Figure 2.27
Breaker types that occurred at the Zuidbout during the storm of March 12th.

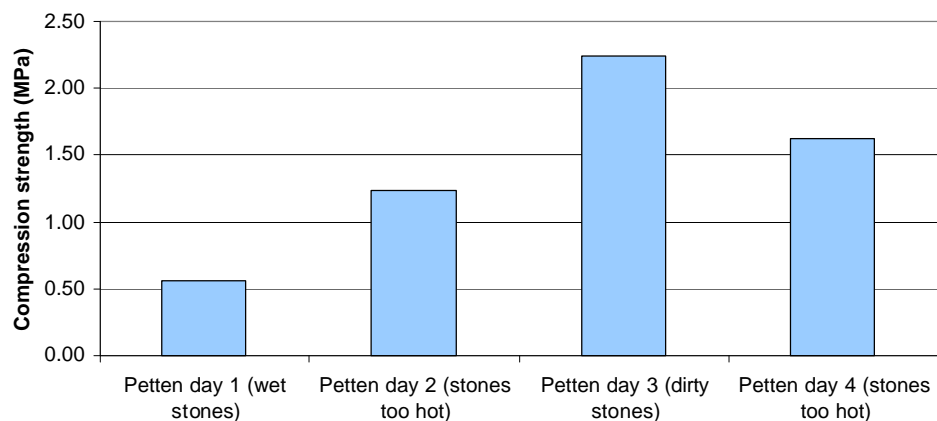
Figure 3.7

Results from compression strength tests on samples taken from the Petten pilot.

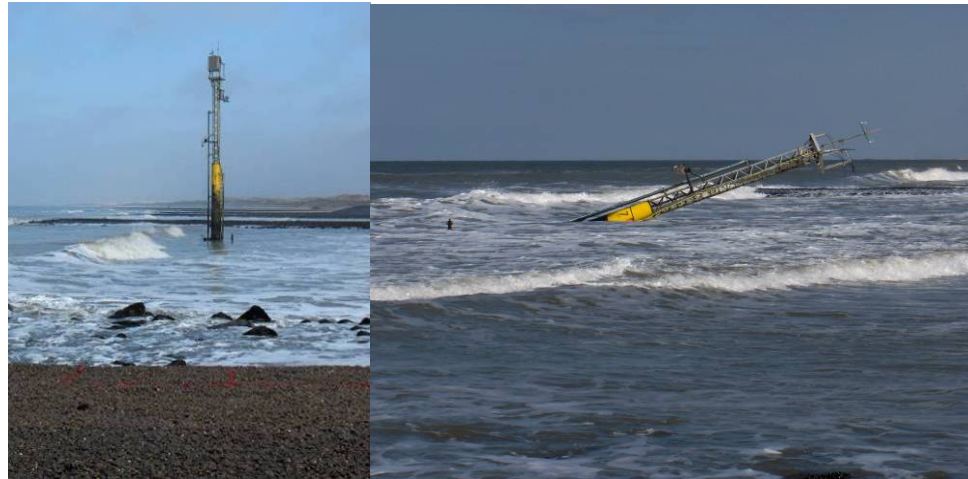
Figure 3.10

Due to defects of the measuring equipment data, an analysis of the storm season 2007/2008 could not be retrieved for the entire periods of October to April. No data is available for the month of December and beyond February 12th. During a storm at the beginning of February the foundation of measuring pole 6 was undermined and the entire pole collapsed. Therefore the rendering measurements from this point on are useless (figure 3.11).

Measuring pole number 6 before and after the storm of February. Although the pole is marked with a '7', it really is number '6' as was indicated in figure 2.8. The Elastocoast structure is visible in the front of the left picture.

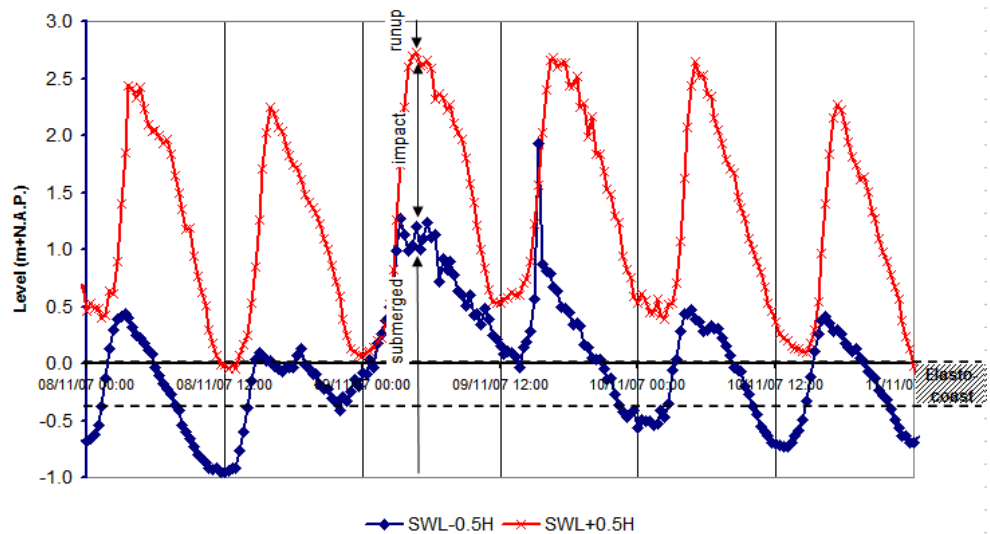
The following graph shows the upper and lower level of the wave attack zone in comparison to the level of the Elastocoast structure. The graph shows that the Elastocoast structure was completely submerged for most part of the time, especially when the most extreme waves were measured.

Figure 3.20
Position of upper and lower level of the wave attack zone.

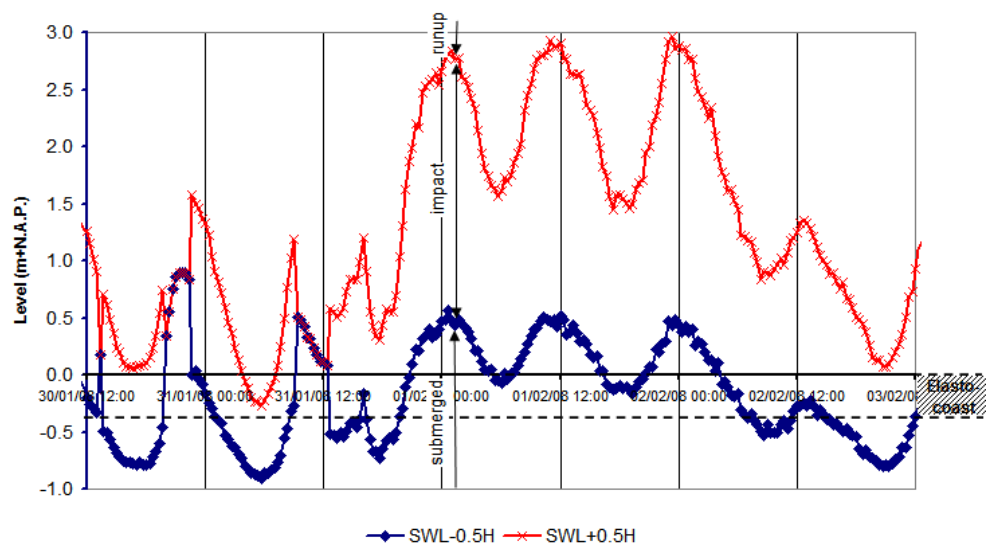
The following graph shows the upper and lower level of the wave attack zone in comparison to the level of the Elastocost structure. The graph shows that the Elastocost structure was completely submerged for most part of the time, especially when the most extreme waves were measured.

Figure 3.25
Position of upper and lower level of the wave attack zone.

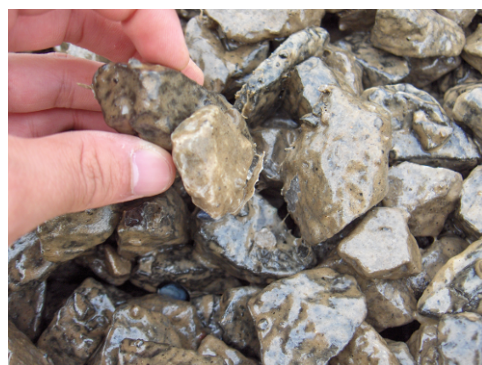
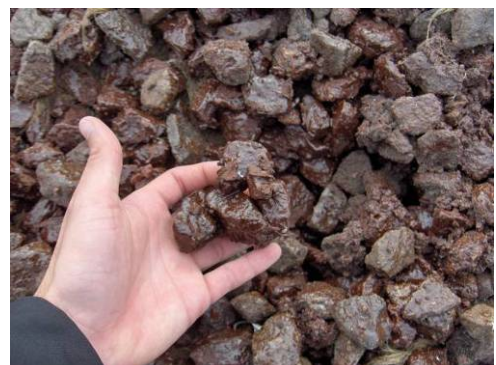
Problem area B: extra 10 cm on top of bad area where stones were too hot.

Problem areas A (left) and C (right): some stones can be removed by hand. Stones in Area C are red due to dust from tumbler.
