Wear Induced Failure of Automotive Disc Brakes—A Case Study

Abstract: This paper investigated a failure in a ventilated disc brake in an automobile. The failed brake disc had been in service for approximately 10 years. The observed failure was in the form of radial cracks that appeared to have initiated at the outer edge of the disc brake. The cracks were rather straight with no branching. Optical microscope, scanning electron microscope (SEM), and energy dispersive X-ray spectroscopy (EDS) were used to study the microstructure of the failed disc. Vickers microhardness test was also used to evaluate the hardness of the samples. Results showed that the root cause of crack formation, in this case, was related to the excessive wear in the brake disc. Different wear mechanisms, namely abrasive and adhesive wear, were recognized in the failed specimen. Moreover, the worn surface in some areas was covered with fine oxide particles. These particles appeared to have a significant contribution toward abrasion. To further understand the wear mechanisms, pin-on-disc experiments were also conducted on the samples. Results of the pin-on-disc experiments were compared and correlated to the resu

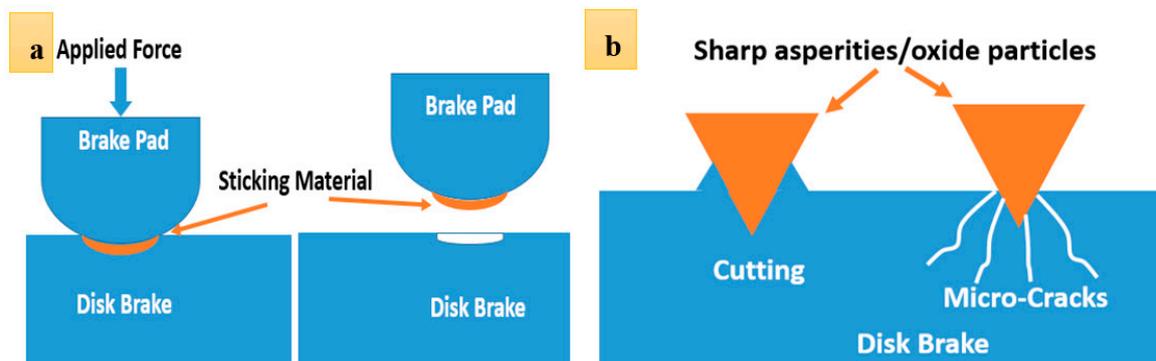
While plastic deformation and spallation are indications of an adhesive wear mechanism, plowing and cutting can be linked to the abrasive wear, inferring that both adhesive and abrasive wear mechanisms contribute to weight loss during wear test. The former wear mechanism has a relatively higher kinetics of weight loss. In severe conditions, contact points in-between sliding bodies can be severely damaged by adhesive wear. In case the surface has some minimum roughness and the applied load is high enough, metal-metal sticking on contact spots becomes inevitable. In case the so-called sticking layer is weakly bonded to the disc, it will eventually be detached from the surface. This is schematically shown in Figure 10a. In comparison to the adhesive wear, abrasive wear takes place when a hard particle/asperity is sliding over a surface. Hard particles/asperities can cause abrasion without having to induce any major plastic deformation on the surface. In case particles/asperities are sharp enough, they create surface cutting. However, their attributions are not limited to cutting, as they could also cause surface micro-fractures and grain pull-outs (see Figure 10b) [23]. Cutting and micro-cracks are essentially more dominant features on the fracture surface. Surface cutting results in the detachment of wear debris. Where the wear debris is hard and fragile, they will be fragmented and entrapped in between sliding bodies and inside surface grooves, and, in turn, contribute to the abrasion of the surface. The attribution of wear debris to the wear rate depends on the relative hardness of wear particles to that of the worn surface. Fast abrasion is expected to take place when the hardness of the matrix is less than 80% of the hardness of particles [23]. If the load at the contact points is high enough, the temperature at the contact points increases, and therefore, oxidation of the wear debris is also likely to take place. This appears to be the case in this failure (see Figure 7). Oxide particles are clearly hard and are expected to cause further abrasion. Both cutting and micro-cracks are less probable when the worn surface is ductile in nature. Results show that in this case, both adhesive wear and abrasion control the wear of the disc brake during service. Figure 11 shows the SEM images of debris after wear tests. Debris can primarily be categorized into large plate-like chips, with their sizes being in the range of a few ten micrometers, and fine agglomerated particles. EDS analysis shows that

Figure 10. Schematics of (a) adhesive wear and (b) abrasive wear mechanisms.

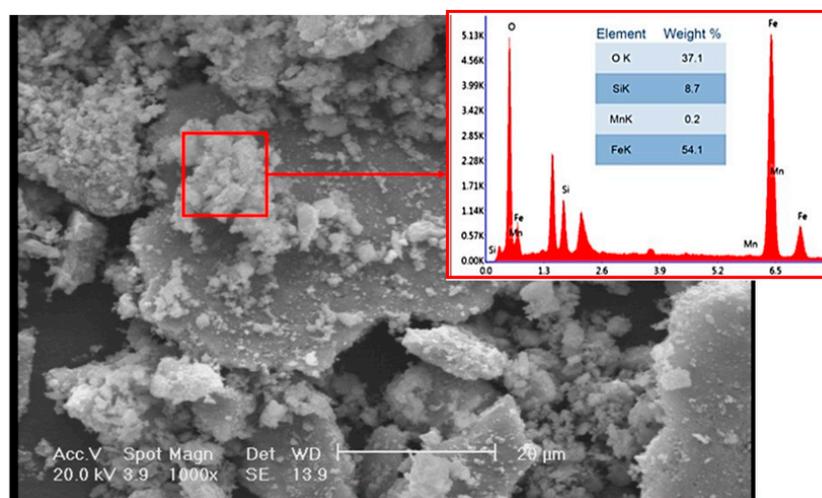
these particles are oxide particles, thereby supporting the aforementioned argument concerning the formation of oxide particles due to temperature increases in-between the pin and the disc.

Figure 11. SEM image/EDS analysis of wear debris (x-axis: KeV, y-axis: a.u.).
