**Rolling contact fatigue
Spalling versus transverse fracture of rails**

Rolling contact fatigue: Spalling versus transverse fracture of rails

Michaël Steenbergen

Delft University of Technology, Faculty of Civil Engineering and Geosciences, Railway Engineering Group, Stevinweg 1, 2628 CN Delft, The Netherlands

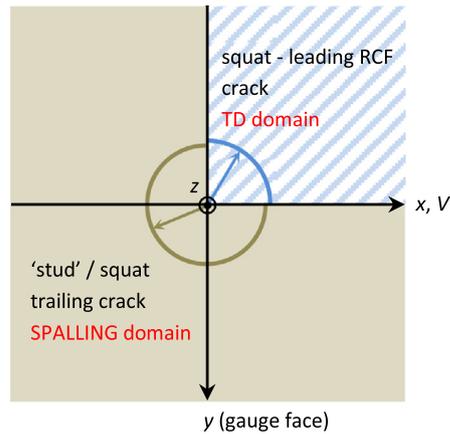
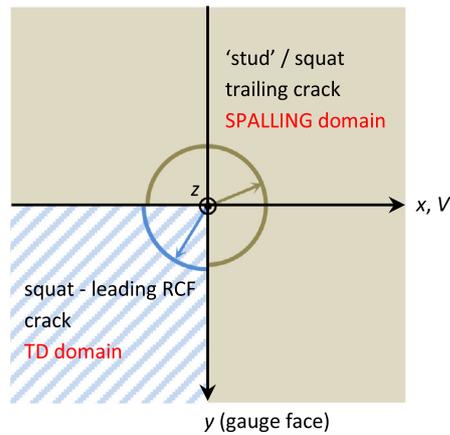
subsurface (+z,+x,+y) crack propagation direction & failure domains

Fig. 10. Transverse defect (TD) versus spalling domains (quarter-spaces) for surface-breaking cracks in the running band of the rail in different track situations, assuming one-directional train operation.
