### A case study of St. Christopher in Maria Church, Nisse

Gatto, Valentina; Anisimov, Andrei G.; Lettinga, Wouter; Tao, Nan; Lantman, Merel; Crijns, Bernice; Groves, Roger M.

# Application of shearography and the percussion method for the structural inspection of wall paintings: a case study of St. Christopher in the Mariakerk, Nisse

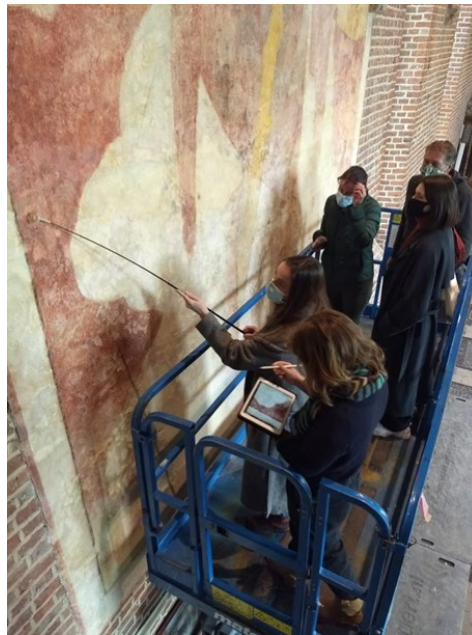
Figure 2. Percussion testing in Maria Church, wall painting depicting St. Christopher.

The percussion tests were executed in a collective approach, in order to reduce biases and subjective inclinations (Figure 2). After the tapping or the rolling of an area had occurred, the generated acoustic reactions were discussed and subsequently mapped (Figure 4 (a)). It can be easily observed that the implementation of the two percussion methods, despite involving the same mechanism of interpretation and collection of data, gave somewhat different results (Figure 4 (a)). It can be stated that the percussion method involving the tapping of a nail resulted in identifying more areas with delaminations than the percussion methods involving the rolling of the acoustically isolated plastic ball. In overall, some similarities in the results obtained were observed, especially in areas surrounding the wooden lintel, part of the door underlying the wall painting of St. Christopher (left and right side on the lower part of the wall painting in Figure 4 (a)).
