Train Hunting Related Fast Degradation of a Railway Crossing—Condition Monitoring and Numerical Verification

Abstract: This paper presents the investigation of the root causes of the fast degradation of a railway crossing. The dynamic performance of the crossing was assessed using the sensor-based crossing instrumentation, and the measurement results were verified using the multi-body system (MBS) vehicle-crossing model. Together with the field inspections, the measurement and simulation results indicate that the fast crossing degradation was caused by the high wheel-rail impact forces related to the hunting motion of the passing trains. Additionally, it was shown that the train hunting was activated by the track geometry misalignment in front of the crossing. The obtained results have not only explained the extreme values in the measured responses, but also shown that crossing degradation is not always caused by the problems in the crossing itself, but can also be caused by problems in the adjacent track structures. The findings of this study were implemented in the condition monitoring system for railway crossings, using which timely and correctly aimed maintenance actions can b

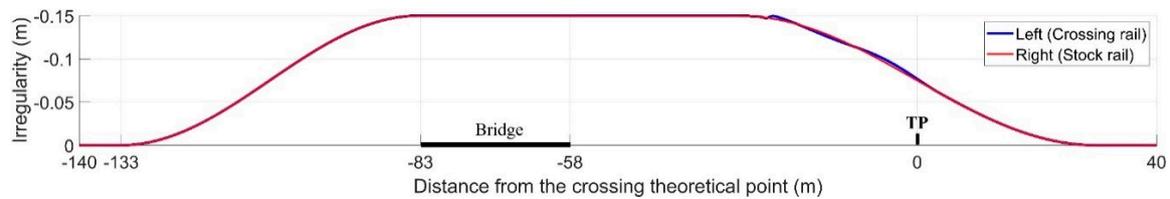
Figure 19. Equivalent lateral irregularities in the track.

In order to verify the effect of the track lateral misalignment on the performance of the crossing, both the bridge-introduced curve and the track gauge variation were input into the MBS vehicle-crossing model (Figure 9). The equivalent track lateral irregularities as the model input are shown in Figure 19.

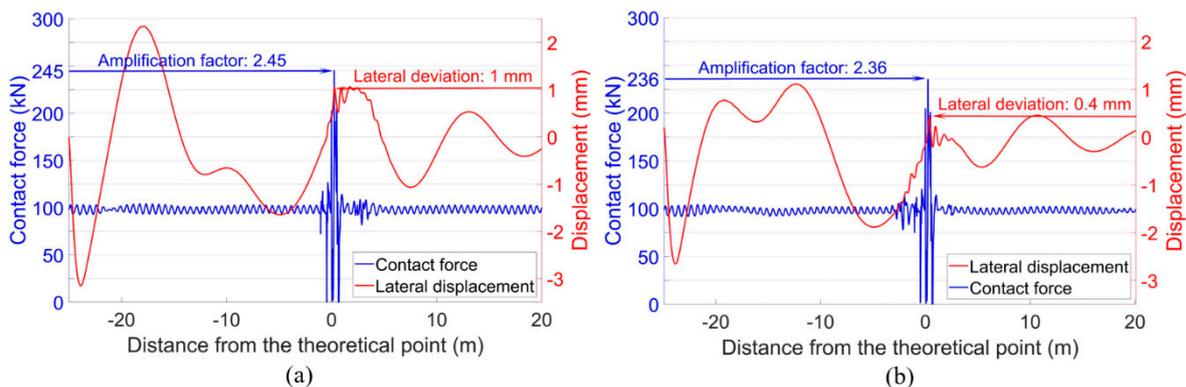
Figure 25. Wheel-rail contact forces and wheel lateral displacements. (a) Front wheel. (b) Rear wheel.

The effect of the track gauge deviation on the wheel-rail interaction is demonstrated in Figure 25. Different from the effect of the bridge-introduced curve, the deviated track gauge activated the hunting motion of the passing wheels. Still, the resulted lateral wheel displacements were not large enough to amplify the wheel-rail impact. The maximum displacements corresponding to the wheel impacts were 1 mm in the front wheel and 0.4 mm in the rear wheel, respectively.

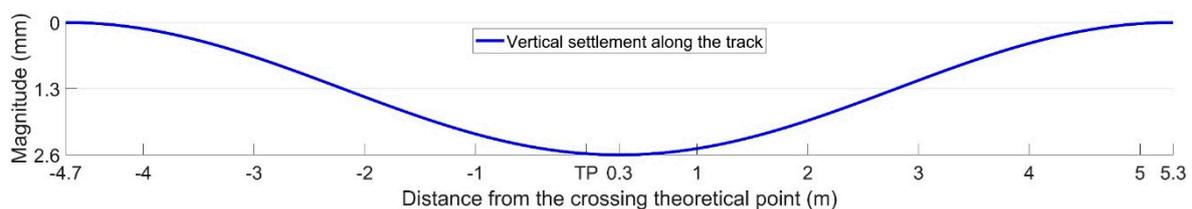
It is shown in Figure 13 that the detected ballast settlement was around 2.6 mm. To simplify the problem, a vertical irregularity was introduced in the MBS model to simulate the ballast settlement, as shown in Figure 26. In this irregularity function, the amplitude was 1.3 mm, and the wavelength was 10 m. The trough of the wave was located 0.3 m from the TP of the crossing, which was consistent with the instrumented accelerometer and the installed displacement target.

Figure 26. Ballast settlement introduced in the MBS model.

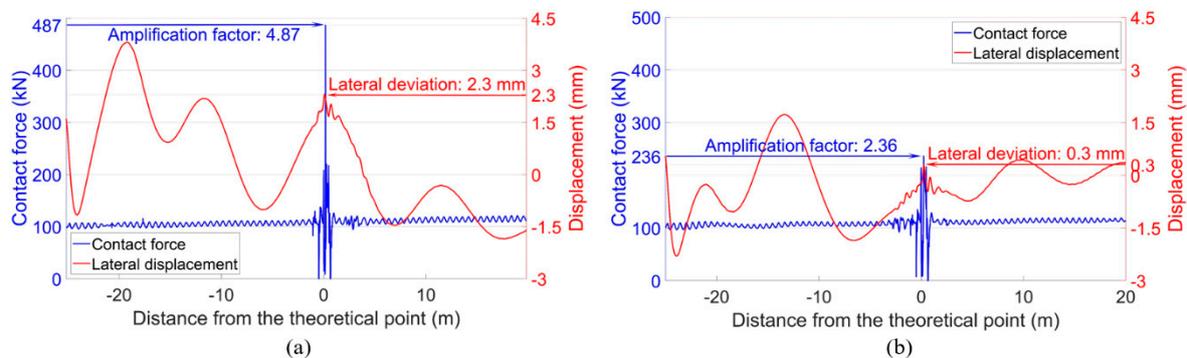
With the ballast settlement taken into account in the MBS model, the dynamic performance of the crossing was simulated. The representative results are shown in Figure 27. It can be seen that the simulation results were almost the same as those without ballast settlement (Figure 23), despite the slightly increased impact force of the front wheel (from 468 kN to 487 kN). It can be concluded that the existence of ballast settlement had a limited influence on the dynamic performance of the crossing. From another point of view, the ballast settlement was more likely to be the accumulated effect of the

high wheel-rail impacts. Such results further explain the ineffectiveness of the frequently performed ballast tamping since ballast settlement is not the main cause of the extremely high wheel-rail impacts.

Figure 27. Wheel-rail contact forces and lateral wheel displacements. (a) Front wheel. (b) Rear wheel.

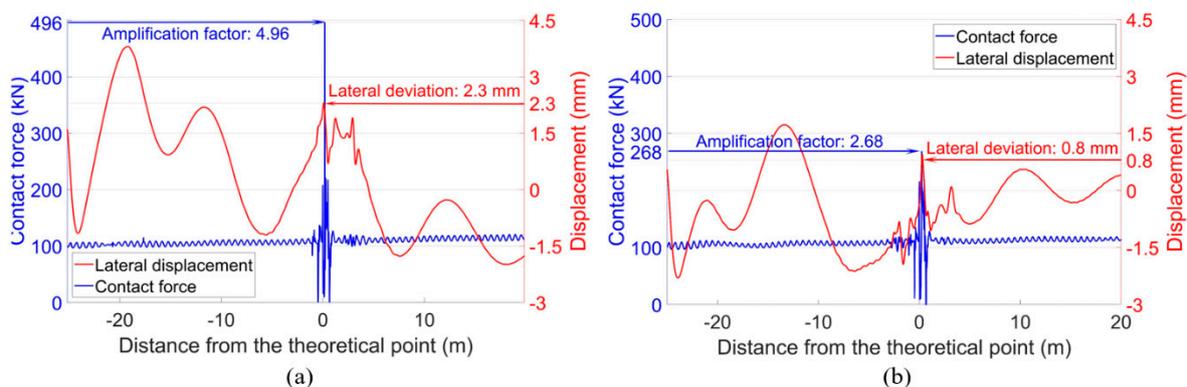
It is shown in Figure 16 that the defects of the fastening system can increase the instability of the wheel-rail impact in the crossing. Combined with the maintenance action and the simulation results in Section 5, it can be inferred that this effect was caused by the reduced lateral track resistance. To verify this inference in the degraded model (Section 5.2), the input lateral stiffness of the clips in the crossing panel was reduced from 280 MN/m (Table 2) to 2.8 N/m, and the corresponded damping was reduced from 580 kN·s/m to 5.8 N·s/m. Based on these inputs, the wheel-rail contact forces and the lateral wheel displacements were calculated, as presented in Figure 28.

Figure 28. Wheel-rail contact forces and lateral wheel displacements. (a) Front wheel. (b) Rear wheel.

It can be seen from Figure 28 that with the reduced lateral stiffness and damping of the clips, the impacts of both the front wheel and the rear wheel were slightly increased (compared with the results in Figure 23). Moreover, the hunting motion of wheels in the crossing panel was more intense. As a result, the lateral deviation of the rear wheel increased from 0.3 mm to 0.8 mm. It can be imagined that with the impacts of the passing trains, the track alignment will continuously be changing due to the reduced structural integrity. The changed track alignment will, in return, act on the wheel-rail interaction and eventually lead to more unstable wheel impacts in the crossing (Figure 17). From this point of view, renovating the defected fastening system is necessary for a monitored crossing. Enough track lateral resistance can help to maintain better crossing performance.
