HOPTILLE, FROM STIGMA TO CHARISMA

TECHNICAL ANALYSIS - COLLECTIVE

*Image enhancing transformation of
post-modern architecture while retaining its identity*

*S2C.3: Technical Analysis - collective
AR3AH105 - New Heritage
Graduation studio Adapting to 20th Century Heritage
Master Architecture, Urbanism and Building Sciences*

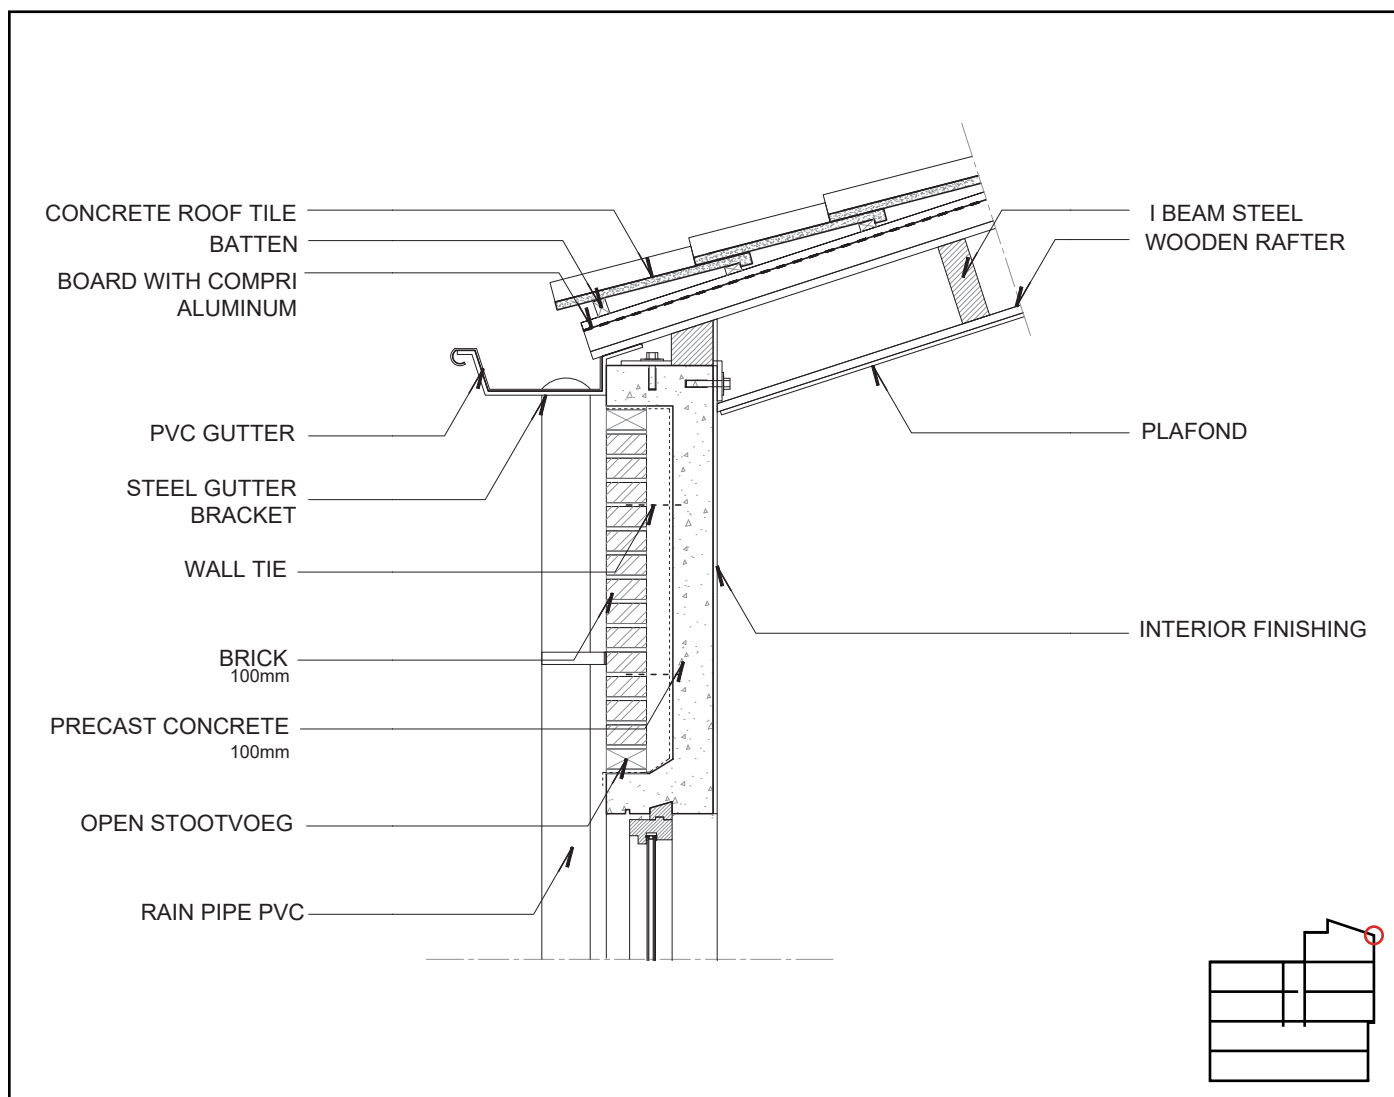
DETAIL 1

Steel structure, no insulation
cold bridge

The detail shows the slanted roof components of the north-east facade of Hoptille. It has five storeys high on this side, thus the roof itself is barely seen from the ground level.

In general, the roof is steel structure with concrete roof tile. The steel structures seat in the prefabricated concrete wall in the main structure and prefab concrete in the facade. The 240mm I-beam profile has a span of 4,350mm. The rafters are made out of wood meanwhile the battens are steel hollows to support the concrete roof tile. From the original drawing of this detail, it did not indicate the presence of any roof insulation. So this raised concerns of heat loss and a cold bridge from the roof.

The facade in the fifth floor shares the same principle with other parts of the Hoptille' s facades. It has brick work as outer layer and cavity of 65mm followed by prefabricated concrete panel 100mm in which also becomes a cold bridge because of exposure to the outside just above the windows.

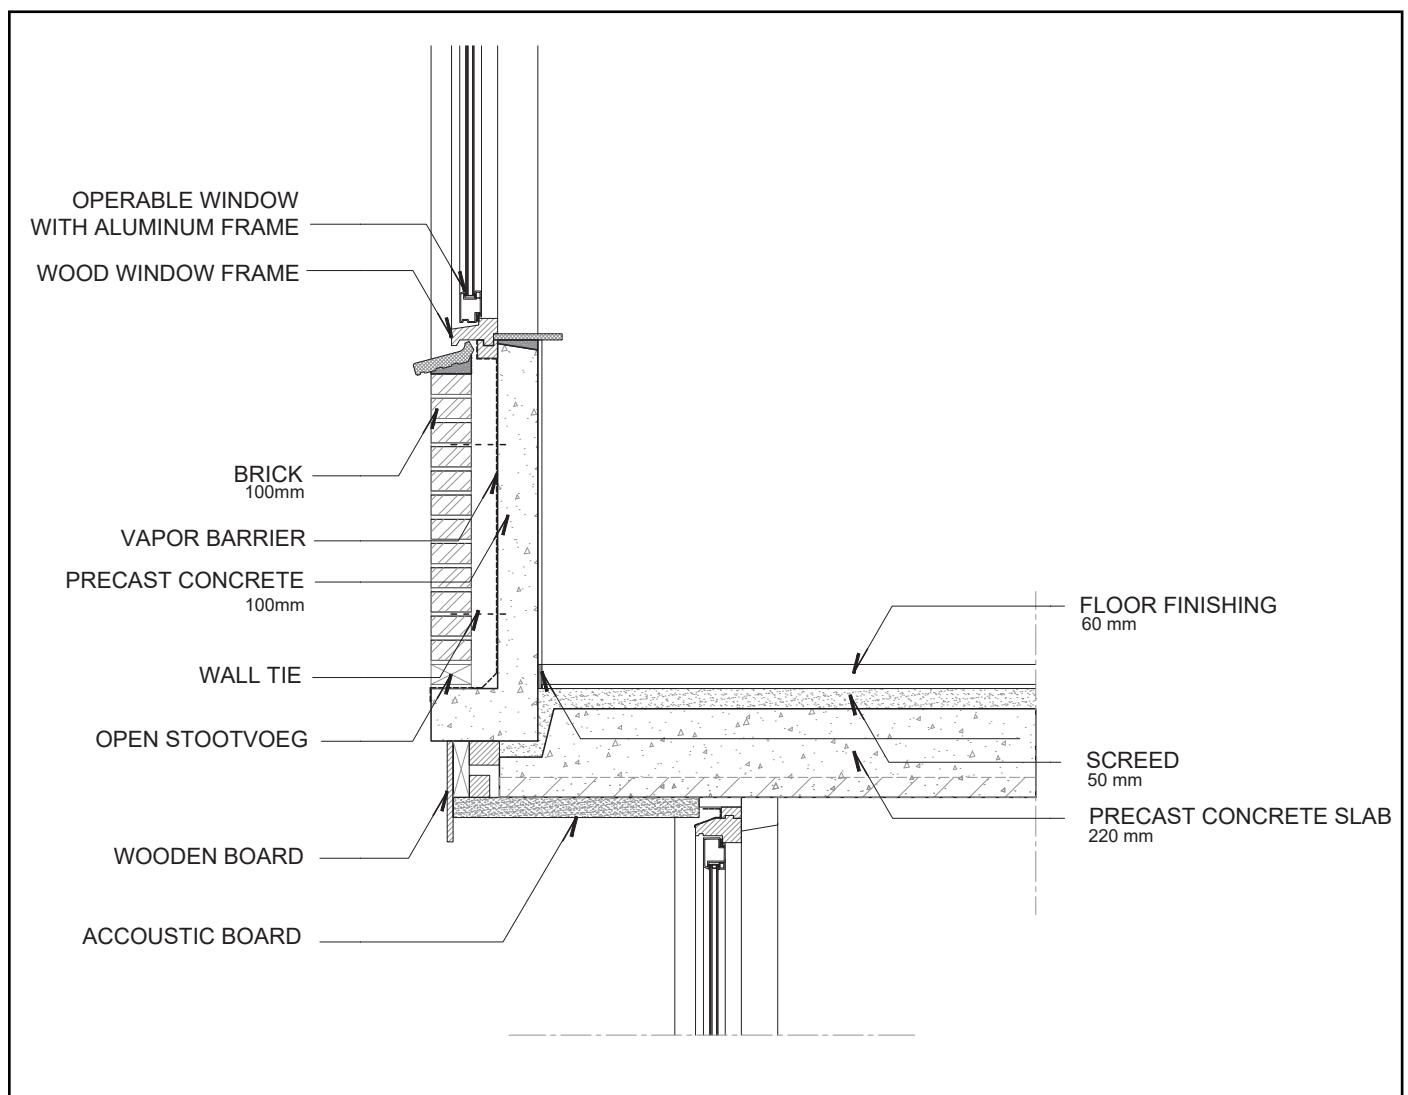
DETAIL 2

Self supporting facade,
cold bridge

Like the rest of the building, the floor is a precast concrete slab with the corresponding finishes. The facade structure is also the same as the rest of the building; 100 mm brick exterior wall supported by a self-supporting concrete facade construction of 90 mm thick, with a cavity of 30 mm and 40 mm insulation in between. The original framework from 1980 is a wooden outer frame and an aluminum inner frame.

Considering the recessed façade, the detail differs from the original. The self-supporting facade was conceived in the original design by a wooden plate of approximately 500 mm high, but the plate is according to recent photos half as high. Secondly, this wooden plate would also be used on the bottom of the recessed façade. Ultimately, a fire-resistant and insulating wood wool cement board was chosen. Finally, the visible concrete facade construction takes on a different shape than originally conceived. The load-bearing facade element is located completely at the bottom instead of the 150 mm higher, aligned with the higher wooden plate. This has no consequences for the technical performance; both variants are a cold bridge.

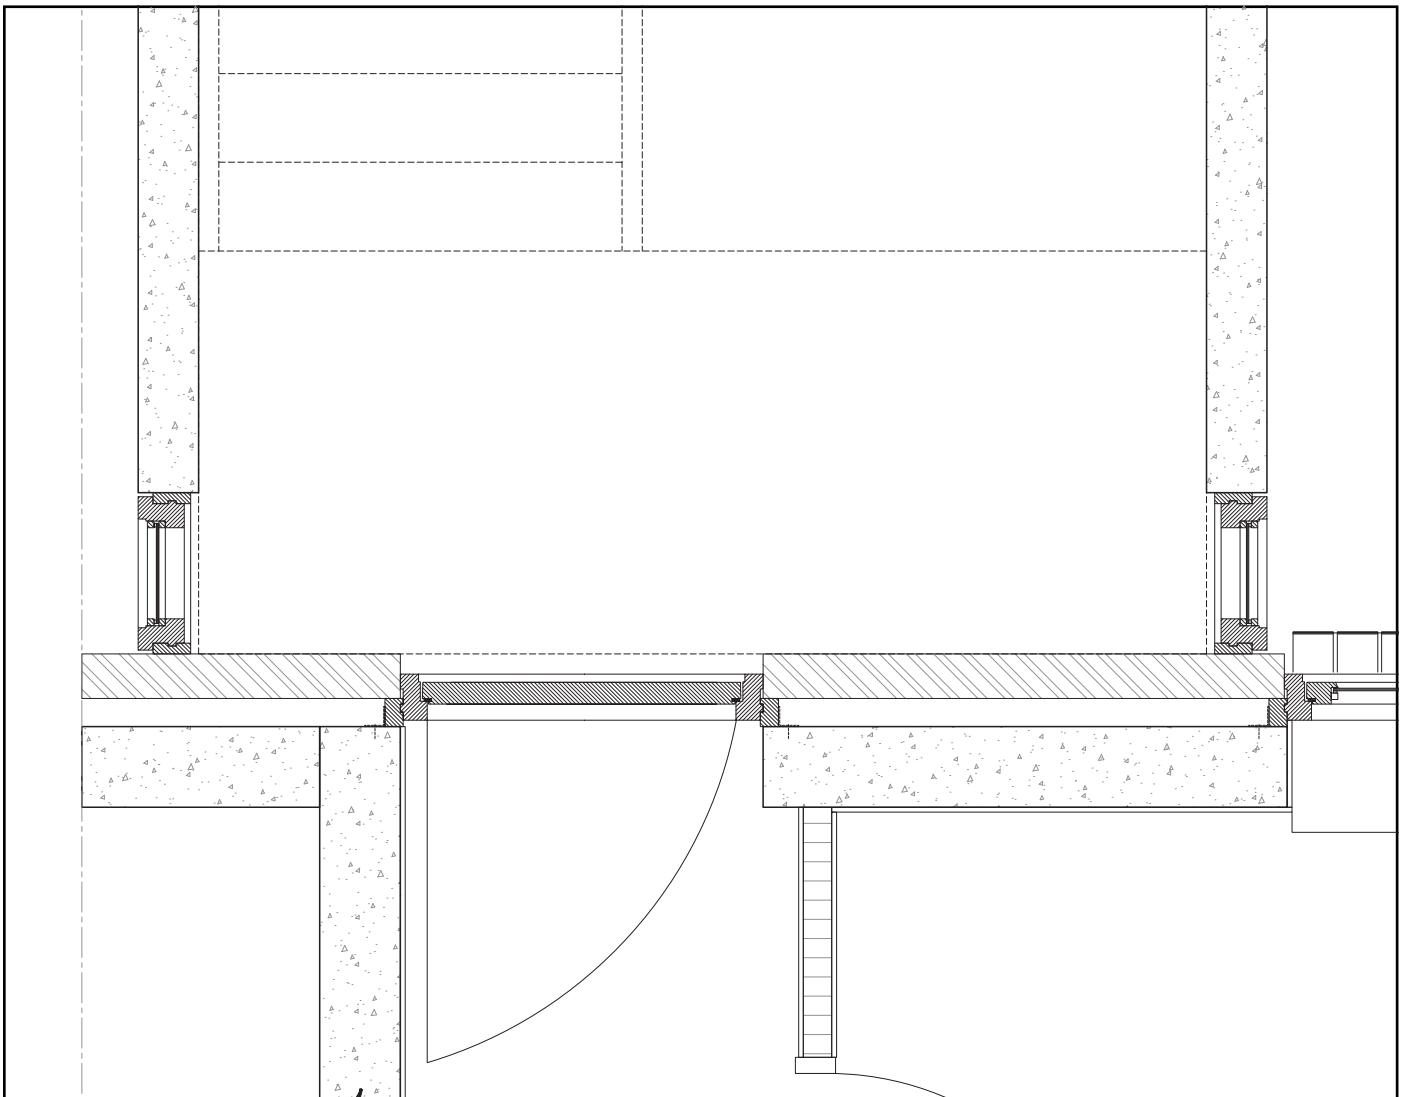
DETAIL 3

Connection between the facade and staircase, renovation

The façade structure is also the same as the rest of the building; 100 mm brick outer wall supported by a self-supporting concrete façade construction, or 90 mm thick, with a cavity of 30 mm and 40 mm insulation in between.

Given the floor plan drawing, not much has changed the original. The details show that not much has been done to insulate the house properly. The load-bearing wall is not insulated, which creates thermal bridges

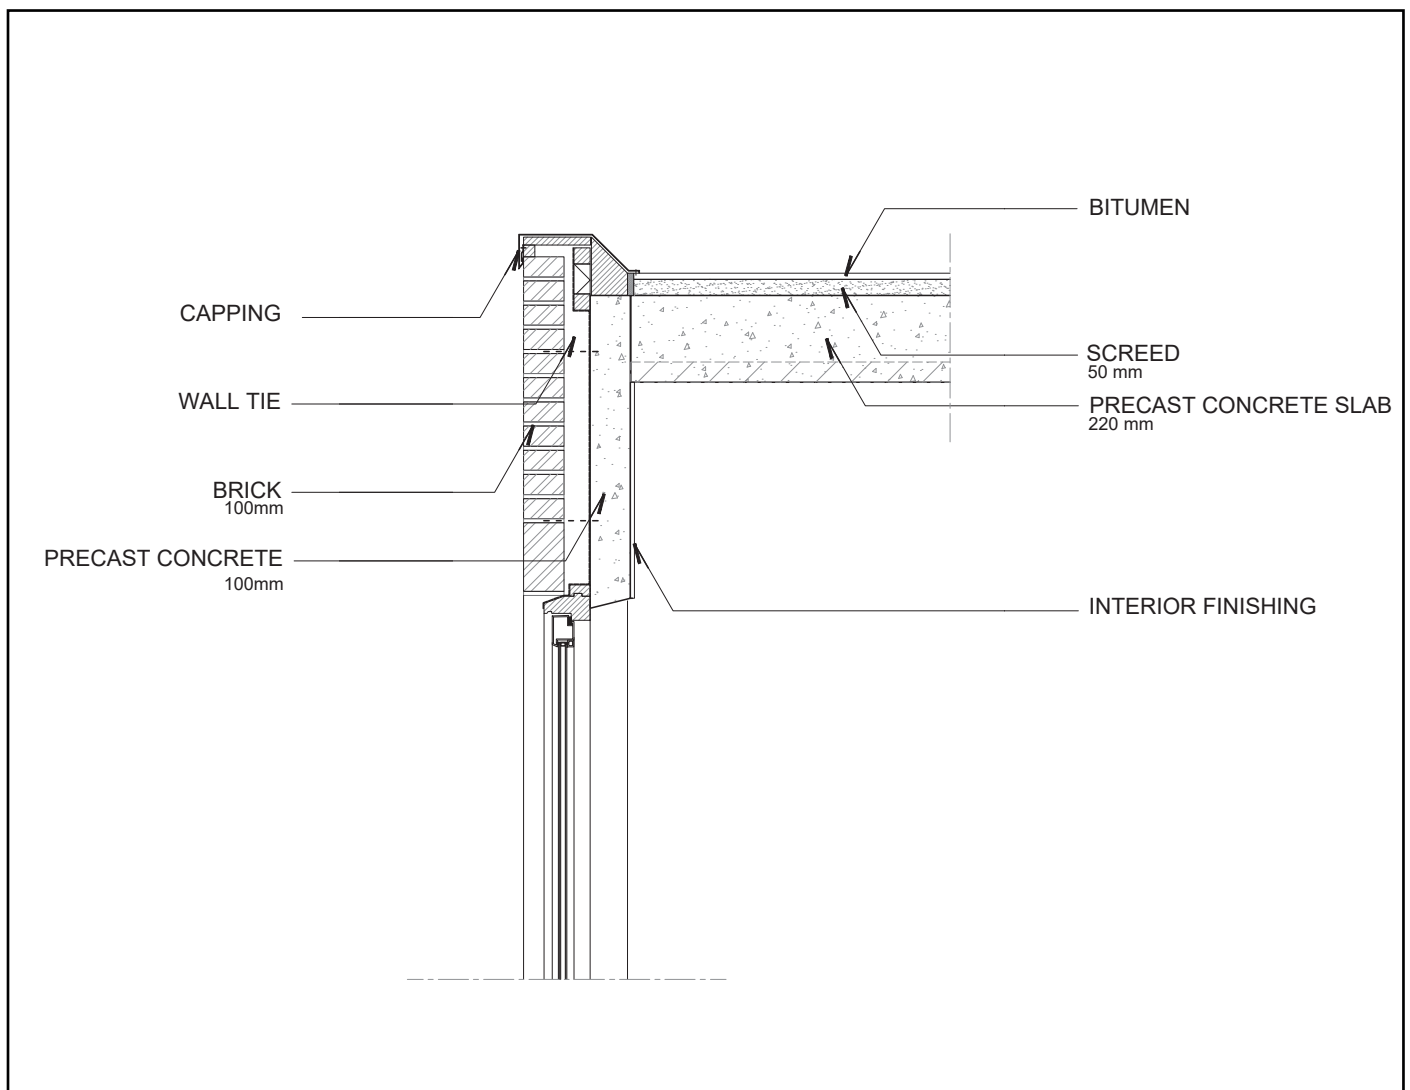
DETAIL 4

Significant change drawing and construction

This detail shows the connection of the roof to the facade on the south-west side of the building. Originally this detail had 2 variations, one with brickwork and one with panels as the facade exterior finish. This last variant however, is not present in the mid-rise building of Hoptille. While comparing the brickwork detail with the pictures of the facade it turned out that there was one major difference in the two. The detail shows that the final facade should show a concrete strip right above the windows on this floor, when looking at the picture it becomes clear that this has been changed in the process. The updated detail shows how we suspect that the current facade is built.

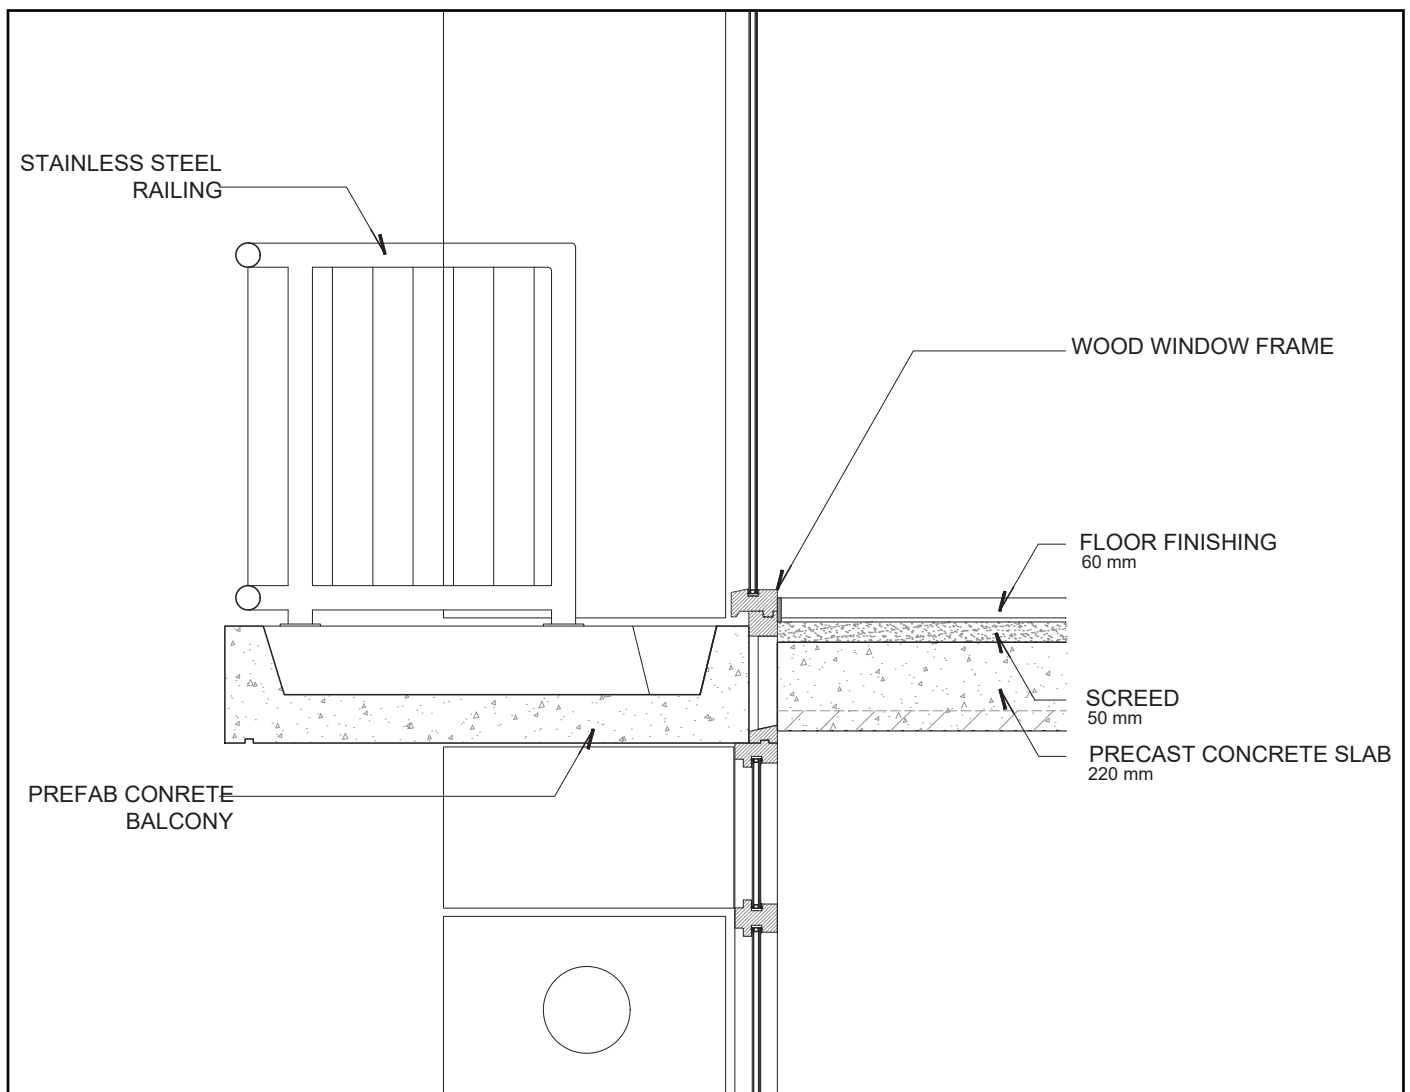
DETAIL 5

Prefab balcony on consoles,
meeting the concrete floor and
facade window frame.

The facade is made of wood window frames spanning from floor to floor. And the balcony is made of prefab elements, resting on the consoles sticking outside the facade. These consoles are connected to the bearing walls and thus puncture the thermal line of the facade.

The balconies themselves must have some way of draining rainwater near the facade side, since there is no visible path to drain that surface on the front side. The drain pipes in some cases even go through the interior of the building.

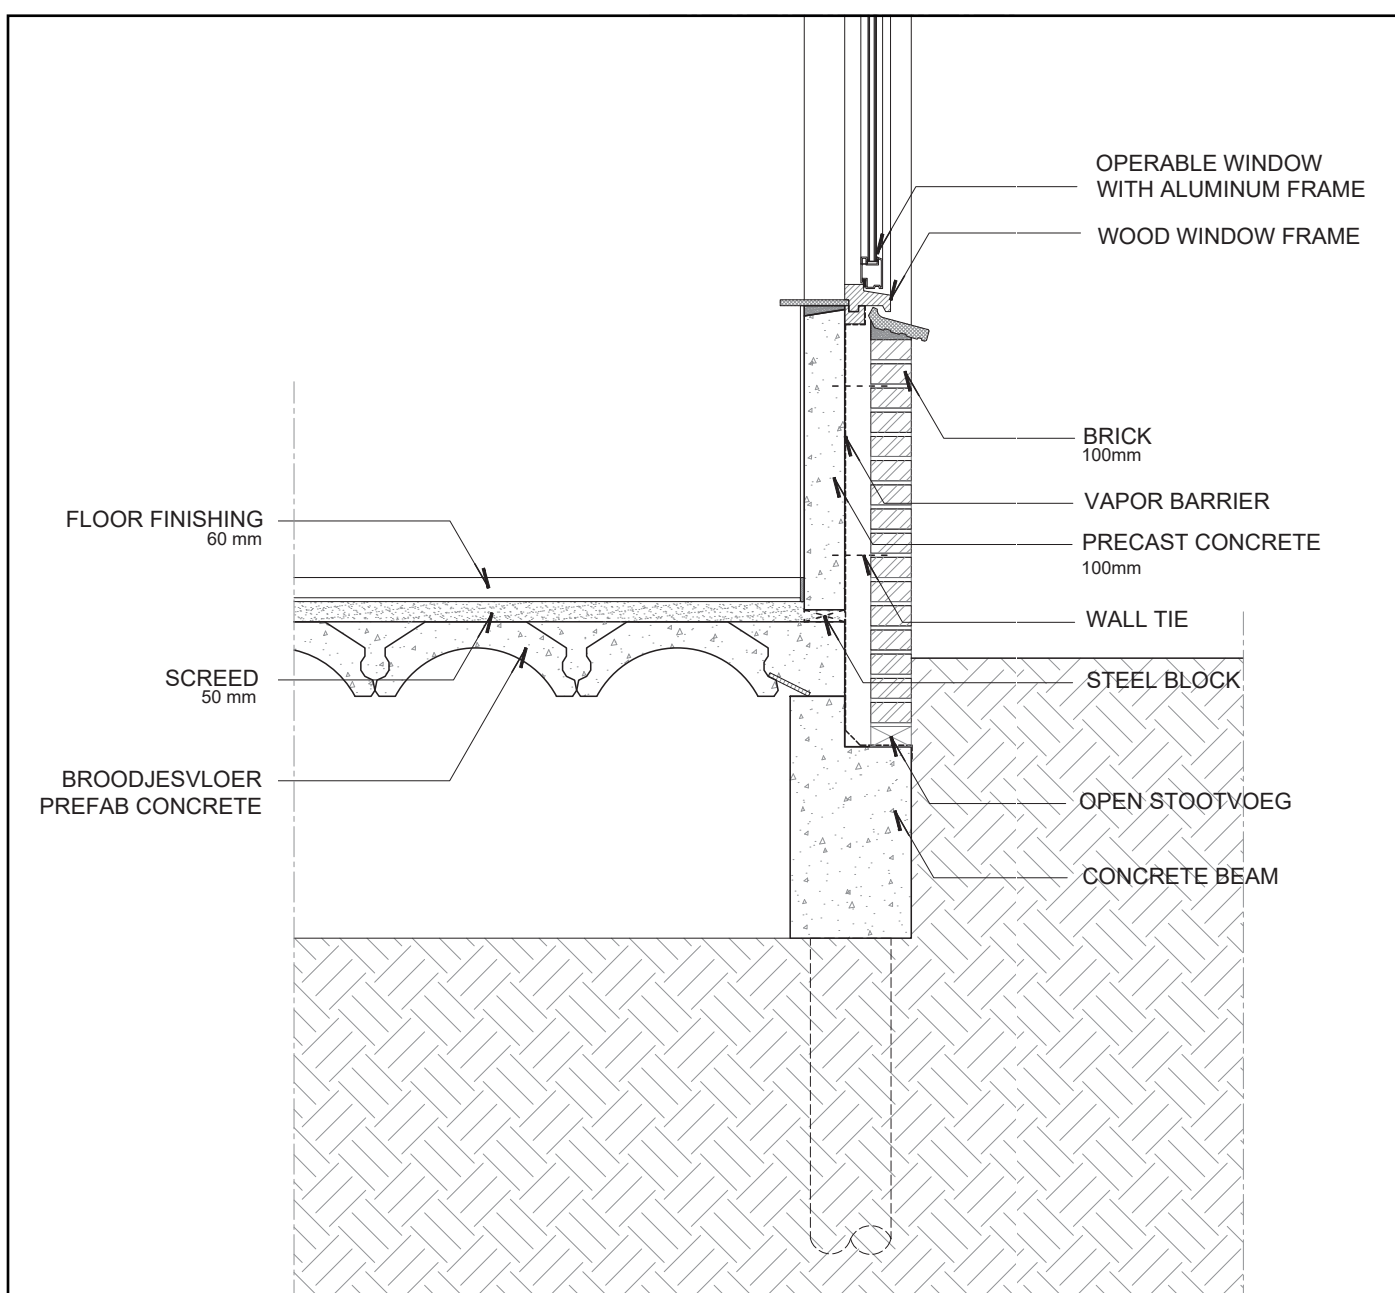
DETAIL 6

Connection between foundation, beam and block floor and precast concrete facade

The original drawing does not show the detail as it has been constructed. Some features are not shown on the drawing, such as the ventilation shaft, as shown in the photograph, which is used to ventilate the crawl space beneath the building.

Furthermore, the original drawing does not

show the actual connection between the facade and the ground floor, as the drawing is quite abstract. A standard drawing supplied by the contractor creates a better understanding of the connection, even though the facade in this drawing does not match the facade of the building.

The beam and block floor is placed parallel to the facade, the gaps between the slabs filled with in-situ concrete. The floor rests directly on the foundation, as does the brick facade. The brick facade is kept in place by wall ties connected to the precast concrete wall slabs, with a cavity in between the brick and concrete.
