Rolling Contact Fatigue in relation to rail grinding

Abstract Spalling defects of a periodic nature are sometimes observed on heat-treated pearlitic steel rails. Defect properties suggest that there may be a relationship between maintenance grinding on a regular basis and the initiation of rolling contact fatigue (RCF). In this work, the effects of maintenance grinding are investigated experimentally for both standard and heat-treated pearlitic rails. Results show essentially different behaviour for both steels. On standard grades, friction-induced martensite (FIM) generated during grinding delaminates when in service. However, grinding induces severe top-layer deformation which coincides with that induced by train operation, thus yielding ‘pre-fatigue’ of the rail. On heat-treated grades, portions of FIM accumulated at groove edges during grinding are pressed into the deeper pearlitic matrix in combination with severe plastic deformation under tangential wheel-rail contact stresses. That process results in severe and extensive crack initiation. According to quantitative test results reported in the literature, this initial condition yields a reduction of the normal RCF life by ro

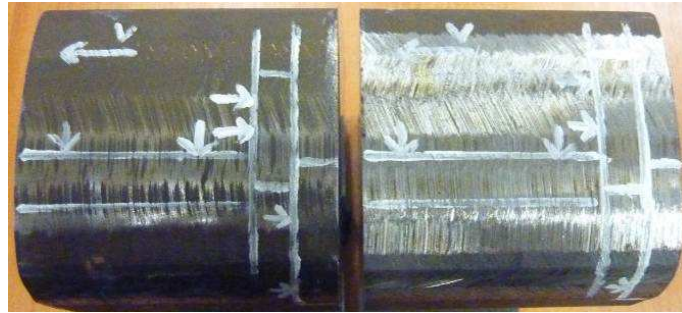
Grinding is supposed to ‘reset the initial conditions’ of the rail life. Therefore, the aim of the experimental programme was to establish these conditions for the treated surface of both standard carbon (R260Mn) and heat-treated pearlitic rail grades (R370crHT/MHH). For both grades, a regular track was selected in the Dutch network with mixed passenger and freight traffic, where cyclic maintenance grinding (with a nominal take-off of 0.2 mm) was to be performed by the grinding train (Speno RR64M with flat rotational grinding principle). The R260Mn sample was taken from straight track and the R370crHT/MHH sample from the high leg of a curve. A rail sample of 75 mm length was taken out immediately after the grinding train had passed and replaced by an enclosed arc welding. This was repeated after a few days of train operation and thus a relatively very small number of train passages. This setting was chosen to investigate the effect of a combination of normal and tangential stresses on the freshly ground surface for a limited number of wheels, at the offset of the loading history; this loading history itself as well as an eventual difference in the loading parameters as a result of track configuration were of minor importance. In this way, four rail samples were collected in total. Figs. 10 and 12 show the two samples collected for each of the grades R260Mn and R370crHT/MHH respectively; Fig. 11 shows a close-up of the ground surface in Fig. 10.

Fig. 10 Surface of heat-treated rail (R370crHT/MHH) immediately after grinding (right) and a few days of train operation (left); examined longitudinal and transverse cross-sections.

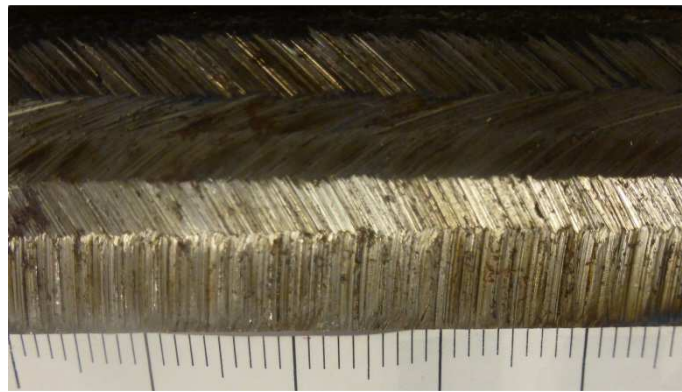
Fig. 11 Close-up of Fig. 10: heat-treated rail (gauge corner) surface roughness and facets immediately after grinding.

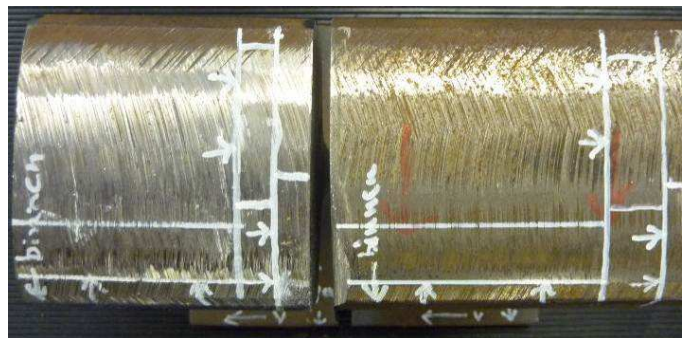
Fig. 12 Surface of standard carbon rail (R260Mn) directly after grinding (left) and a few days of train operation (right); examined cross-sections along the surface.
