**Post-flood field survey of the Ahr Valley (Germany)
Building damages and hydraulic aspects**

Technical Report

07.03.2022

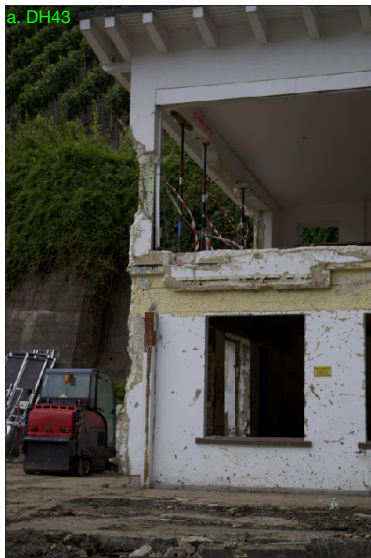
Figure 3.9. Case Study D_G

This structure looks to be impacted by debris. Its outer insulation appears damaged. In a few locations at the side of the building facing the flood wave, where large window openings were present and piers were consequently narrow, some piers were knocked out by the flood. Their locations match where the structure is propped up by steel pipes. Interestingly, only piers on the second level were affected. This may be due to two reasons: firstly, the higher location may have coincided with the depth of floating debris at the surface of the water (as supported by the watermarks); and secondly, the upper piers carried a lower vertical load which has a stabilising effect against lateral load and thus were more vulnerable than the piers on the first level which carry the entire first floor and upper storey of the building.

By the time this survey took place, the hotel had removed all the windows and renovation work had begun. It is suspected that many windows were affected by the flood.

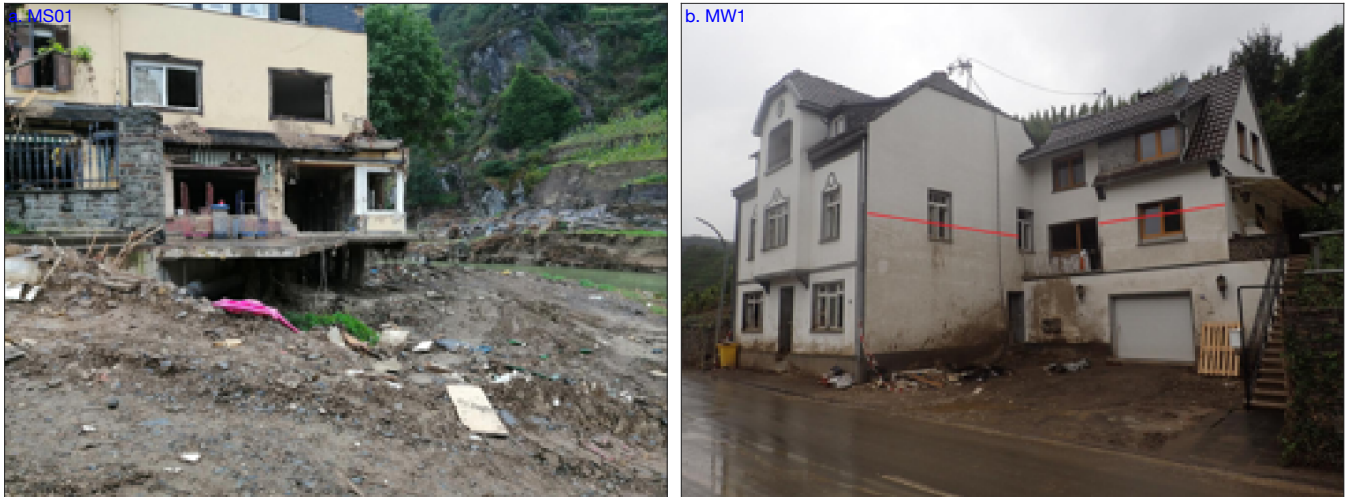
Figure 5.2. Watermarks Mayschoß

Watermarks in Mayschoß revealed low to medium water levels of approximately 4.1 m at the upstream side, where the water reached half of the 1st floor, as shown on the map and throughout pictures in Figure MW1.

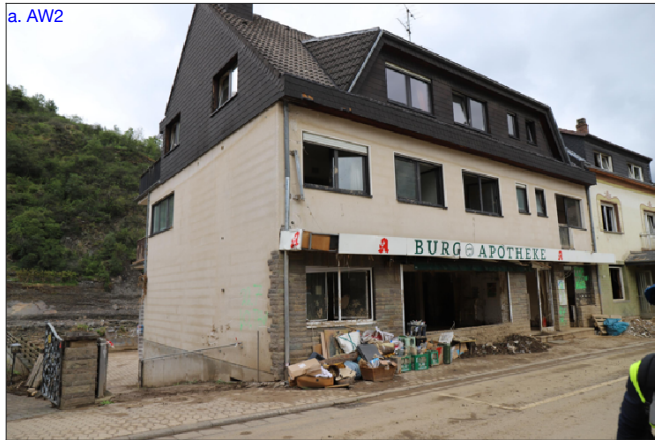
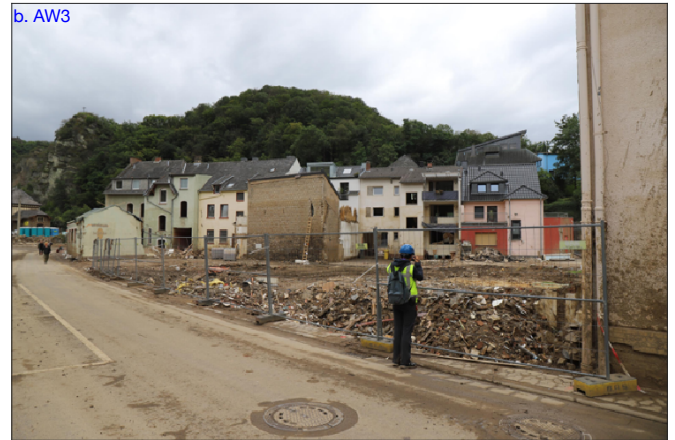
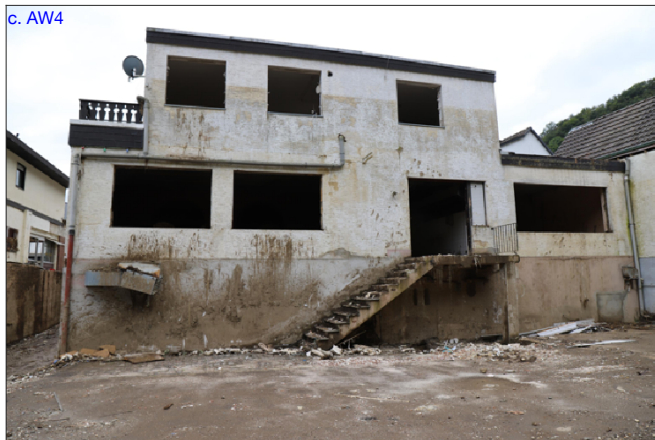
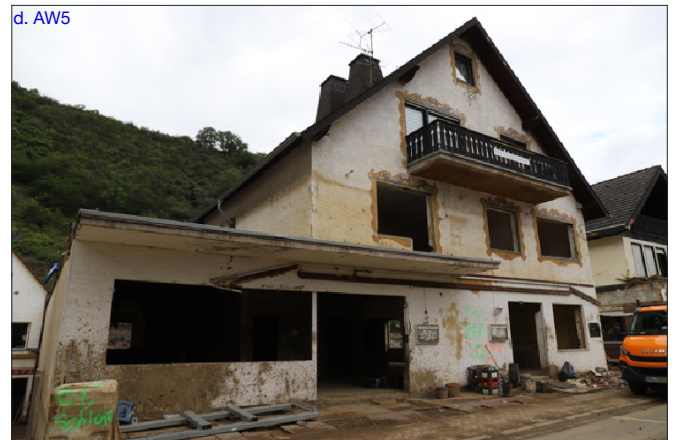
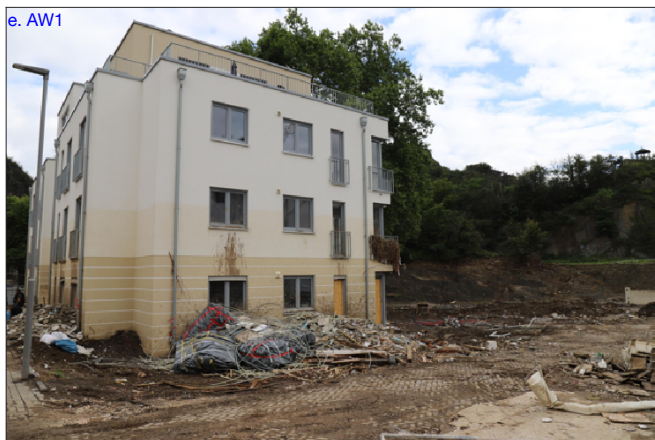
Figure 6.2. Watermarks Altenahr

In multiple locations, the water marks were easily detectable, as shown in Figure AW2. A noticeable difference was observed between the inundation depths on the Seilbahnstraße and those on the riverside due to topographical differences (Figure AW2). In the downstream part of the village, i.e. on the left bank of the Ahr River, slightly lower water depths were observed.

In particular, the building Hotel Lang (case study A_A) at Altenburger Strasse 1 showed marks from the previous flood level, approximately 0.85 m above ground level. However, in the 2021 flood, at that location the maximum water level recorded was 6m, which damaged all the non-structural components of Hotel Lang. While in this location many small structures were destroyed, large structures seem to have mostly suffered from non-structural damages.

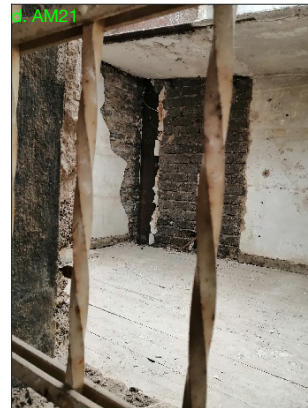
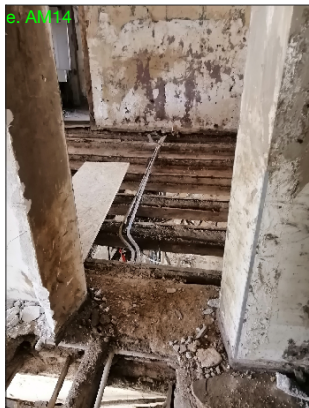
Figure 6.6. Case Study hotel Lang

The flow depth measured at the location was 6m, and a water depth of 1.8 m was identified at the first-floor slab level. The hotel was a framed structure, with columns (either RCC or composite) and beams (I section or composite section) spreading in the longitudinal direction. In the transverse direction, the timber joists spanned to support the wooden slabs (could be a one-way slab). The timber joists were positioned over the horizontal beams for support. Structurally, the hotel survived the flood. However, the internal components of the buildings were severely damaged; see figure. The façade of the building was utterly distorted during the flood. However, the supporting steel frames were unaffected.

Interestingly, although the flow depth did not reach the second-floor level, the timber flooring on the second floor was equally affected (Figure 6.6). A portion of the concrete spalled out in the transverse beam (It should be a composite section), and the crack was developed even at the second-floor level beams. The hydrostatic pressure was capable of dislodging the wall masonry wall from its position, even at the second-floor level. Overall, although the load-bearing columns and the beams were unaffected, the walls and the timber slabs were more affected. This kind of buildings required detailed structural member inspections followed by major retrofitting works for the non-structural member. Similar kinds of failures were observed in the nearby locations (see this section's map).

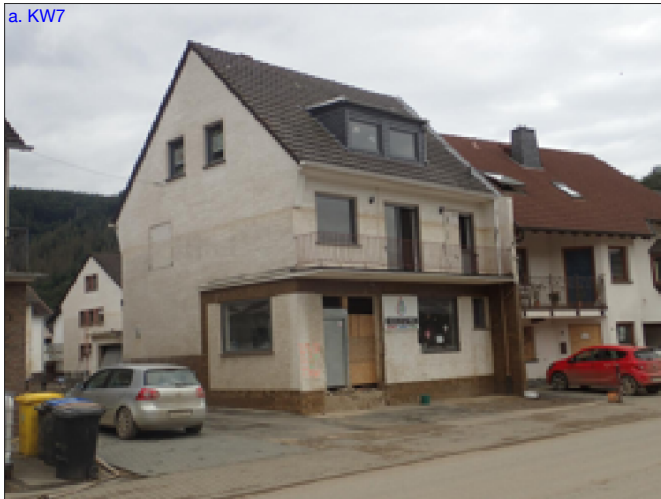
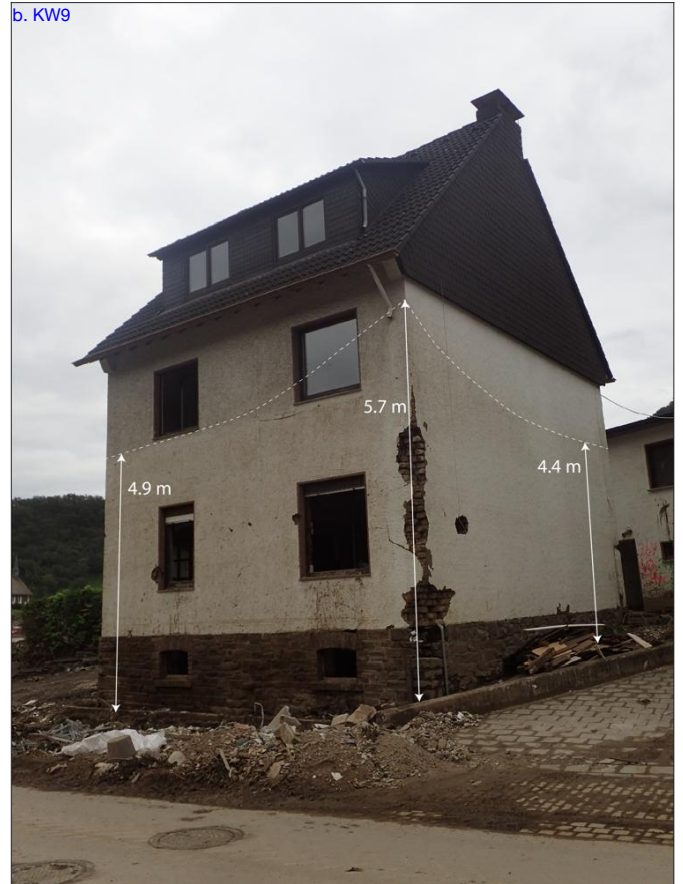
Figure 7.2. Watermarks Altenburg

Water marks can clearly be seen in Figure KW7, indicating that the water reached the top of the first floor. Compared to other sights, a lesser amount of debris was found in Altenburg which exhibited also surprisingly low damages, despite the high water levels. No scour was reported during the survey, thus suggesting slightly lower velocities in this area.

From a hydraulic perspective, the Haus Irmgard was of particular interest, which is located on the upstream side of the village. This building reported water marks of approximately 4.9 m on the downstream side (Figure KW9), while the corner of the upstream side revealed marks up to 5.7 m. This corresponds to a ratio of 1.16, which is in line with previous laboratory observations for steady flows around buildings with various geometries (Wüthrich et al., 2020). In addition, local damages attributed to the impact of debris were observed only below 4.9 m, with no visible damages in the remaining 1.8 m. These data confirmed the temporal and spatial variability of the flow conditions during floods, as well as the non-uniform distribution of loads exerted on buildings.

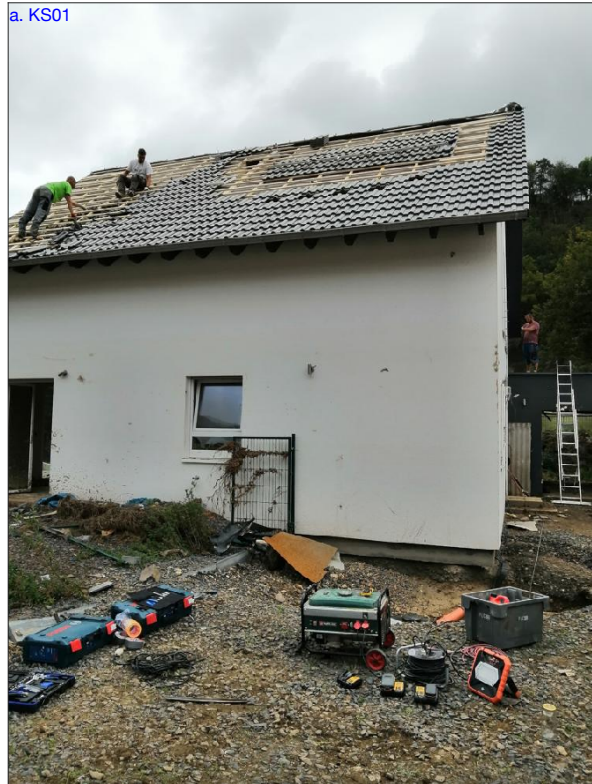
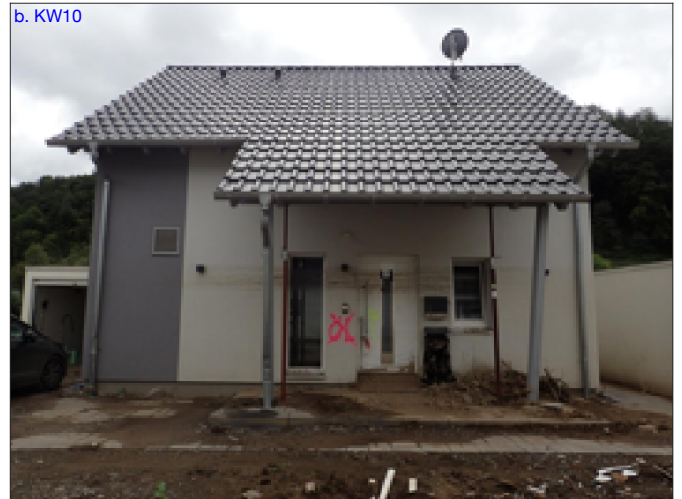
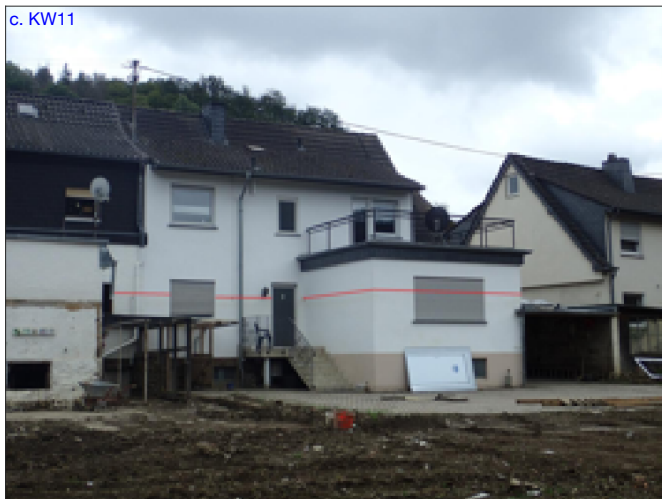
Figure 8.2. Watermarks Kreuzberg

The building in Figure KS01 was the last in the Am-Brunnen Strasse and faced the flow directly. Scour depth of 0.75m and scour length of 2.5m was observed at the corner of the building.

Large amounts of debris were observed in the flood plains of Kreuzberg. Many oil tanks and cans stored in the basement for heating became sources of oil spread in the building and debris in that area (Figure KH02). These accumulation piles in Figure KM03 are likely the result of reconstruction and recovery plans; however, they show the nature of the debris that were transported during the flood, including both wooden (Figure KM03) and man-made metallic debris (Figure KM02).

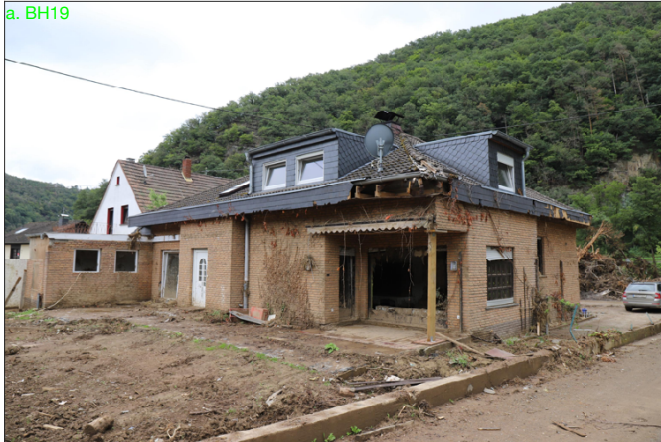
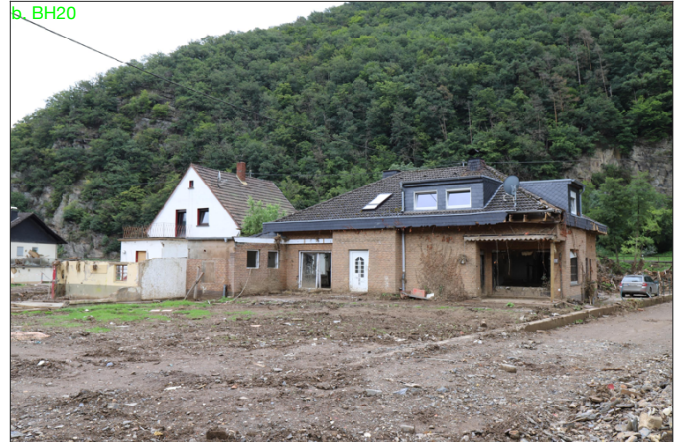
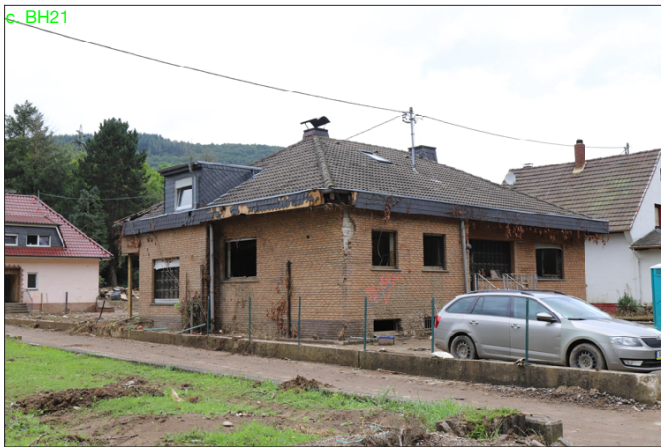
Figure 9.4. Case Study B_B

This masonry structure, with an outer clay brick veneer was almost fully submerged by the flood. The corners of the outer wall and of the roof seem to have been affected by debris.

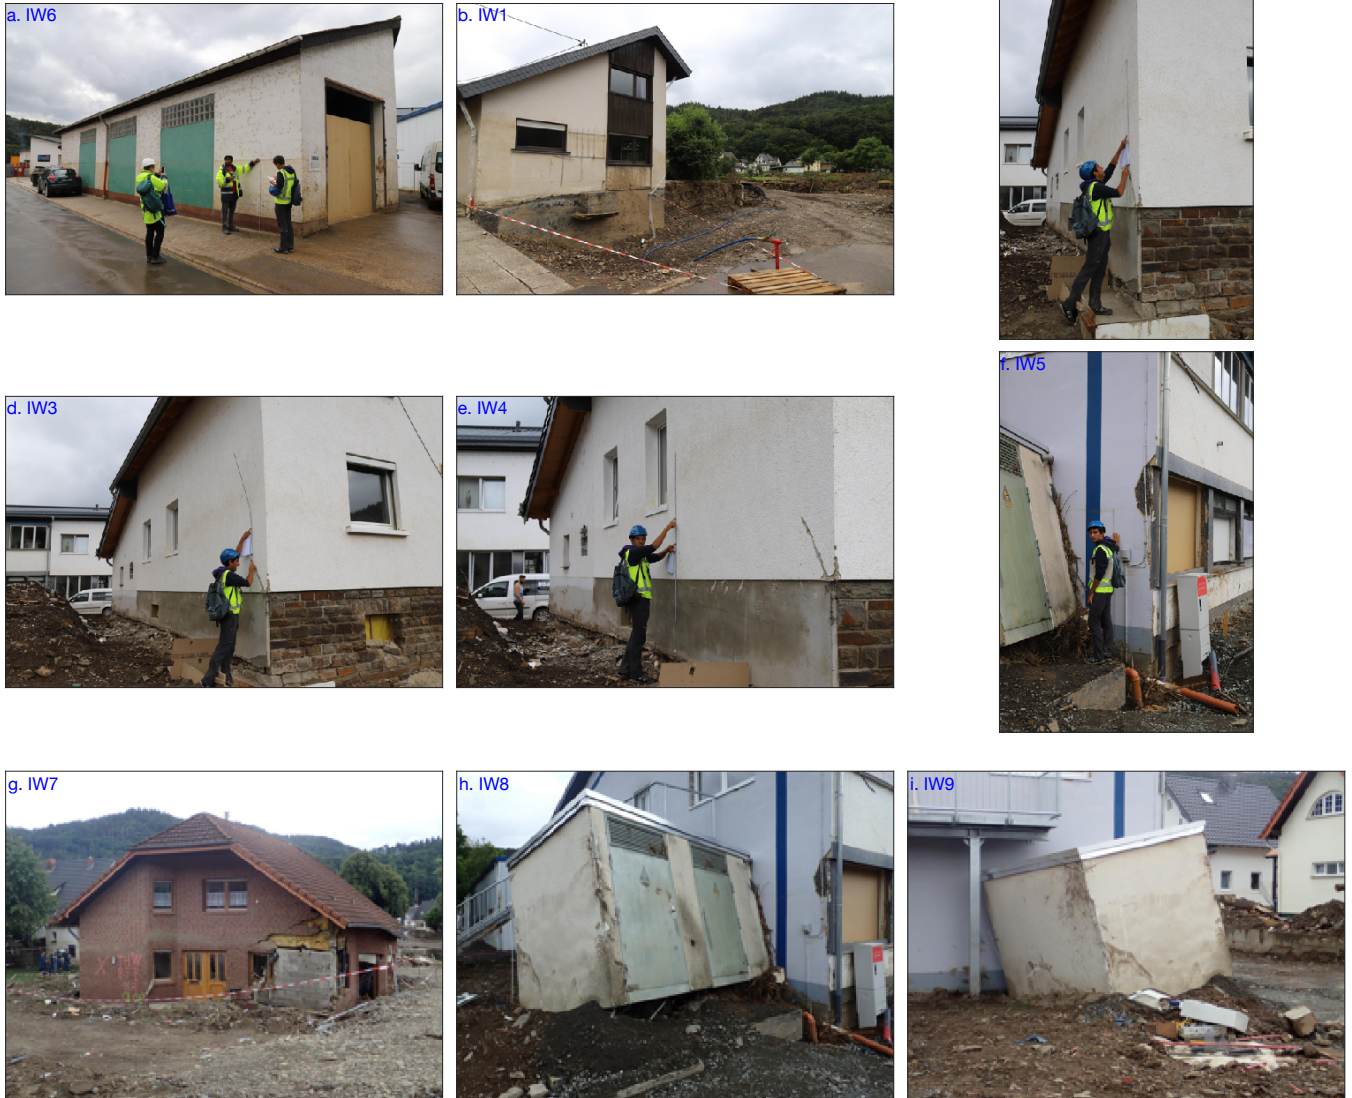
Figure 10.2. Watermarks Insul

Some buildings presented water marks at different elevations depending on their exposition to the flow. An example is the one presented in FIGURE IW7, where assuming a brick height of 71mm (typical in Germany) and a mortar height of 10mm, allows to estimate the flow depths to 2.1, 2.9 and 2.3m, respectively. Closer to the river, higher water levels of 3.5 m were recorded (IH28_C), responsible for severe building damage and bank erosion.

A specific case study was investigated in IW8, where a concrete block was lifted by the flow. The survey showed that the building had a length of 4.2 m, a depth of 2.58 m and a height of 2.73 m with a corresponding overturning angle estimated at 10-15 degrees. Water marks on the side showed flow depths of approximately 2m, sufficient to generate a failure of the foundation and overturning of the structure with an uplift on the upstream side of approximately 0.47 m.

Smaller floating debris generated during the flood event accumulated inside the buildings through openings (Figure IH27). This pointed out a potential negative effect linked to the presence of openings, increasing the loads on the structure.

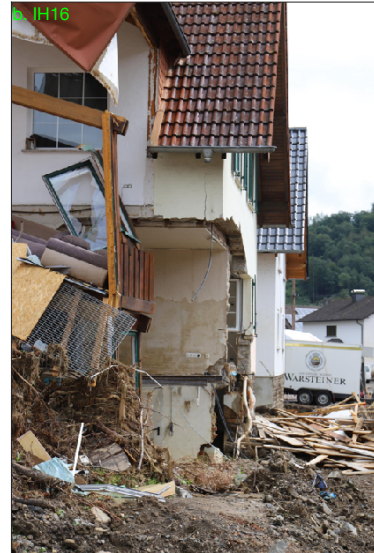
Figure 10.3. Case Study I_A

The failure of the basement-ground-floor wall is likely to have begun at the corner where debris may impacted the structure. The steel-beam floor is only stiff in one direction and thus could not provide lateral support for the wall at the corner. Once the corner was affected, the rest of the façade was, likely, pushed outwards by the flow of the water.

The building also sported an extension on the side as a separate, light structure constructed from timber members. This structure seems to have been undermined by erosion at its foundation. It is difficult to say whether the scour appeared before or after the collapse of the basement wall.

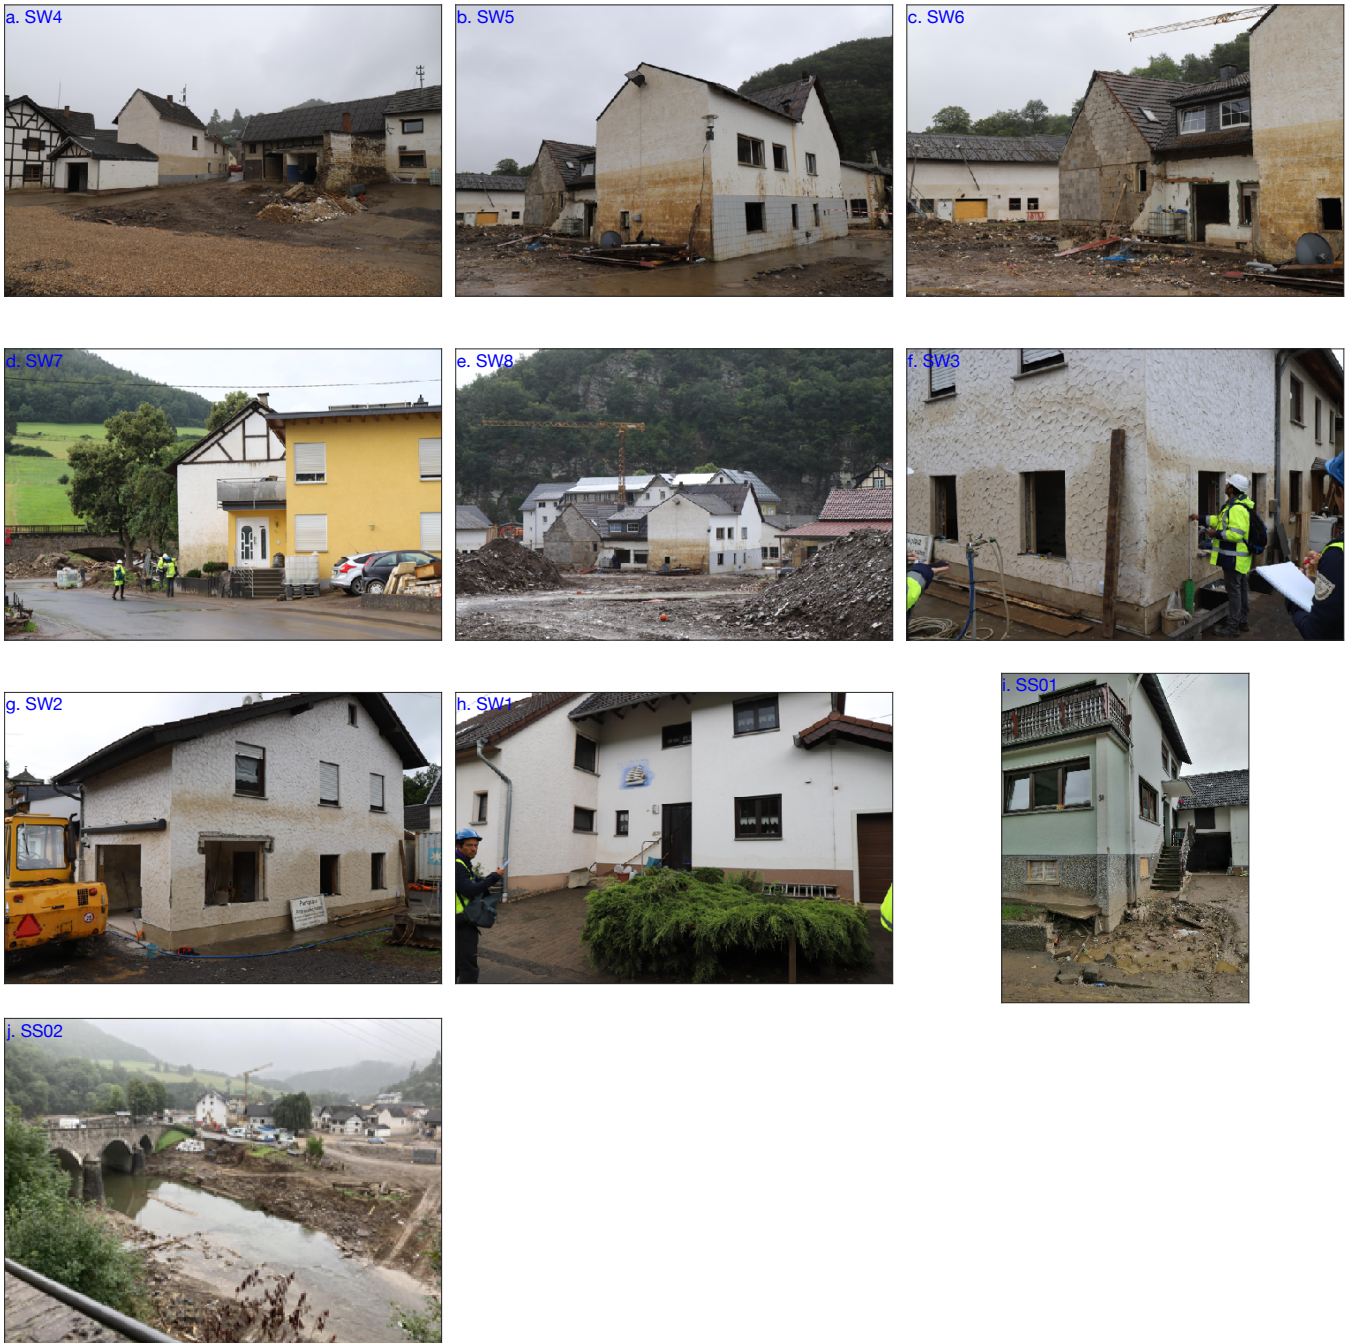
Figure 11.2. Watermarks Schuld

Selected examples of watermarks observed in Schuld are presented in SW5, where the highest water levels reached the windows of the first floor. An interesting pattern was observed at a building in the centre of the village (SW9 and SW2), where the side that was frontally exposed to the flow showed water marks of 3.0 m, while the sides had marks at 2.1 m. This showed a ratio between front and side of 1.4, which was higher compared to previous locations, thus suggesting a slightly faster flow at this specific location. Nevertheless, this confirmed the variability of flow characteristics within the village and, therefore, the non-uniform distribution of the forces acting on the building during floods.

In terms of scouring and bank erosion, the village of Schuld seemed to be less affected compared to other locations. SS01 provides an example of scour around a building corner and some bank erosion on the downstream side of the bridge (SS02), but their entity remains limited.

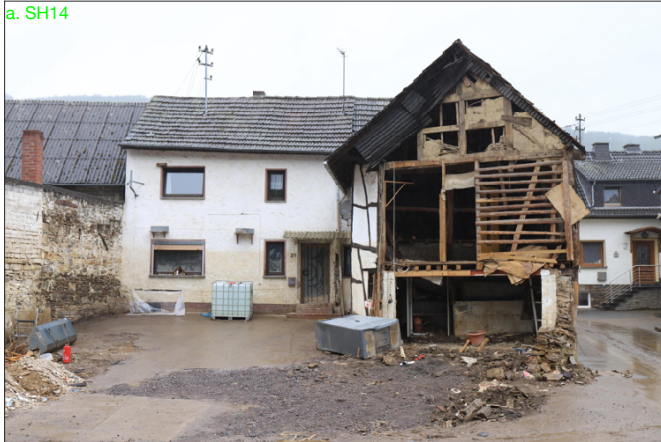
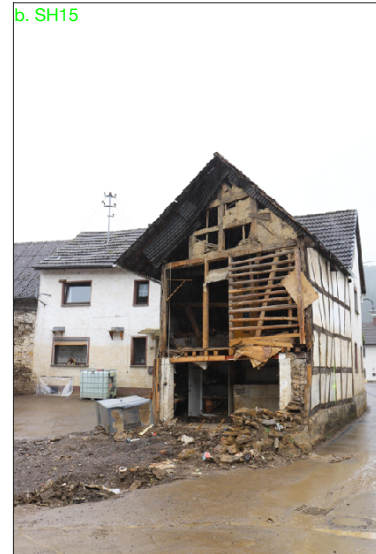
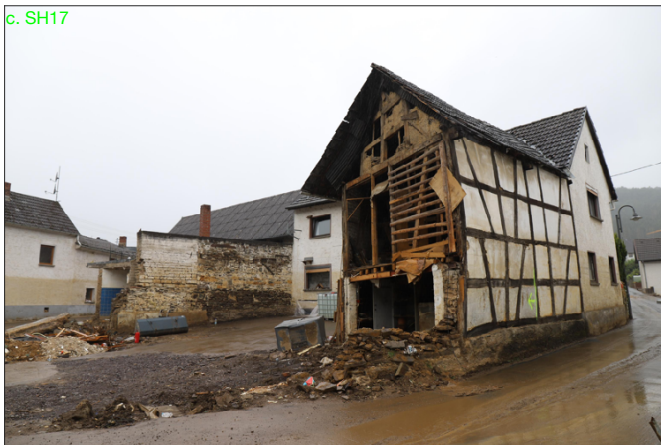
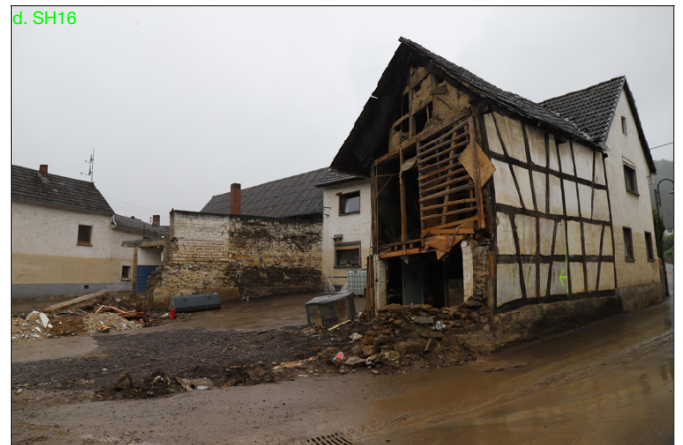
Figure 11.5. Case Study S_C

This traditional, filled-timber-frame building was affected by the flood with water levels covering to about the ceiling of the ground floor. The load-bearing side walls appear undamaged, but the end wall has collapsed. It is not clear if the structure had any additions on this end and if they were removed by the flood too.

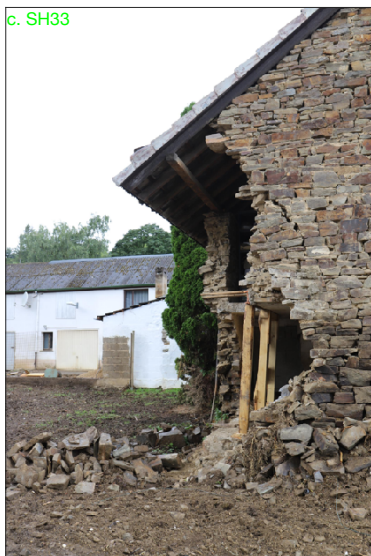
Figure 11.7. Case Study S_E

This building had two thick walls from natural stone brick (almost rubble stone masonry). The front façade seems to be a combination of concrete-block masonry and filled timber frame, where the filling is actually brick masonry (the material is unclear but could be earthen bricks). The first floor appears to be composed of I-shape steel beams with (pre-fabricated) concrete plates between them. The roof is a timber construction. In this sense, the building is a mix of building materials and techniques, referring perhaps to various retrofits over the decades.

The corner of the building facing the presumed floor direction and made out between the two natural stone walls appears entirely collapsed. It is likely that the water flow carrying floating debris dislodged the stones from the wall until failure occurred.
