## Corrosion-fatigue damage identification in submerged mooring chain links using remote acoustic emission monitoring

Marine Structures

# Corrosion-fatigue damage identification in submerged mooring chain links using remote acoustic emission monitoring

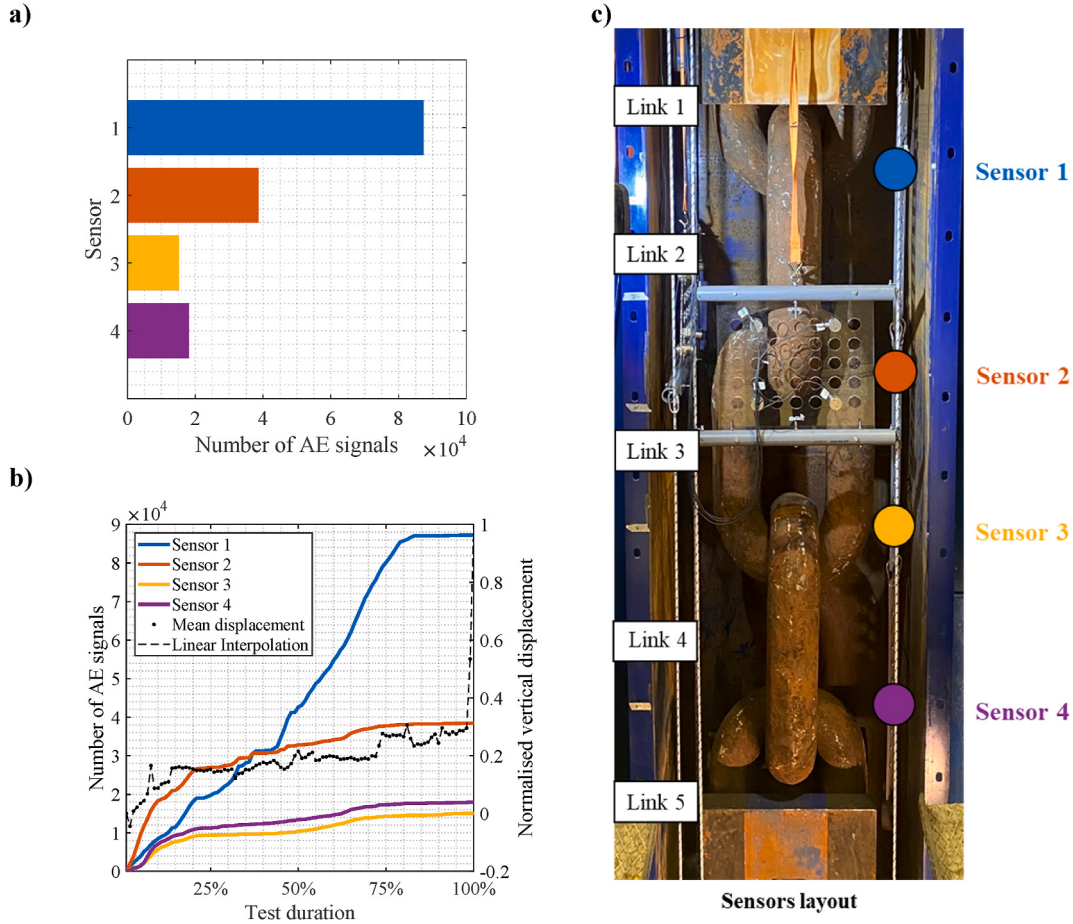
**Fig. 6.** (a) Total number of AE signals and (b) cumulative number of AE signals measured by the vertical arrays of transducers and normalised vertical displacement throughout the test. (c) Layout of the vertical array of transducers.

The total number of AE signals indicates sensor 1 as the most active in the vertical array pointing out Link 1–2 as the most active area in the test rig. This can be due to the combination of main damage-induced ultrasound signals with noise signals from the upper clamp of the test rig. On the other hand, the latter is expected to be limited by the SNR-based filter used in the pre-processing of the data. The acoustic activity decays toward the bottom of the test rig. However, sensor 4 shows increased activity compared to sensor 3 possibly due to noise generated by the clamp and the water inlet at the bottom of the test rig.

The cumulative number of AE signals shows a clear distinction between the activity in the top part of the chain segment and the mid-lower one. The slope of the cumulative trend is represented by the AE hit rate (in Fig. 7). Note that in previous research, the correlation between crack growth and AE hit rate has been demonstrated [51,52] and the slope of cumulative AE parameters has been used to identify different crack growth stages [21,26]. Sensor 1 displays a relatively steep curve throughout the experiment. In particular, two slopes can be observed. First from 0 % to 35 %, and second from 45 % to 85 % of the test duration. This could indicate a corrosion-fatigue damage growth at two different rates between 0–35 % and 45–85 %, respectively. During the latest stage of the test, a characteristic AE quiescence is observed. Besides that, sensors 2–4 show relatively similar trends that differ from the one followed by sensor 1. The cumulative number of signals measured by sensors 2–4 undergoes a steep increase between 0 and 15 % of the test duration while it has a very low slope during the remaining part of the experiment. The AE activity at the initial part of the test could be related to crack formation. There seems to be a correlation between the local jumps in the elongation curve and changes in the slope of the cumulative number of AE signals in different channels. A more detailed assessment of the correlation however would require the selection of the AE events per damage location, hence not discussed further in this section.

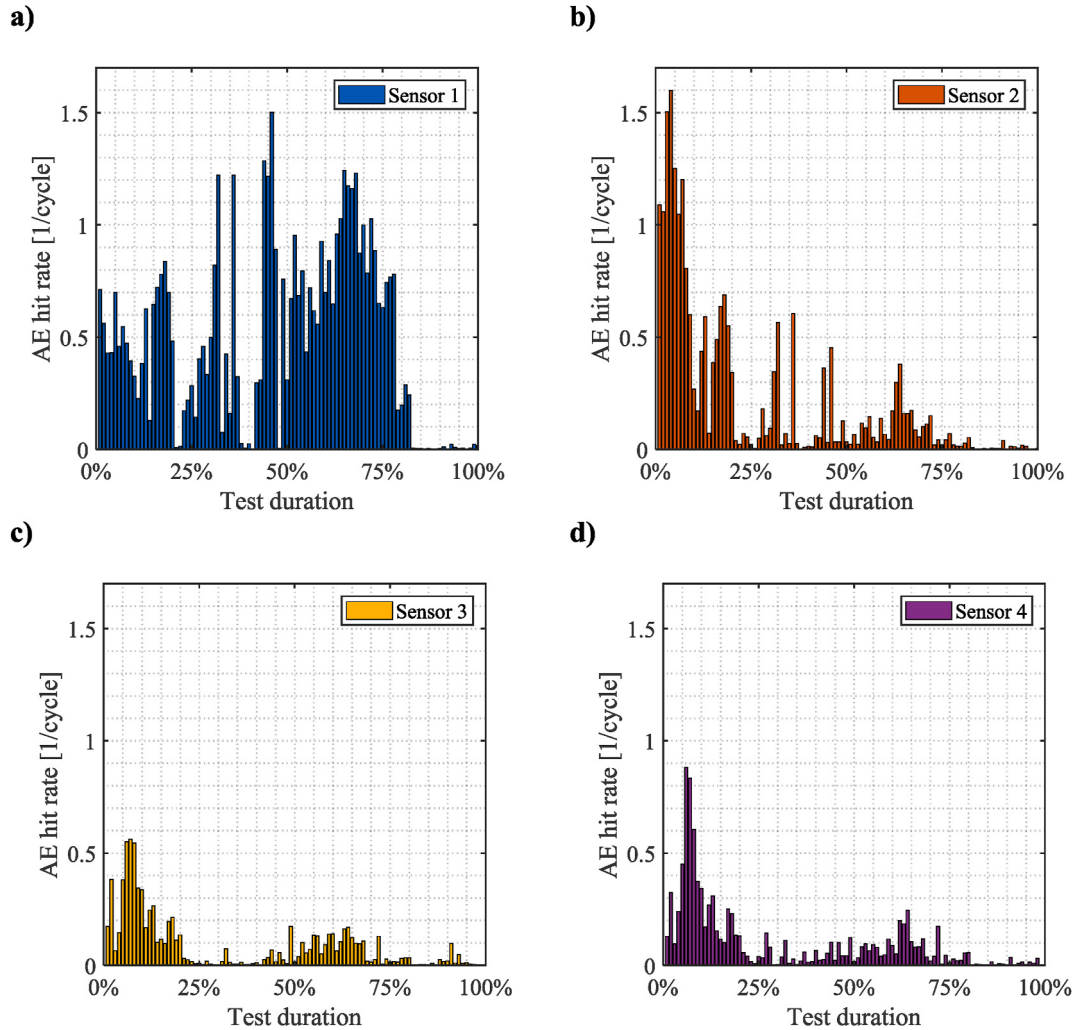
Fig. 7. AE hit rate measured by the vertical array of AE transducers.

Fig. 7 shows the AE hit rate for the vertical array of transducers. Sensor 1 displays an AE hit rate value of 0.7–0.8 signals per cycle from 0 % to about 35 % of test duration. The AE hit rate jumps above 1 signal per cycle after 35 % of the test duration. This possibly

indicates two different rates of crack growth. After 85 % of the experiment, the hit rate level drastically decreases (i.e. AE quiescence). Sensors 2–4 show relatively similar behaviour between each other. Initially, they present an AE hit rate level in the range (that is the case for sensors 3 and 4) or even higher (see sensor 2) than the one of sensor 1. After about 25 % of the test duration, however, the hit rate does not exceed 0.5 signal per cycle (suggesting an average of 1 hit per every two load cycles).

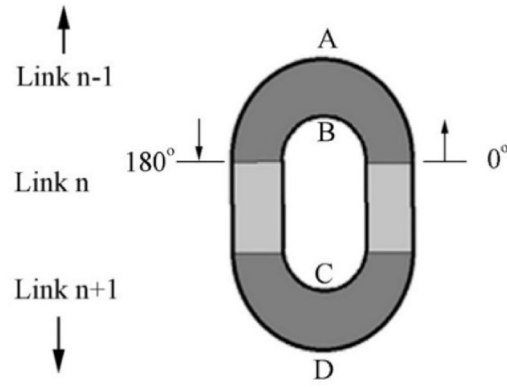
Fig. 10. Positions in each link. Dark grey areas in the sketch were tested.

The condition of the chain segment was assessed at the end of the experiment through visual inspection and magnetic particle (MP) testing. All the links of the chain segment were tested. The positions in each link are labelled A, B, C, and D as shown in Fig. 10. The reported observations are located in the crown area of the chain links. The results of the post-failure inspection are shown in Fig. 11. The main fracture (Fig. 11a) was observed in Link 1 towards Link 2. The results of the post-failure inspection are summarised in Table 3.
