Building Resilience: Analyzing Beira's Drainage Network and Flood Management

The impact of failure mechanisms on flooding in informal settlements

Job Knoop

to obtain the degree of Master of Science
at Delft University of Technology,
to be defended publicly on November 10, 2023 at 10 AM.

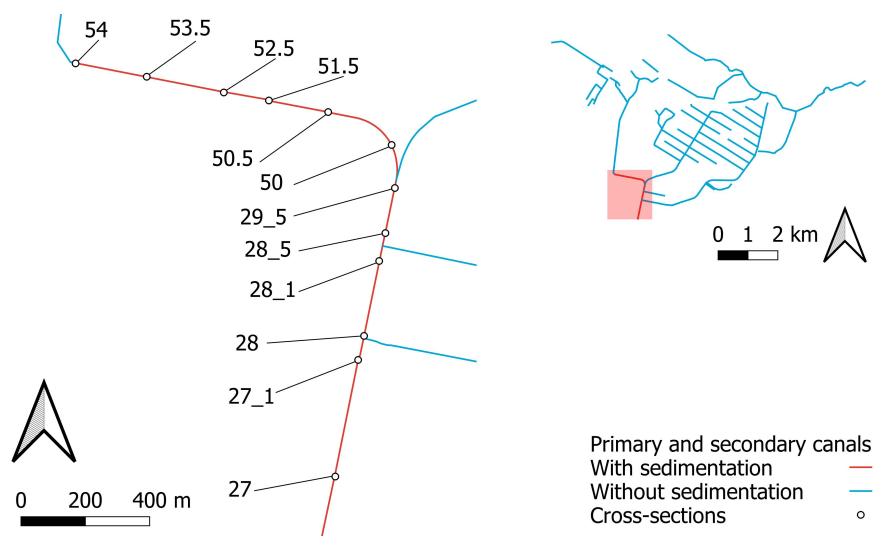
Figure 4.6: Canals which are affected by sedimentation

Sediment accumulation is modeled in the primary canal since the designed dimensions of this canal are known from the design and it is impossible to measure dimensions of the unlined canals. To quantify sedimentation, bed heights are measured on the sides of the canals and the depths in the center are estimated. To model this, the cross-sections of the affected canals (Figure 4.1.4) are altered based on the technical measurements which are performed. An overview of the old and new cross-sections per canal provided in Appendix E.

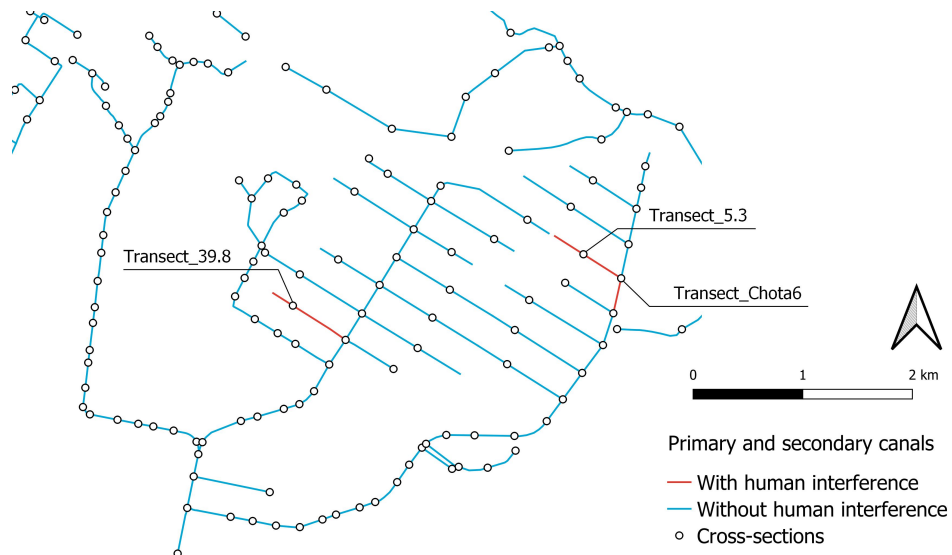
Figure 4.7: Canals which are affected by human interference

Human interference is modelled similarly as sedimentation, by changing the cross-sections of the canals. The new cross-sections are determined by visual estimations. The locations of the canals which are affected by human interference are determined during the transect walks. Figure 4.7 presents the locations of the canals which are affected by human interference. Appendix E presents the cross-sections of the initial situation versus the situation with human interference.

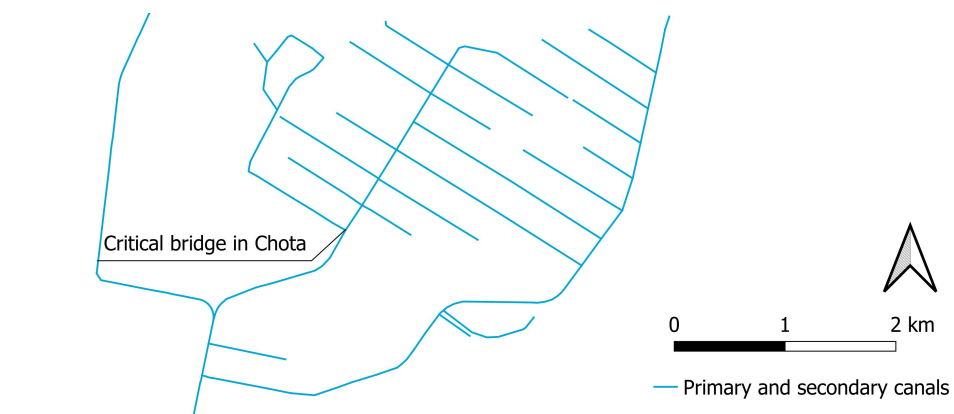
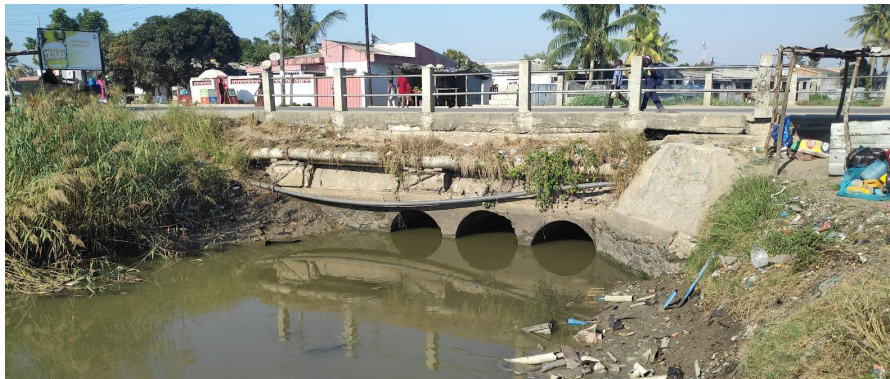
Figure 4.8: Critical bridge in Chota

The impact of underdimensioned constructions is focused on one critical bridge in the system; this bridge, located in Chota (Figure 4.8a), has a small available flow surface area. It consists of three

circular culverts next to each other. Technical measurements in the field showed that the outer two culverts have a diameter of 1.5 meter and the central culvert has a diameter of 1.4 meter; the total flow surface area is therefore 5.1 m².

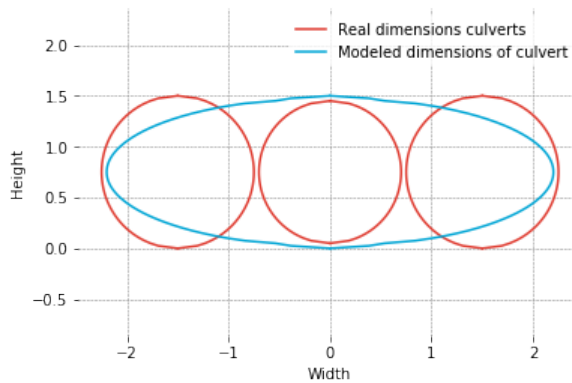
Figure 4.9: Size of the culvert, representing the underdimensioned bridge

Hydraulic modelling in D-FLOW FM 1D2D does not allow three culverts next to each other in the same canal. The three different culverts are therefore simplified into one larger culvert. The width of this culvert at a certain height is equal to the sum of the widths of the three culverts. Figure 4.9 presents the dimensions of the culverts which are measured and the dimensions of the culvert which is applied in the model.

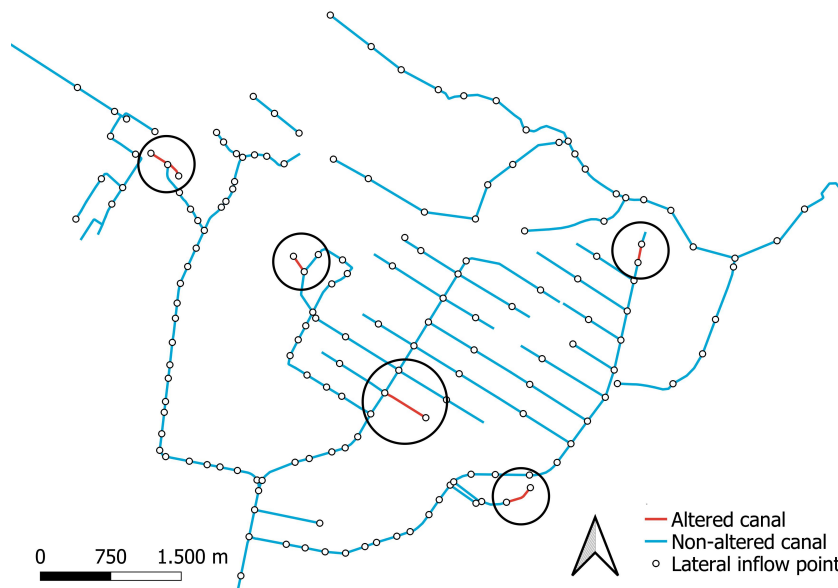
Figure 4.10: Canals with reduced sizes to investigate connection blockage

To model the impact of blockage of connections, an approach is chosen which gives an indication of the effects of a blockage of a connection. In order to do this, cross-sections in certain existing dead-end canals are reduced in size, to force overland flow out of these canals. The canals which are chosen to be altered are indicated in Figure 4.10. All altered canals are replaced with a canal with a width of 0.10 meter and a depth of 0.10 meter.

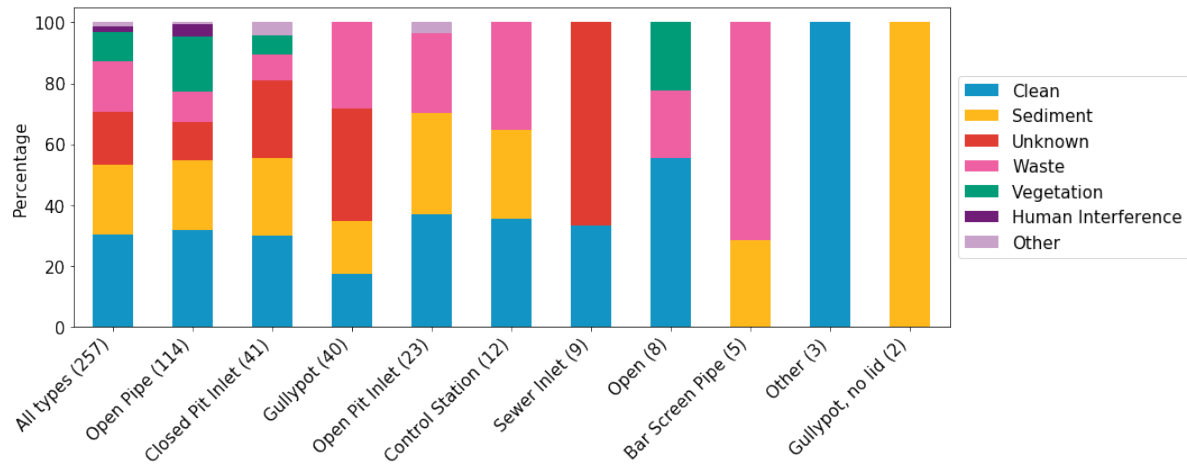
Figure 5.1: Failure per connection type

Firstly, failures per connection type are discussed. Figure 5.1 presents the results of the failure modes per connection type. This analysis shows that 30.4% of the connections were clean. Besides this, the main failure modes are sedimentation, waste and vegetation. Human interference and other failures are found less often. A fraction of the failure modes was unknown (17.4%); this mainly included closed pits and gully pots which were too dark to make an appropriate assessment of the failure.

Considering different connection types, the largest part of the dataset consists of open pipes, followed by closed pipe inlets and gully pots. The bar screen pipe should be highlighted; all five observed bar screen pipes contain waste to some extent as this is trapped in the bar screen. Furthermore, the fraction of waste is high in control stations and inlet points.

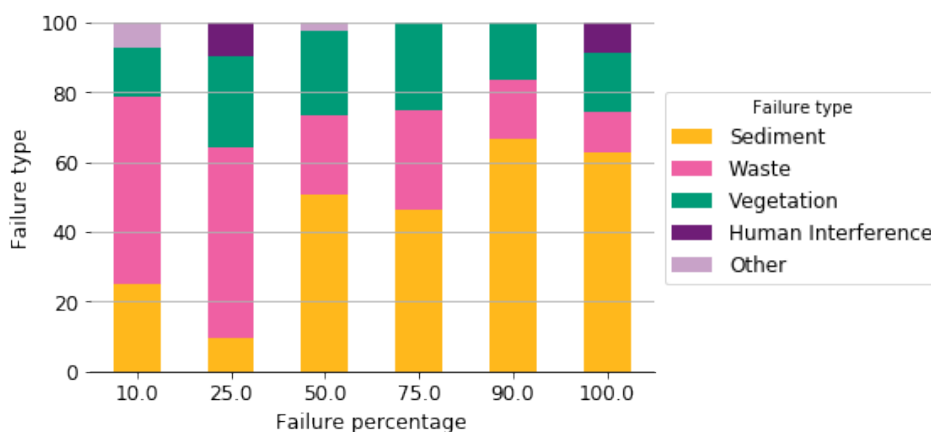
Figure 5.2: Failure Type versus degree of failure in connections

Figure 5.2 presents the relation between the failure percentage and the failure modes. It shows that as the degree of failure increases, the portion of sediment in the total failures increases as well. An opposite trend can be found for waste; waste accounts for around 50% of the small failures with a

lost surface area of less than 25%. Vegetation can be found in small and large failures and is therein accountable for approximately 10% of the failures.

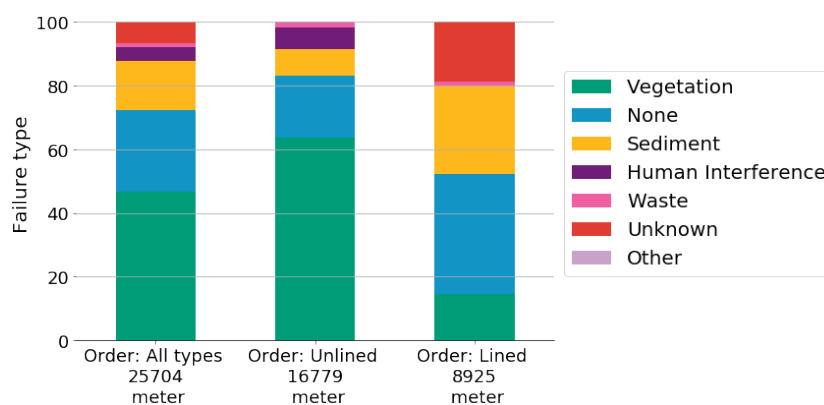
Figure 5.3: Failure modes in lined versus unlined canals

Figure 5.3 compares failure modes in lined and unlined canals. Lined canals more often have no failure mode, compared to unlined canals (38% versus 9%, respectively). In unlined canals, vegetation accounts for more failures (64%) than in lined canals (15%). Human interference is not found in lined canals whilst it accounts for 7% of the failures in unlined canals. As it was generally difficult to measure the degree of sedimentation in unlined canals, this fraction is higher in lined canals.

No registration is done on the vegetation type that was observed, but during the transect walks, it became evident that different vegetation types are found in unlined and lined canals. In lined canals, the predominant type was *Pontederia crassipes*, whilst *Phragmites australis* was mainly found in unlined canals.

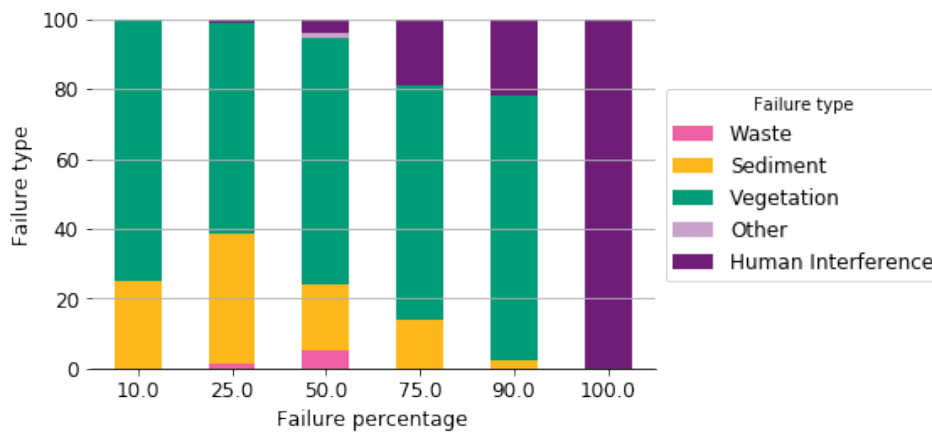
Figure 5.4: Failure Type versus degree of failure in canal stretches

Combining both failure type and degree of failure, an opposite trend for sedimentation was found compared with the connections; sedimentation was generally found in canals with smaller failures. This can be seen in Figure 5.4. Furthermore, human interference generally causes larger failures. Vegetation is widely found in the canals and there does not seem to be a trend in the occurrence of this failure mode.

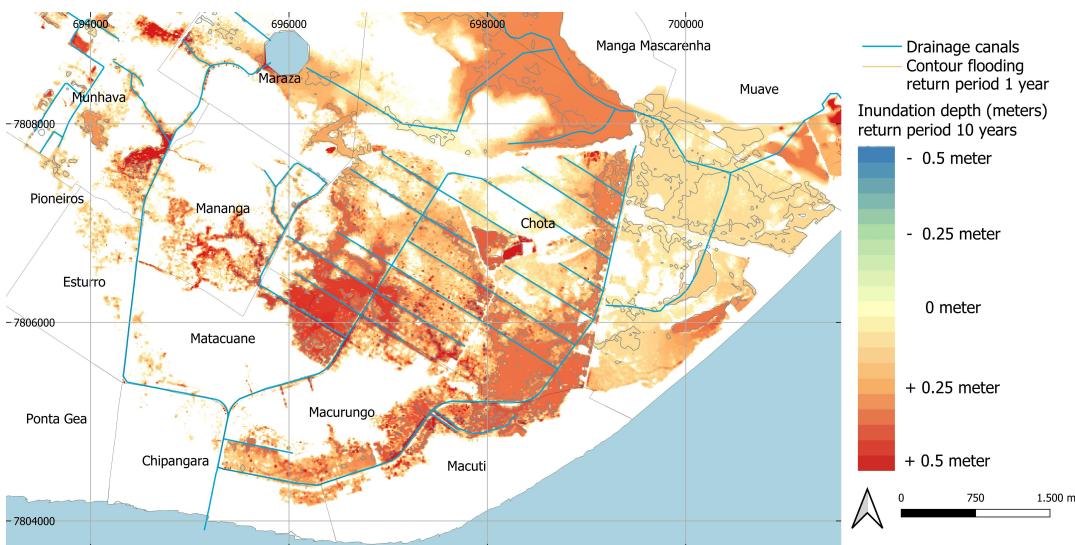
Figure 5.6: Inundation increases caused by overall severe vegetation at t = 24 hours. The scale of this map ranges from -0.5 to +0.5 meter and is therefore different from the other maps

Considering the fact 64% of the canals in the unlined section contain vegetation to some degree, the increase in inundations seems to be limited. However, if all canals would have a severe blockage caused by vegetation, this shows a more concerning image. If this is modeled, the inundation increases with more than 20 centimeter and peaks of 50 centimeter. The map is presented in Figure 5.6.

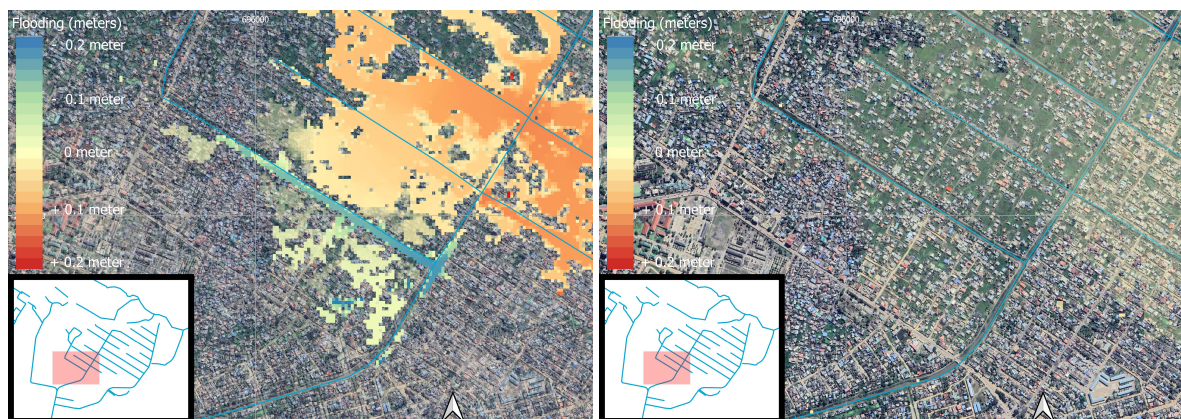
Figure 5.8: Inundation increases caused by human interference at $t = 24$ hours

Figure 5.8 compares the results of the inundation depth increases under the precipitation event happening once per year and once per ten years. It shows the inundation depth increase is stronger in under the precipitation event with a return period of one year (around 12 centimeter) versus the one with a return period of ten years (less than 2 centimeters). It therefore becomes evident that in this canal, human interference primarily impacts inundation depths for smaller precipitation events.

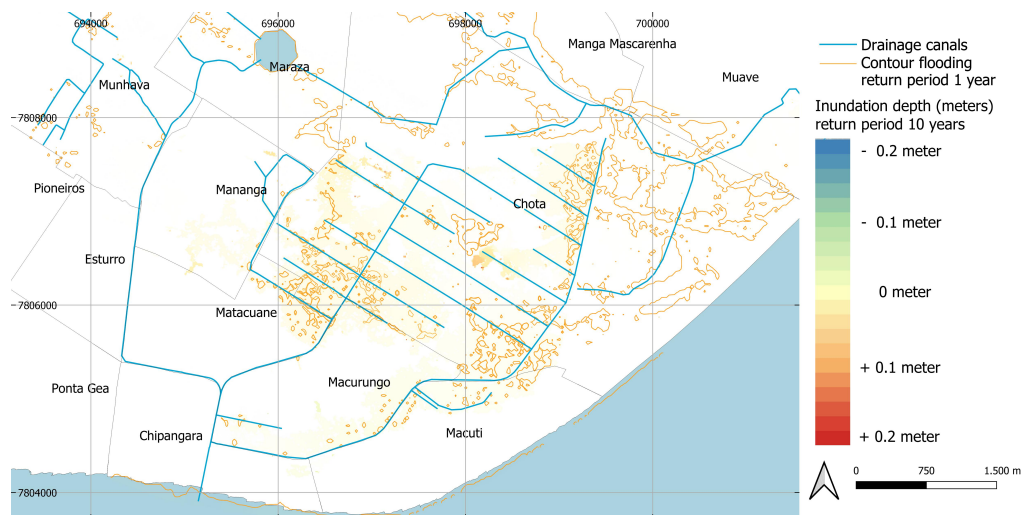
(a) Scenario 1: impact of vegetation in canals. Scale ranging from -0.2 to +0.2 meter

The difference in inundation depths caused by the observed vegetation is presented in Figure 5.7a. It shows that the increase in inundation between 2 and 5 centimeters and can be mainly found in the Chota neighbourhood. This is coherent with the fact that most of the canals affected with vegetation can be found in Chota.

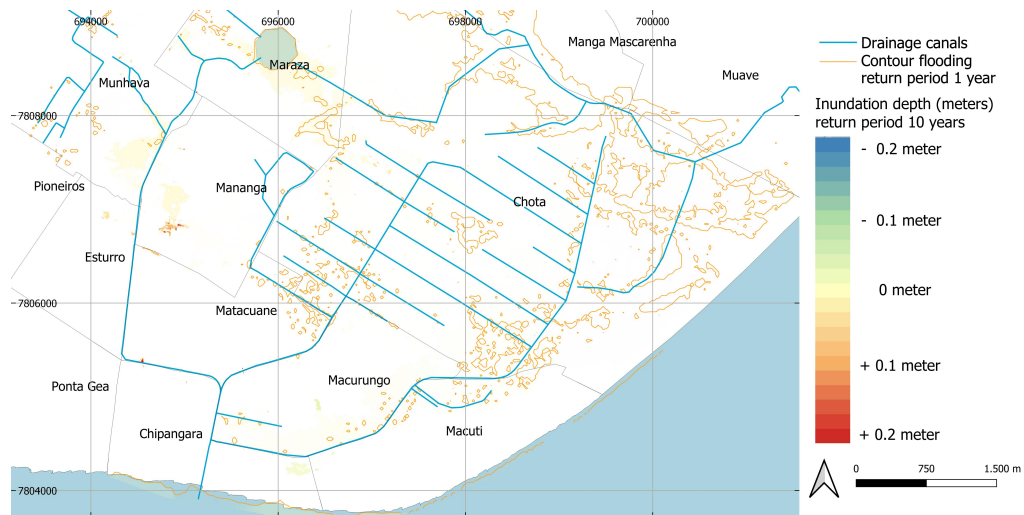
(b) Scenario 2: impact of sedimentation in canals. Scale ranging from -0.2 to +0.2 meter

The effects of sedimentation is mainly visible in the retention basin Lagoa Municipal da Beira in the north of the Phase 1 area. Increased inundation levels in this basin can be observed caused by the decrease of the retention capacity in the primary canal. After 12 hours, just following the peak of the precipitation event, it can be observed that this causes a sharp increase in inundation in a small part of the western region of the Phase 1 area, with inundation levels rising by up to 20 cm. The differences in inundation decrease after 24 hours, resulting in increases of approximately 1 cm in some regions, as shown in Figure 5.7b.

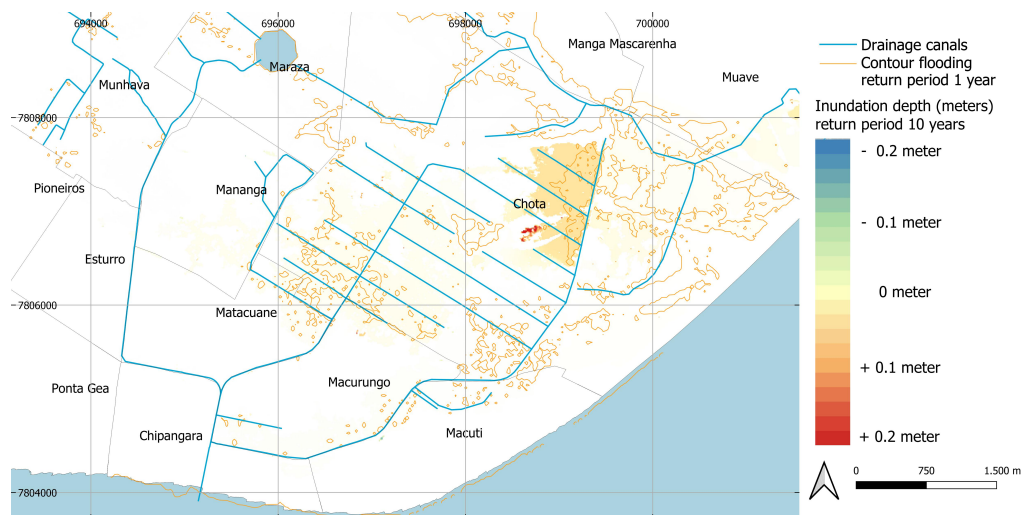
(c) Scenario 3: impact of human interference in canals. Scale ranging from -0.2 to +0.2 meter

Figure 5.7c presents the results of the scenario with human interference. During the transect walks, it was observed that two canals were affected by human interference. After 24 hours, the inundation depth increase is around 0.5 cm around the southern canal and significantly more around the northern affected canal (35 centimeter).

In the southern canal, the areas surrounding the points of human interference experience increased inundation depths up until $t = 11$ hours. In this region, inundation depth increases of more than 10 cm are widespread and peaks of 30 cm can be found. However, beyond $t = 11$ hours, the difference between the modified scenario and the base scenario diminishes. In the northern canal, the difference in inundation depths between the base scenario and the scenario with human interference does not diminish after $t = 11$ hours but remains high.

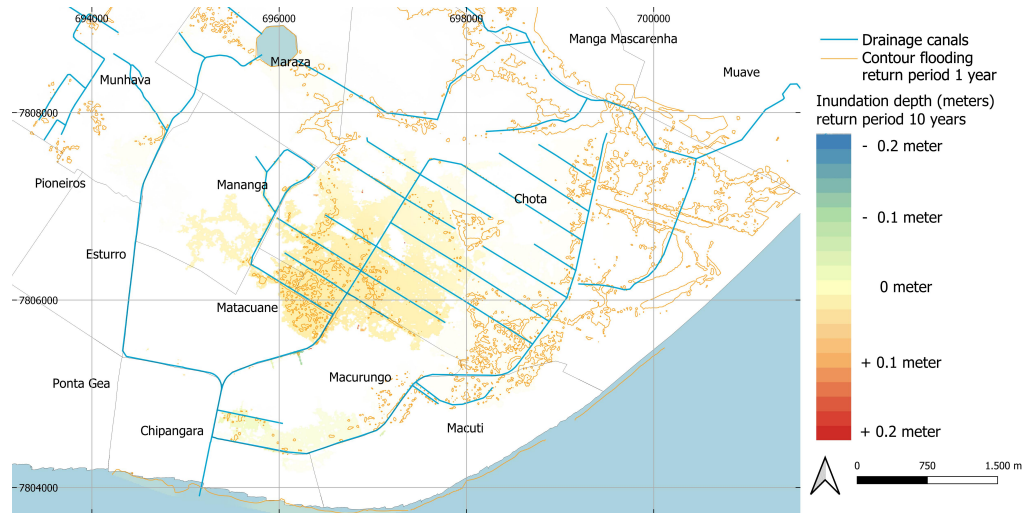
(d) Scenario 4: impact of underdimensioned structures in canals. Scale ranging from -0.2 to +0.2 meter

The impact of underdimensioned structures, which is modeled by including a bridge in Chota, mainly affects floodings in the end of the precipitation event. In the initial stage, inundation depth increases are mainly focused in the already existing canals. From 15 hours onwards, the increase in inundation extends to the entire upstream area of the bridge and peaks at a 2 cm increase over a large surface area after 24 hours. The bridge therefore seems to strongly affect the capacity to drain the flooded area

in a late stage of the precipitation event. Figure 5.7d presents the results on the scale of the whole city.

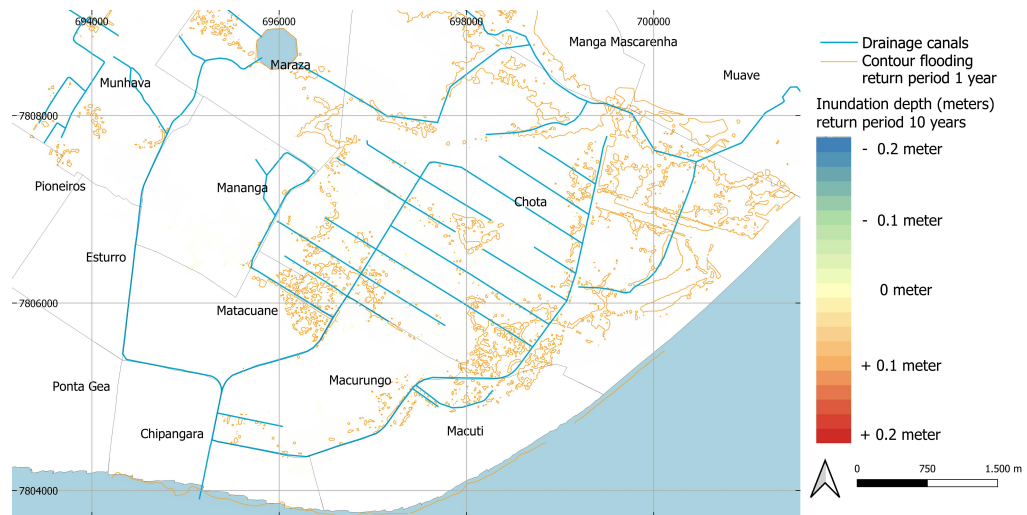
(e) Scenario 5: impact of waste in the Palmeiras outfall. Scale ranging from -0.2 to +0.2 meter

In the scenario where a part of the outfall in Palmeiras is obstructed, the model finds an initial increase in water depths during the flooding event. The water depth rises with a maximum of 2 cm in this situation on a relatively small area. There is hardly any difference in inundation depths between the base scenario and the scenario with this failure after $t = 12$ hours. Results are presented in Figure 5.7e.

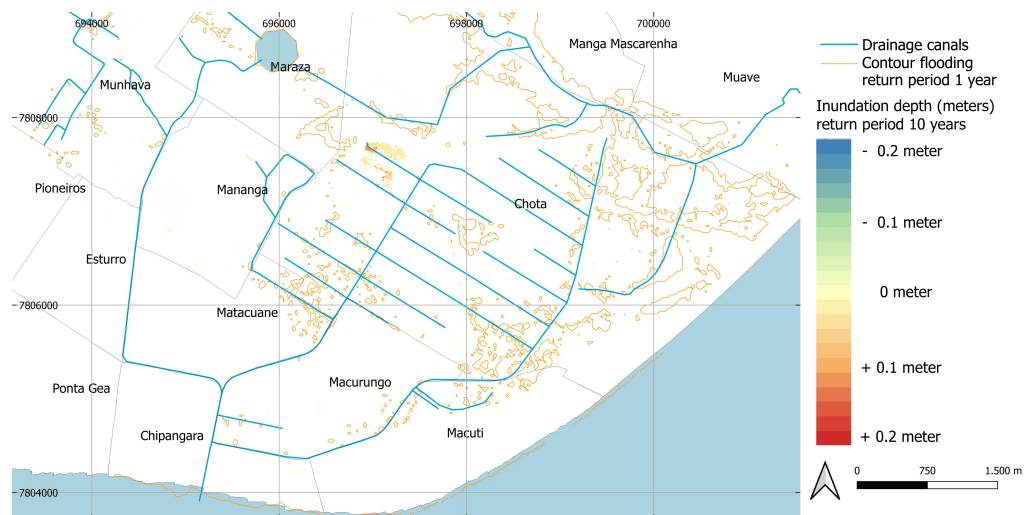
(f) Scenario 6: impact of blockage of the connections. Scale ranging from -0.2 to +0.2 meter

The scenario involving the blockage of connections focuses on certain dead-end canals, which are reduced in size in the model to simulate the obstruction of these canals. These canals show varying results depending on their location. In most cases, there is an increase in inundation levels just after the peak of the precipitation event (at $t = 12$ hours), followed by a reduction in differences. Results of

the impact of the blockage of connections can be found in Figure 5.7f.

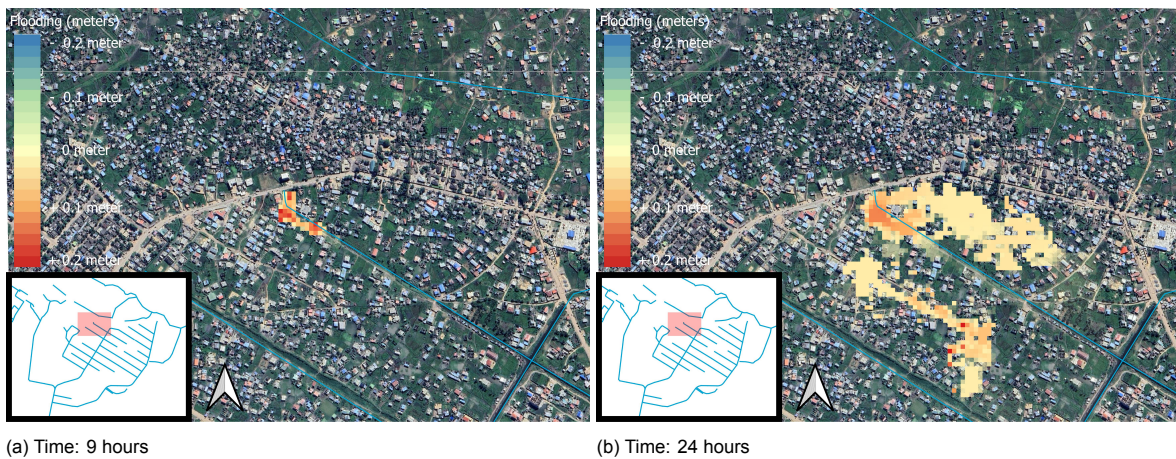
Figure 5.9: Inundation increase caused by hypothetical blockage of the connections in the northeast of Chota

The impact of canal blockage varies across the system. In flood-prone areas, as shown in Figure 5.10, blockages affect inundation levels until 12 hours, after which overland flow becomes the predominant flow in both the base scenario and the scenario with blockages. In other regions where there is no overland flow in the base scenario, such as in Figure 5.9, the blockages cause a very localized increase in inundation depths, reaching up to 20 cm.

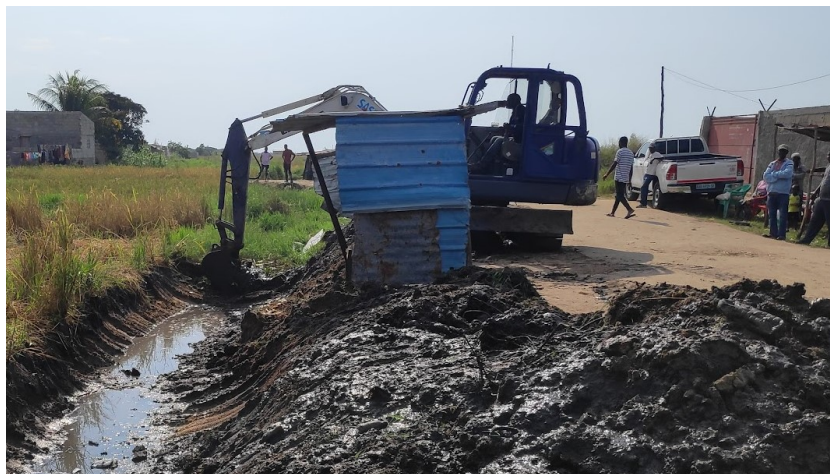
The removal of sediment, waste, and vegetation from canals is performed using two excavators: a large one and a smaller one used for shallower canals (Figure 5.12). Unfortunately, during the visit, the larger excavator was non-operational and unavailable. Additionally, vegetation is managed through tidal flushing of the canals during the dry season. This involves opening the sluice gates at Palmeiras during high tides to allow water inflow and increase water levels. Subsequently, during low tides, the sluice gates are reopened to flush the drainage network. This practice also enhances water quality.

Figure 5.12: The only operational excavator from SASB (picture by author)

Interviewees from SASB prefer maintenance of the canals with the excavators, as this is easier and regrowth times are shorter. However, costs are also higher: in August 2023, it was estimated that manual cleaning costs 42 Mozambican metical (MZN) per meter canal. Mainly fuel prices causes the costs of cleaning with excavators to be from 56 MZN/m (for a small excavator) up to 113 MZN/m for the large excavator.

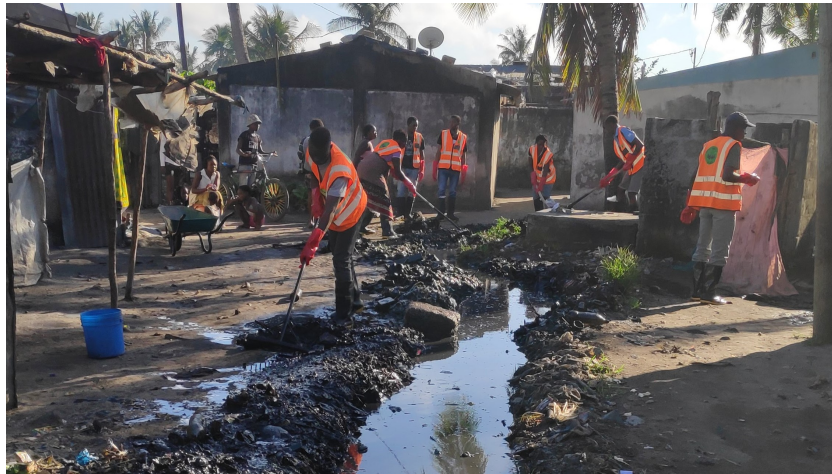
One of these cleanup sites was visited during the visit in Beira (Figure 5.13). It became evident that there was significant enthusiasm for collaboration with these cleanups, as a discussion quickly arose about who would be permitted to participate. The cleanup lasted for two hours, during which the canals in a densely populated area of approximately 5 hectares were cleaned and cleared. Participants were equipped with gloves, boots and shovels, provided by FACE.

Although a lot of canal stretches were cleaned, it is noteworthy that certain sections of the canal, obstructed by human interference, remained untouched. These sections were considered "too challenging to clean" and were consequently left blocked, obstructing the entire canal. Moreover, the canals were not excavated to connect with a secondary canal's inlet, as this inlet was positioned higher than the ground level. Instead, water was let to flow towards a nearby swamp to evaporate. These cleanups are

therefore effective for the removal of waste on locations which are easy to reach, but are less effective on locations with combined failure modes.

Figure 5.13: One of the cleanups organised by FACE (picture by author)

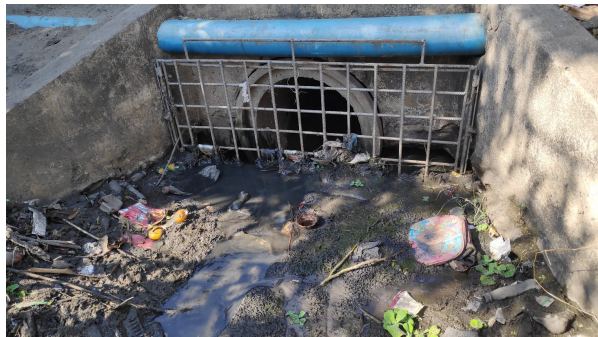
Bar Screen Pipe The bar screen pipe is similar to the open pipe, but holds a bar screen that traps solid waste (picture by author).

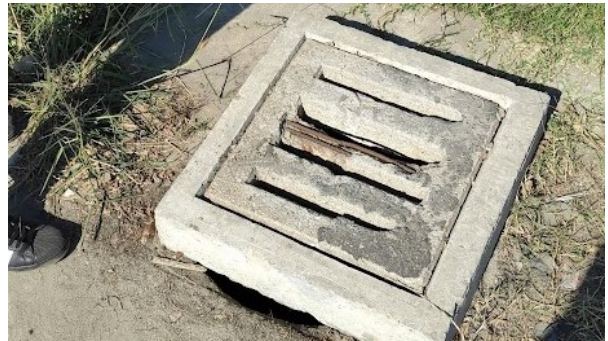
Gully pot The gully pot is an inlet structure which is typically located on the side of the street. It consists of a water collection box of approximately 50x50 cm. It is closed off by a lid with rectangular holes which filters large solid waste. A pipe approximately 10 centimeters above the bottom allows water to flow out of the gully pot, so that sediments are collected on the bottom of the box (picture by author).

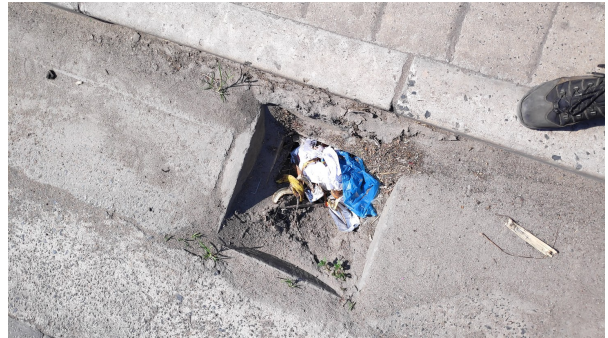
Gully pot, no lid The gully pot without a lid is similar to a gully pot but does not have a lid (picture by author).

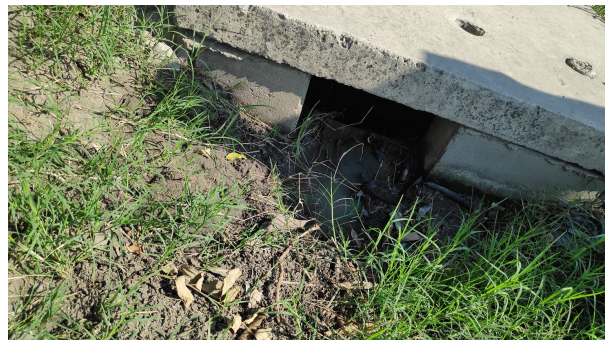
Closed Pit Inlet The closed pit inlet consists of a box of approximately 1x1 mtr which collects water through a hole in the side of the pit. It is closed off with a concrete lid which has small holes for inspection. The water exits the pit through a pipe approximately 3 cm above the bottom of the pit (picture by author).

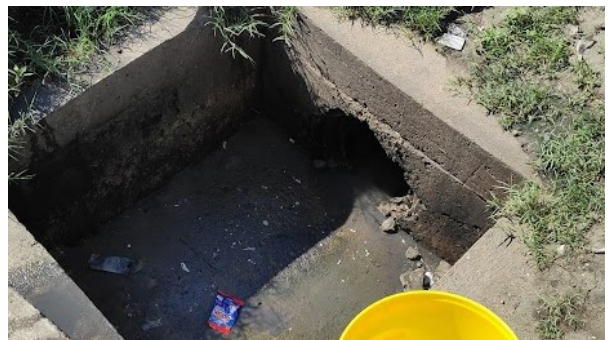
Open Pit Inlet The open pit inlet is similar to a closed pit inlet but does not have a lid (picture by author).

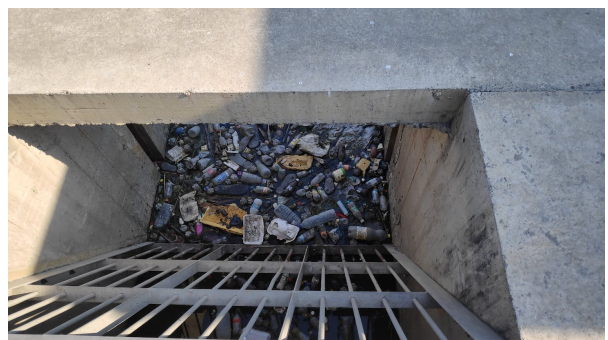
Control Station There are five control stations in the system that can be completely opened or closed using gate doors. Some control stations have a bar screen to collect solid waste. Each control station typically has 4 or 5 doors. One of the control stations is the Palmeiras outlet (picture by author).

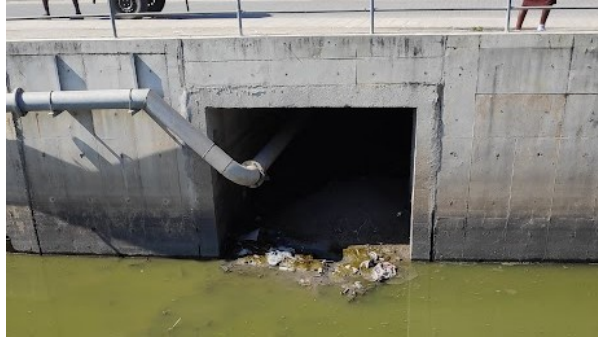
Sewer Inlet The sewer inlet is the connection of a part of the underground sewer network to a canal (picture by author).

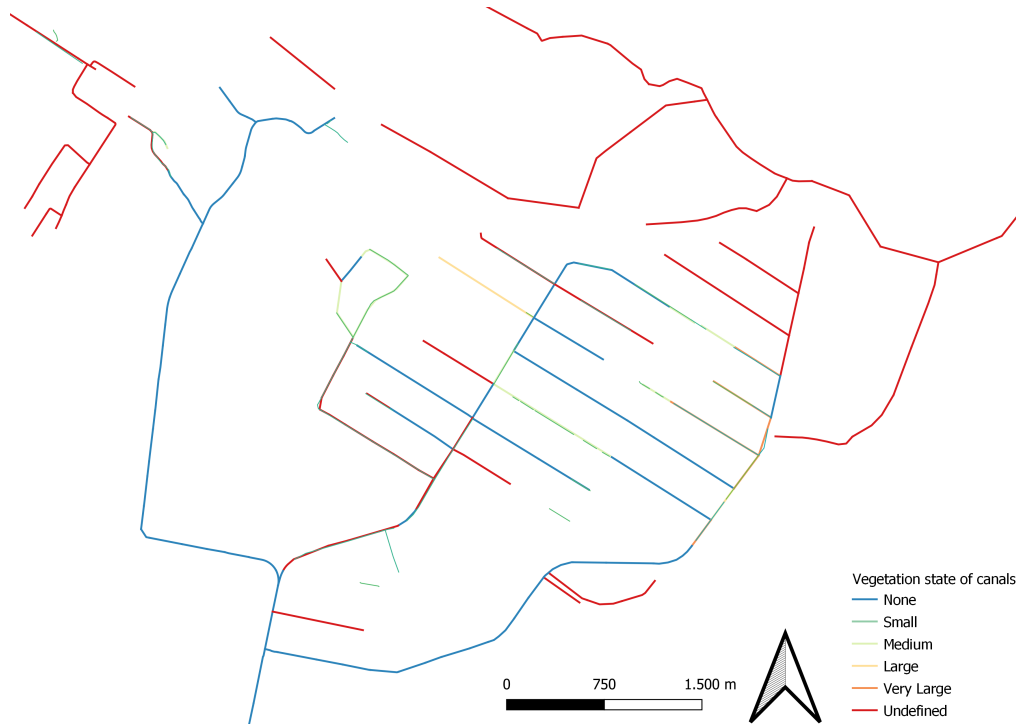
Figure E.2: Locations of the cross-sections that are affected by vegetation

This section describes the canals that are affected by vegetation. A map of the locations of the canals that have some degree of vegetation and the associated degree of failure is presented in figure E.2.

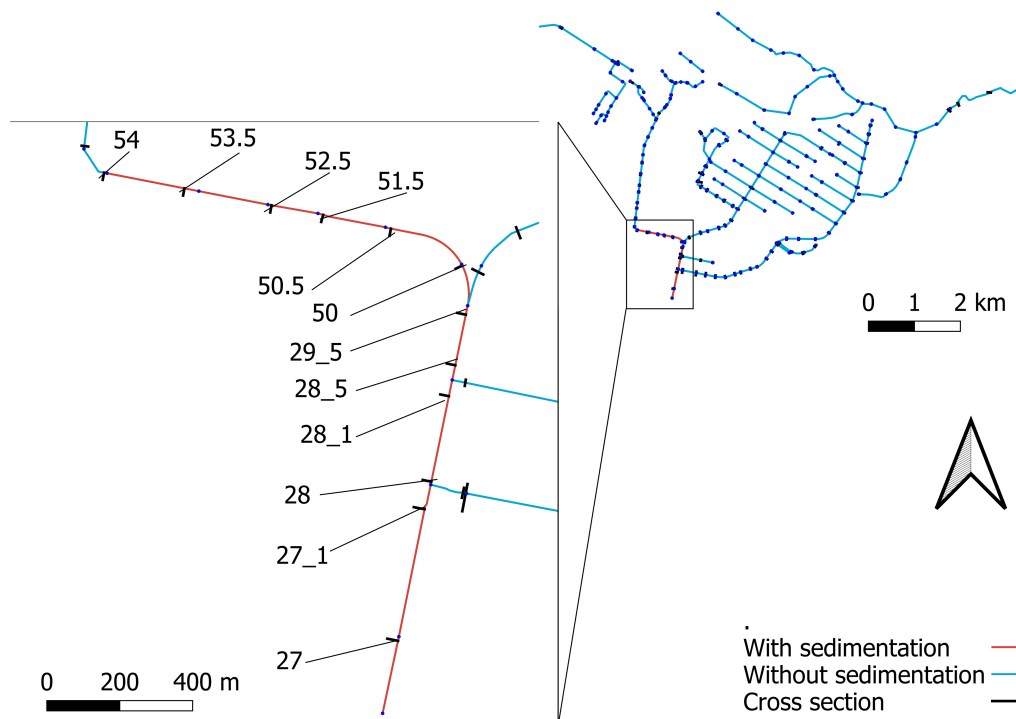
Figure E.3: Locations of the cross-sections that are affected by sedimentation

In the sedimentation scenario, 12 cross-sections are modified to incorporate sedimentation in the model. The locations of the cross-sections and the cross-sections for both the designed and measured situations are presented below:

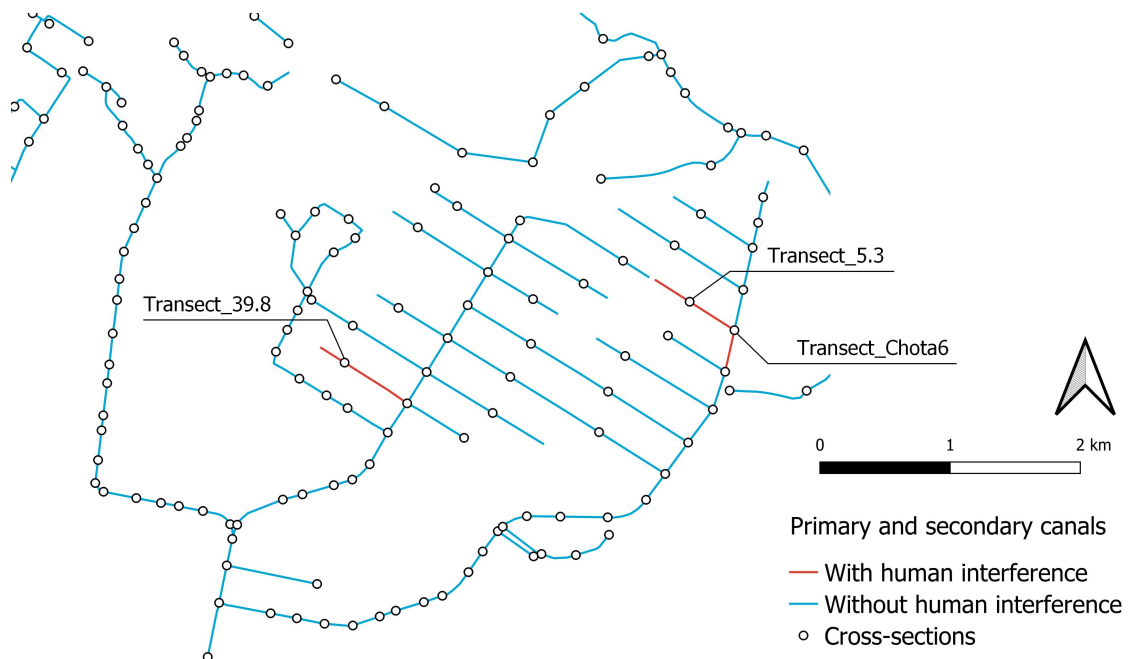
Figure E.5: Canals that are affected by human interference

In the human interference scenario, 3 cross-sections are modified to incorporate human interference in the model. The locations of the cross-sections and the cross-sections for both the designed and measured situations are presented below:

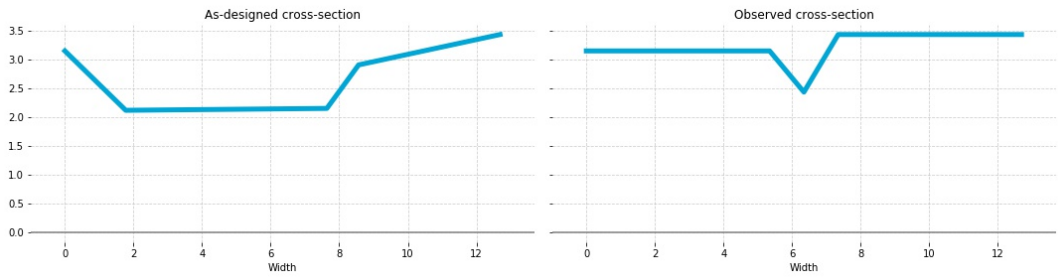
(c) Cross-section canal 27_1

Figure E.6: Changes made to the cross-sections of the canals caused by human interference

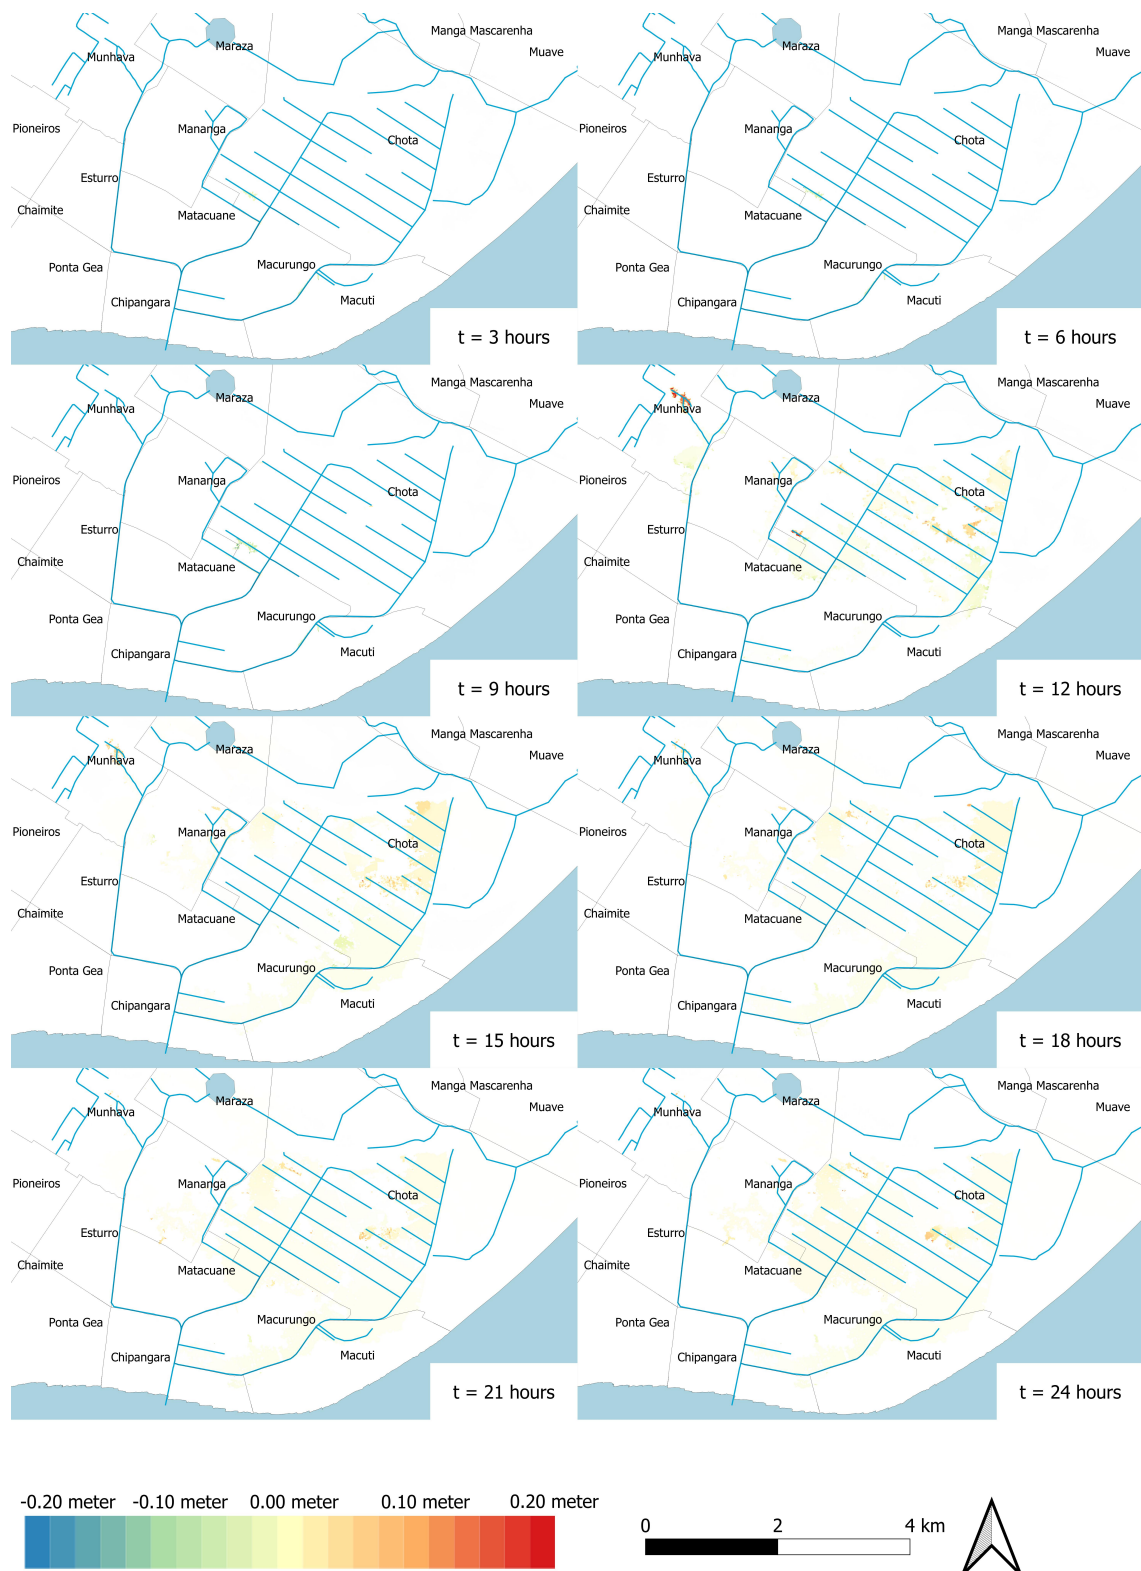
Figure F.2: Inundation depth increases in scenario 1: impact of vegetation and waste in canals under precipitation event occurring once per 10 years

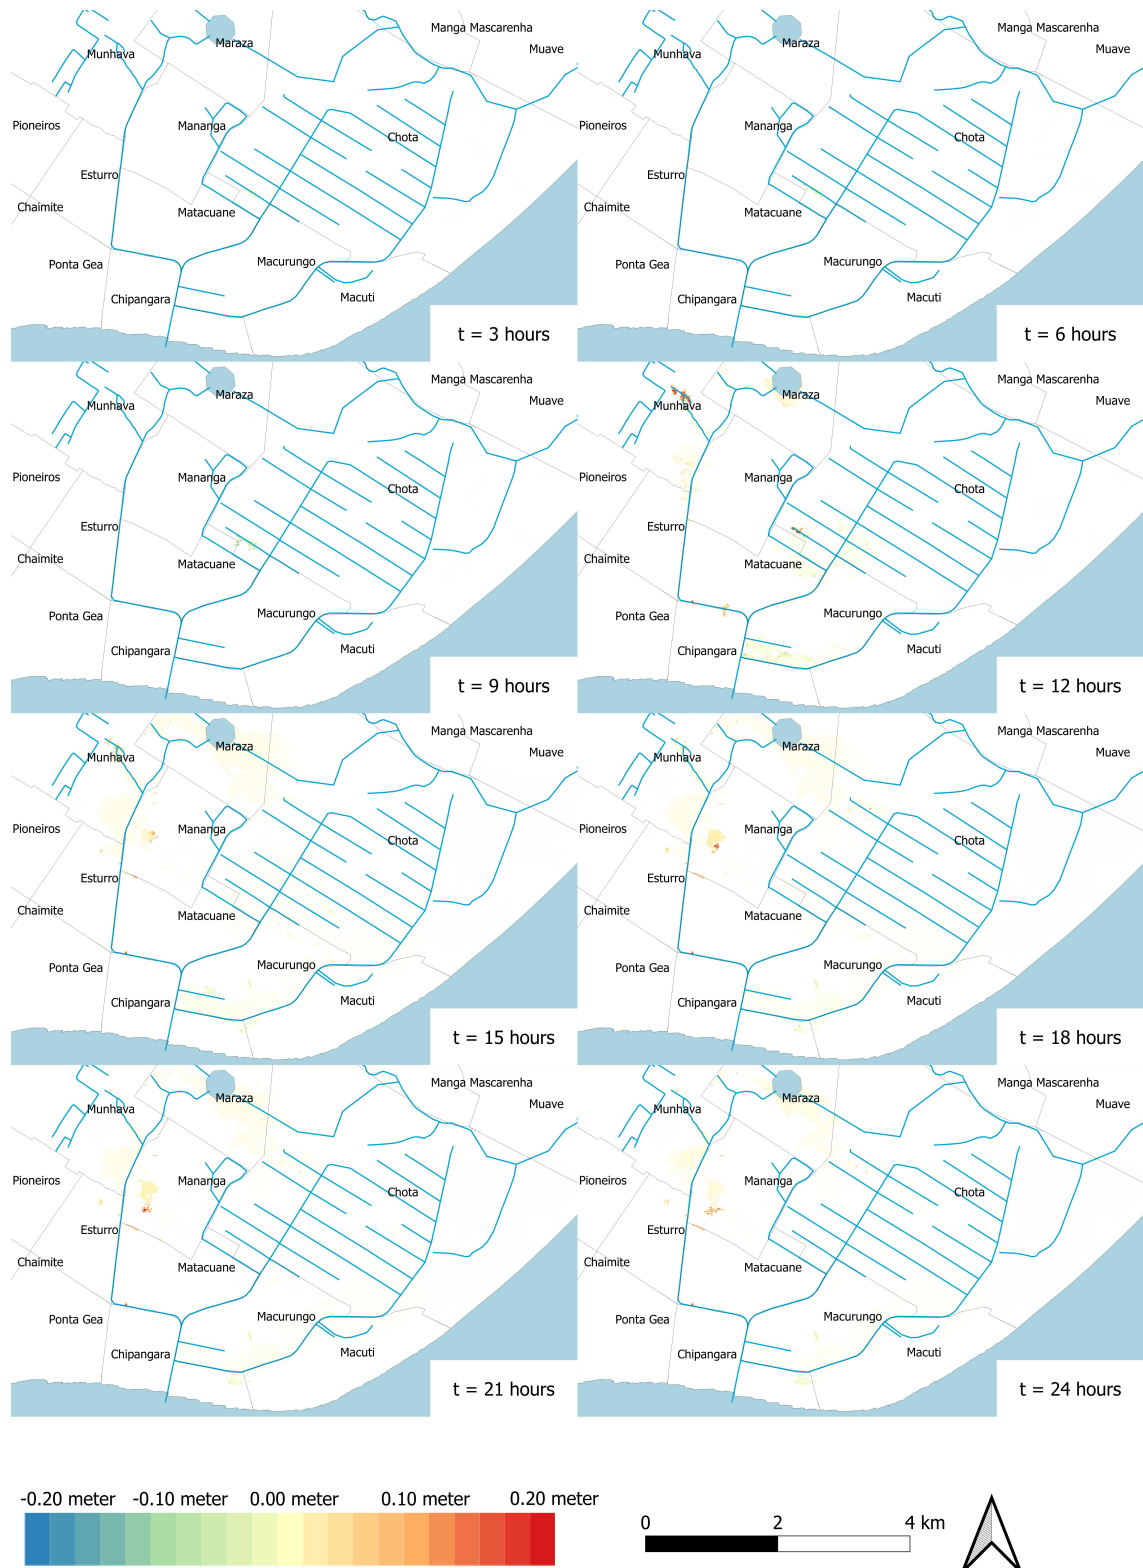
Figure F.3: Inundation depth increases in scenario 2: impact of sedimentation in canals under precipitation event occurring once per 10 years
