Building Resilience: Analyzing Beira's Drainage Network and Flood Management

The impact of failure mechanisms on flooding in informal settlements

Job Knoop

to obtain the degree of Master of Science
at Delft University of Technology,
to be defended publicly on November 10, 2023 at 10 AM.

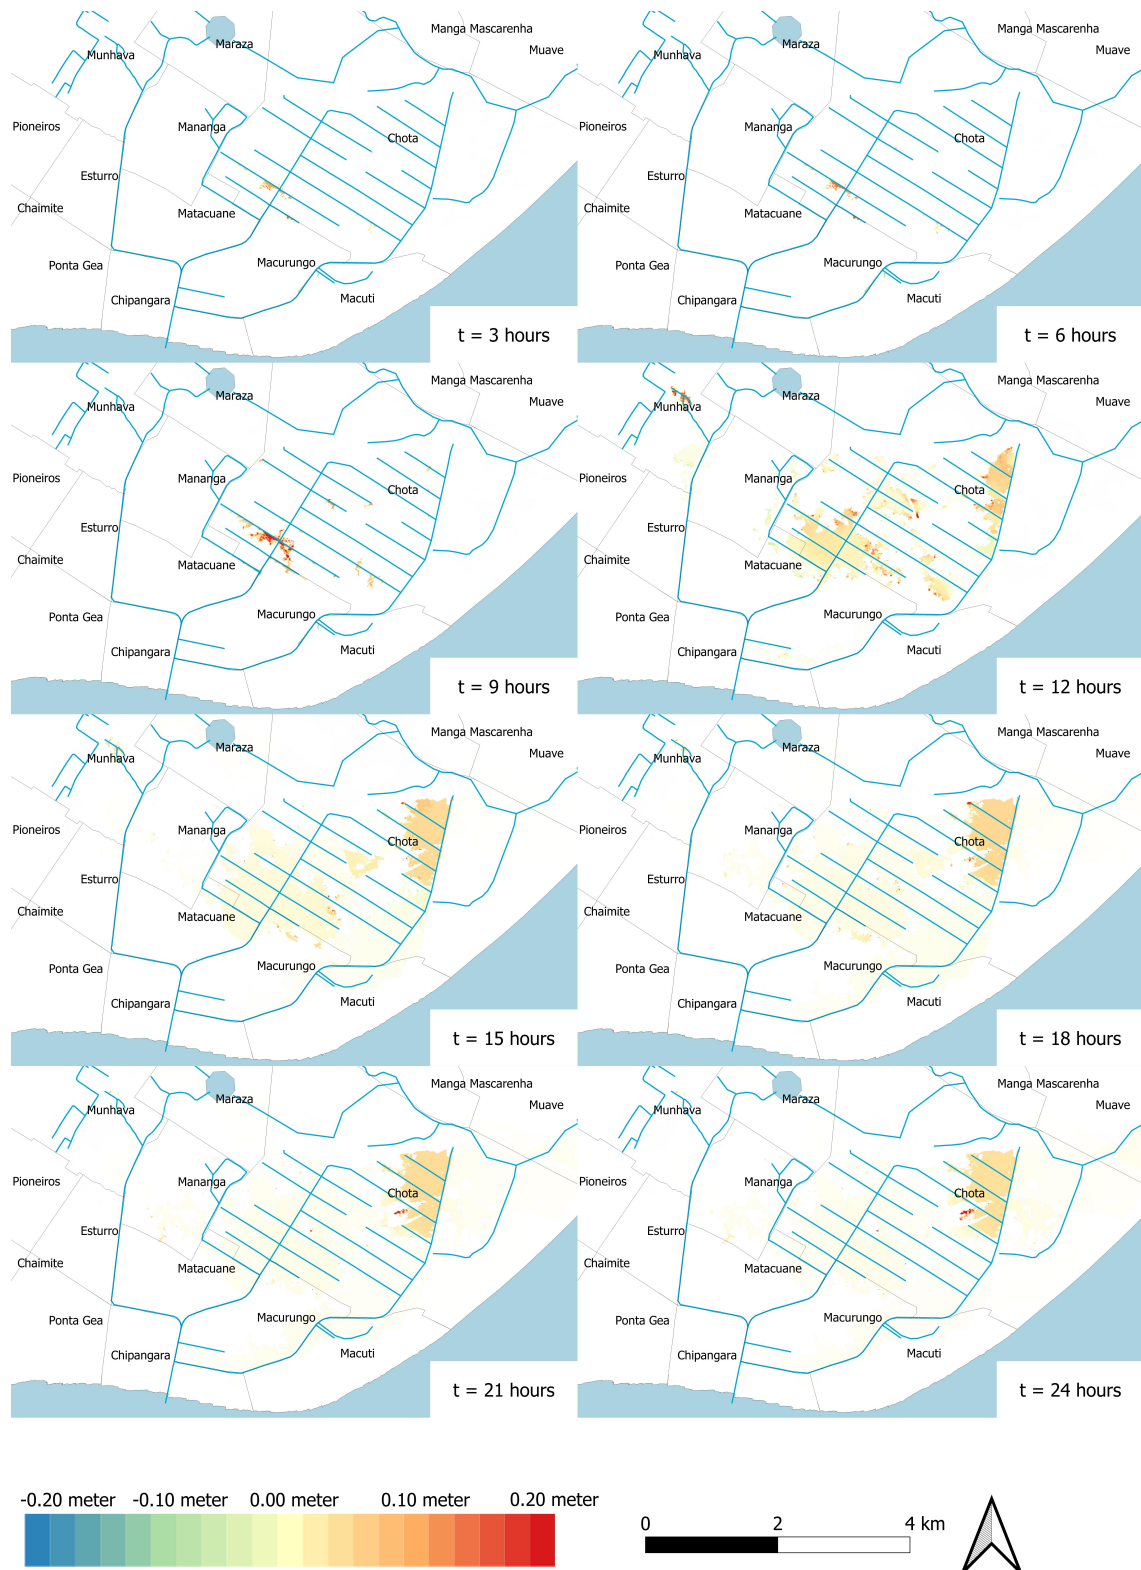
Figure F.4: Inundation depth increases in scenario 3: impact of human interference in canals under precipitation event occurring once per 10 years

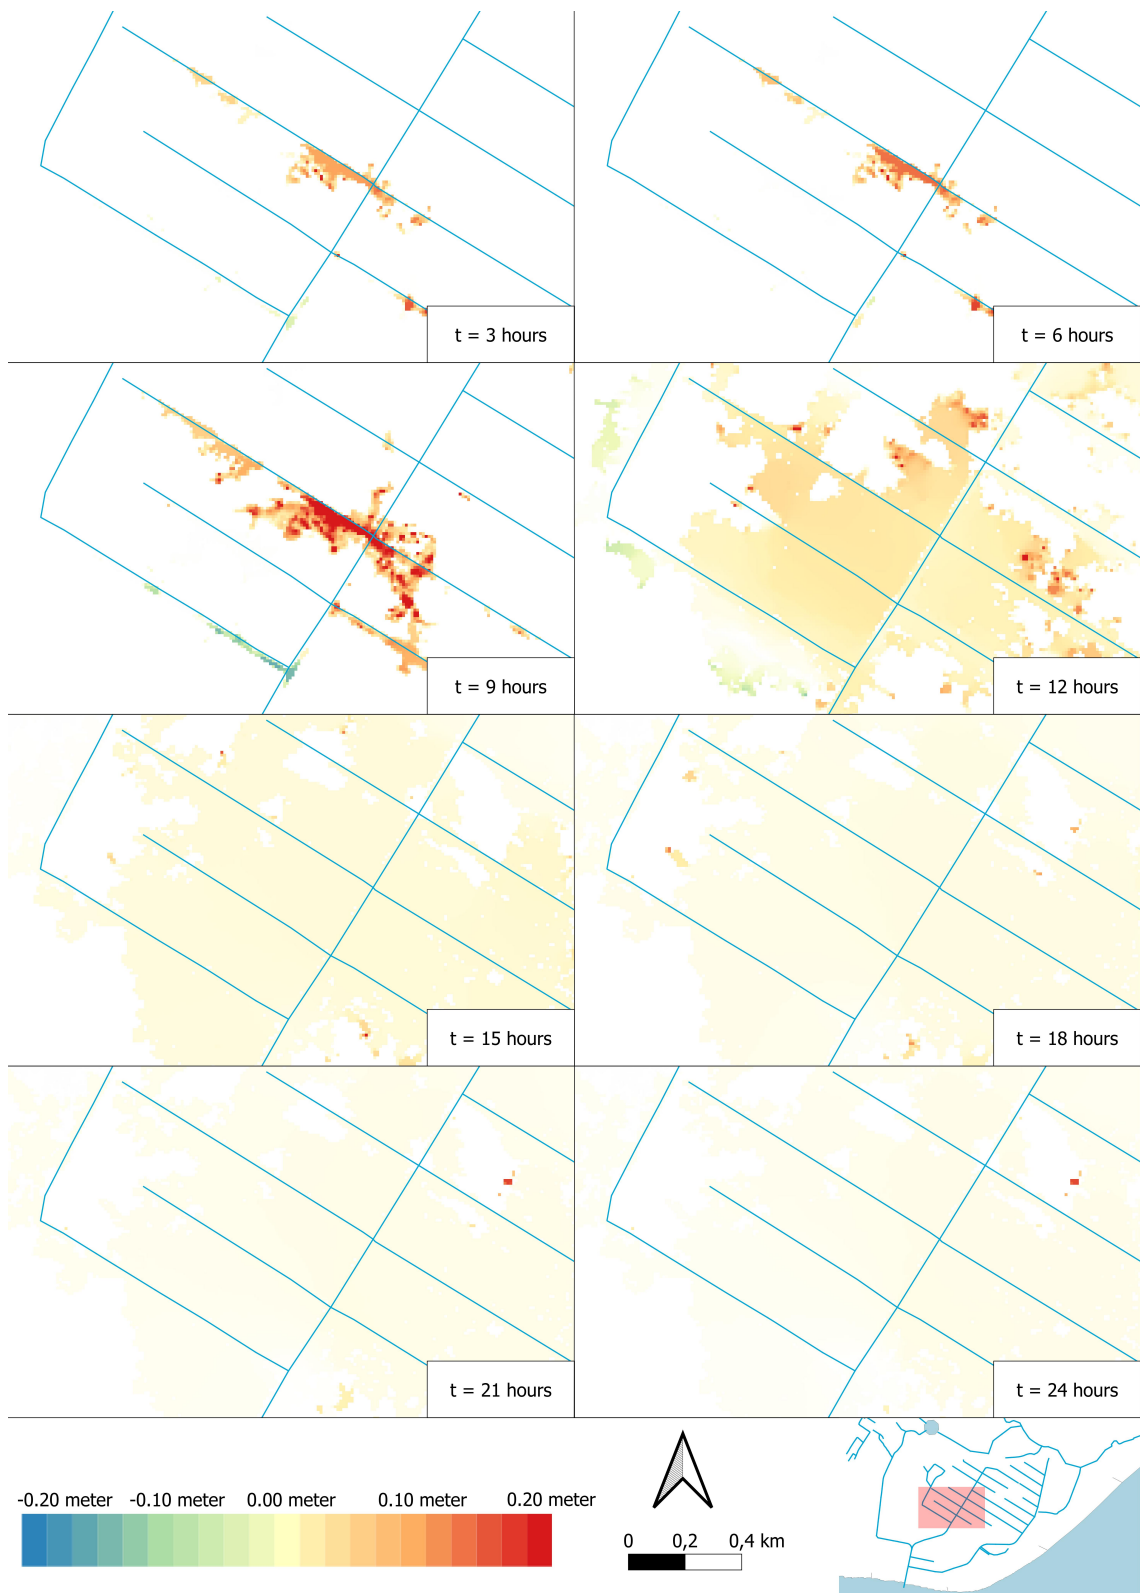
Figure F.5: Inundation depth increases in scenario 3: impact of human interference in canals under precipitation event occurring once per 10 years, in the southern part of Chota

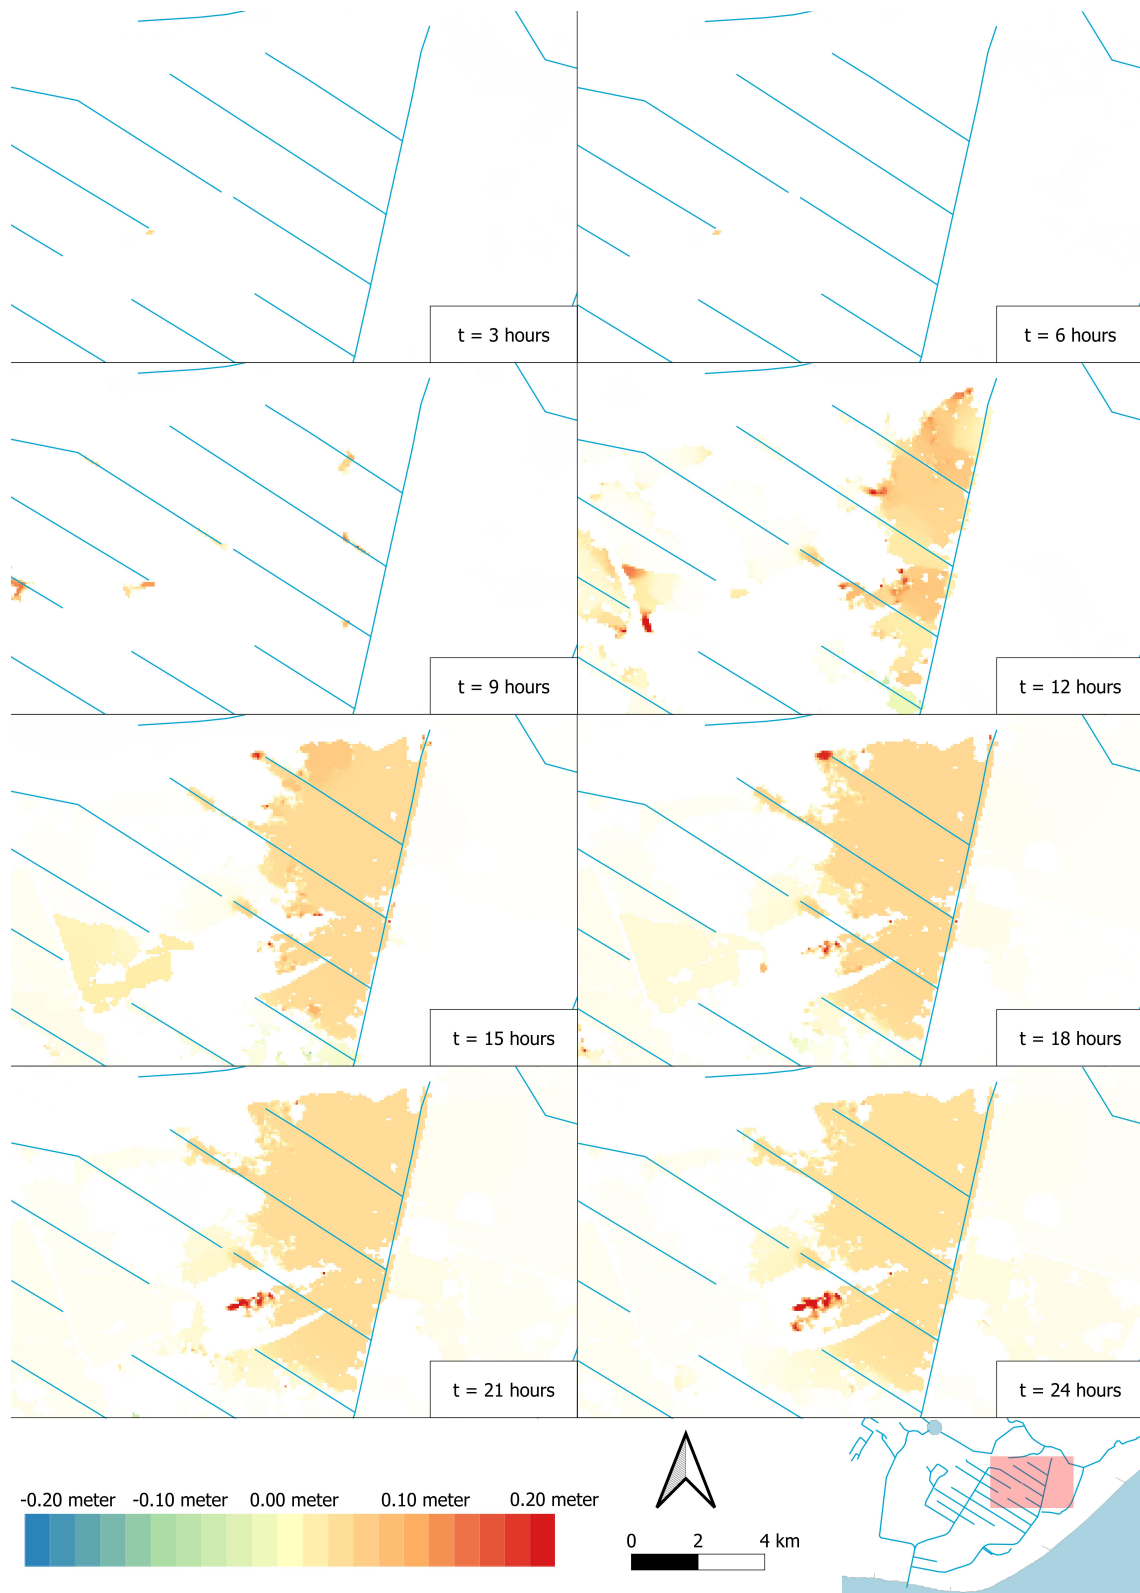
Figure F.6: Inundation depth increases in scenario 3: impact of human interference in canals under precipitation event occurring once per 10 years, in the northern part of Chota

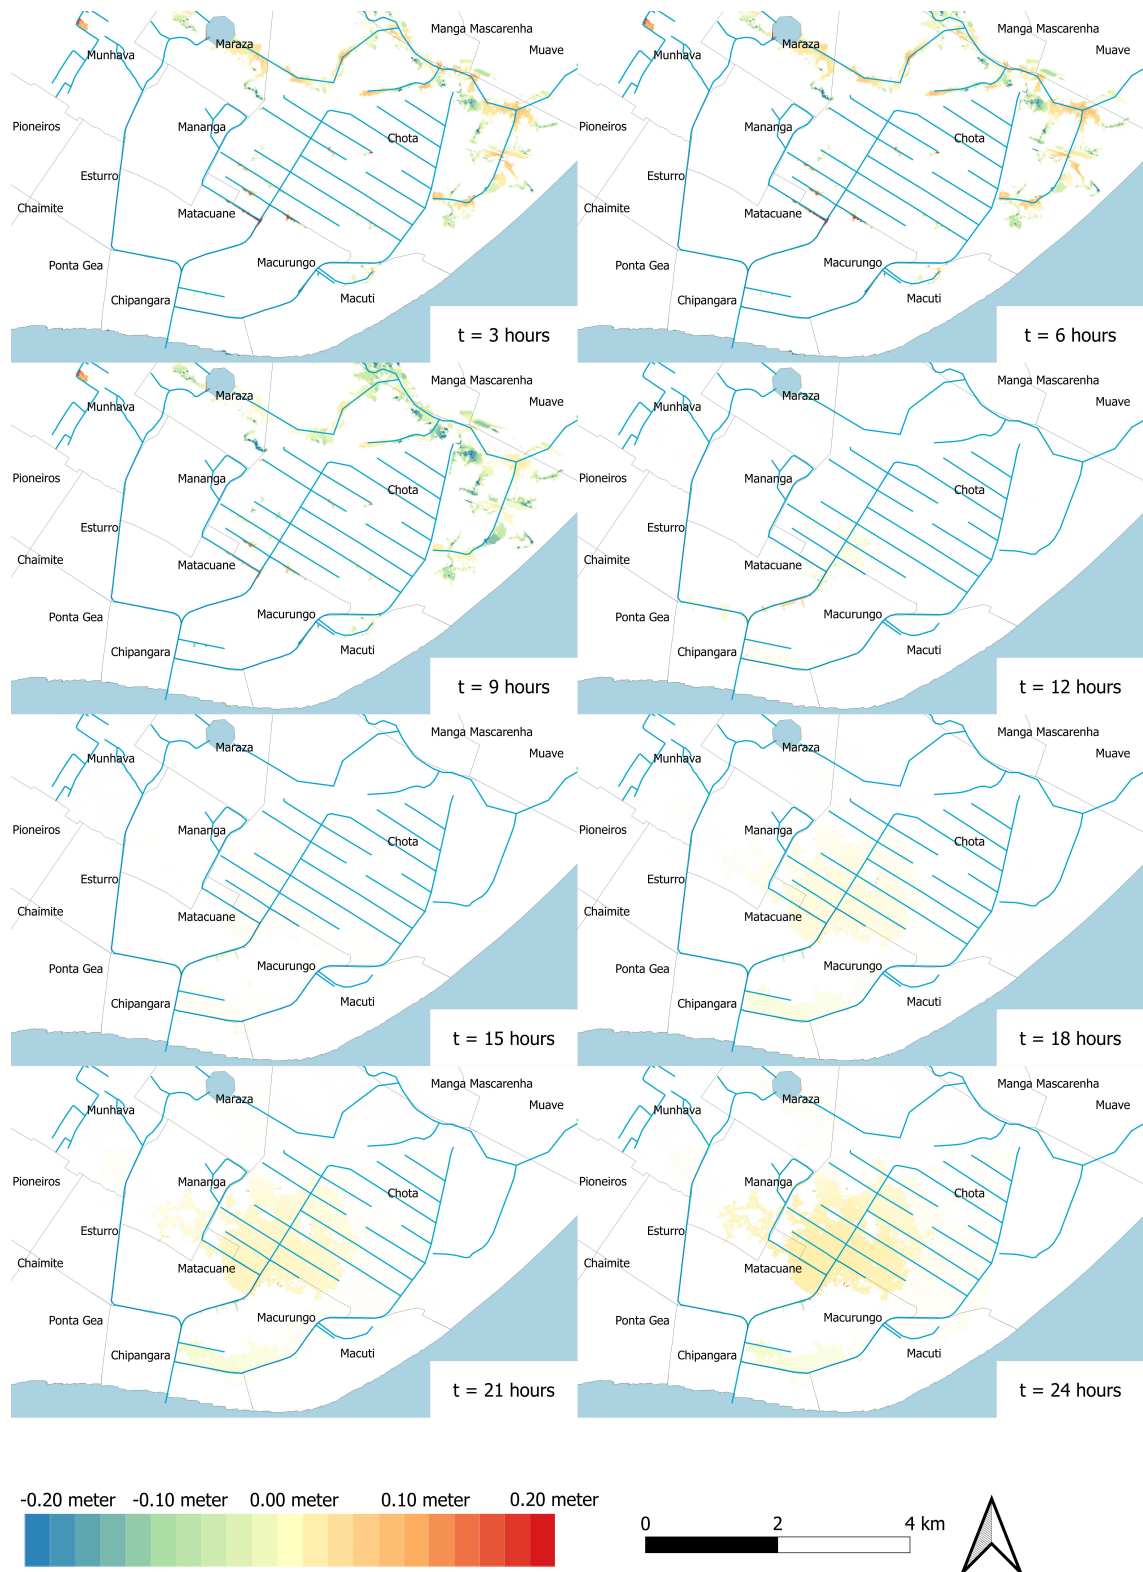
Figure F.7: Inundation depth increases in scenario 4: impact of design issues in canals under precipitation event occurring once per 10 years

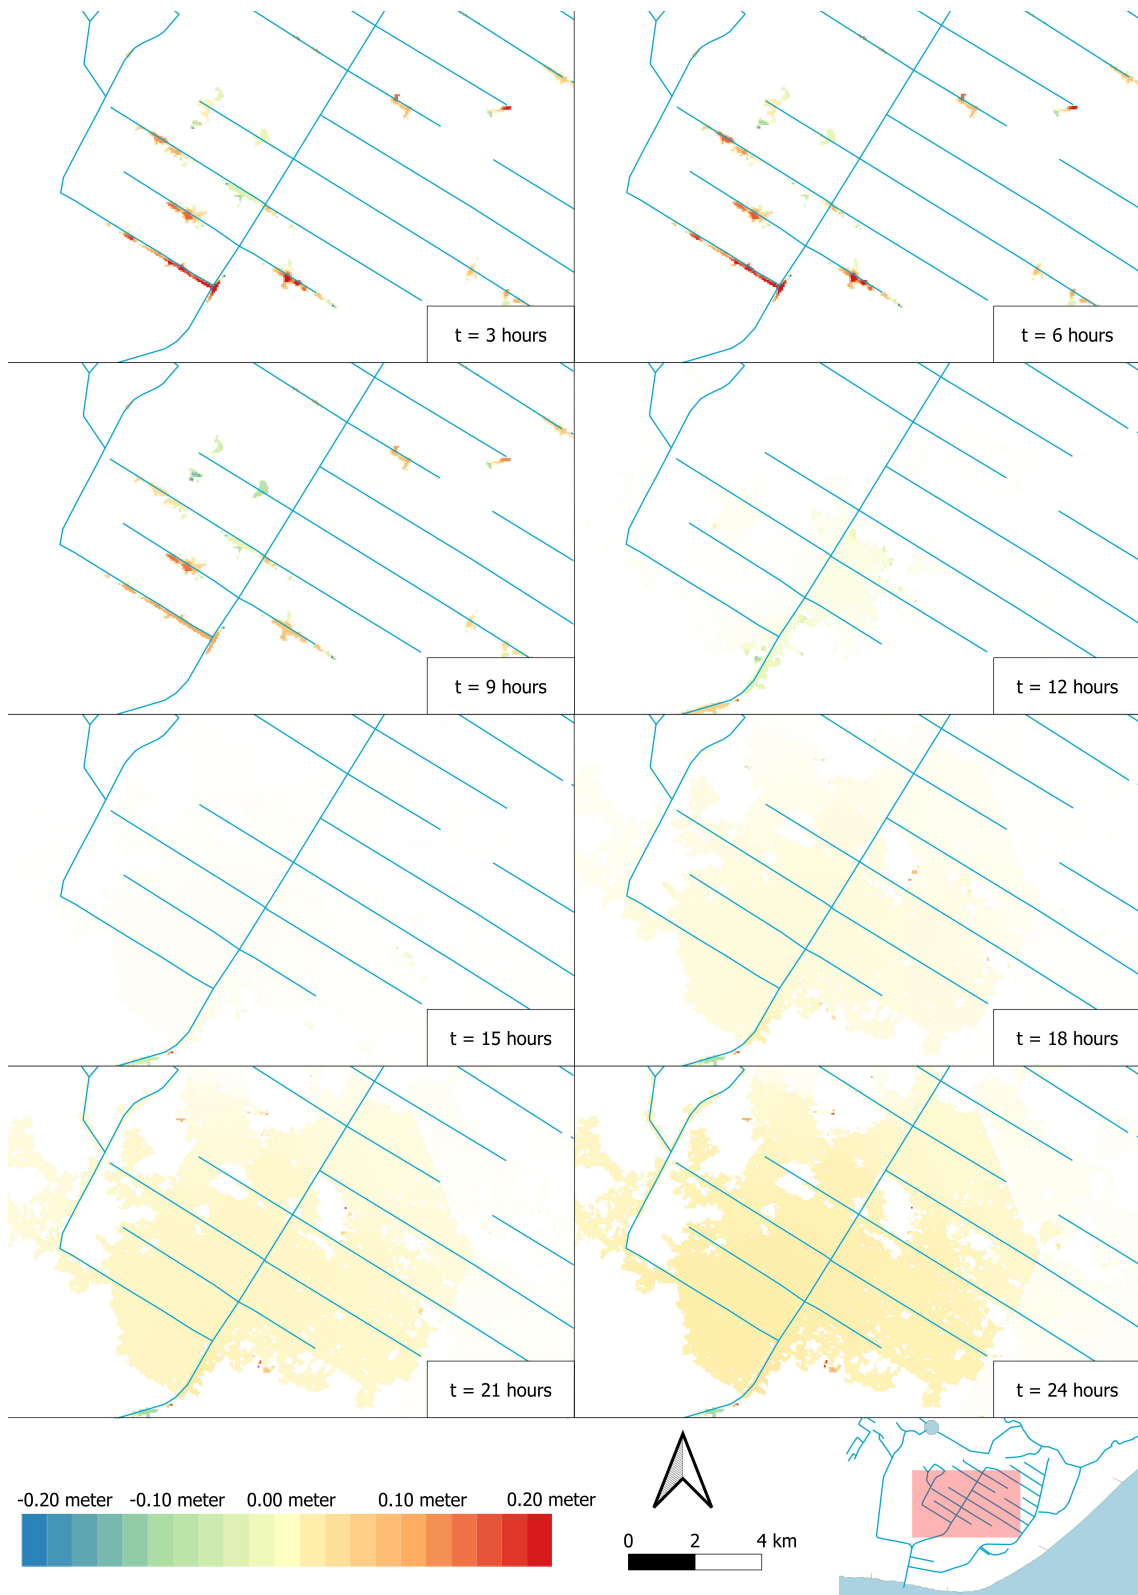
Figure F.8: Inundation depth increases in scenario 4: impact of design issues in canals under precipitation event occurring once per 10 years, in the southern part of Chota

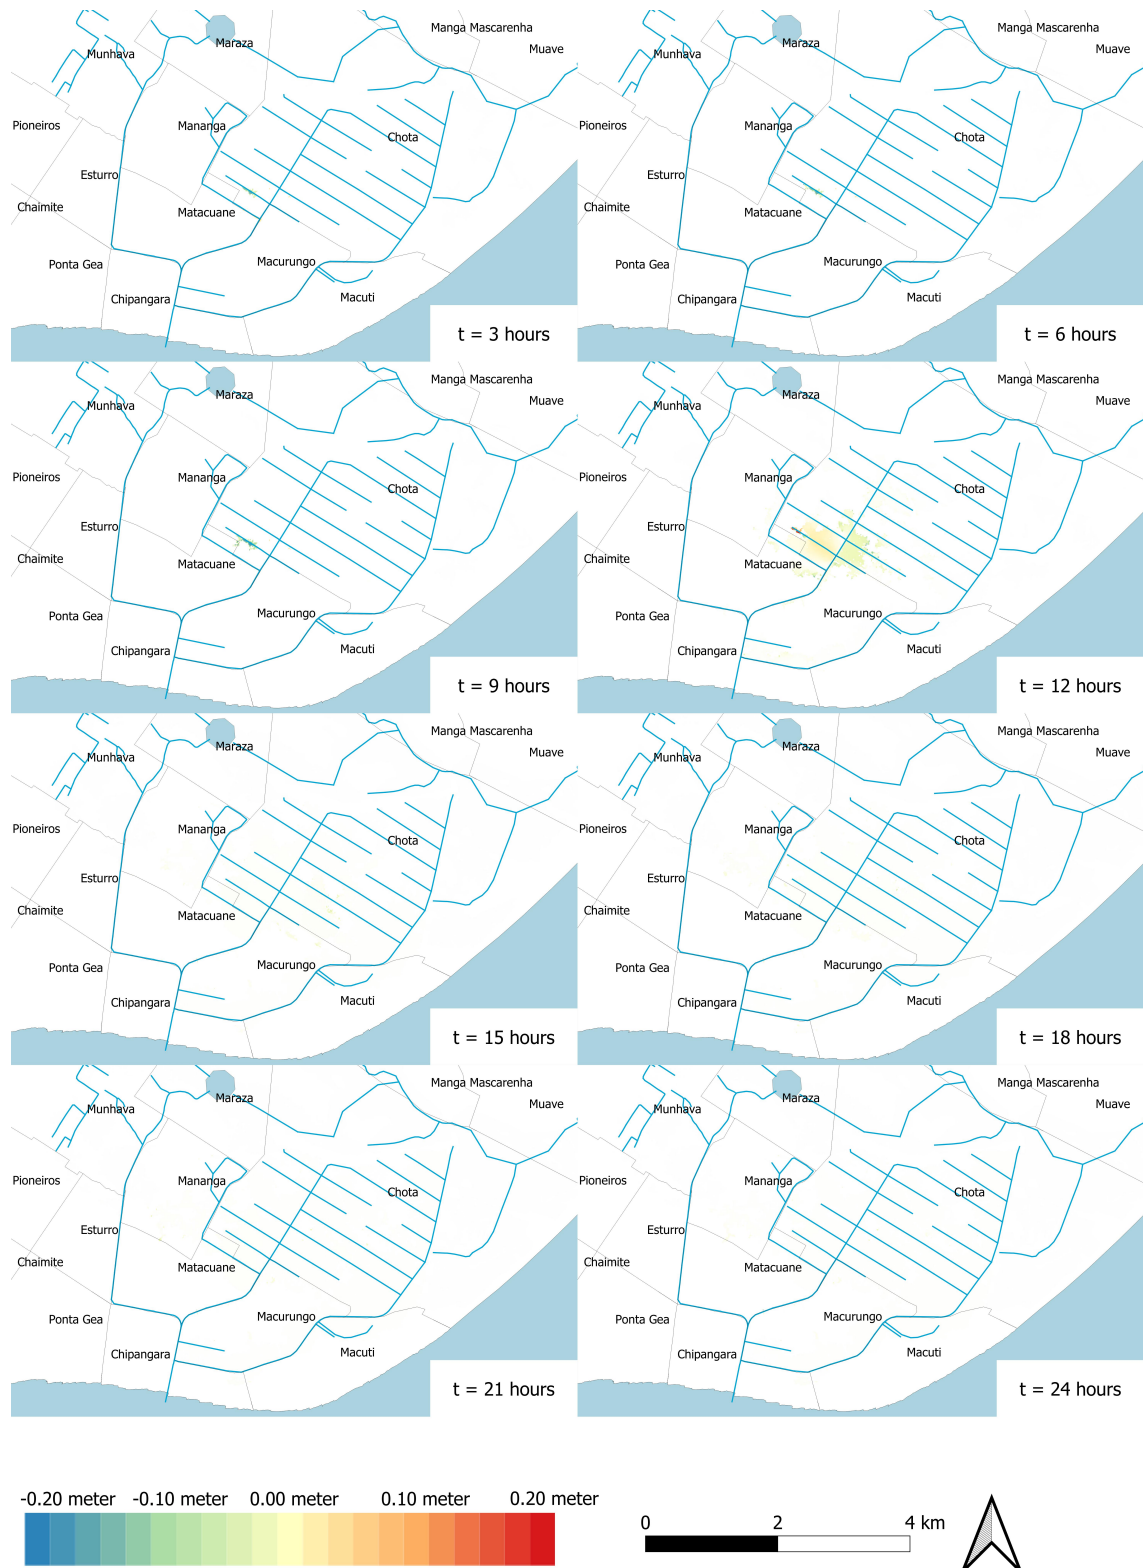
Figure F.9: Inundation depth increases in scenario 5: impact of waste in the Palmeiras outlet under precipitation event occurring once per 10 years

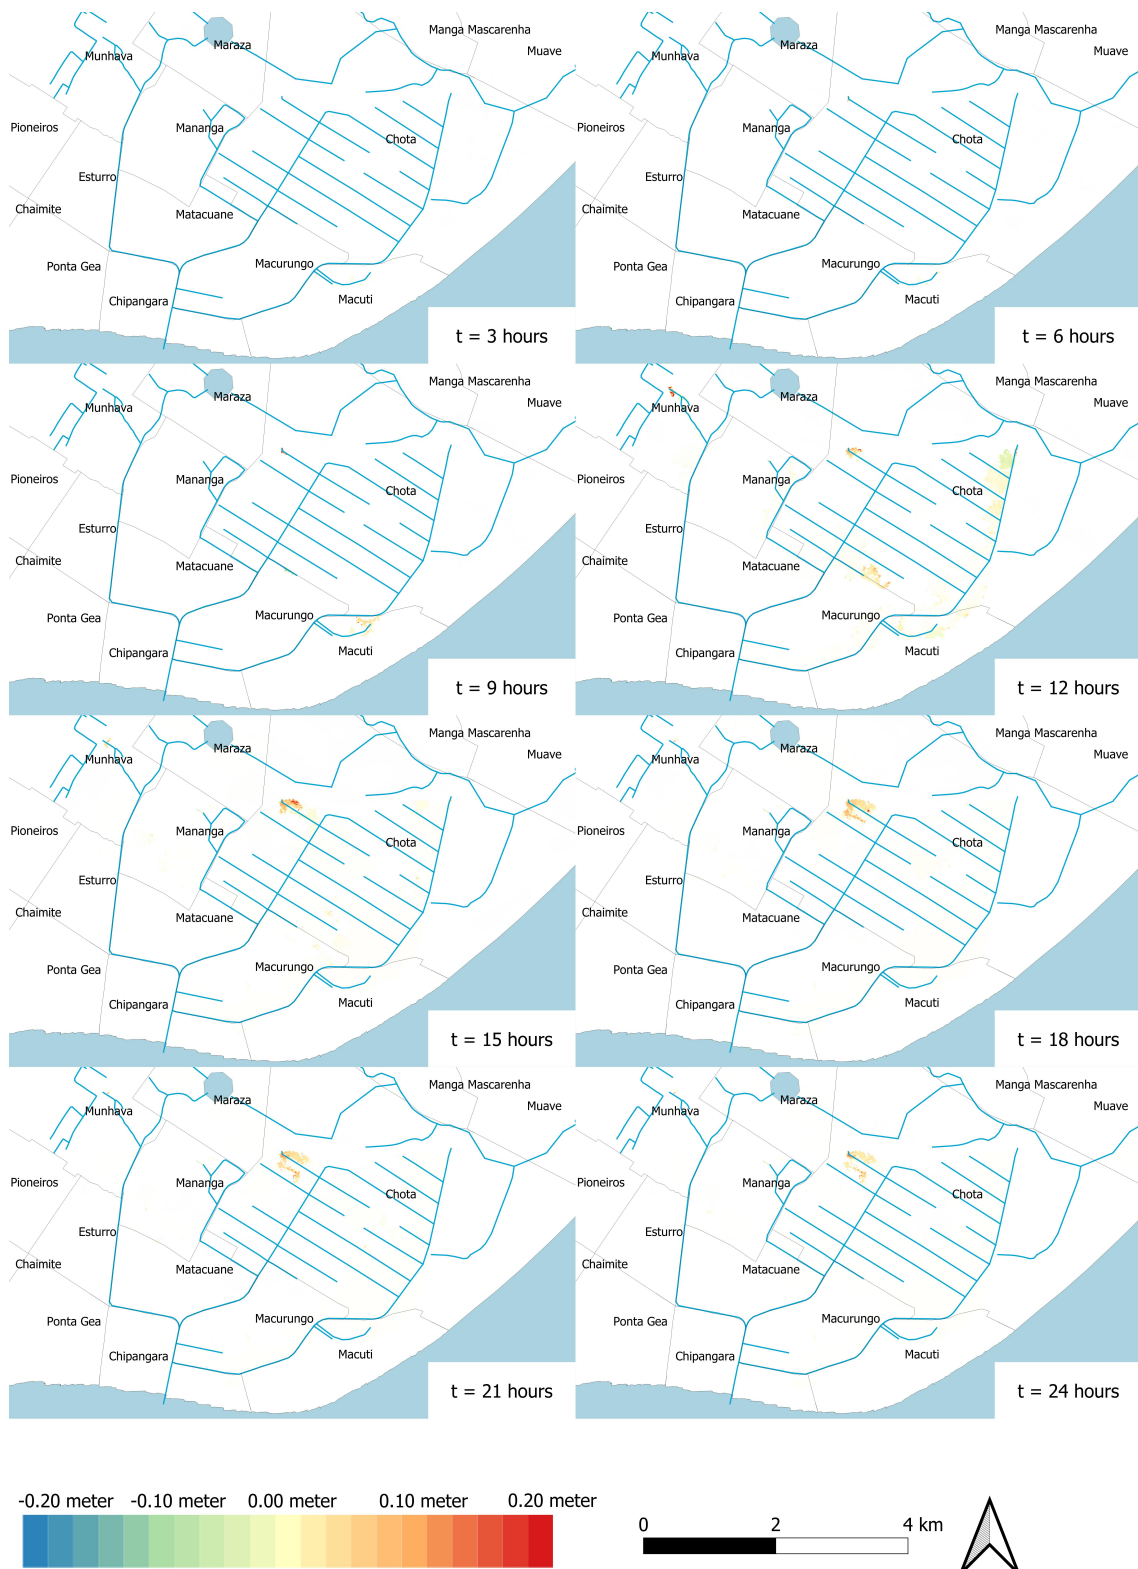
Figure F.10: Inundation depth increases in scenario 6: impact of blockage of the connections under precipitation event occurring once per 10 years
