## Experimental Study of Key Parameters in Turnout Crossing Degradation Process

X Liu<sup>1</sup>, V. L. Markine<sup>1</sup>, I.Y. Shevtsov<sup>2</sup>, R.P.B.J. Dollevoet<sup>1, 2</sup>

**KEY WORDS:** Railway turnout crossing; degradation process; field measurements; dynamic frequency response function; condition assessment

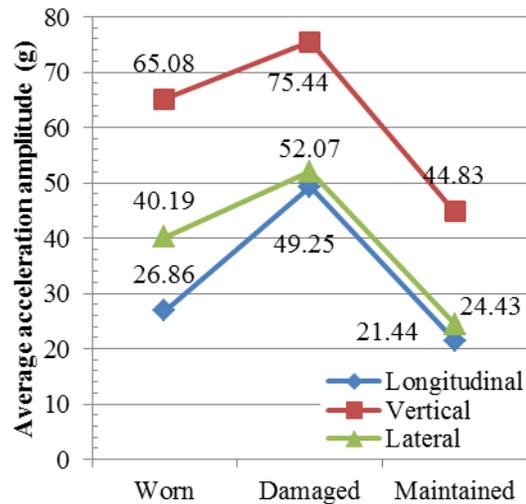
Figure 1 Average accelerations ( $a$ ) in different crossing conditions

Figure 2 indicates the increased responses with deteriorated crossing condition (from “Worn” to “Damaged”) and the positive maintenance effect (from “Damaged” to “Maintained”). Faster growth of longitudinal and lateral accelerations (from “Worn” to “Damaged”) leads to larger contact angles in these two directions (Figure 4). After maintenance, crossing accelerations dropped lower than in the “Worn” stage.

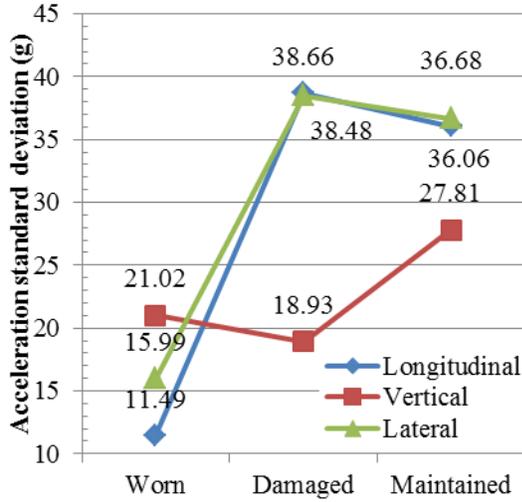
Figure 2 Standard deviations of measured accelerations

Dramatically increased standard deviations in longitudinal and lateral accelerations reflect the contact uncertainty in these two directions in “Damaged” crossing, which in Figure 4 are the

increase of both mean values and standard deviations in wheel/rail contact angles.

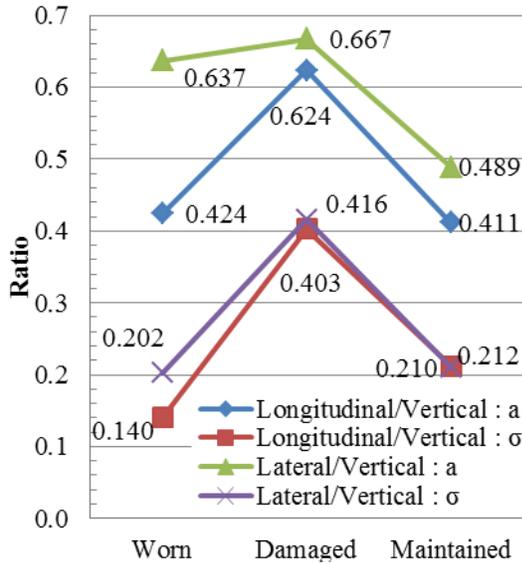
Figure 3 Mean values (a) and Standard deviations (σ) of contact angles

with Figure 4, wheel/rail contact angles varied in short contact section, which also reflects the irregularity of rail profile as shown in visual inspection.

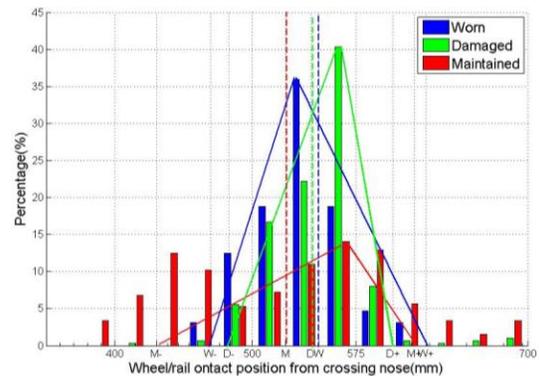
Figure 4 Histogram of wheel/rail contact positions

Table 2 and Figure 5 illustrate that the average wheel/rail contact position is relatively stable, but σ decreased with degraded crossing and increased after maintenance. The wheel/rail contact position centralized with “Damaged” crossing rail. Combine

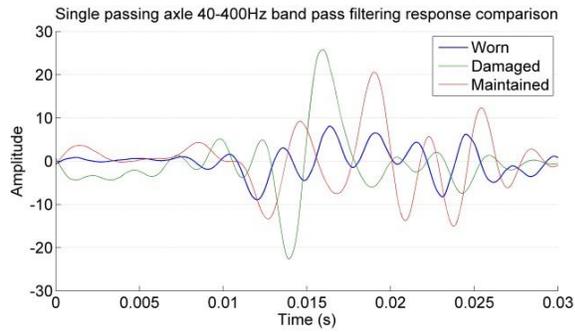
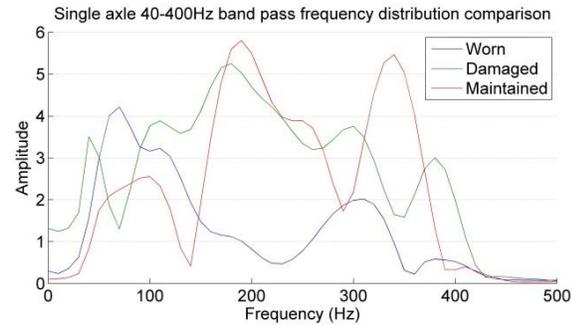
Figure 6 Vertical acceleration 40-400Hz band pass responses comparison

The impact area illustrates similar tendency as shown in Table 5. The wheel/rail interaction area centralized with deepened wear. From “Worn” to “Damaged” stage, the increase of acceleration is mainly contributed by ballast degradation (40-400Hz). After grinding and welding, responses from rail vibration (400-1500Hz) and noise (1500-5000Hz) were dramatically reduced. Relatively high responses in 0-40Hz and 40-400Hz reflect unstable foundation.

In this series of measurements, frequency domain substructure responses (40-400Hz) continuously shifted to higher frequency band (Figure 6), which is related to the ballast degradation.

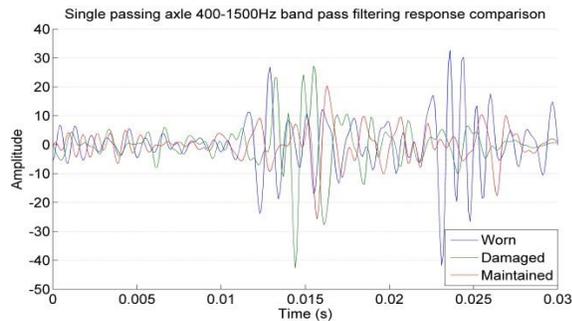
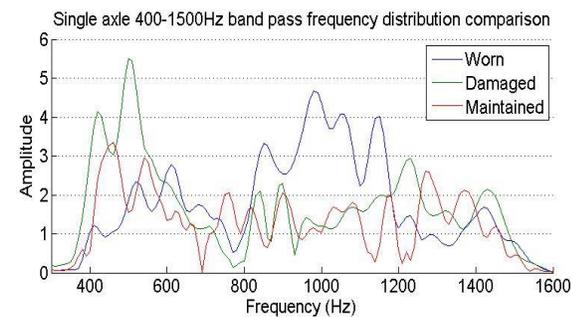
Figure 7 Vertical acceleration 400-1500Hz band pass responses comparison

Compared with the other two measurement results in 400-1500Hz, “Worn” crossing response in frequency domain is in the highest frequency band (800-1200Hz). Since this condition is a turning point when the crossing rail is going to be damaged, the shift of frequency response is also instructive.
