# The fire safety of car parks

# Focussing on structural damage

# K. Terlouw

Delft, October 2019

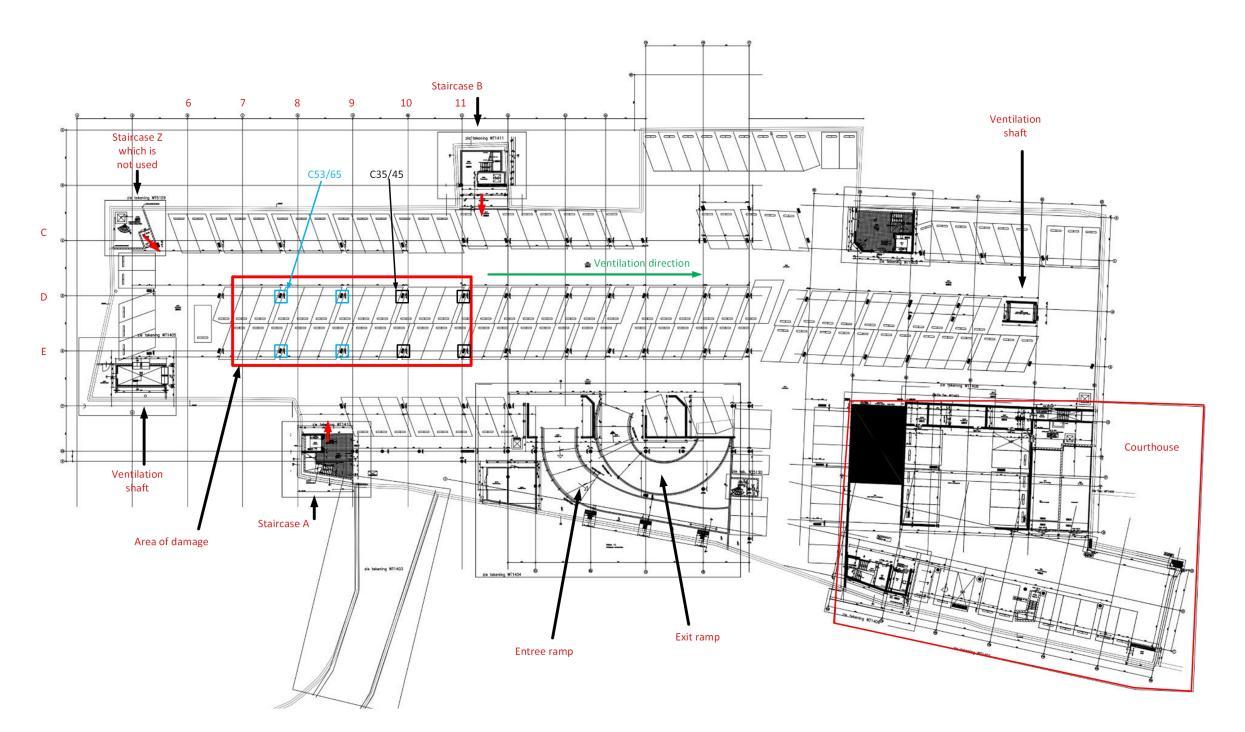
To gain a better understanding of how the fire department tried to attack the fire, figure 3.2 [35] can be used. Staircase A and B are used by the fire department to extinguish the fire, however they have not used the staircase in the left upper corner, staircase Z. This staircase was not equipped with a dry riser and therefore not part of the fire department access points. The mechanical ventilation system in the car park started directly when the fire detection systems went off, resulting in a ventilation direction from left to right. Therefore staircase A and B are 'downwind' and this could explain the bad visibility for the firefighters. If the staircase in the upper corner was used, the firefighters would have had the wind blowing in their back and possibly a better visibility. The red box indicated the area where the structural damaged was located. The exact locations of the 26 cars that burned down were not reported. However, in the red box twenty-four parking spots are located. So it seems likely all these spots were filled and two other cars were located in the row above. Photos are available showing that the cars located in the most left row are undamaged, at least not burned. During the fire, the mechanical ventilation system pushed air from the left shaft towards the right shaft. Therefore it seems likely the fire started on the left side of the red box and propagate to the right side of the red box. An enlarged image of the red box can be seen in figure 3.3.

Figure 3.2: A floor-plan of the -2 level of the Appelaar [35]. Gridlines are indicated on the left and top side of the figure. The red box indicates the location of the structural damage. Entree locations of the car park are indicated, the red arrow shows the access door to enter/exit the staircases. Two ventilation shafts are indicated and the air flows from right to left. The strength class of the damaged columns are indicated. On the right side of the figure, the car park for the courthouse is separated from the Appelaar car park.

The structural damage was investigated by Hageman, a Dutch consultancy company. They assessed the damage caused by the fire and advised on how to repair the damage. In the red box (figure 3.2) eight columns and two beams are located. On seven of the eight columns spalling occurred (figure 3.3). Spalling also occurred on the beams and floor elements. Between gridline ten and eleven in the floor element, the reinforcement came down and was hanging from the ceiling. Also in figure 3.4 A and B the severity of the spalling can be seen, a lot of reinforcement is visible and therefore directly exposed to the fire. In addition to the spalling damage, debonding between the beam had occurred between gridline ten and eleven. The prefab elements have no connection with the poured layer of concrete and were hanging from the ceiling. To assess if the reinforcement was affected by the fire, samples were taken from a beam (gridline D between nine and ten (figure 3.3) and pulling tests were done to test the tensile strength. In this beam two types of reinforcements were used varying in diameter, 8 and 16 mm. The 16 mm reinforcement was slightly reduced in strength. However, the strength of the 8 mm reinforcement was reduced by 40 %. The 8 mm reinforcement had less cover than the 16 mm in the beam. To verify how much the concrete strength was reduced, four samples were taken from the columns between row nine and ten. So, two samples are outside the damaged area and two inside the red box. The concrete samples outside the damaged area had a strength far greater than the design value. At the columns with spalling damage, the strength at the surface is reduced to 34,4 N/mm<sup>2</sup> and 40 N/mm<sup>2</sup>, so below the 45 N/mm<sup>2</sup> design value. In the core the measured strength is 47 N/mm<sup>2</sup> and 52 N/mm<sup>2</sup>. The maximum spalling depth on the columns (column at gridline E-11) was 30 mm and locally some reinforcement was visible (figure 3.4).

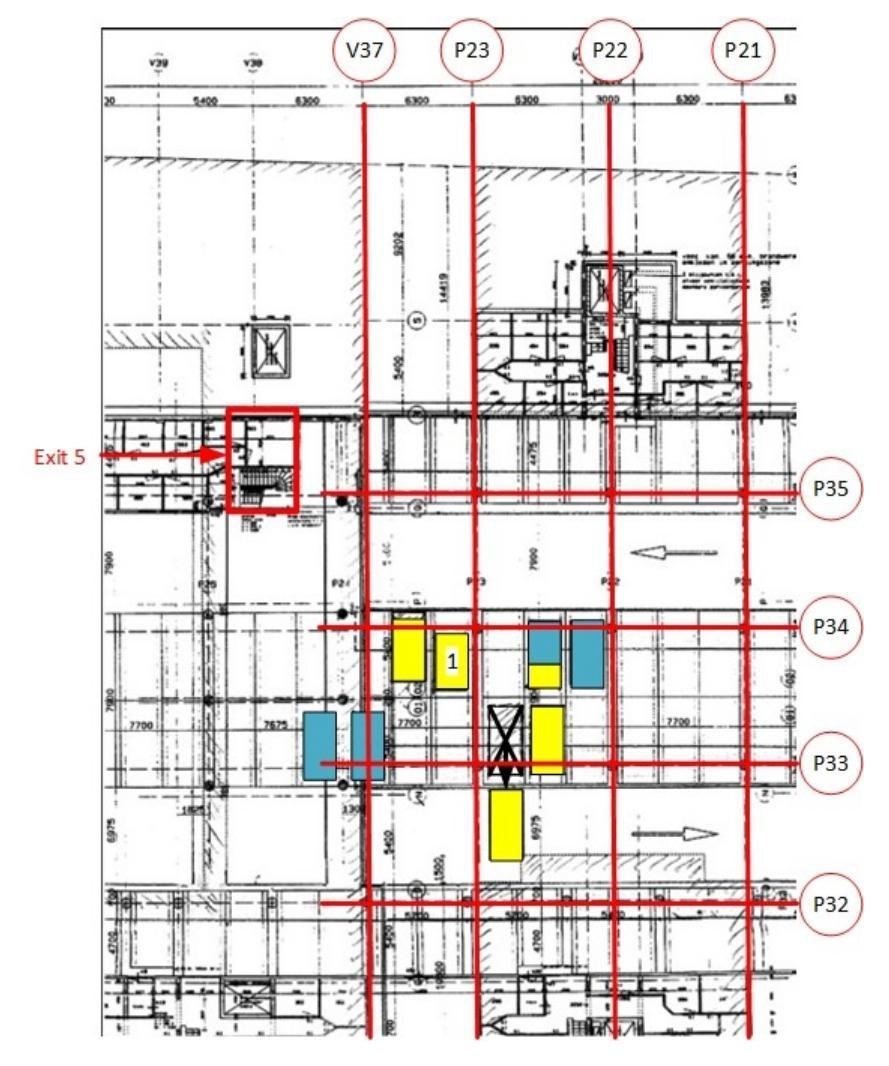
development and not bringing a thermal camera with them the localise the fire it took rather long. According to the timeline the fire was located after an hour and therefore the fire could freely develop until this moment. So, the fire propagated to five cars in roughly an hour which seems to be in line with the guidelines of "Bouwen met Staal" which indicates four cars are on fire after an hour. However, the car park was not full and the fire skipped some open spaces. The vehicle that is parked on the intersection of V37/P33 was also near the source of the fire. It seems logical this car would also have been involved in the fire but this is not indicated in the available reports. Possible explanations could be the ventilation direction, which is unknown and the car nearest to exit five would have been extinguished first. Maybe the fire propagated already to the next car (intersection V37/P33), but no car window had broken and so the fire inside the car could not develop.

Figure 3.7: An overview of the cars that were involved in the fire. The yellow blocks are completely burned down, the blue blocks are unburned cars. Number one is the first car. The gridlines are highlighted, P21 up to P32 and V37. Exit 5 is also indicated in the upper left part of the figure [29].

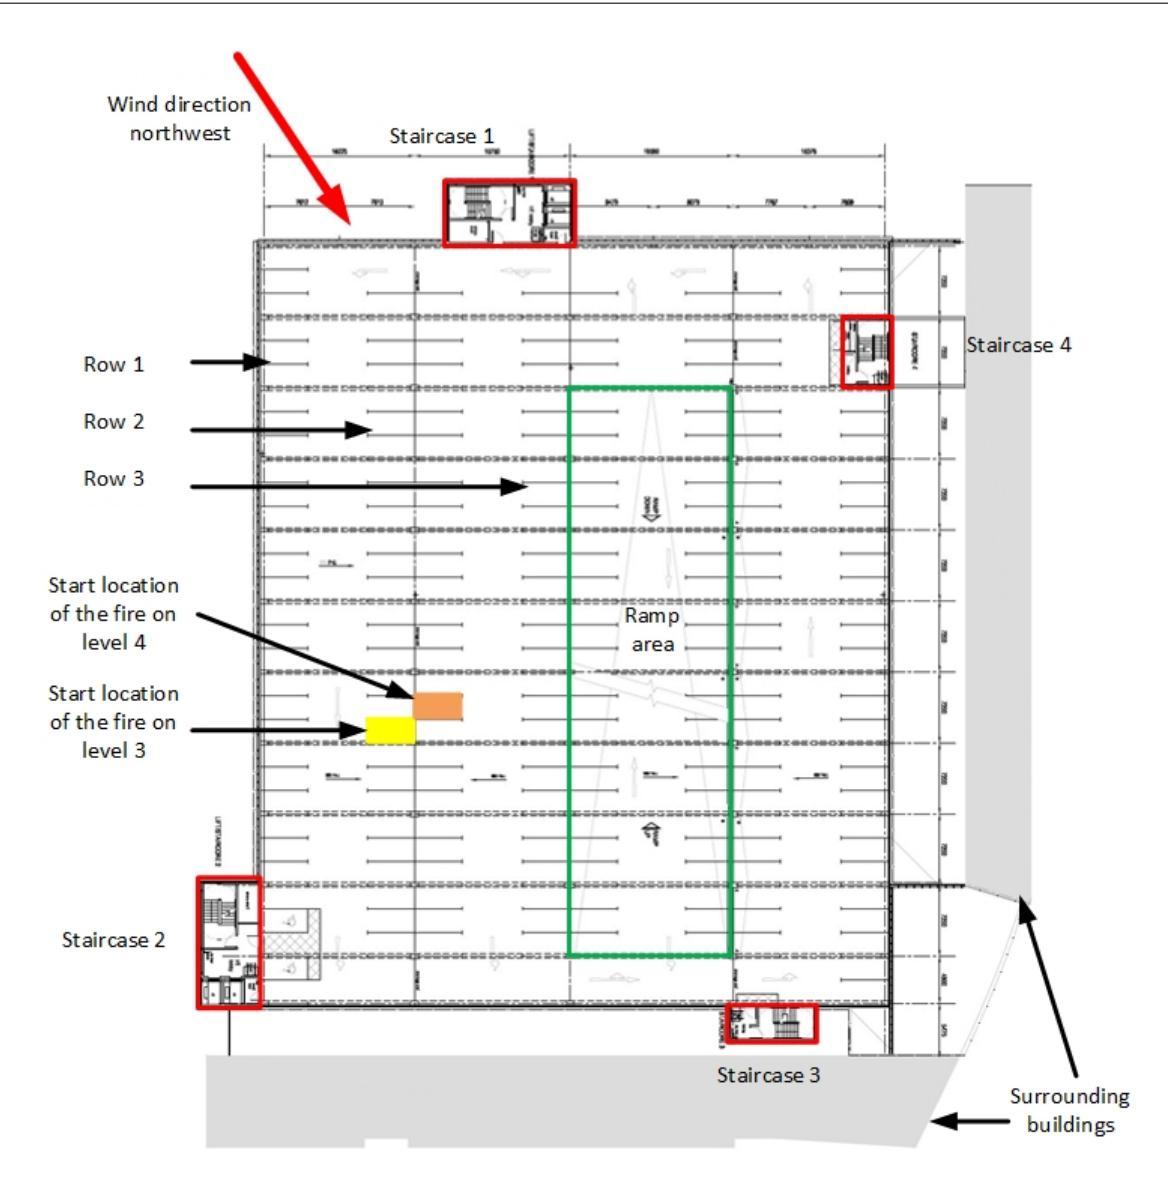
Figure 3.11: Floor plan of the car park. Staircase one and two are firefighting shafts, three and four are regular staircases. The ramp area is indicated with a green box.

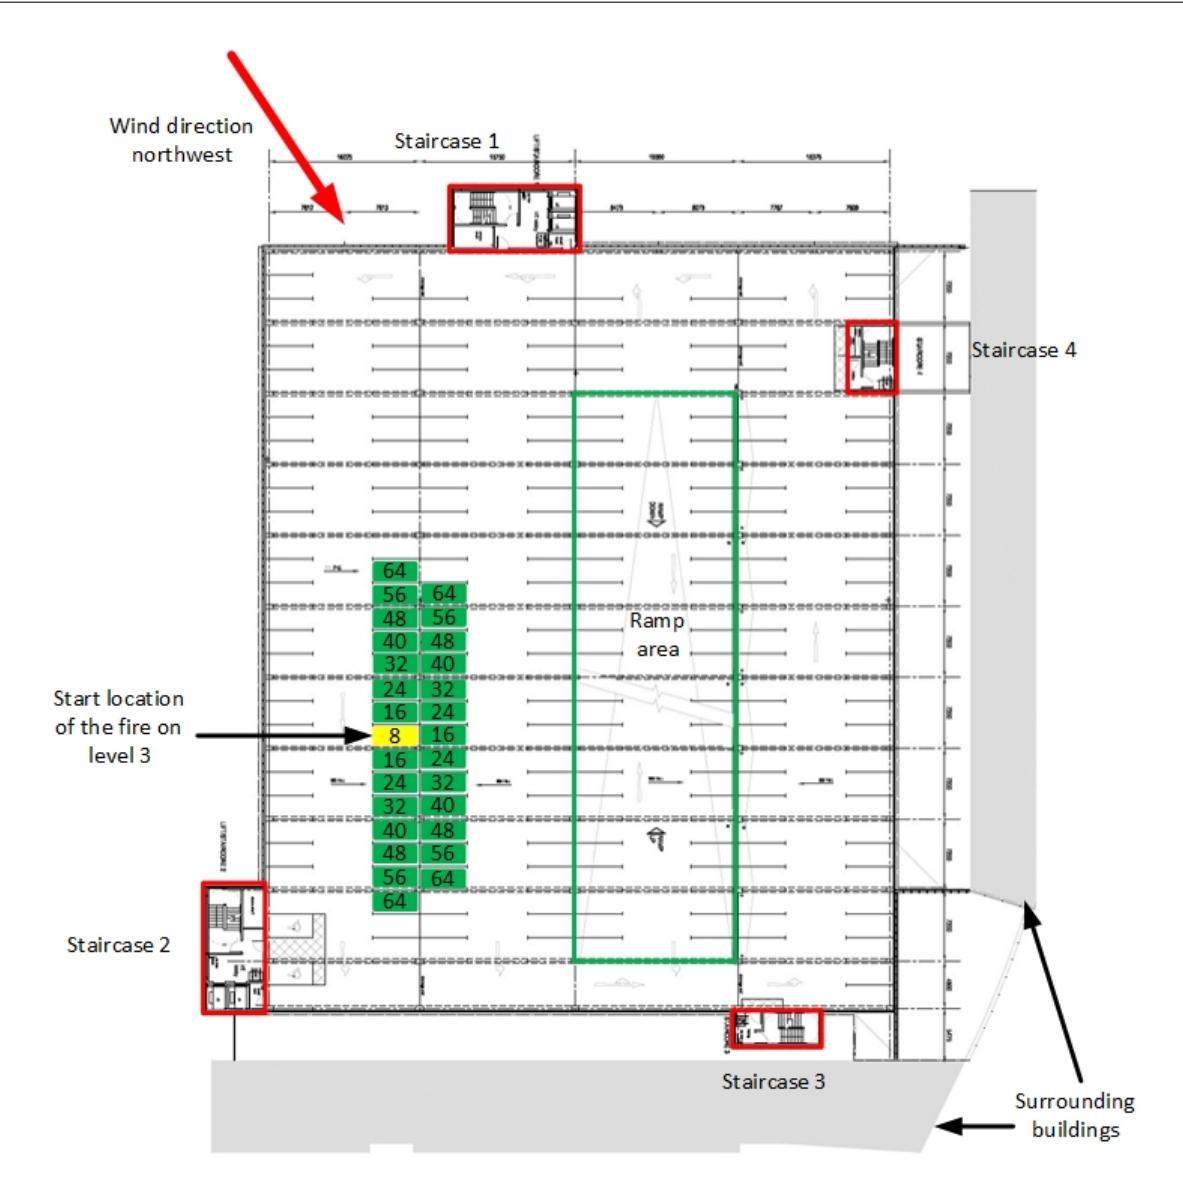
With the help of the CCTV and the communication between the firefighters, the development of the fire can be determined. At 16:29, smoke is visible from the car. After the owner had parked the car at 16:27, he walked around the car looking for something. Later he explained he was smelling something that was burning and was controlling the car. The car could not be checked after the fire because it was unsafe to move any vehicle in the burned structure. However, fireworks and vandalism can be ruled out with the help of the CCTV. Also, foul play by the owner can be ruled out, as there are not lawsuits against the owner of the car. So, the most logical explanation is a (technical) malfunction inside the car. The car was an older type Range Rover and had a petrol engine. The car had a Ministry of Transport (MOT) certificate, in Dutch 'APK'. Range Rovers are large cars and therefore the fire load of the first car was probably high. Due to the smoke and the not very useful position of the CCTV camera, the time before the neighbouring cars caught fire, cannot be determined. However, flames are visible from the car after eight minutes, so it took roughly eight minutes for the fire to develop to an 'one car' fire. The next indication of the size of the fire is at 17:40 and thirty cars are on fire. So, in 62 minutes the fire developed from one car to thirty cars which is rather fast. As a general car burns forty minutes, the first cars will not have been on fire anymore. However, it is not very clear of this thirty is an exact number or a rough estimation. The fire is only located in row two and three (figure 3.12. Using these boundary conditions every 8 minutes four new cars caught fire.

Figure 3.12: A rough estimate on the possible fire propagation on level 3. The numbers in the coloured boxes indicate the time it took to ignite the car. In total 28 spots are coloured, indicating that more places in row two and three were on fire after 62 minutes.
