MAISON DE LA MISERICORDE
RESEARCH BOOKLET

Floor Visser
4345053
Master track Architecture
Studio: Heritage and Architecture
Graduation tutors: prof. ir. Wessel de Jonge, ir. Lidy Meijers,
ir. Frank W.A. Koopman, ir. Bert van Bommel
Delft University of Technology
19-05-2017

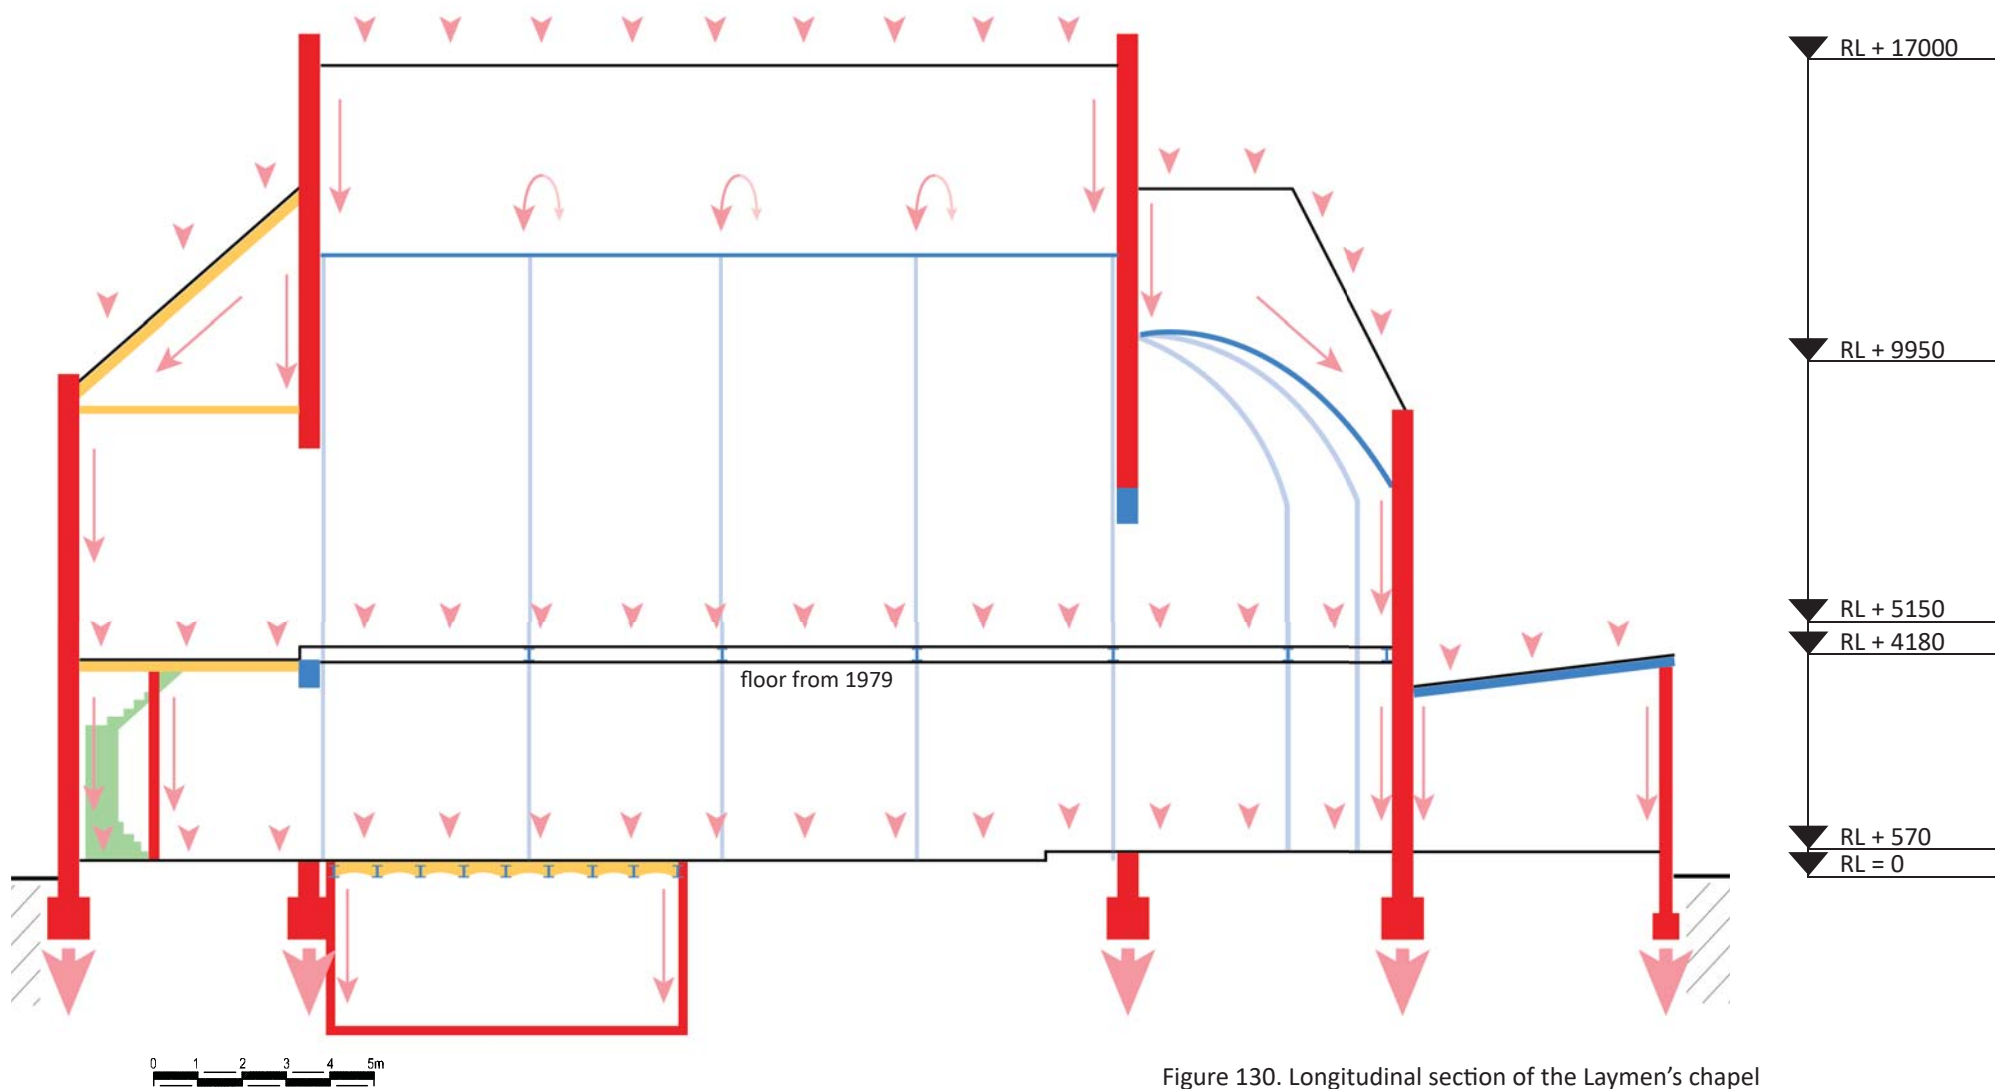
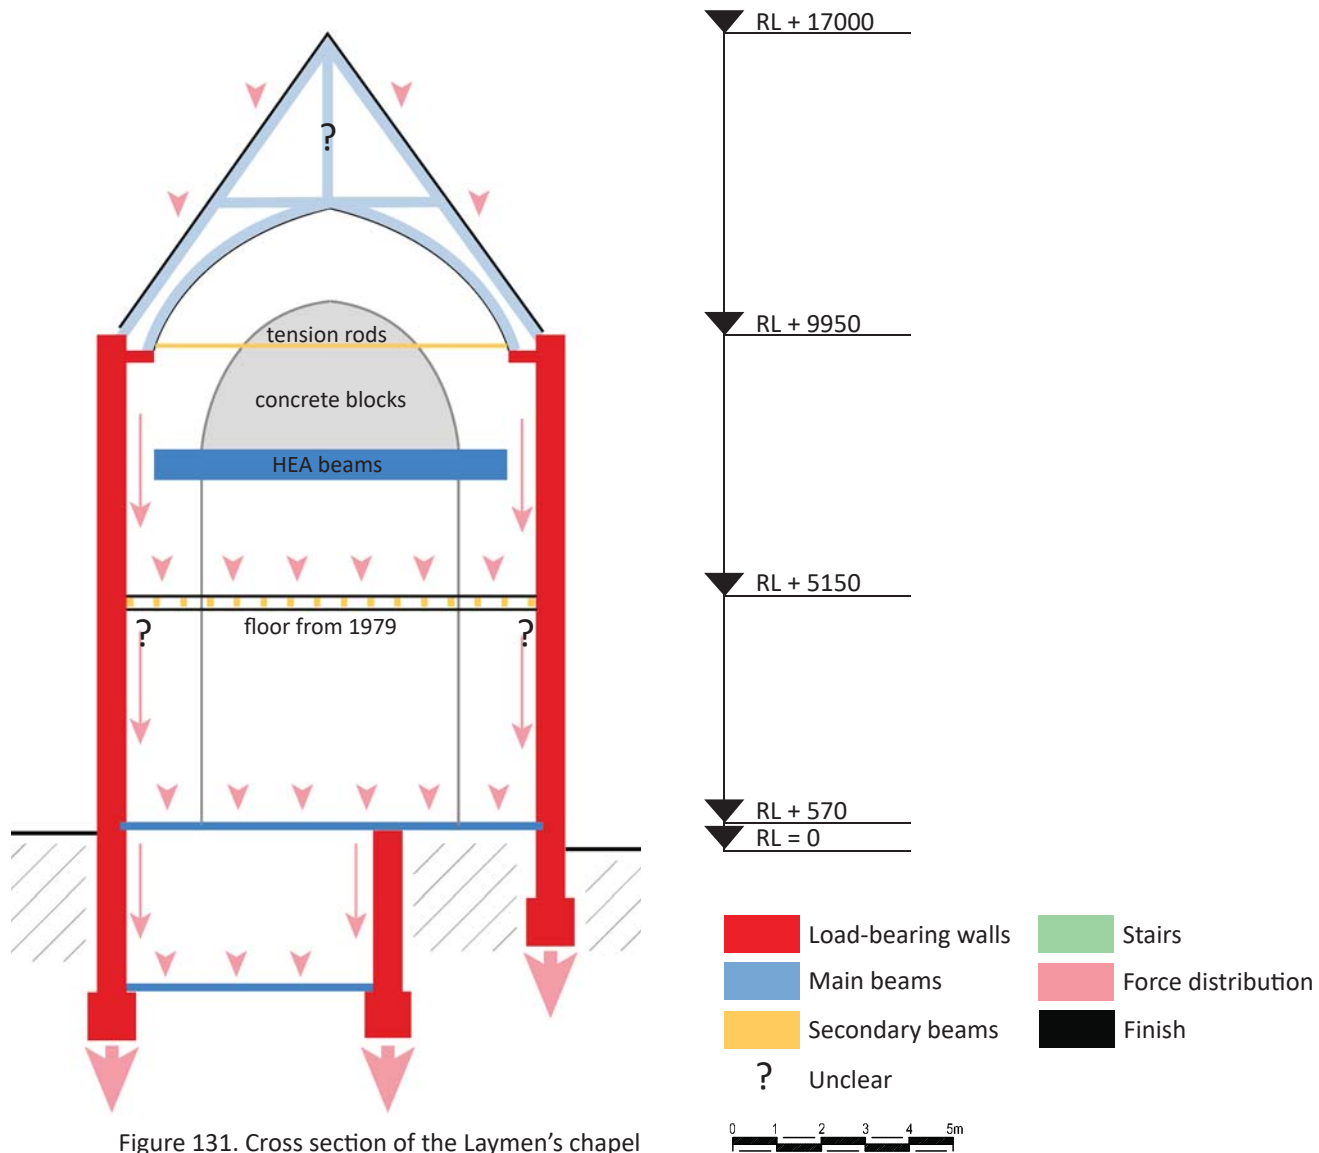
Figure 131. Cross section of the Laymen's chapel

The transformation of the Misericorde complex to the use of City-Centrum barely changed the structure of this building. A new floor was added, as can be seen in the cross section of the building in figure 131, and is constructed of steel beams. It is unknown whereupon this floor rests, a new or old structure or perhaps clamped into the load-bearing walls.

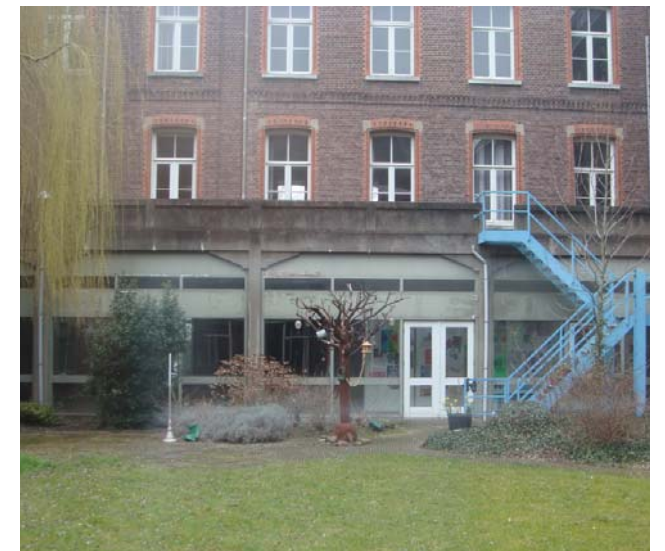
Figure 141. The concrete balcony seen from the inner courtyard

During the transformation of the Miséricorde complex to the use of the City-Centrum the space underneath the balcony was closed with, presumably, wooden frames which obscure the beauty and slender of the concrete balcony.

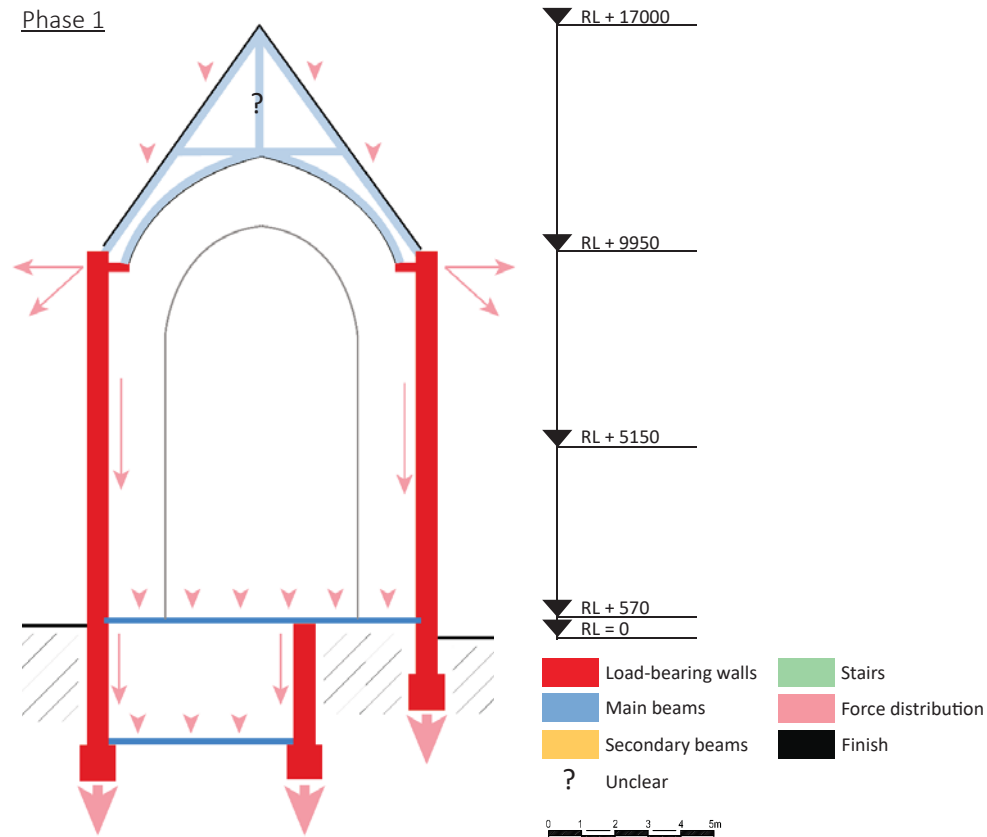
Figure 173. Crack in load-bearing wall

Missing this vital connection, the walls of the chapel began to expand/bulge outward. This is shown in figure 172. The expansion/bulging of the walls caused major fractures in the load-bearing walls and in the wall between the nave and the choir.
