**LABORATORY TESTS ORTHOTROPIC DECK
BASCULE BRIDGE VAN BRIENENOORD**

29 March 2000

M.H. Kolstein

Ministerie van Verkeer en Waterstaat - Bouwdienst Rijkswaterstaat
Nr.: BDN-3324
Projectcode: 3146
Datum: 19-12-97

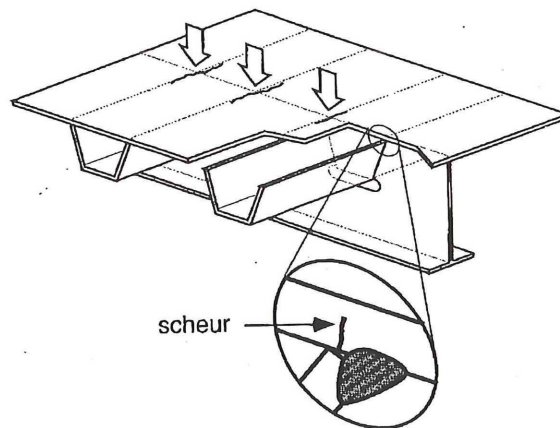
Studied welded connection

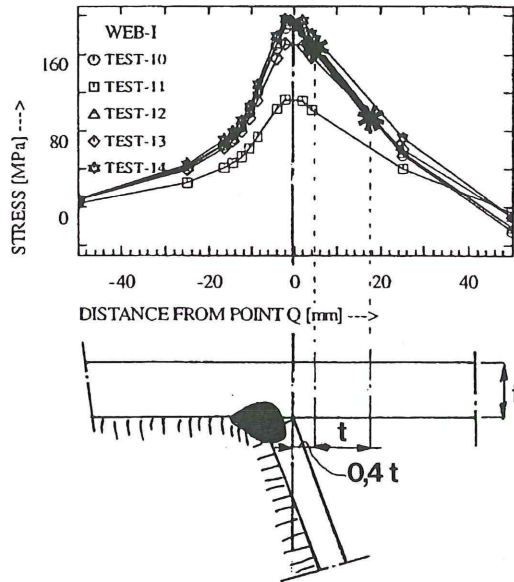
Figure 5.11 Extrapolated stress

For the definition of the stresses as used in the S-N diagram the measured stresses as given in Table 6 have been multiplied by a factor 1.5. The stresses obtained in this way are comparable to the extrapolated stress at the weld root using measured stresses at a distance of 0.4 times and 1.4 times the thickness of the deck plate (see Figure 5.11). A review of the data as used for the fatigue classification of the detail is given in Table 8.

The definition of stress as used in Table 9 and Figure 5.12 is the linear extrapolated stress at the weld root using the measured or calculated stress at 0.4t mm and t mm from point Q (see Figure 5.11). Based on this definition of the stress range considering the number of test results, the type of crack and inspection possibilities a fatigue design stress range of 73 MPa at 1.10^7 is recommended.
