RESEARCH & ANALYSIS REPORT - TECHNICAL ANALYSIS

Manutenção Militar Complex - Lisbon, Portugal

STATE OF CONSERVATION

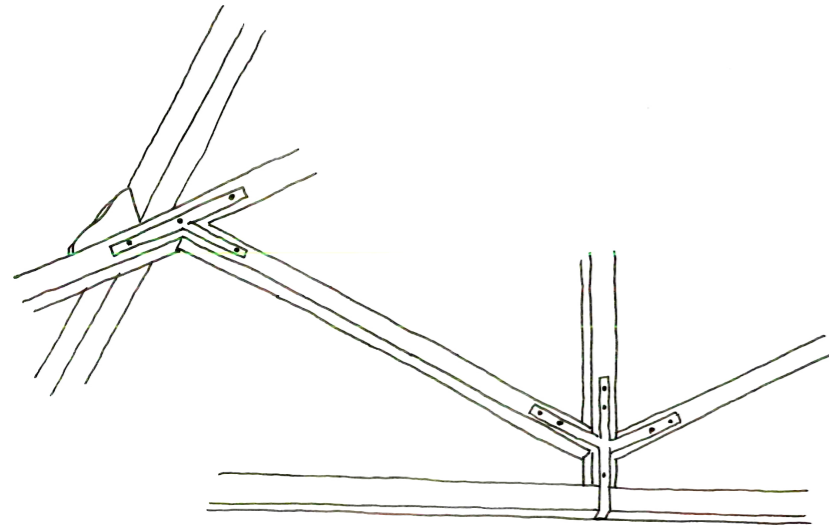
Wooden truss - elements connected with steel strips

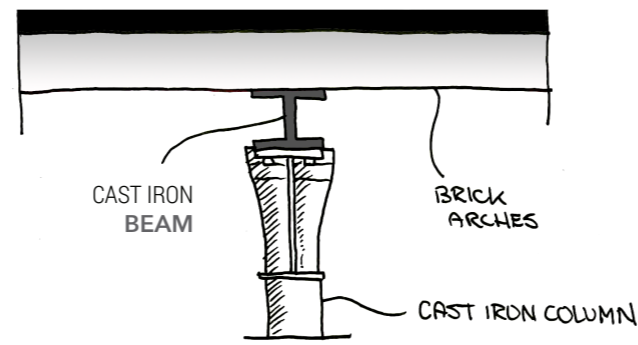
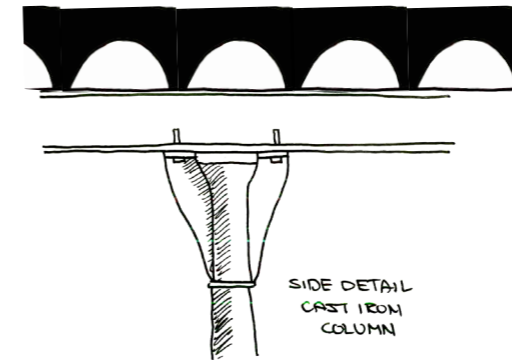
Cast iron columns (two views of same column)

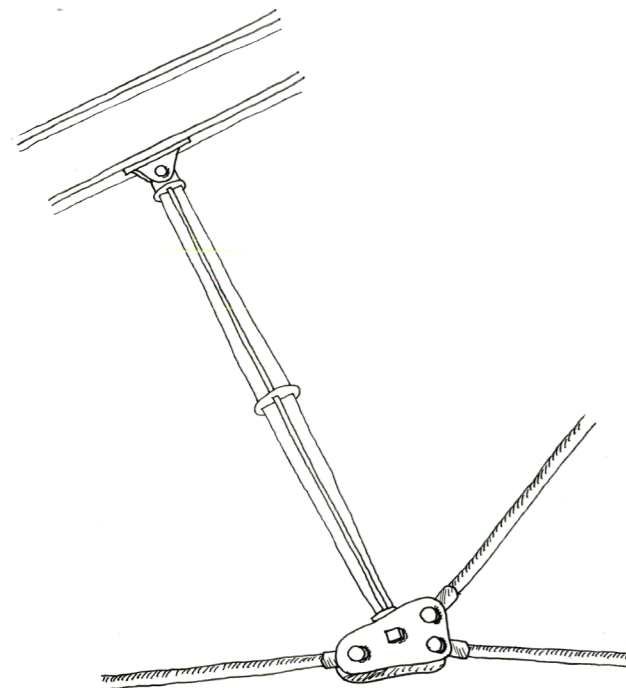
Steel truss - elements connected with screw bolts

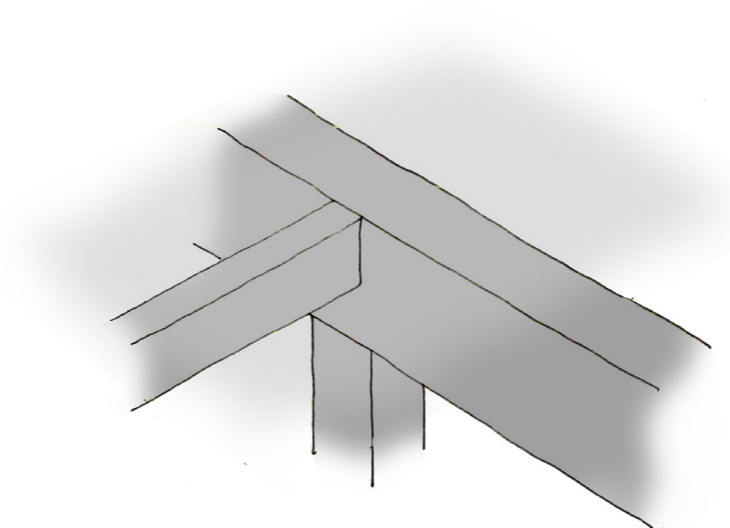
Monolithic concrete structure

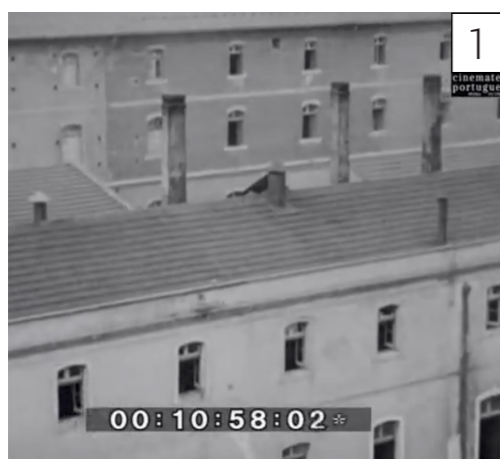
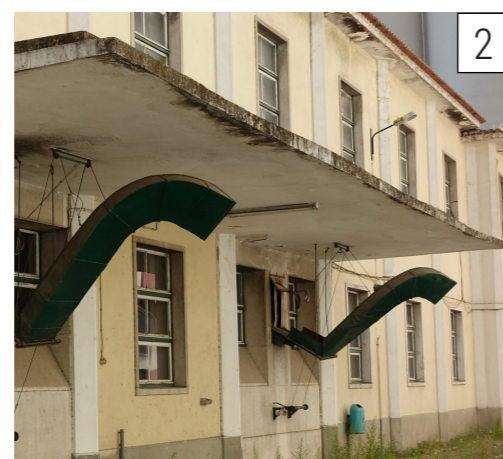
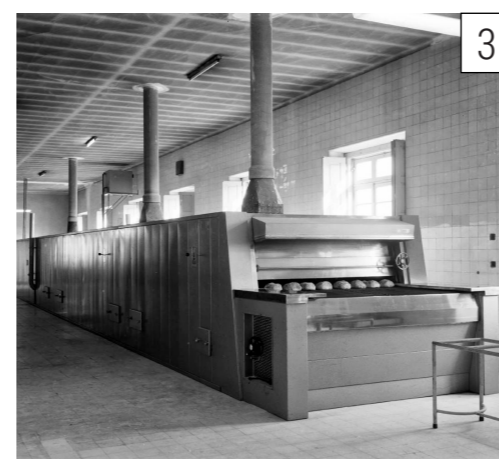
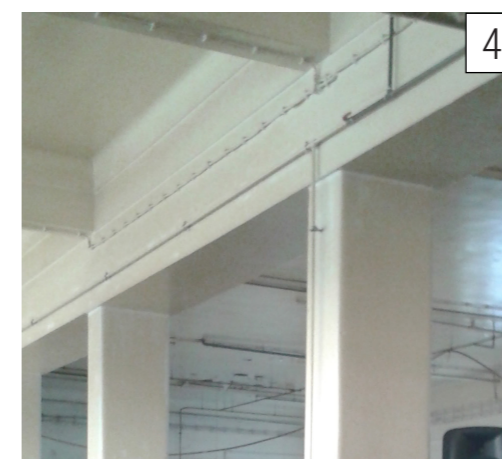
The fact that the windows of the bakery are right-angled at the top suggests that there is a kind of lintel, like bricked shelves or a concrete or stone lintel. Since the rest of the structure is made out of concrete we assume that it is a concrete lintel. When you compare the windows in the screenshot of a movie of 1927 (image 1) with the ones in the photo of the baker system (image 2) you can conclude that the windows have been replaced. The baker system, implemented around 1934, was of such dimensions that possibly the existing roof had to be removed. Other possibilities were the on-site building of the machine or replacing of (part of) the facade. We consider the first assumption as most realistic. For the installation of the machine the likely existing structure of cast iron columns, see pattern analysis p. 43, has been removed and replaced by concrete floors to create a column-free space. For this it is possible that a concrete edge-beam is poured on top of the original facade. It is also possible that this is done during the installation of the automatic ovens in 1955. The fact that the 'beam' in the facade is of the same height as the one inside the bakery, constructed in 1955, advocates this. Since there is unity in the façades of the individual buildings it is possible that they decided to replace all the arched windows for rectangular windows.

1. Arched windows bakery - front - and milling building - back (screenshot video of 1927 from www.cinamateca.pt)
2. Facade bakery (photo by Hielkje Zijlstra, 01-09-2016)
3. Baker system bakery (photo 1930s, provided by Docomomo)
4. Concrete beam inside bakery (photo by Ruben Klinkenberg, 01-09-2016)

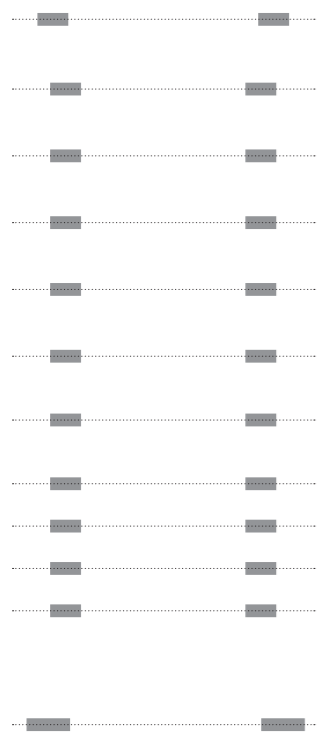
1. Irregular pattern columns

The pattern of the silo is tuned to the existing openings in the façades of the bakery and cookie factory. This is the explanation for the irregular pattern of the columns of the silo on the ground floor and thus can be stated that the silo has been built afterwards. Second evidence for this is the fact that the yellow plaster of the bakery is still visible between the columns on the ground floor. This conclusion corresponds to the assumptions made on the previous pages.

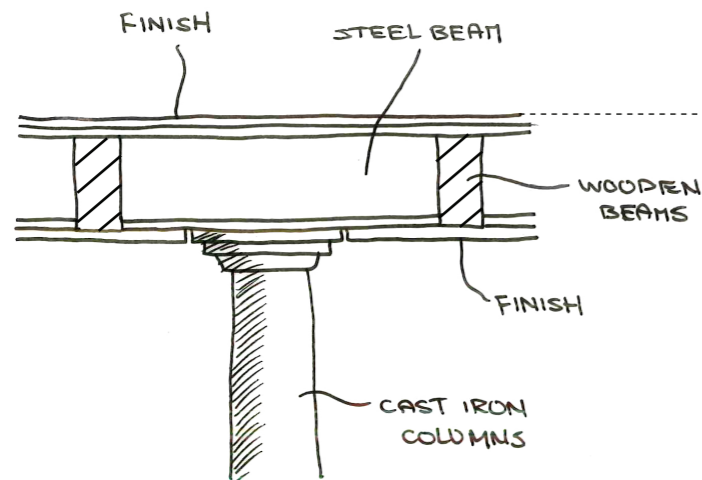
Detail A - floor construction

There is a difference between the details of the first floor in the two parts of the building. The wooden beams in the left part lie in the cast iron beams, while the wooden beams in the right part lie on the cast iron beams (image 1 and 2). The exact reason for this is not clear, but it is possible that the floor in the left part has been replaced, for example because of damage to the original floor, and that it was easier to lay the wooden beams on top of the cast iron beams.

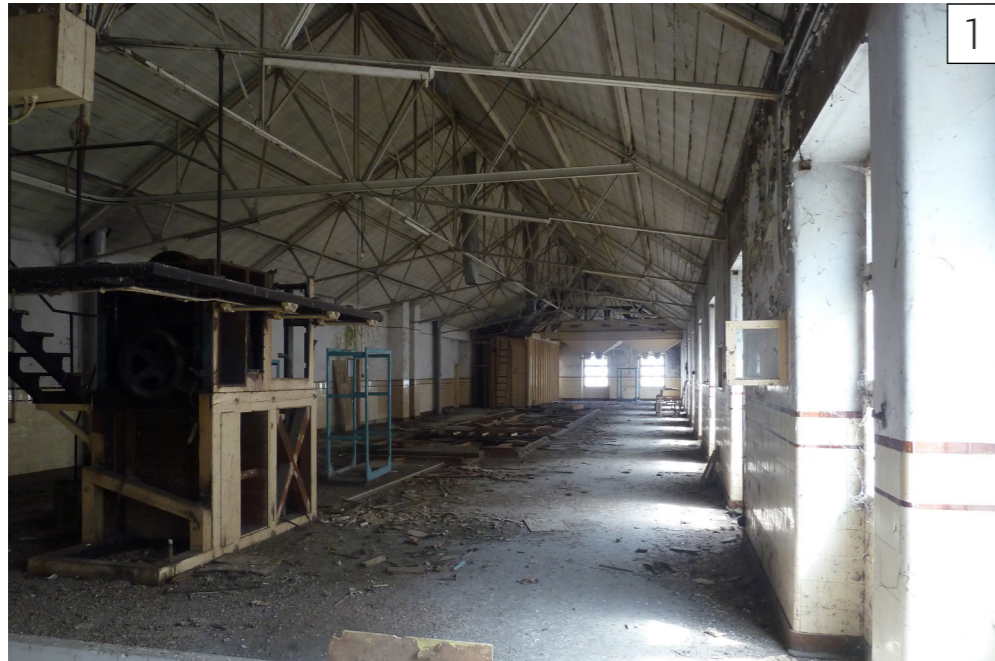
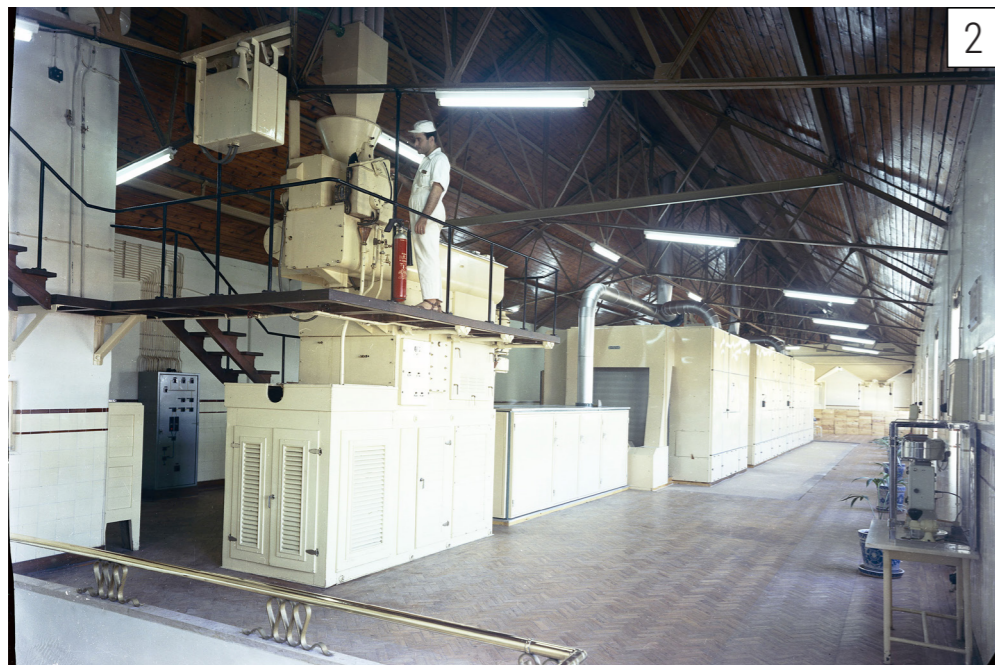
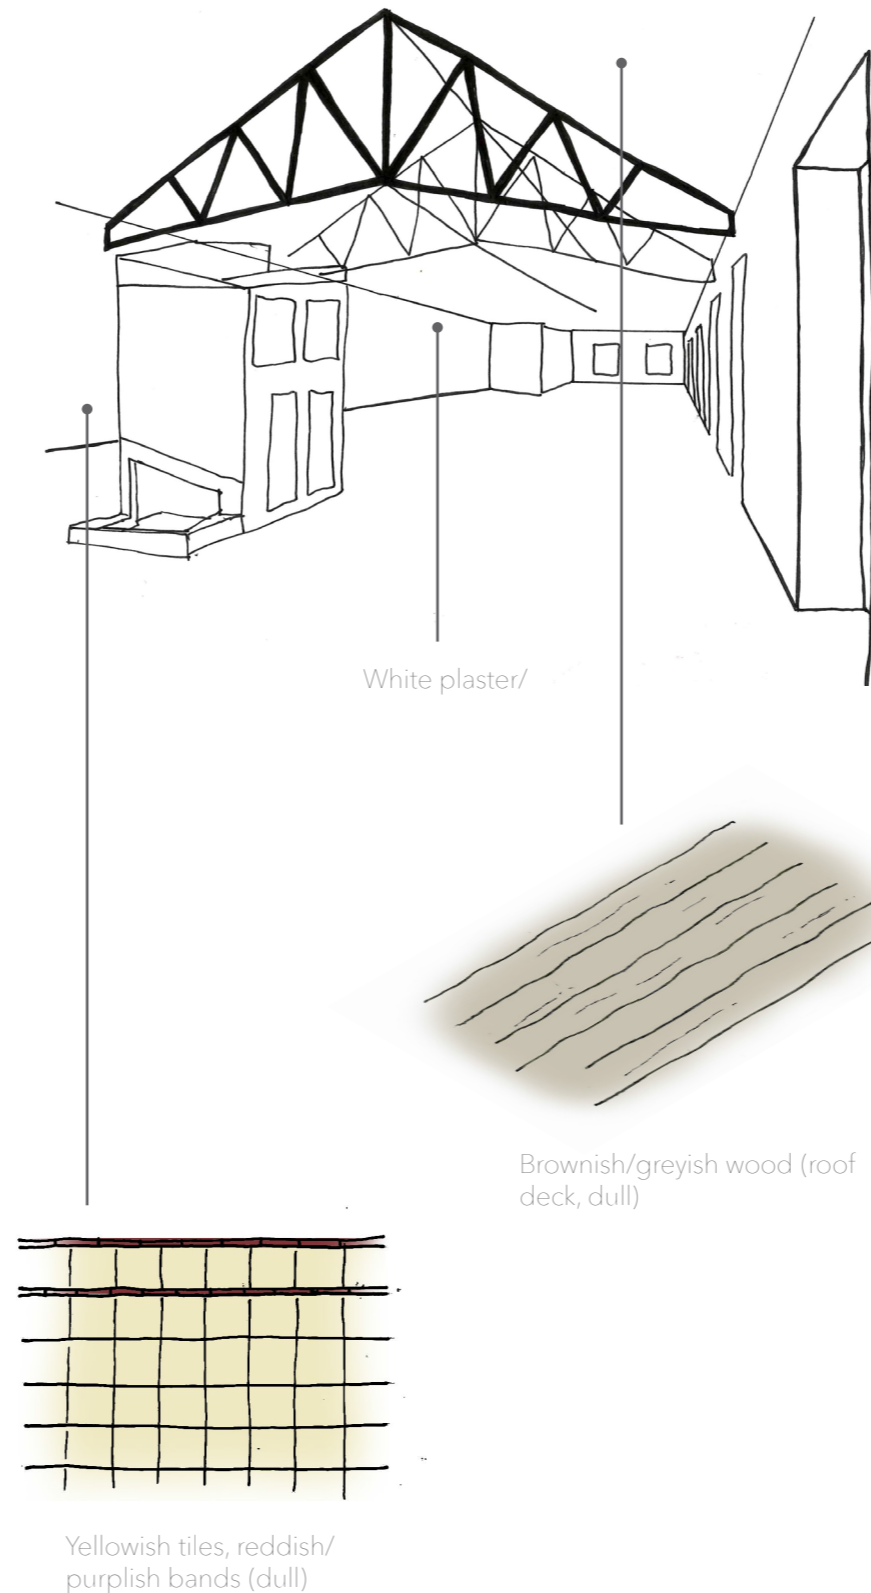
Due to all the dirt it is hardly visible what finishing the floor has. From an archive picture (image 2) it is clear that there used to be a wooden finish in a herringbone pattern. During the next site visit we have to determine the current finish. Only part of the walls are clad with tiles. These are the same tiles as in the bakery, which are probably put on the wall around 1955 (p. 46). For this reason we think that the tiles on the first floor of the bakery are also not original. It's obvious to state that these tiles are put on the walls around 1955 as well. We expect that the roof deck is original, because there is no reason to state differently.

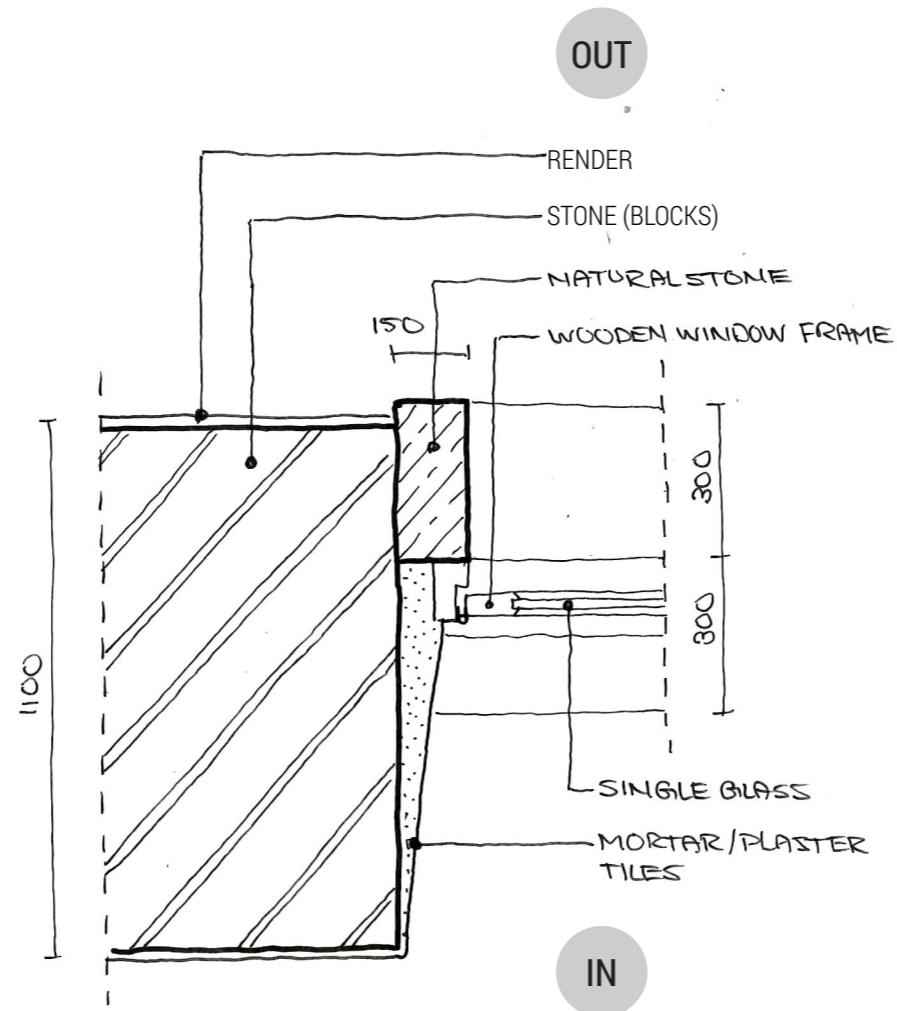
This are the vertical and horizontal details of the wooden window frames on the first and second floor of the milling. The side and top sill of the wooden window frames are not visible from the outside. For this reason we can conclude that it is inside glazing. Local natural stone, which is visible from the outside, is used as a mounting frame. Because the frame protrudes on the outside and the slope of the bottom sill is minimal, a lot of dirt accumulates around the windows (image 3). The bevels have been created with mortar or plaster.

The wooden window frames need to be maintained, because the paint starts to peel and the wood begins to rot. Despite the internal changes in this part of the building during the 1970s, we assume that this are the original window frames: the detailing of it is comparable to the window frames on the ground of the silos in the mill building. Only the tiles on the inside date from the 1970s (p. 80).

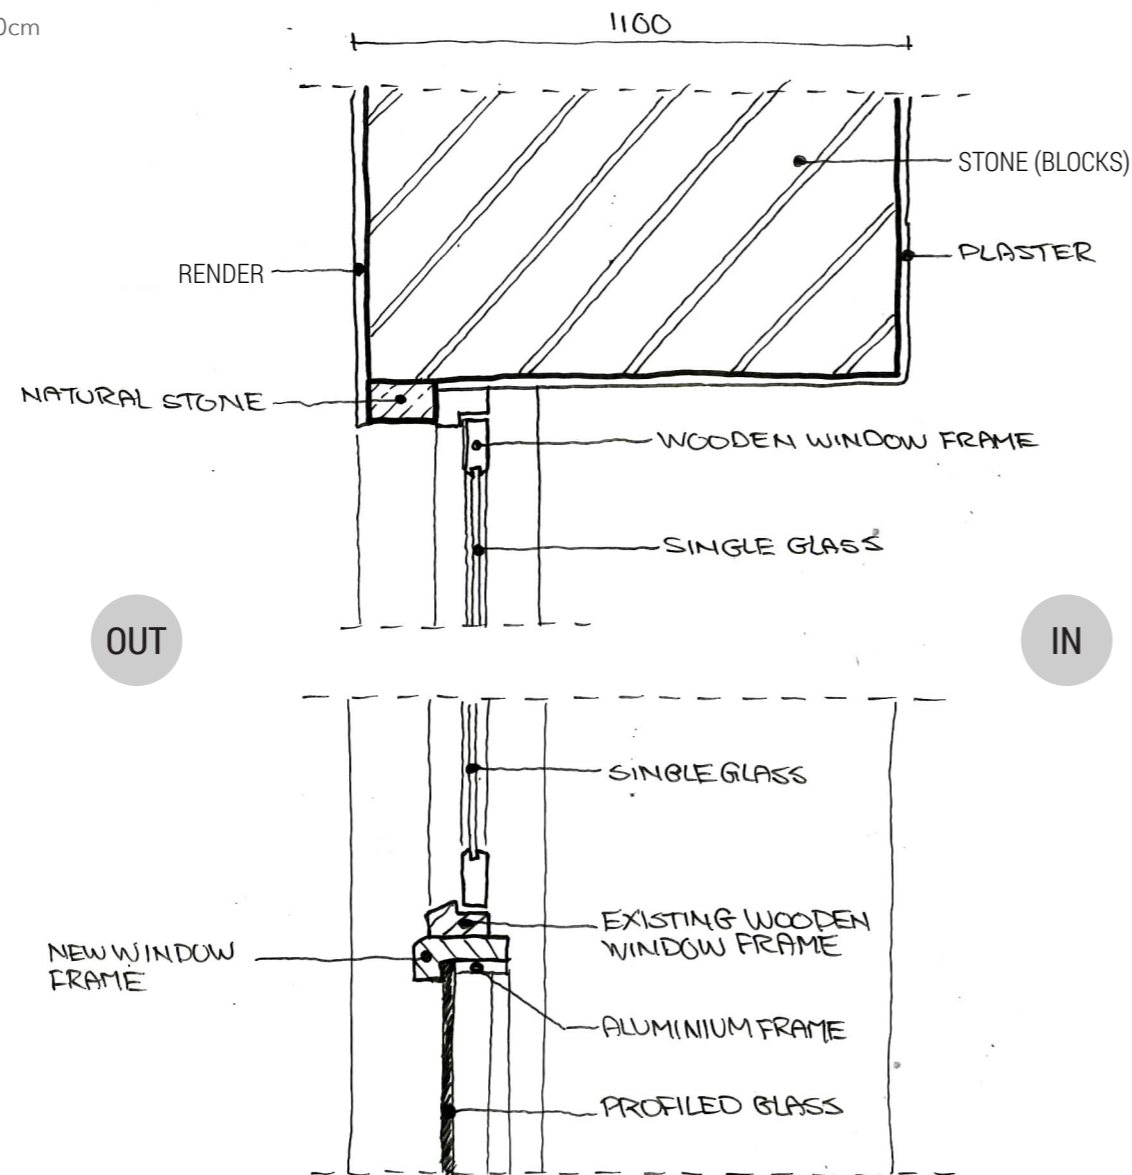
This are the vertical details of the upper part of the wooden window frames on the ground floor of the milling. The side and top sill of the wooden window frame are not visible from the outside. Unlike the windows discussed on the previous pages this is outside glazing, as will become apparent on page 90. Also for this window local natural stone is used as a mounting frame. This frame is finished with a render on the outside. We think that the wooden window frames are original, like all the wooden window frames in the milling, and that the profiled glass is an addition of the 1970s (see facing page).

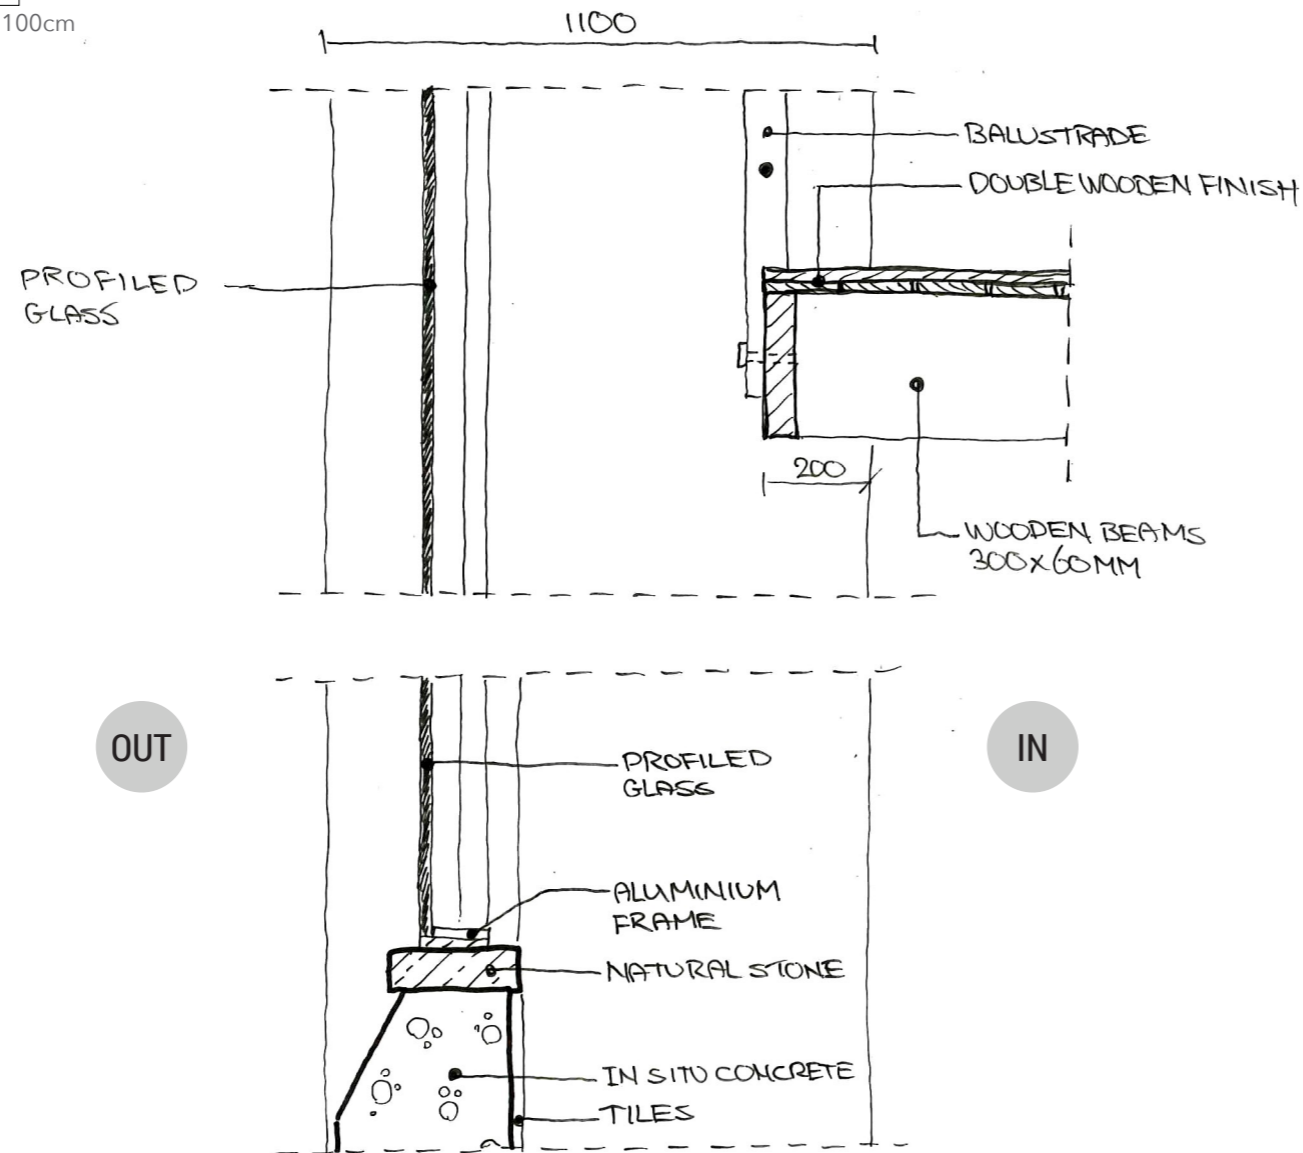
This are the vertical details of the lower part of the wooden window frames on the ground floor of the milling. The profiled glass that is used is a typical material of the 1970s. This can be seen as a characteristic of the internal changes during the 1970s due to the modernization of the production process (p. 25-33). For the same reason the ground floor became a double height space (p. 90). We also believe that the sill and the concrete wall beneath the window are from the 1970s.

Another interesting observation is the double wooden floor on top of the wooden beams: the direction of the wooden parts at the bottom differs from the ones on top. The assumption is made that only the bottom layer is original, since the direction of the wooden parts of the top layer does not correspond with the ones in image 4 on page 28. The upper layer is probably added because of the holes that were made for the machinery (maybe the mills) that once stood there. They 'repaired' this by adding a new layer of wood. It can be assumed that this is done in the 1970's as well.

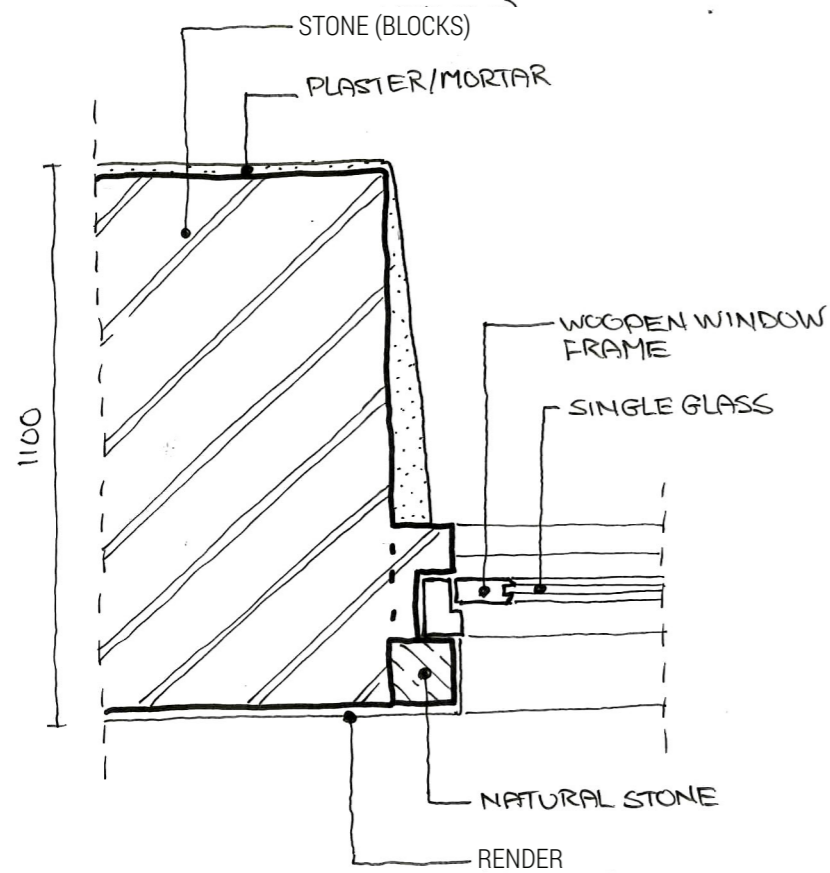
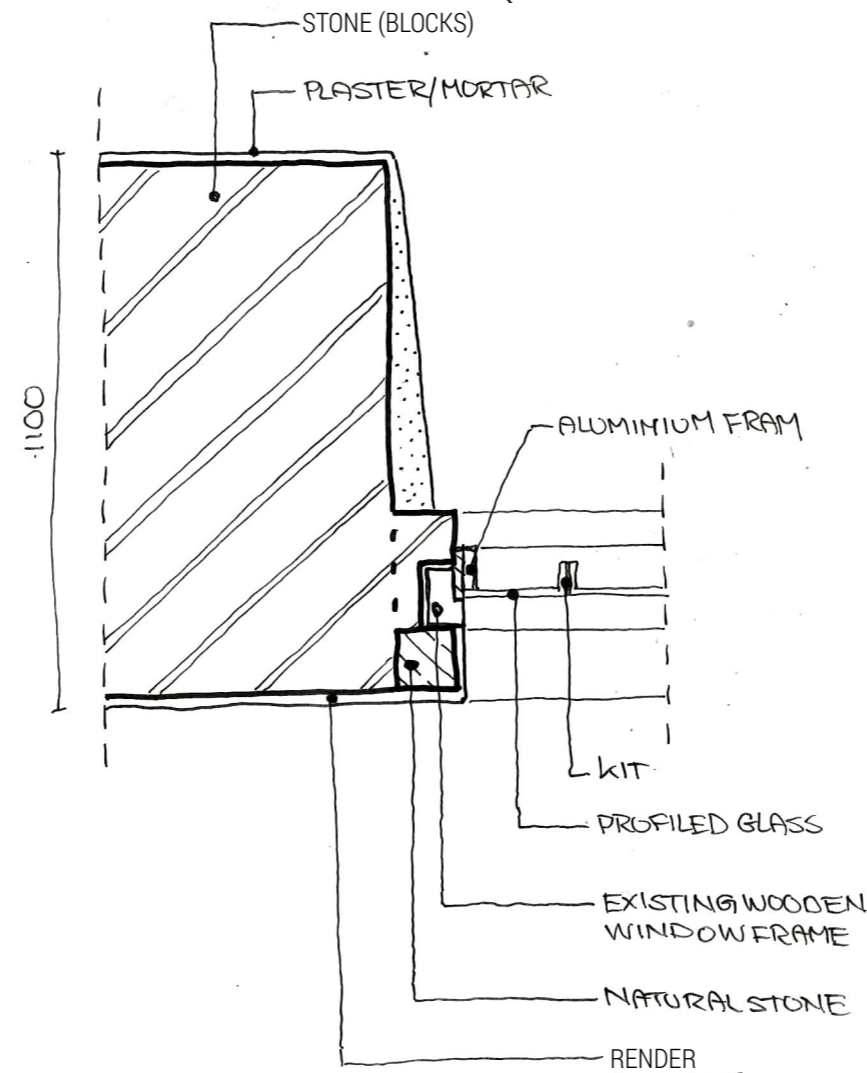
This are the horizontal details of both the upper (left detail) and lower (right detail) part of the wooden window frames on the ground floor of the milling. In the current situation the ground floor has a double height because the new machinery asked for this. We think that originally there used to be an extra floor, which is still the case in part of the milling (p. 81). In contrast to the windows on the upper floors (p. 86-87), outside glazing is used on the ground floor: they could not place the big windows from the inside because of the originally 'extra' floor. On the ground floor, during the 1970's, they've changed the single glass for profiled glass. For this, they re-used the original wooden window frames (right detail), because it was impossible to remove the frame without demolishing part of the exterior wall.

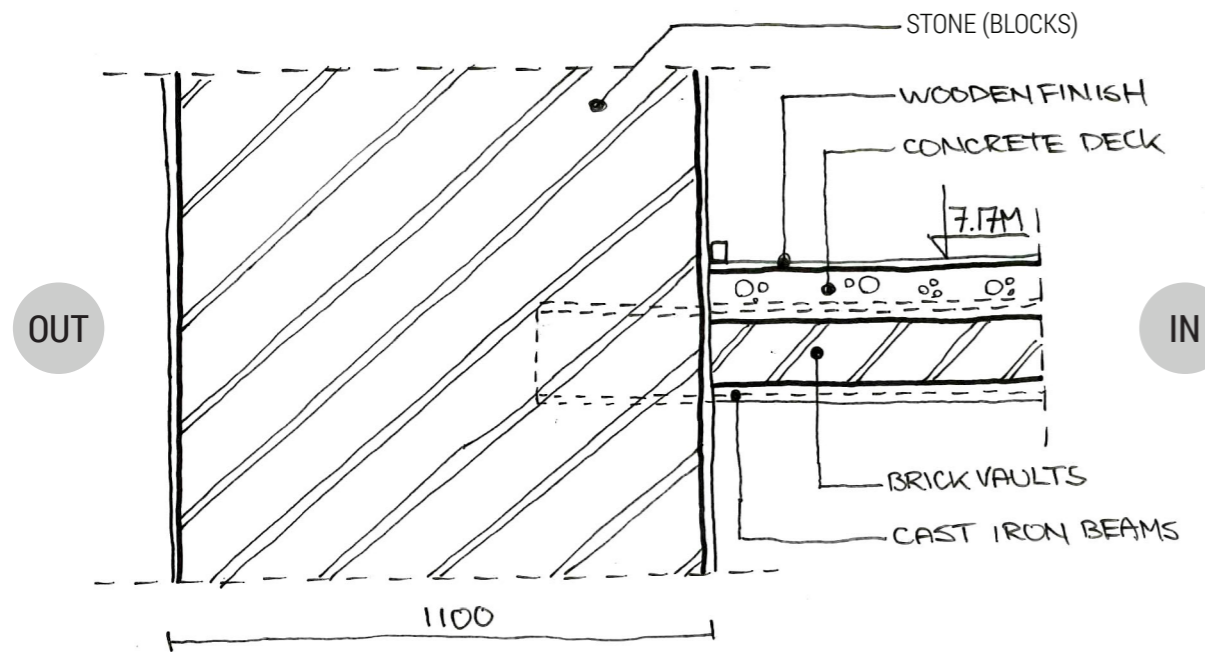
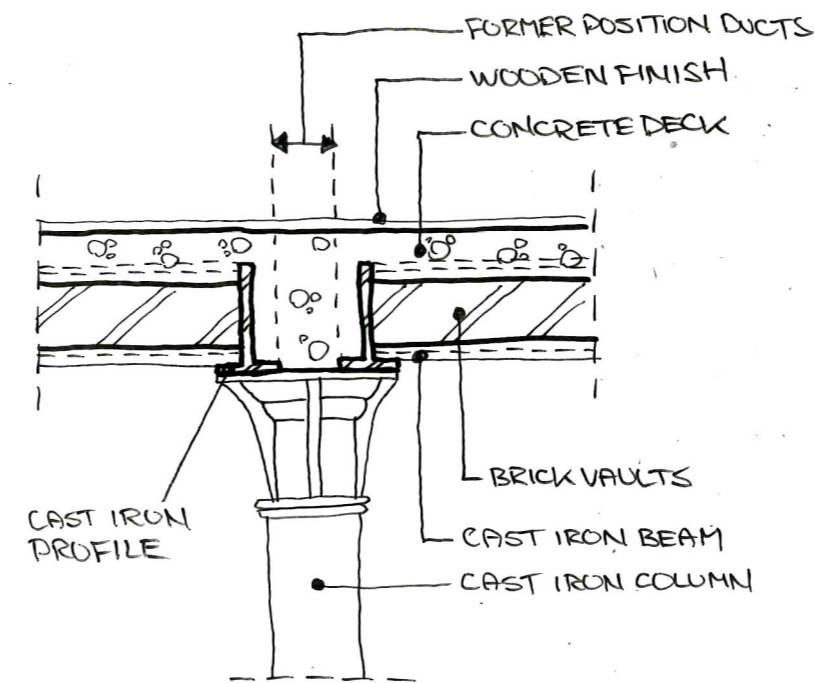
This are the horizontal details of the floor in the original part of the milling. It is composed of cast iron columns and beams, brick vaults, a concrete deck and wooden finish. The beams are integrated in the brick vaults, as is illustrated in image 3. On the right detail it is visible that two beams are used to hand over the forces to the column. In this way, the beams could have smaller dimensions (as well as the floor).

During the 19th century the definition of fireproof construction was all-masonry construction of walls and partitions, iron beams and columns and arch floors. The selling point of cast iron beams and columns were its fire resistance, slender proportions and light appearance. The common mode of filling-in between the cast iron beams was the brick arch, which was seen as almost indestructible. Arches were used relatively more frequently in industrial buildings, were the higher live loads were more efficiently resisted by the strong segmental form and were a scalloped ceiling was not an aesthetic problem.¹ This latter, combined with the conclusion on the facing page, proves the pragmatic attitude that was adopted in relation to the (development of the) buildings.

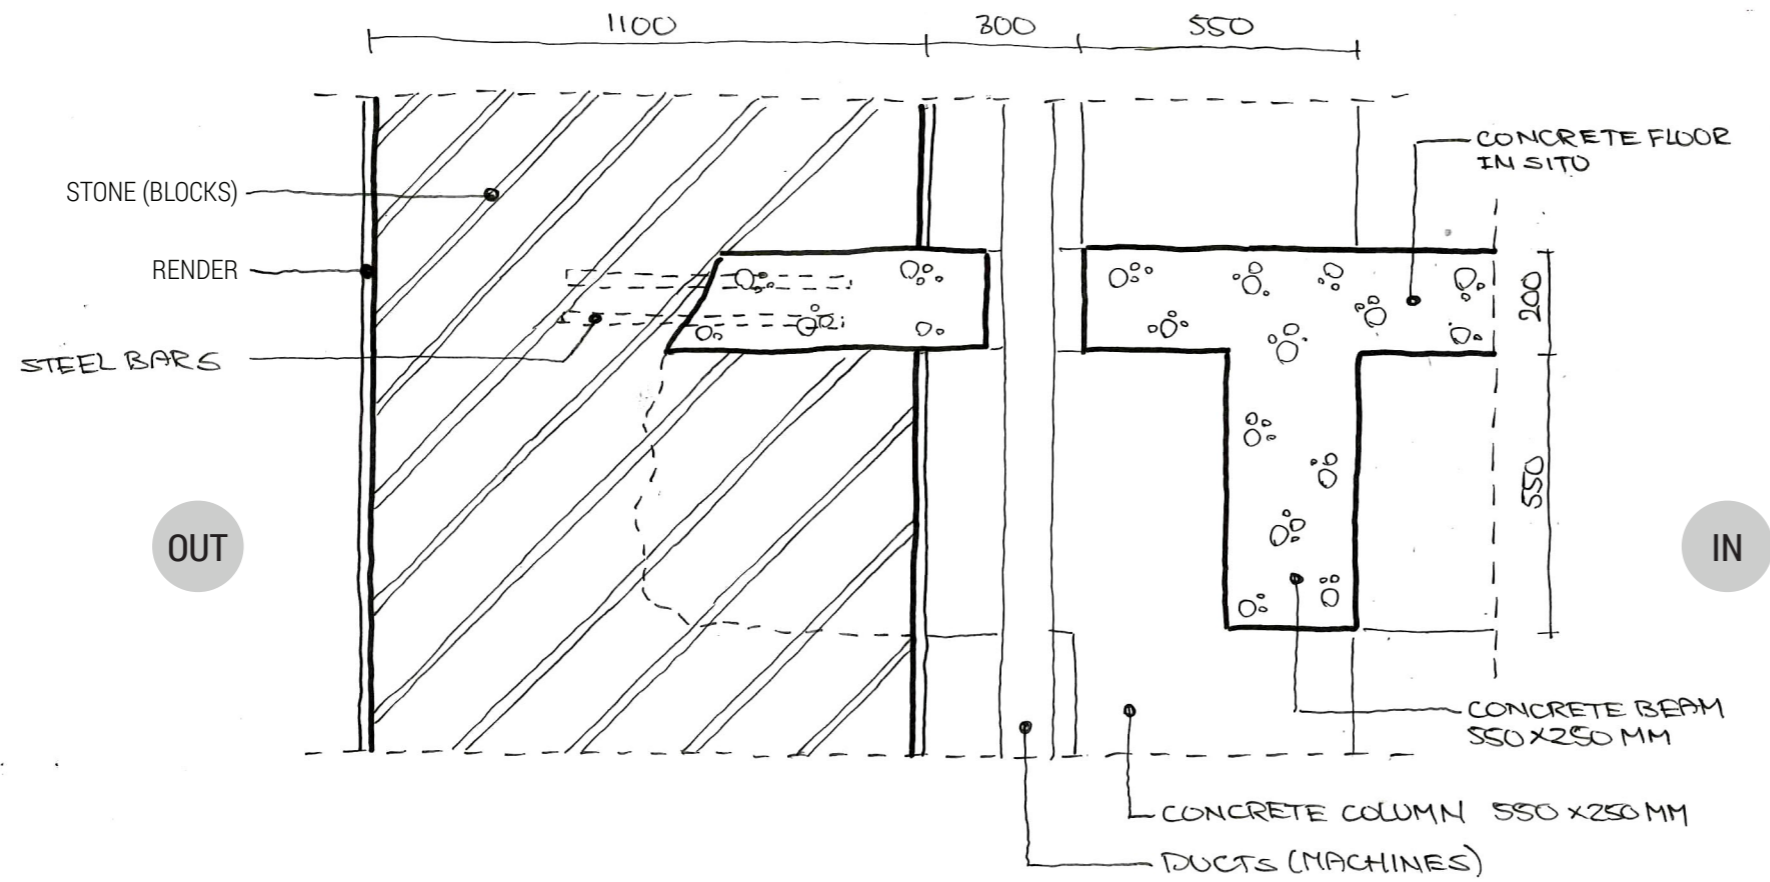
This is a horizontal detail of the connection of the concrete structure from the 1970s and the original facade of the milling. After 1900 reinforced concrete was rapidly adopted for industrial buildings of one or several stories. Reinforced concrete buildings could be built quickly, were fireproof and could resist vibrations from heavy machinery.¹ The concrete structure that has been implemented in the 1970s, because of the modernization of the production process, is placed within the original, massive load-bearing facade (re-use). For a good connection between the two structures, part of the facade was removed and steel bars were integrated. After the concrete structure was poured, the wall has been replenished and finished with a plaster.

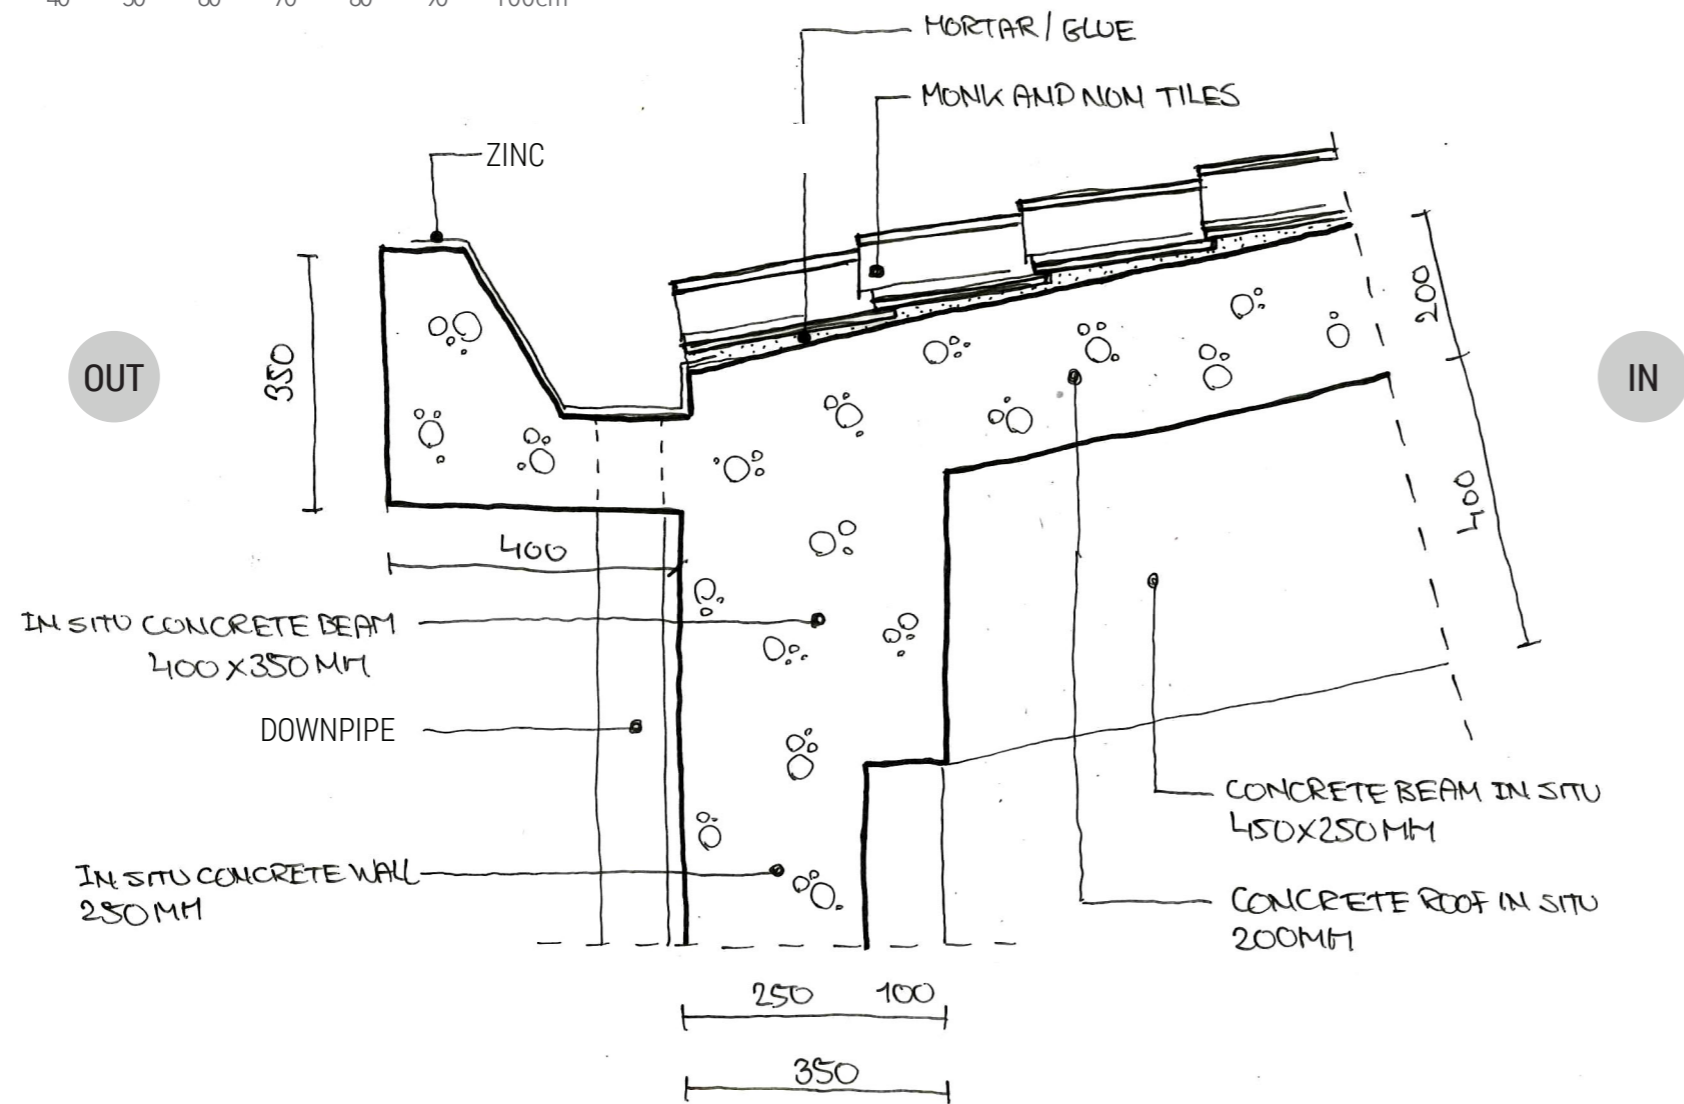
This is the detail of the eaves of the silo. As already mentioned, the construction is made entirely of concrete. Also the gutter, which is probably cladded with zinc, is part of the monolithic structure. The filling-in of the structure is done with concrete as well and contributes to the stability of the whole. In image 1 you can see that the roof is cladded with monk and nun tiles. We assume that these are fixed with mortar on the concrete roof, but we are not sure about this. With regard to the drainage it's probably not necessary to have tiles on the roof. It could be done for aesthetic reasons, since the roofscape plays an important role in a 'sloping city' as Lisbon.

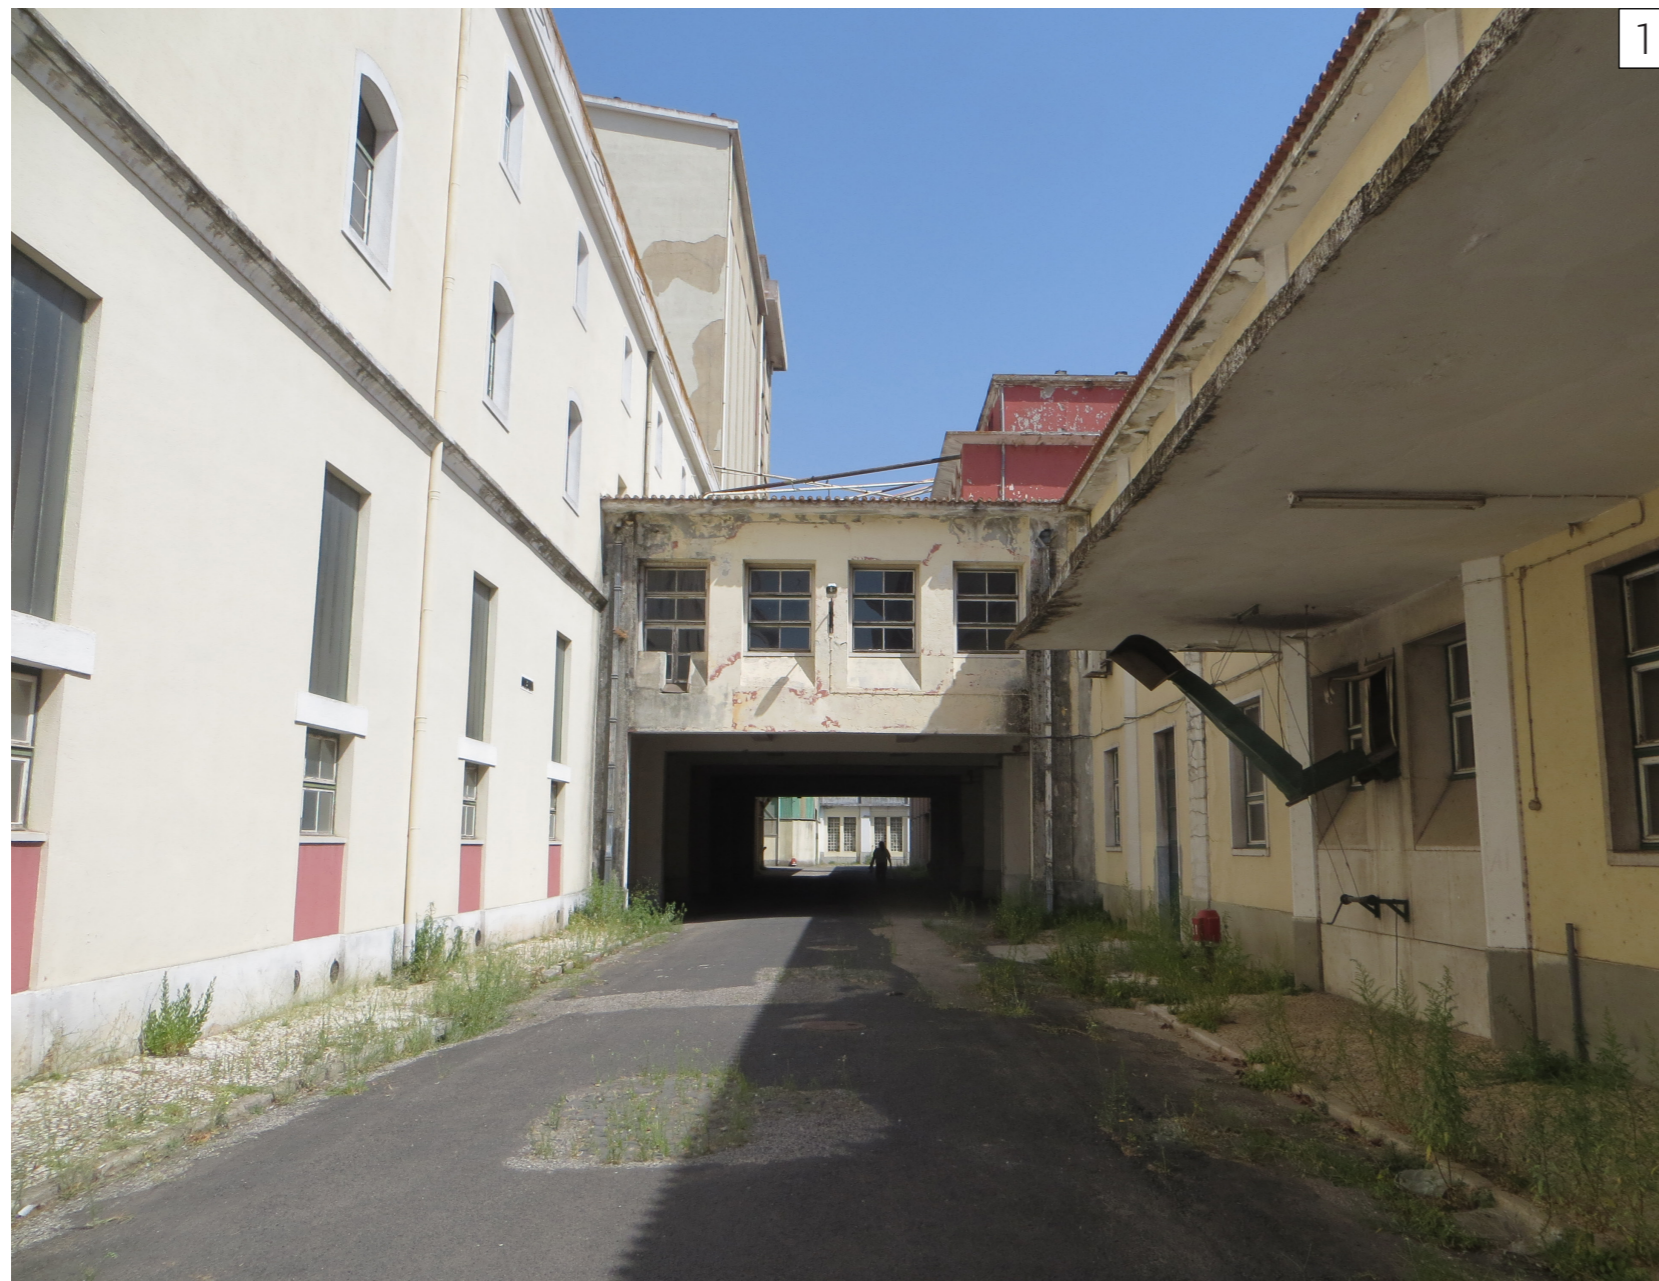
The overall state of conservation of the ensemble is very good, which suggests that there was regular maintenance of the buildings while functioning for the army. The lack of maintenance of the last couple of years resulted in the first signs of damage caused by dirt, water and overall neglect.

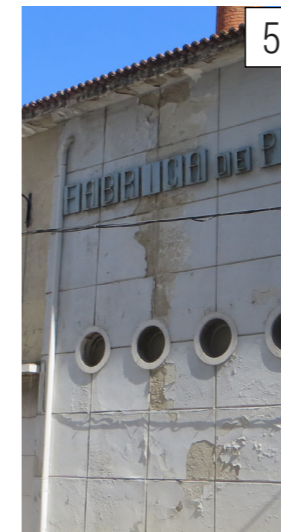
Water damage

Most of the damages that are present in the ensemble are caused by water. This water damage is the consequence of leakages in the drainage system or because of the storage added in the 1970s (building 16B): the faulty connection of it with the older building components of the ensemble, like the milling and bakery, forces the water to penetrate into the interior of it. The water damage causes mould, lichens and scaling.

On the left some examples of the water damage on both the exterior (image 1-5) and interior (image 6-10) of the ensemble are shown. When redeveloping the buildings it is important to think about the drainage system, especially between the different building components.

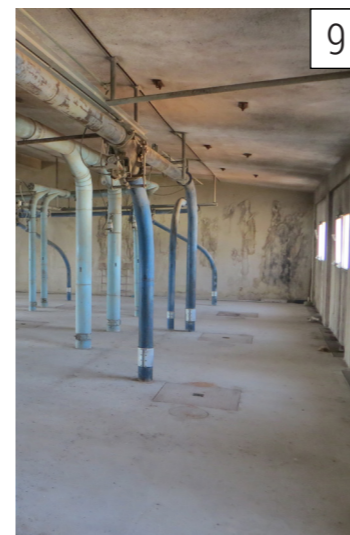
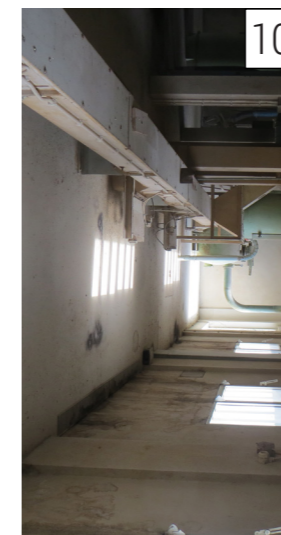
Building 18 and 19: water damage caused by leakages and badly detailed windows.

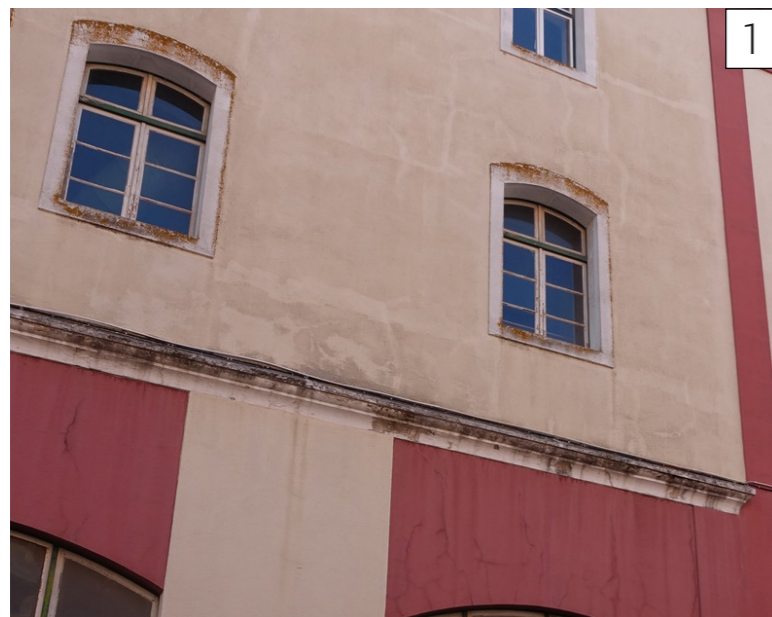
Scaling

A lot of damages are visible in the plaster and paint of the buildings, sometimes due to water damage but also because of a lack of maintenance.
