RESEARCH & ANALYSIS REPORT - TECHNICAL ANALYSIS

Manutenção Militar Complex - Lisbon, Portugal

STATE OF CONSERVATION

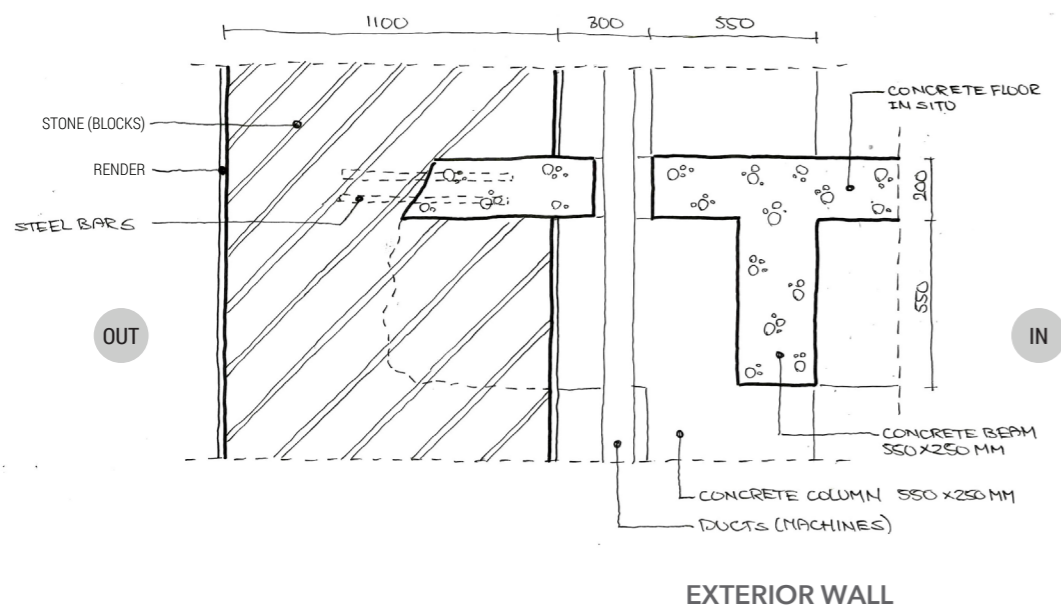
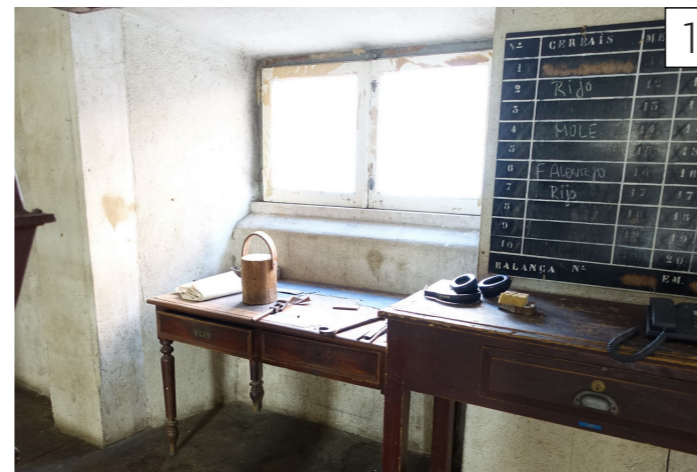
The first thing that came into mind in relation to the climate are the massive load-bearing façades of the milling. These walls have a high accumulating capacity which contributes to a constant internal temperature. The walls are of such dimensions (1100mm) that you can hardly speak of a thermal bridge: it has a relatively high Rc-value. On the other, this increases the risk of condensation near the wooden window frames and the roof construction, since the Rc-value of these elements is lower. Partly for this reason most of the wooden window frames are damaged (p. 125).

1. Damaged window frames ground floor silos milling (photo by Hielkje Zijlstra, 04-09-2016)
