### **A case study**

# Wear Induced Failure of Automotive Disc Brakes—A Case Study

**Abstract:** This paper investigated a failure in a ventilated disc brake in an automobile. The failed brake disc had been in service for approximately 10 years. The observed failure was in the form of radial cracks that appeared to have initiated at the outer edge of the disc brake. The cracks were rather straight with no branching. Optical microscope, scanning electron microscope (SEM), and energy dispersive X-ray spectroscopy (EDS) were used to study the microstructure of the failed disc. Vickers microhardness test was also used to evaluate the hardness of the samples. Results showed that the root cause of crack formation, in this case, was related to the excessive wear in the brake disc. Different wear mechanisms, namely abrasive and adhesive wear, were recognized in the failed specimen. Moreover, the worn surface in some areas was covered with fine oxide particles. These particles appeared to have a significant contribution toward abrasion. To further understand the wear mechanisms, pin-on-disc experiments were also conducted on the samples. Results of the pin-on-disc experiments were compare

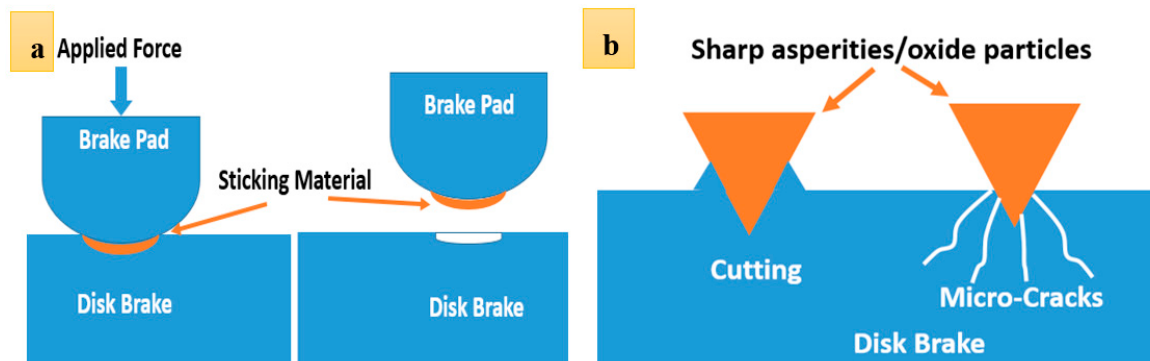
**Figure 10.** Schematics of (a) adhesive wear and (b) abrasive wear mechanisms.

While plastic deformation and spallation are indications of an adhesive wear mechanism, plowing and cutting can be linked to the abrasive wear, inferring that both adhesive and abrasive wear mechanisms contribute to weight loss during wear test. The former wear mechanism has a relatively higher kinetics of weight loss. In severe conditions, contact points in-between sliding bodies can be severely damaged by adhesive wear. In case the surface has some minimum roughness and the applied load is high enough, metal-metal sticking on contact spots becomes inevitable. In case the so-called sticking layer is weakly bonded to the disc, it will eventually be detached from the surface. This is schematically shown in Figure 10a. In comparison to the adhesive wear, abrasive wear takes place when a hard particle/asperity is sliding over a surface. Hard particles/asperities can cause abrasion without having to induce any major plastic deformation on the surface. In case particles/asperities are sharp enough, they create surface cutting. However, their attributions are not limited to cutting, as they could also cause surface micro-fractures and grain pull-outs (see Figure 10b) [23]. Cutting and micro-cracks are essentially more dominant features on the fracture surface. Surface cutting results in the detachment of wear debris. Where the wear debris is hard and fragile, they will be fragmented and entrapped in between sliding bodies and inside surface grooves, and, in turn, contribute to the abrasion of the surface. The attribution of wear debris to the wear rate depends on the relative hardness of wear particles to that of the worn surface. Fast abrasion is expected to take place when the hardness of the matrix is less than 80% of the hardness of particles [23]. If the load at the contact points is high enough, the temperature at the contact points increases, and therefore, oxidation of the wear debris is also likely to take place. This appears to be the case in this failure (see Figure 7). Oxide particles are clearly hard and are expected to cause further abrasion. Both cutting and micro-cracks are less probable when the worn surface is ductile in nature. Results show that in this case, both adhesive wear and abrasion control the wear of the disc brake during service. Figure 11 shows the SEM images of debris after wear tests. Debris can primarily be categorized into large plate-like chips, with their sizes being in the range of a few ten micrometers, and fine agglomerated particles. EDS analysis shows that
