MAISON DE LA MISERICORDE
RESTORATION BOOKLET

Florencia Marije Anna Visser
Student number: 4345053
Master track Architecture
Studio: Heritage and Architecture
Graduation tutors: prof. ir. Wessel de Jonge, ir. Lidy Meijers,
ir. Frank W.A. Koopman, ir. Bert van Bommel
Delft University of Technology
15-05-2017

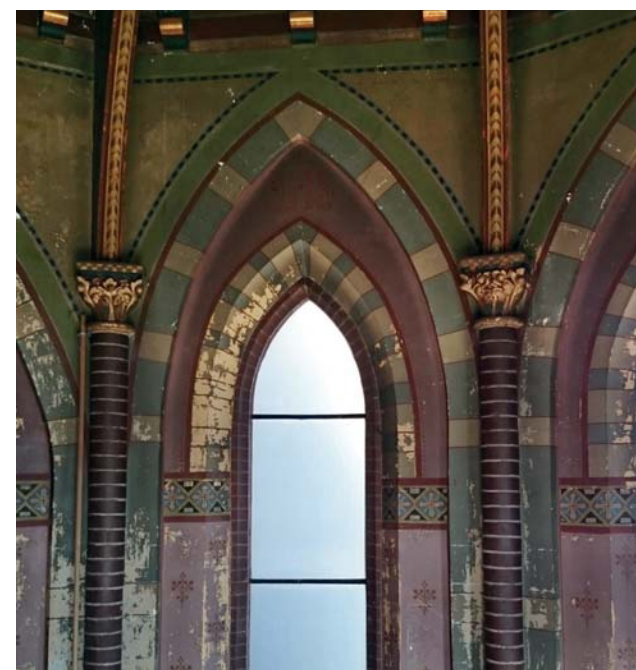
The walls with windows show green and pink/purple colours above the strip. As can be seen in figure 22.

Figure 22. The paintwork on the walls; choir

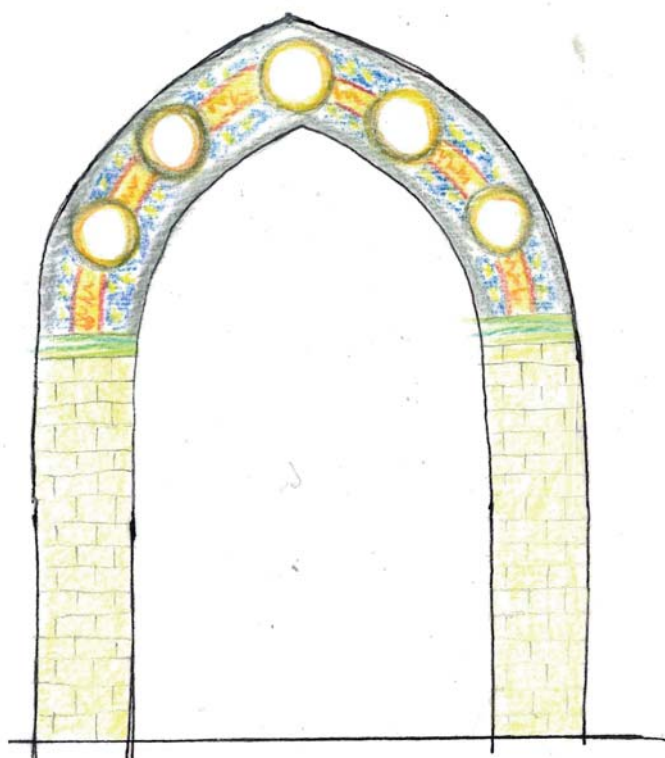
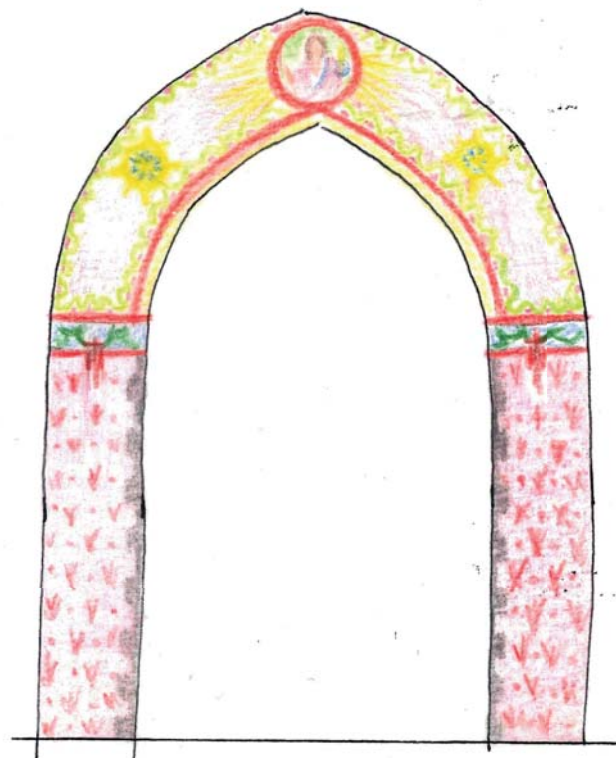
Figure 20. Impression of the paint layers

Due to the degradation of the outer paint-layer in the chapel an older layer with paint has become visible.

The first layer

The second layer

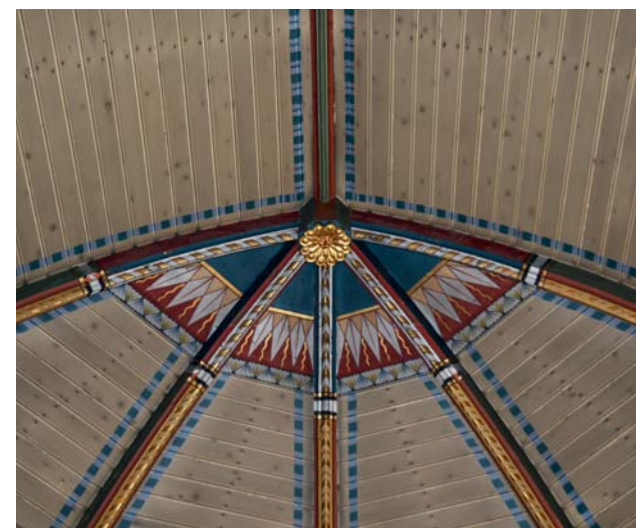
The wooden vault were painted together with the first layer of the walls. These paintings have not been painted over. Figure 23 shows how these paintings look.

Figure 23. The paintwork of the vaulted ceiling; choir

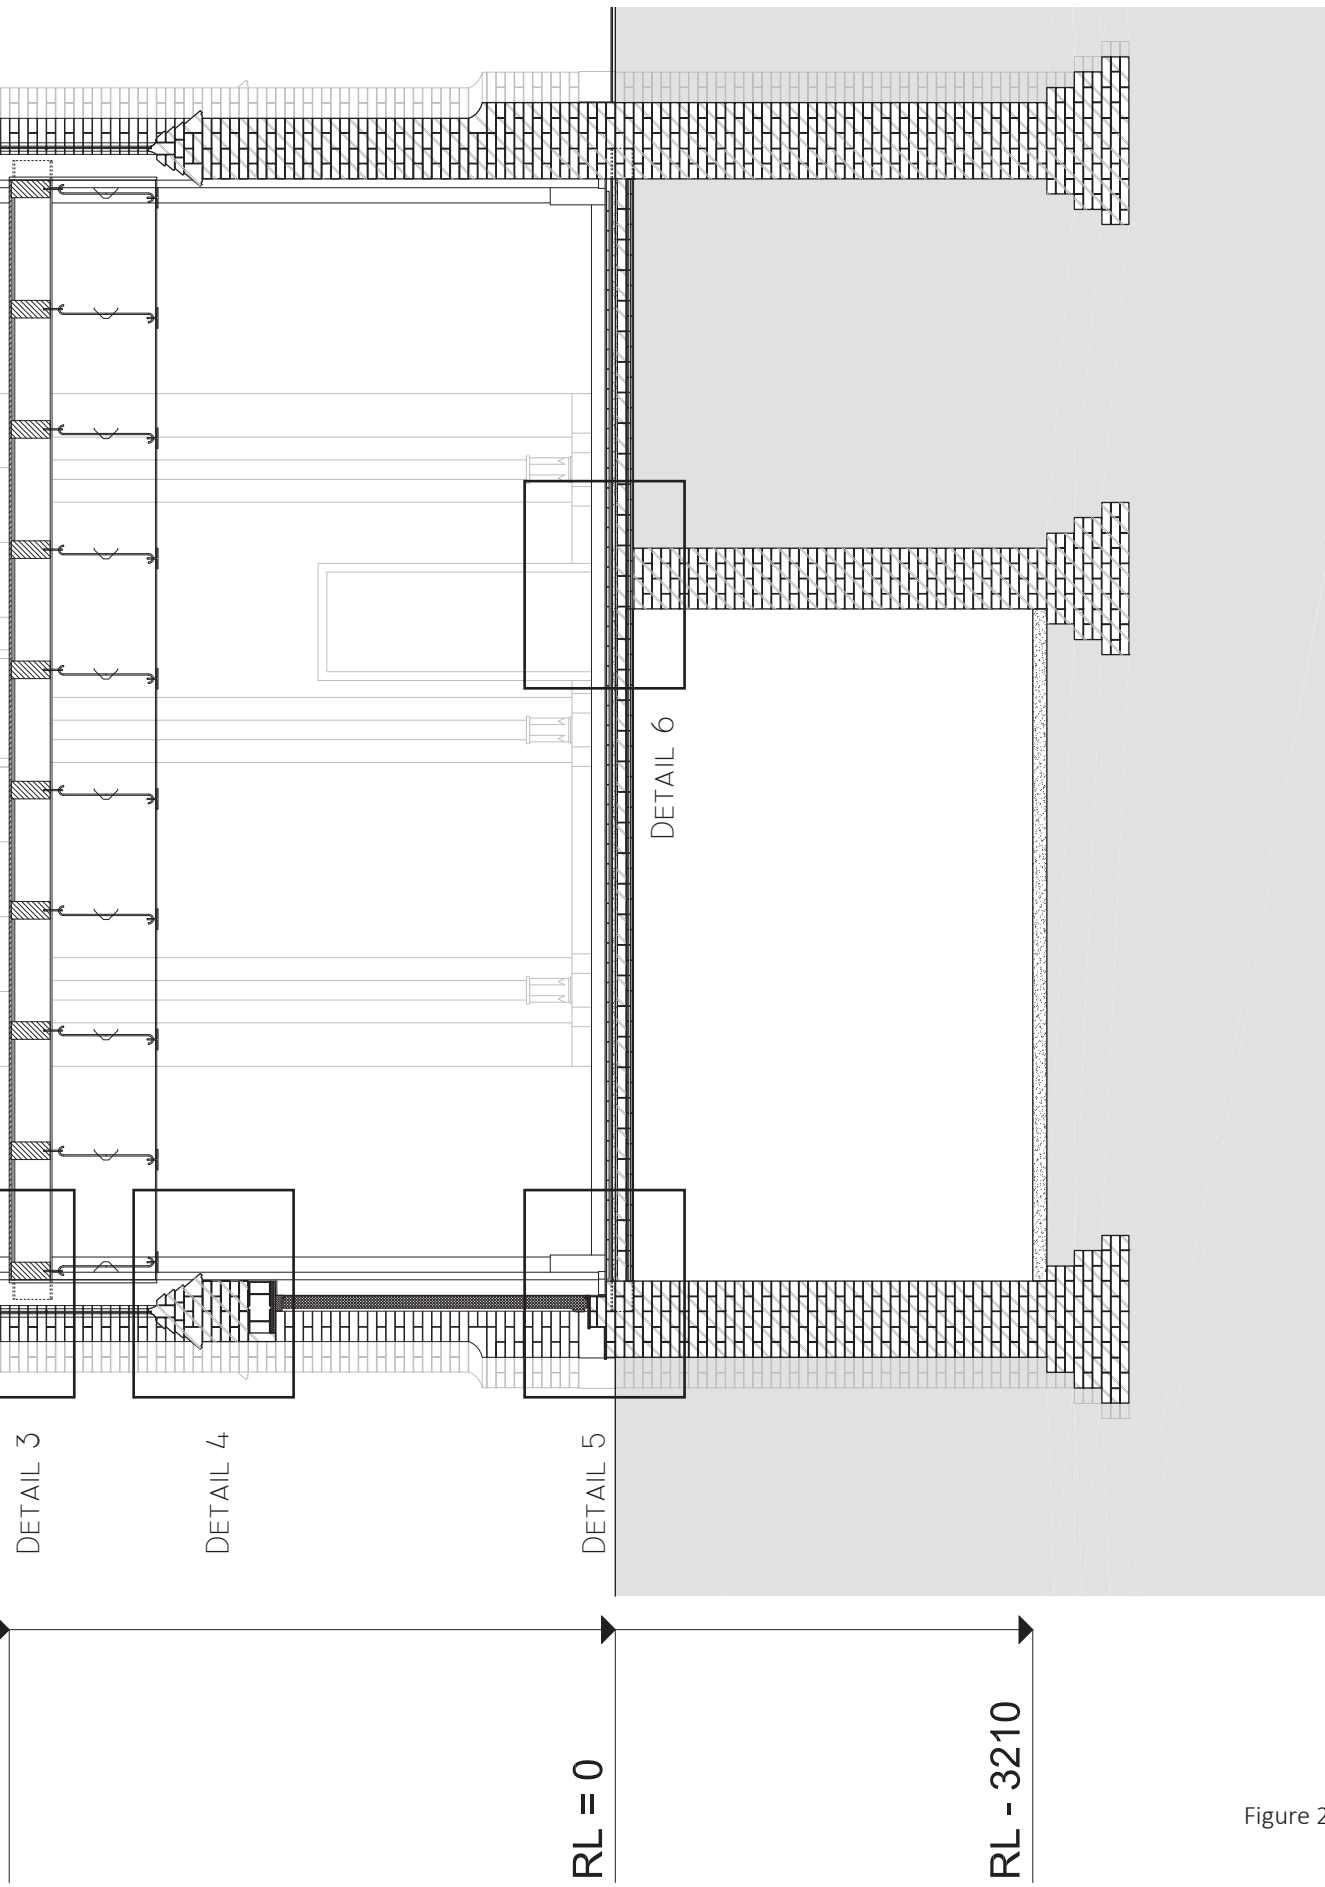
Figure 26. Cross section of the chapel; facing east
scale 1:50

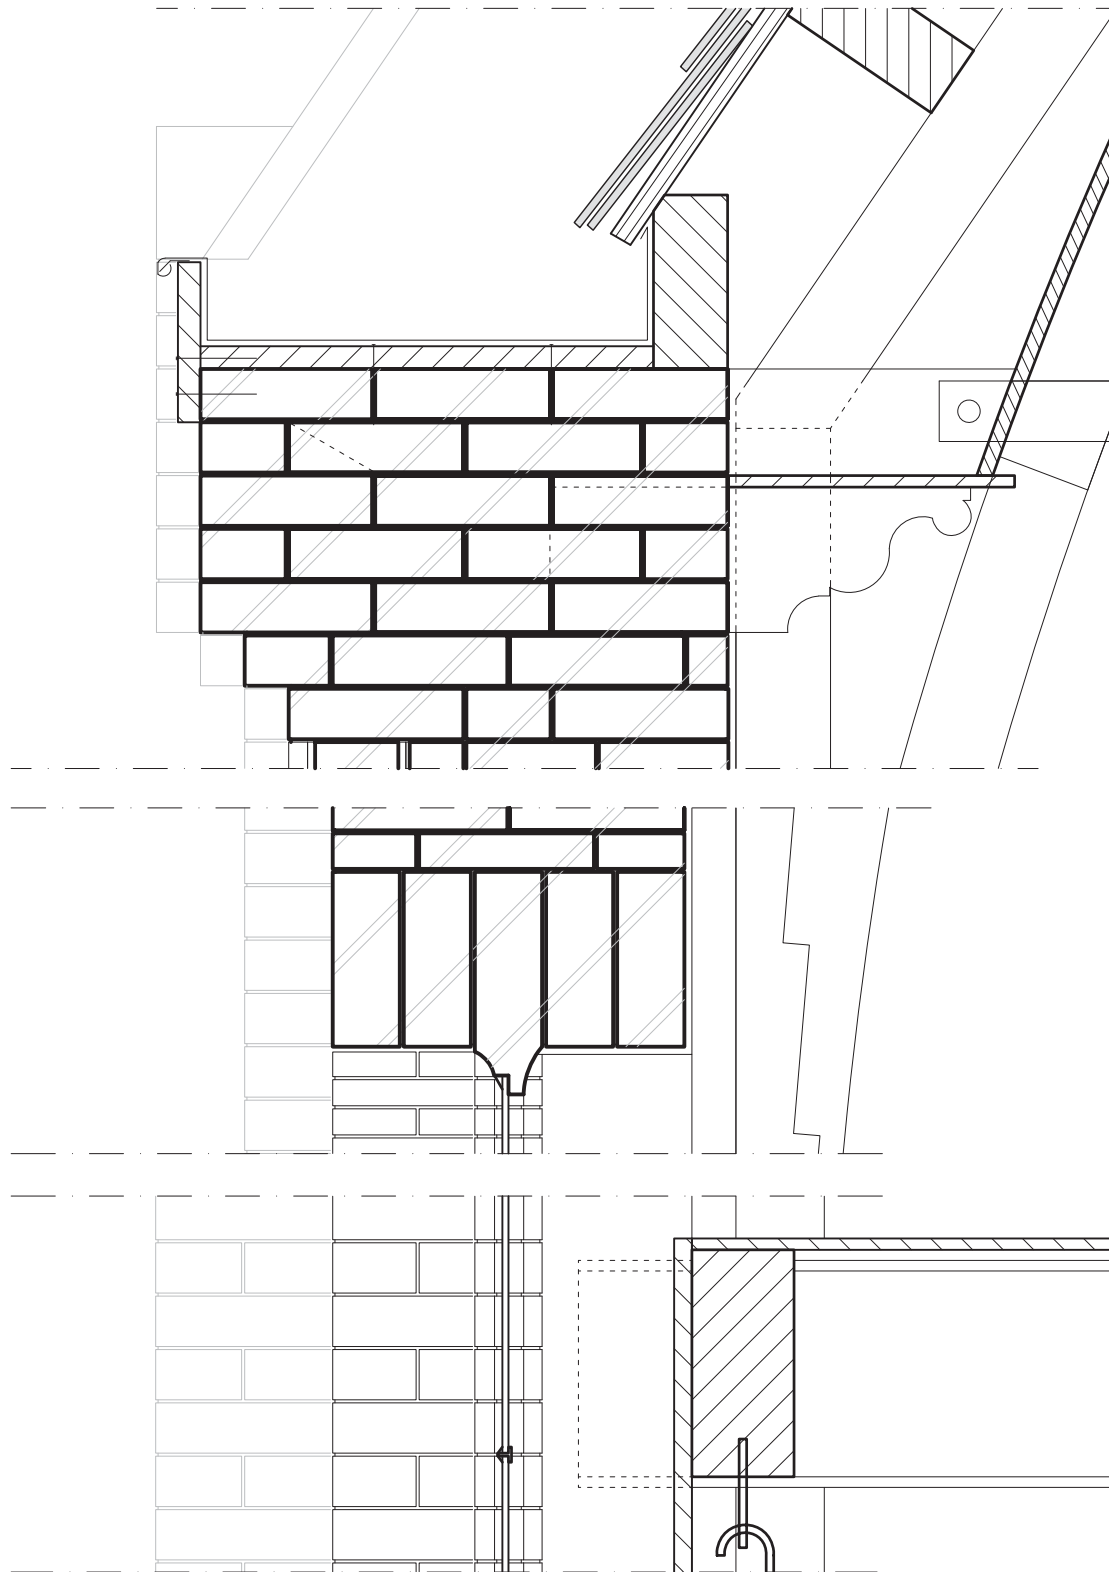
In the same period a new floor was added to the chapel. This wasn't meant to do anything for support but this addition too has damaged the chapel. The points where the floor is embedded in the walls will always be visible, bricks have been taken out together with the layer of paint that covered it. Detail 3 on page 24 shows how this floor is assembled.

Figure 27. Details 1-3
scale 1:5
