## A study on deterioration and residual service life of recovered azobé (*Lophira alata*) sheet piles

European Journal of Wood and Wood Products

# A study on deterioration and residual service life of recovered azobé (*Lophira alata*) sheet piles

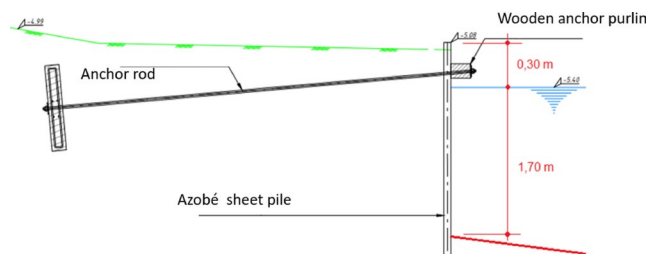
**Fig. 8** Cross section of azobé sheet pile with a retaining height of 2 m, Taken from (Kamath et al. 2025)

The sheet piles investigated in this study were designed for a soil-retaining height of 2 m (Fig. 8). The soil profile of the location included different layers of sand, silt and clay. Since little knowledge is available about the soil strength parameters, the ones given in Table 2 are assumed. Average
