## Assessing the structural integrity of the wax-resin lining of The Night Watch using 3D shearography

Tao, Nan; van Duijn, Esther; Vos, Lisette; Steeman, Ilse; Groves, Roger M.; Keune, Katrien; Noble, Petria; Anisimov, Andrei G.

Publication date 2025 Document Version Final published version Published in Journal of Cultural Heritage

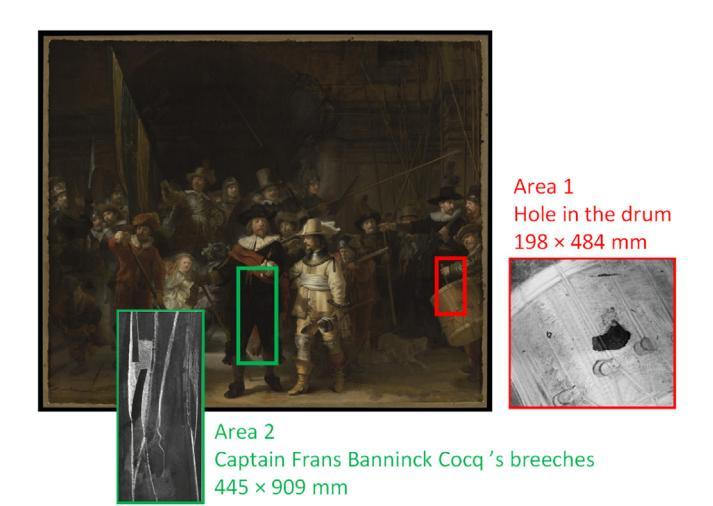
**Fig. 2.** Rembrandt van Rijn, Officers and other civic guardsmen of District II in Amsterdam, under the command of Captain Frans Banninck Cocq and Lieutenant Willem van Ruytenburch, known as 'The Night Watch', 1642, oil on canvas, on long-term loan from the city of Amsterdam [8,9]. Areas 1 and 2 were inspected with 3D shearography.

Two areas of interest in *The Night Watch*, namely the canvas insert in the drum that is located close to one of the seams in the original canvas and the Captain's breeches with the repaired cuts were inspected with the 3D shearography system (Figs. 2 and 4). The final inspection results include in- and out-of-plane phase maps with the shear in the *x*-horizontal and *y*-vertical directions corresponding to the surface relaxation strain during cooling. These phase maps were calculated using the calibration informa-

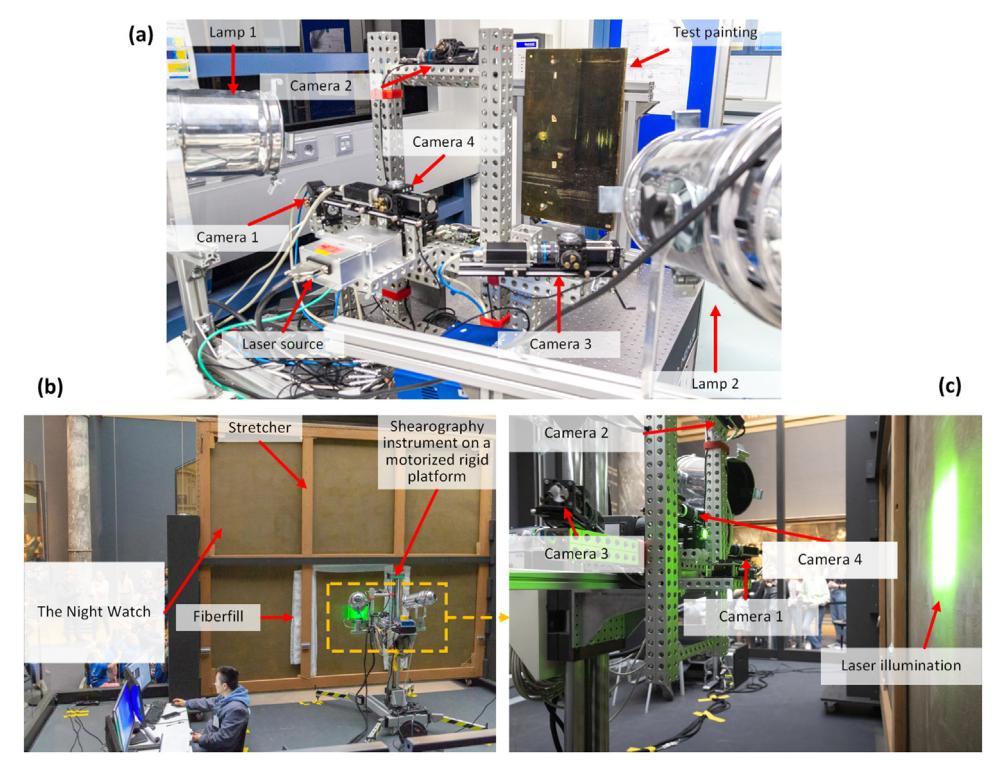
**Fig. 4.** 3D shearography instrument (a) in the lab with the test painting in front of it, (b,c) during the inspection of *The Night Watch* in the galleries of the Rijksmuseum with the shearography instrument mounted on a motorised stage.

1) In the area of the Captain's breeches, a non-woven polyester padding material was placed in between the canvas and the stretcher bars surrounding the area (Fig. 4(b)) to provide local support to the canvas and, effectively, to dampen the vibrations.

2) The ventilation system in the Night Watch Gallery of the Rijksmuseum and the airflow were found to be the main source of the canvas vibrations. During the measurements, the ventilation system was temporarily switched off.

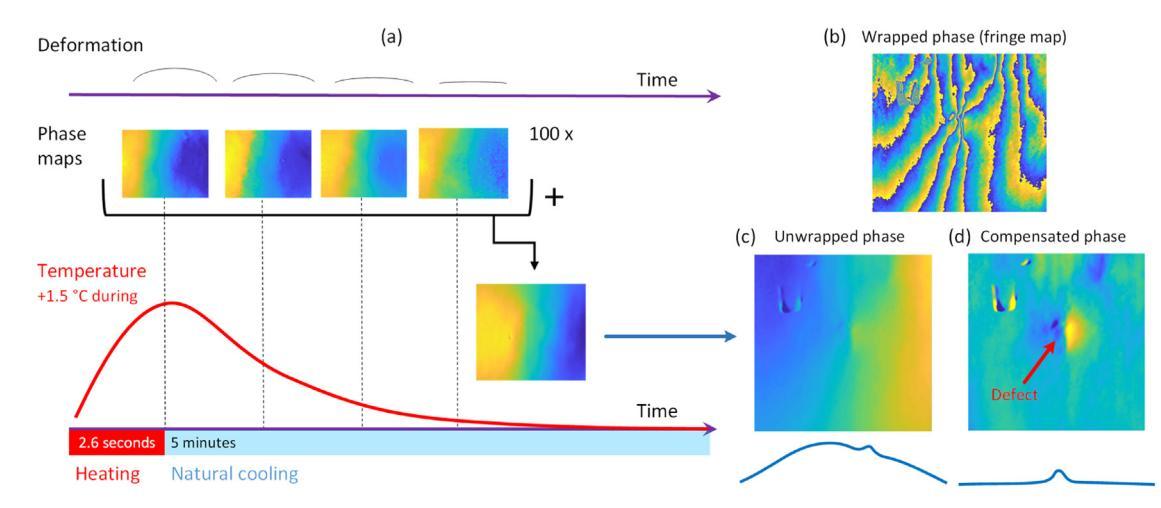
Fig. 5. Thermal loading and continuous measurements during cooling. The total sum of the unwrapped phase is compensated to reveal defects and damage.

- 1. A temperature increase of 1 to 2 °C is sufficient for reliable delamination detection in the test painting from the front and the reverse sides.
- 2. Phase compensation is needed to detect defects as the overall canvas deformation is significant. By doing this (as seen in the Figs. 5(c-d)), the overall deformation can be corrected from the data and the presence of defects can be identified and classified. Other techniques may be used to correct the overall deformation from the data: i) correcting the overall deformation by combining analytical solutions of thermal deformation or prediction by FEM, ii) combining a digital twin of the structure to correct the overall deformation, iii) Fourier transform analysis and/or principal component analysis may also be helpful.
