# The Stratified Significance of a Historic Façade as a Basis for a more Durable Conservation Approach

DOI 10.1515/rbm-2015-1004

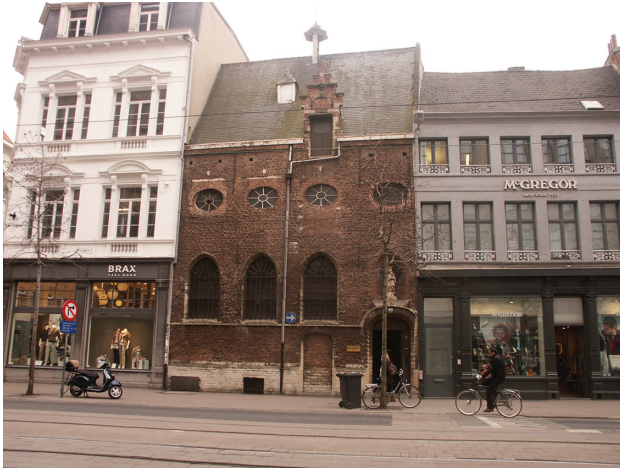
**Figure 1:** Main façade of the Schoenmakerskapel and its immediate surroundings, 2011.

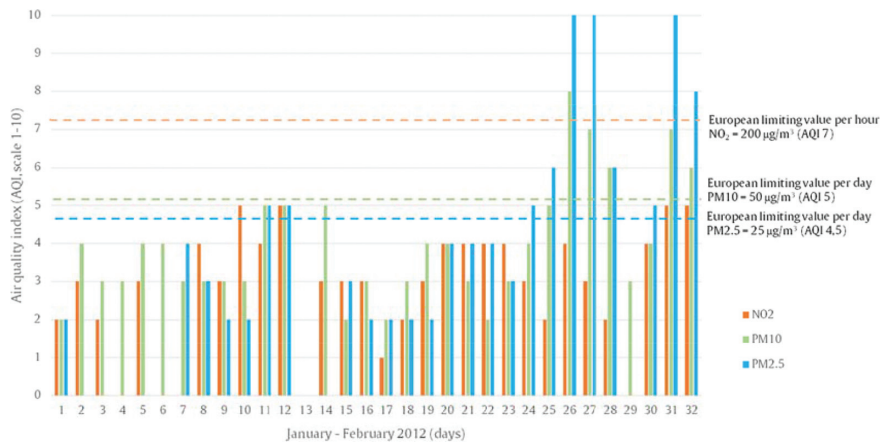
**Figure 2:** Air quality data for Antwerp's city centre, January–February 2012. Results of the assessment of the air quality by the Flemish Environment Agency (data available on the website [www.vmm.be](http://www.vmm.be)),  $\text{SO}_2$  is not indicated since  $=0$  micrograms/ $\text{m}^3$ .

dioxide ( $\text{NO}_2$ ) (Figure 2). The levels of sulphur dioxide ( $\text{SO}_2$ ) are even negligible. This indicates that the present air quality will probably only cause the deposit of particulate matter, resulting in soiling, but not the chemical deterioration phenomena that are often caused by sulphur dioxide ( $\text{SO}_2$ ).

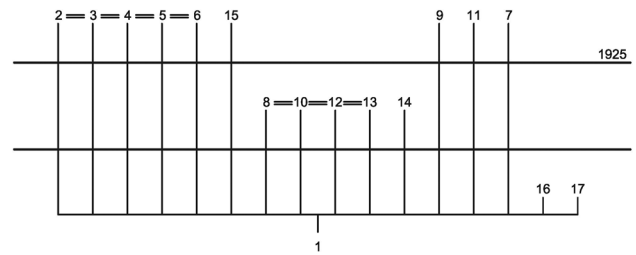
Figure 11: Harris matrix.

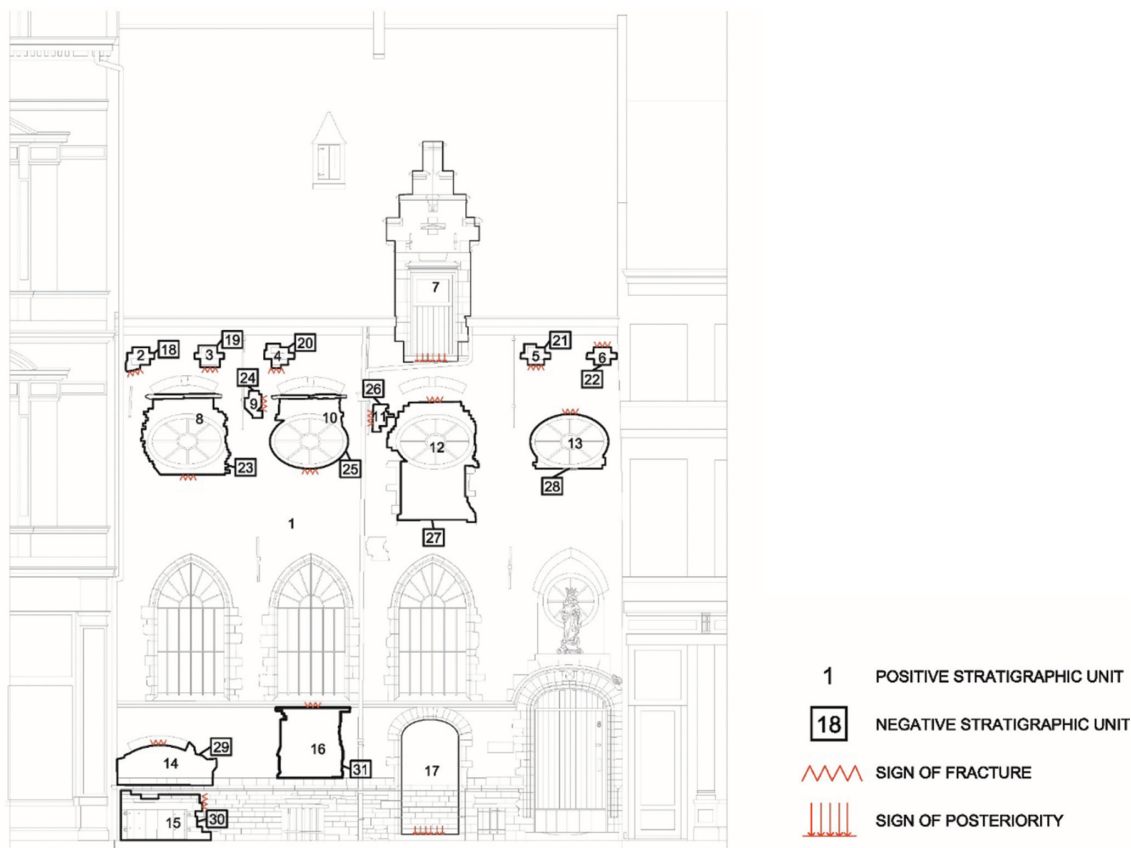
Figure 10: Identification of the stratigraphic units.

windows on the second floor (oculi), in the place of larger windows. The second type of brick, of a more orange colour, was then used. The interior of the chapel stems also from this period. During this intervention, the façade was also finished with a plaster layer, which altered its style and aesthetic appreciation. The next important intervention was the restoration of the façade in 1925, when the plaster was removed, the scaffold holes on top were introduced and the dormer window was reconstructed, with the stepped-gable. Finally, archive documents and pictures suggest that there has been a cleaning intervention in the 1980's.
