# Surgical Quay-wall Renovation

Joost W. Bos Msc.  
Royal Haskoning  
E-mail: j.bos@royalhaskoning.com

Bastiaan Winde BBE  
Port of Rotterdam Authority  
E-mail: sc.winde@portofrotterdam.com

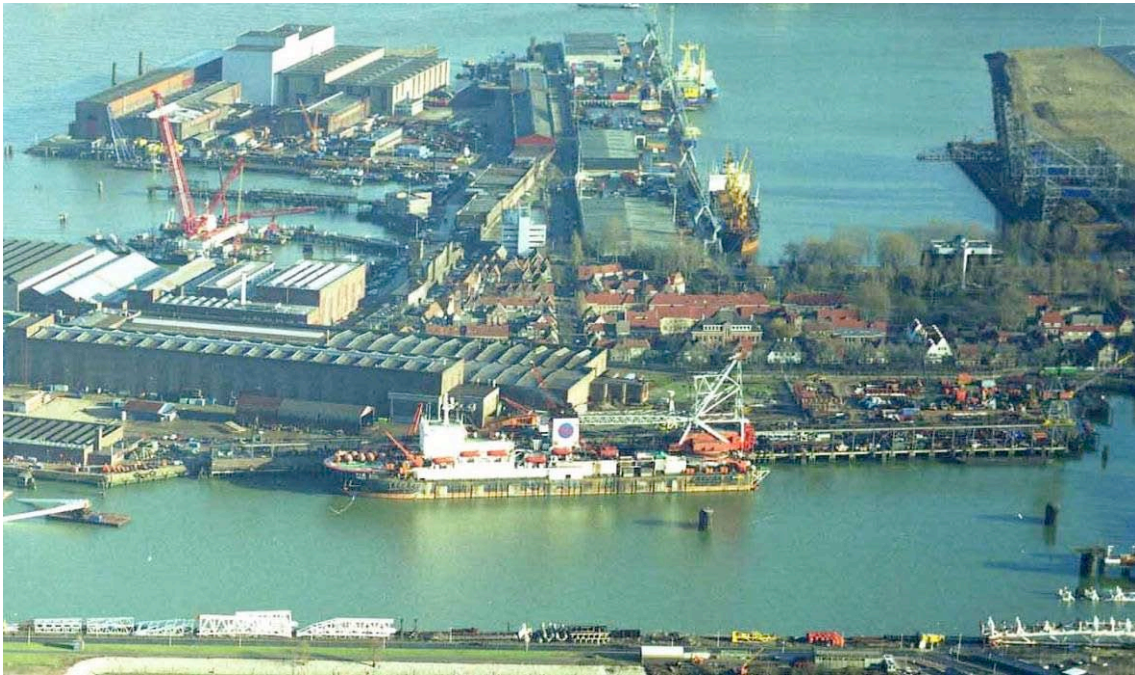
At the premises of the former Rotterdamsche Droogdok Maatschappij (RDM or Rotterdam Dockyard) shipyards in Rotterdam Heijplaat, a case as the above occurred. A deck on piles was no longer in regular use and appeared in bad technical state. This quay-wall, called “kraanbaan 13” (in Dutch) or crane track 13, had originally been in use as ship repair facility. After bankruptcy of the shipyards in the mid 1990s, the terrain was largely dismantled. During this time, the quay was used by a demolition company to ship off heavy steel structures, and it was specifically this use that caused damage to the deck and piles.

*Figure 1. “Kraanbaan 13” with crane vessel during the early 80s.*

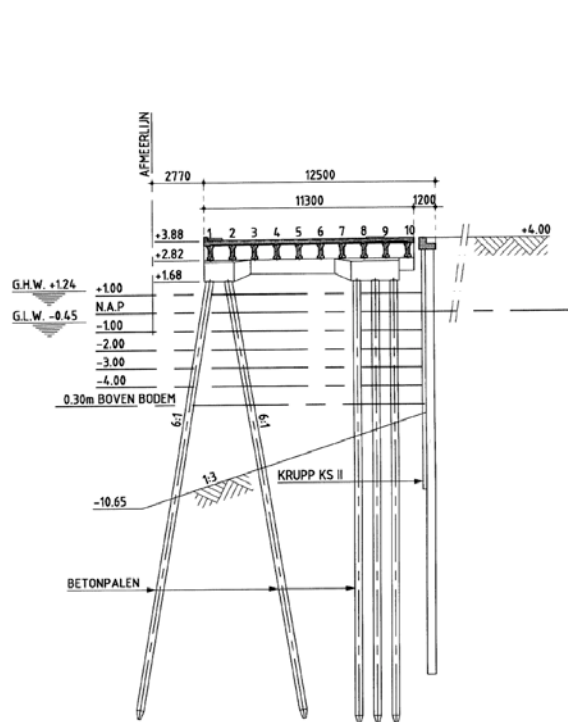
Figure 2. South section design (cross section, not to scale)

- At the South section, 13 foundation piles were found to be broken or completely missing, with another 9 piles damaged (of total 226 piles). 17 I-beams were broken or severely damaged, with another 6 damaged (of total 187 beams). The bituminous deck wear layer was severely damaged. The concrete underneath the wear layer however, was in good state. Chloride intrusion into the concrete was limited throughout the structure. Deck, I-beams, supports and piles generally were in good condition. No polycyclic aromatic hydrocarbons were found in the bituminous wear layer. The presence of asbestos was not suspected, after an inspection by others;

- Replace front I-beam over entire length with new beam, and repair deck behind it;
- Replace limited number of damaged I-beams in the deck, and repair deck around these;
- Add supports of steel tubular piles and bracings to the trestles with damaged/missing piles;
- Local concrete repairs after carbonatation / chloride initiated corrosion of reinforcement;
- Remove bituminous wear layer on deck. Apply antiskid epoxy coating directly on concrete.

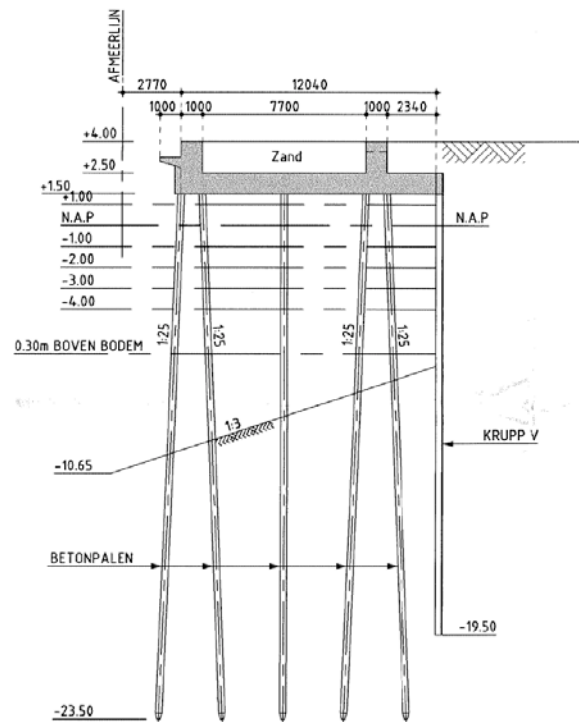
Figure 3. North section design (cross section, not to scale)

- At the North section, the pavement was almost entirely missing. Steel railings were in very bad technical state. But although a lot of local damage was visible to the concrete, in general the North section appeared in good condition;
