Preface

This analysis book is made during the graduation studio *AR3AR111 Zutphen Sustainable City*, in the academic year of 2017-2018. This studio is part of the Heritage & Architecture Master track of the TUDelft. This book is part of a series of analysis on several buildings in the the Nieuwstad, a neighbourhood in the city of Zutphen. The aim of this analysis is to grasp the identity and character of this area.

Technical Analysis

This part will focus on the technical aspects of the buildings. The structure, materials, damages and services will be analysed to get a grasp on the buildings structure and conditions for interventions in the future.

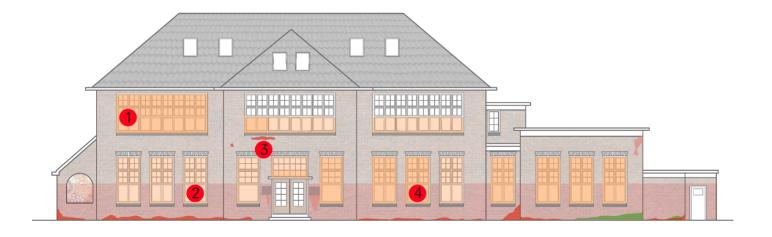
Image 155 Damages window frame St. Jozef (Own photo)

a state of overall decay, mainly due to showing the average state of St. can be spot spontaneously the presence of wood rotting and fungus Joseph's openings, related with on the exterior wall surfaces, growth as well as paint detachments, paint detachment and wood quality mainly just below the window Traces of recent repairs can also be seen. alterations. The edges of the window lids. This location could support

The windows at the top floor level pose An example of a window frame Deposit of a white substance ceramic sill are also partly broken.

the assumption that the effect is related with high humidity levels and the splashing of water on the bricks. Chemicals analysis and moisture content level tests should be done to invest if the deposit is calcium or natrium (most likely) based.

A considerable number of St.Joseph's windows present a serious state of decay. The major source of damages has to do with wood-rot, leading in disintegration of the frames and in many cases white fungus growth. Paint detachment and colour disintegration are damages caused by the high moisture levels of the wooden elements. Extent of damage of windows marked with darker shade of orange is such that immediate repair actions should be taken.

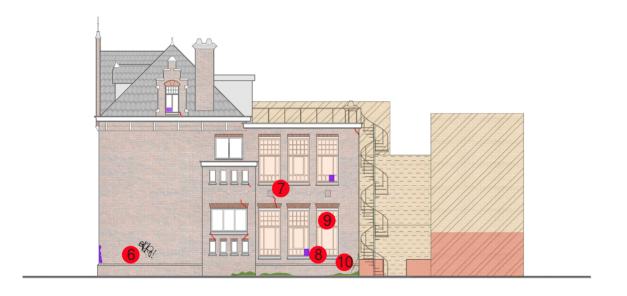
Two cracks derive from the upper corners of the window lintel and extent towards a ventilation opening. It's probably a localized structural failure due to inadequacy of the opening to support the load stressed to it. The red brick lintel is propably intended for ornamental purposes, having not any particular reinforcement behind. Potential repair strategy could be to reinforce the lintel with metallic bars which tight it together while transfers the load at the sides of the opening.

The blue Belgian limestone window sills at the openings of the lower level present a series of cracking, as a result of localized structural failure deriving from stressed performed onto the surface from the window positioned above it.

The corner of masonry wall in present trashes of mechanical intervention since parts of bricks has been broken or removed. Given the height of this damage it could be caused by vehicles crashing on the surface or by careless movement of elements such as bikes or bins around those edges.

Some window present cracks or have some of their parts smashed. One scenarion could be that this is a result of vandalism or mistreatment by the students, while a second cause could be related with the overall decay of the window leading in failure of the rotted wooden frames to support the glazed elements.

Around the whole periphery of the 2001 school building extension a layer of dense white deposit finishing at exactly the same high is present. (Look case study no.15 for furter analysis).

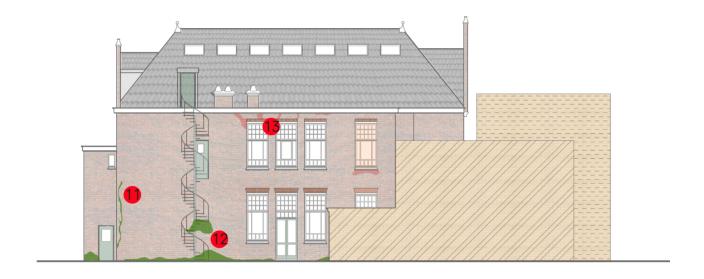
Graffiti can be found covering part of the eastern wall surface of this build extension. Methods such as water jet cleaning, shooting onto the wall with lasers and clorium based chemical application can be among the solutions for their removal. The small extent of the graffiti however most like would request for the application of a soluble substance, such as the latter, in order to weaken the paint bonds and lead to its removal.

A crack connects the sill of the upper window with the lintel of the lower one through the ventilation openina. Localized structural failure which becomes visible at the weakest points.

Just like in the examined case no.4 the parts the window openings have been brutally overall, yet average in extent image of crashed, allowing in this instance room only decay, primarily related with wood rot, for the scenario of mechanical damage paint detachment and in some instances caused either by accident or by throwing disintegration of the bonding between heavy elements directly onto the glass the wooden and glass elements. Repair and restoration action should be taken to prevent deterioration of their state.

Algae and biological growth is evident at the lower level of the wall surface most likely due to gathering of rain water and high moisture levels at this spot.

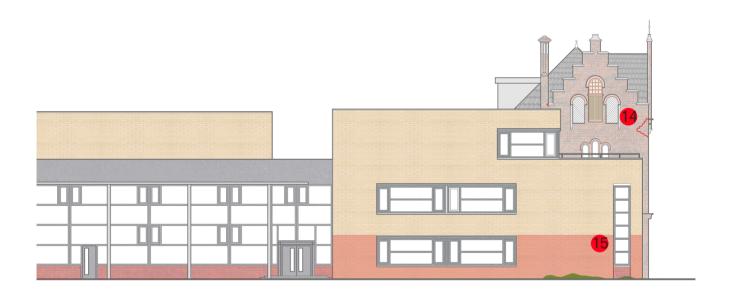
Being the corner just around the case examined in picture no.10 biological and green algae growth on the brick surface can be spot. The location being just next to the rain water gutter makes the conditions ideal for organic growth since moisture levels are high. The plants should be removed before they affect with their roots the foundation .

A white colored substance can be found to concentrate on localized spots just below the roof gutter. The look of it from a distance give the impression that it has a hard textured appearance, fact supporting that this could be a calcium based deposit. Clorium based test should be done in order to define if it salts or calcium, and accordingly propose treatment.

Dense mass of green algae is visible in the area below the spiral staircase and on the brick surface where it is attached on the walls. The location is ideal for their not only because water is expected to be collect there but also because the shadow casted by the stair delays the process of surface drying and creates semi-lighted environment perfect for bacteria growth.

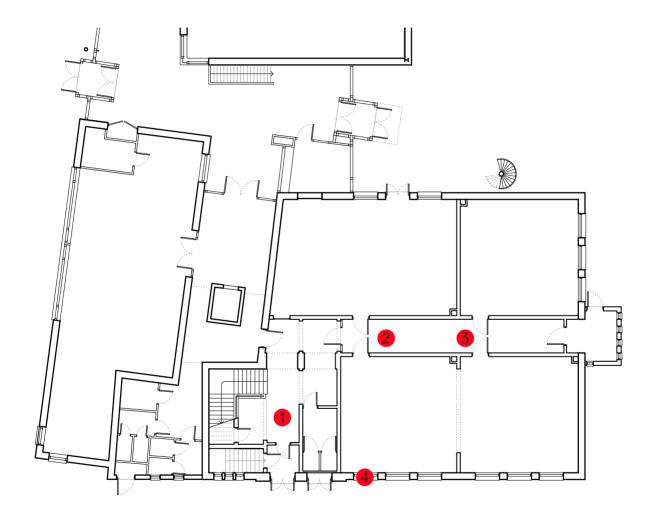
Here we find an extensive wall cracking presenting a V shaped pattern. Most likely scenario is that the cracking is result of a structural failure due to loads stressed by the pitched roof of the building at its façade. The exact location of the cracking is the point where the wooden rafter of the roof is resting on the front façade. As a result the façade structure failed to adequately support this lateral loads and lead to cracking. This potentially could be a serious damage since it may result in detachment of this part of the wall and cause roof structure instability.

Around the whole periphery of the building a layer of white deposit finishing at the same high, is causing a continuous effect. A hypothesis could be that this is a kind of anti-graffiti coating applied to prevent acts of vandalism. On the other had given the fact that the brick walls where built on site, this effect could be result of the nature of the extruded bricks used, and that the level where this effect stops reflects the fact that the builders moved from one brick palette to another, using bricks with the same look but with different properties. A chemical analysis and testing on both bricks and white deposit should be done to subtract further information.

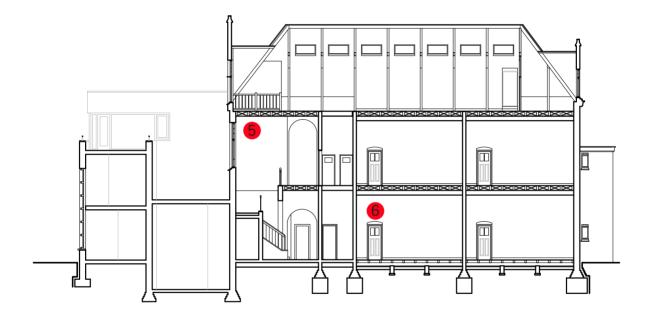
Image 171 Cracks in terrazzo flooring

The cracks in the terrazzo flooring could be caused by different reasons. Either the subflooring concrete slab is uneven and thus the terrazzo cracked under pressure, or the sublooring has been subjected to high levels of moisture, or it did not have the chance to fully bond.

Image 174 Damage on window frame

The damage on the exterior side of the window frames is visible on the interior side as well, which also shows signs of decay.

Image 172 Damage on ceiling

The white deposites formed on the plaster surface suggest high levels of moisture and probably the presence of salts. The cause could be water leakage. Further invesigation would prove whether this damage is related to efflorescence or something else.

Cracks have been formed at the upper part of the walls, specifically close to door openings. These kind of cracks are presumably relief joints. These joints move during the changing of the seasons as indoor and outdoor humidity levels change
