# White Etching Cracks in wind turbine bearings

## Department of Wind Energy Master Report

DTU Wind Energy-M-0131

August 2017

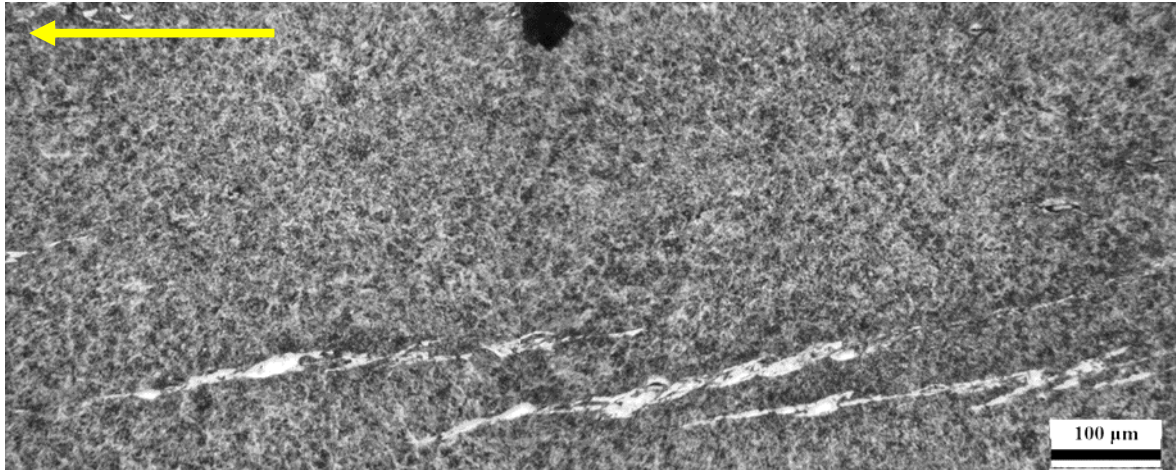
Figure 17 Region of interest for tomography scan.

Figure 16 e) is of interest as it shows an inclusion with a crack going through it and a WEA around the crack. The black dots are the result of an aggressive etching, indicating a possible DER. A region with several cracks was chosen from the sample to perform a tomography scan as shown in Figure 17 where the yellow arrow shows the possible rolling direction and results are presented in Figure 18.

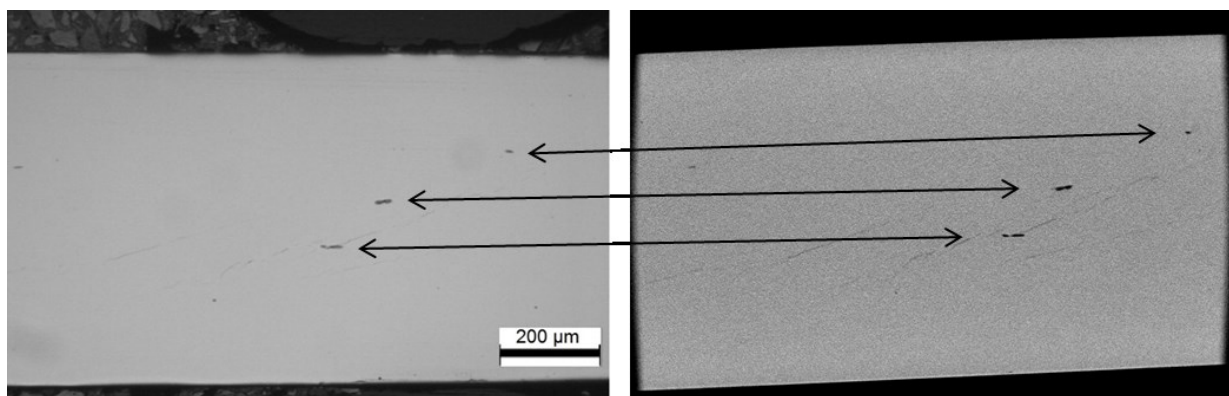
Figure 18 *a)* shows the same view as presented in Figure 17 while Figure 18 *b)* shows the sample viewed from the raceway perspective (top view). It is noticeable that the scan shows the butterfly cracks running parallel to each other, this was later confirmed by serial sectioning. The angles at which they are propagating are well within the range described by other authors, 30° to 50°. The inclusions interacting with the cracks were colored white and artificially enlarged as to make them visible by the region growing segmentation method. Although the segmentation method could not catch all the details of the butterfly cracks, it showed characteristics that otherwise could not be observable. More importantly the results were used to reveal the enlarged inclusions and four regions of interest were identified for serial sectioning. The first revealed surface by optical microscopy shows a remarkable similarity compared to the tomography scan, marked (*I*) in Figure 18, and in the future referred as surface (*I*), the results are compared in Figure 19.

**Figure 19 Comparison of OM (left) vs results from tomography scan of surface (*I*) (right)**

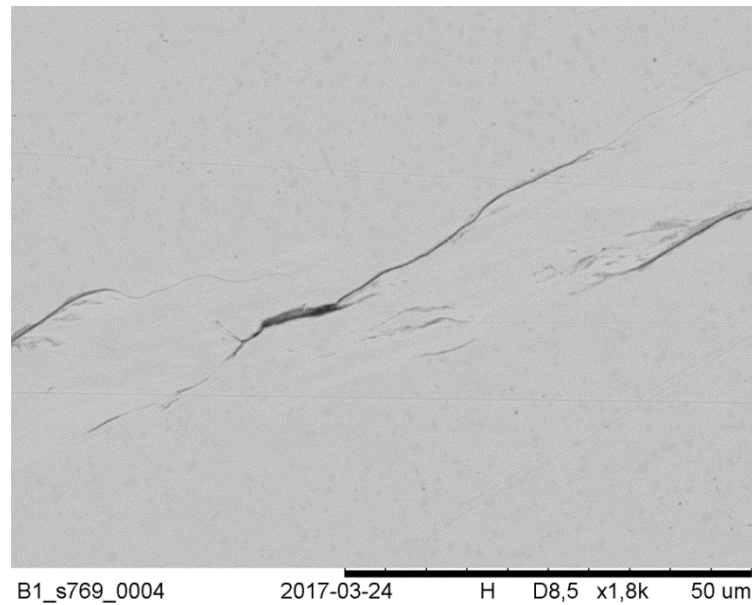
Similarly, Figure 21 shows the second revealed surface as shown in Figure 18 *b*) and labeled as surface (2).

**Figure 21 SEM results for revealed surface (2) as shown in Figure 18**

The EDS results for surface (1) showed two elements, manganese and sulfur, suggesting a manganese sulfate inclusion, on the other hand, results of surface (2) showed a high carbon content, suggesting a graphite inclusion or sample contamination from the epoxy used, the EDS results are shown in Figure 22.

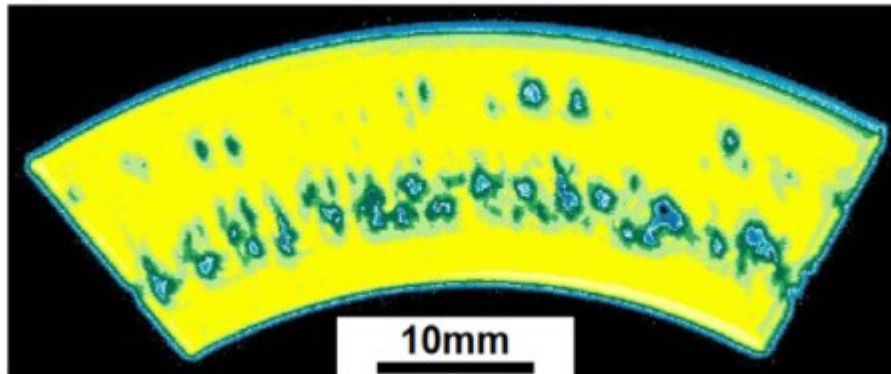
The sample was tested in a FE8 test rig in RWTH Aachen University, Germany with the following operational conditions: axial load: 80 kN (max. contact force), rotational shaft speed: 300 RPM, bearing mass temperature: 100°C, oil flow rate 0.25 l/min and an averaged specific film thickness ratio of: 0.59 [35]. The sample was cut to observe the most damaged region according to an ultrasonic measurement as seen in Figure 24, this experiment was not conducted during this research and results are just shown.

**Figure 24 Ultrasonic results showing the most damaged area of the raceway [35]**

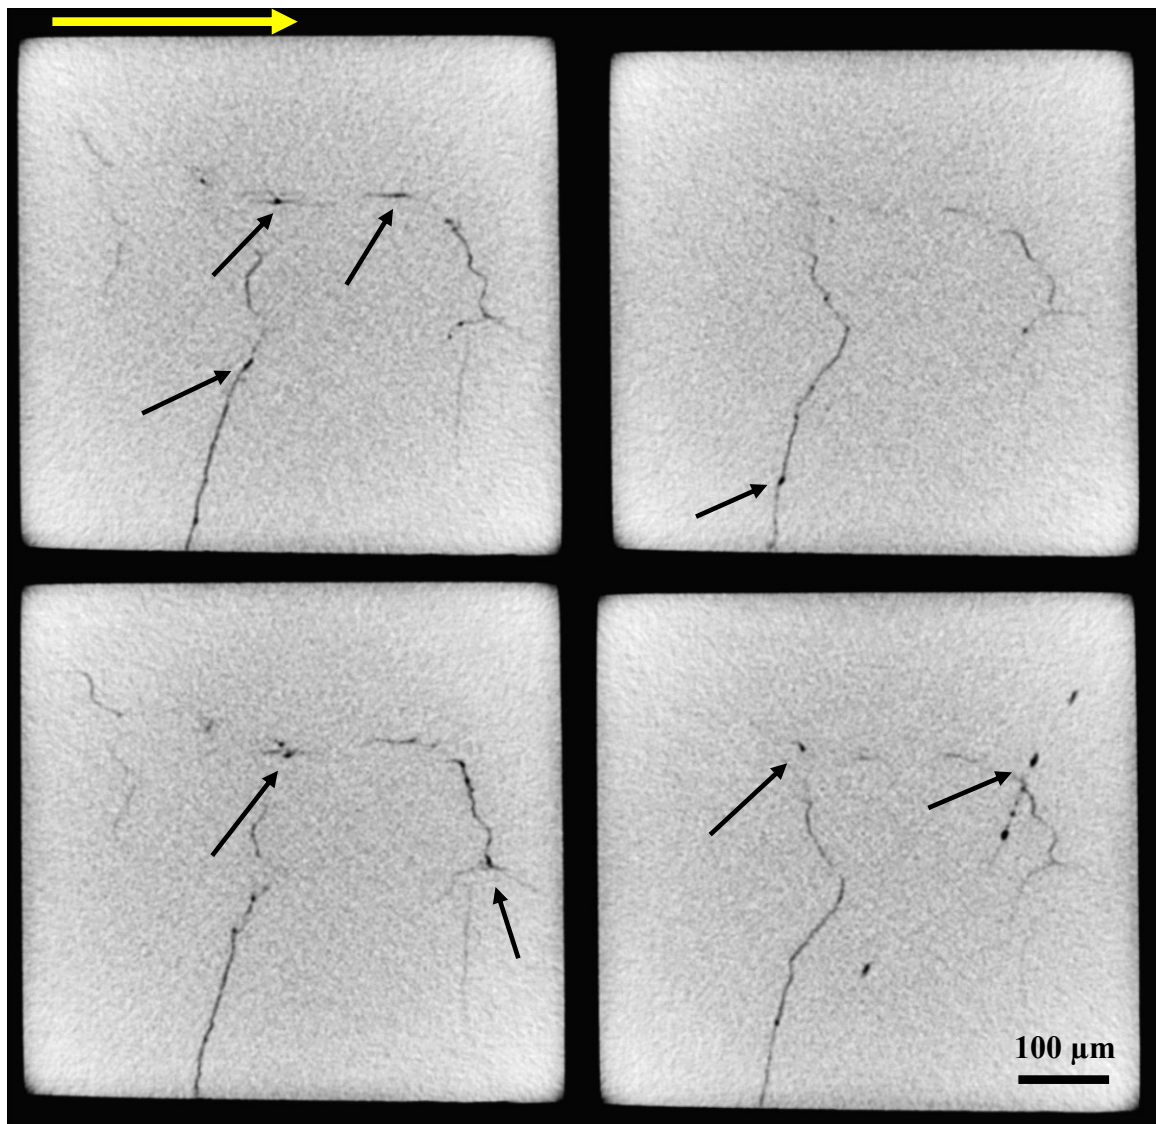
For the serial sectioning a sample was obtained and it was previously studied in [35]. This sample had already been scanned under the tomography, but the raw data needed to be processed to achieve the desired contrast and ease in the matching of images obtained from the OM. In the tomography results it can be observed some interaction between the cracks and voids or inclusion-like particles, as seen in Figure 29 and highlighted by the arrows, yellow arrow indicates rolling direction.

**Figure 29 Tomography scan results from an axial bearing tested in a FE8 test rig**

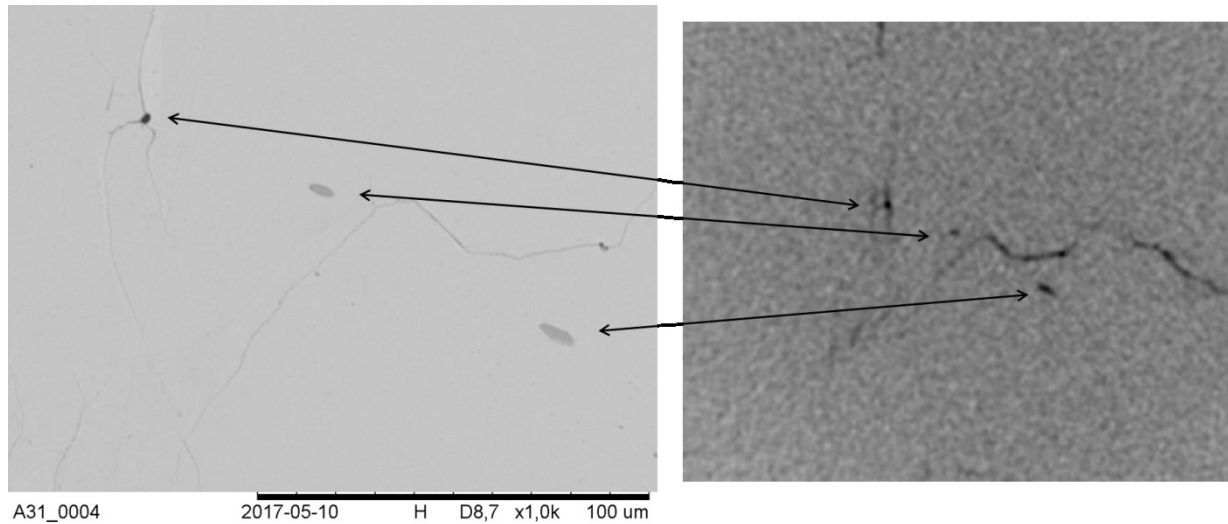
**Figure 30 Comparison between SEM image (left) and tomography scan (right)**

Although it is not an exact match, three inclusions are seen in both images, the discrepancy might be due to the tilting of the sample while pressed in the mounting process. So, the orientation of the physical sample and the data will not match exactly, still the same features can be observed and it was possible to distinguish the position of the cross section and was confirmed by other unique features observed above and below the encounter of this cross section. Once the sample surface was matched with the tomography scan it was not necessary to measure the depth of the polish via a hardness indent or a micrometer. The voxel size of the data set, 0.48  $\mu\text{m}$  for this case, will indicate the depth of future polishing stages and thus reducing the time of the serial sectioning process. Of special interest is the chemical composition of the inclusions observed on the crack and highlighted in a red circle in Figure 30 showing a triple junction and an inclusion-like feature in the middle. The EDS results showed the presence of carbon as shown in Figure 31.

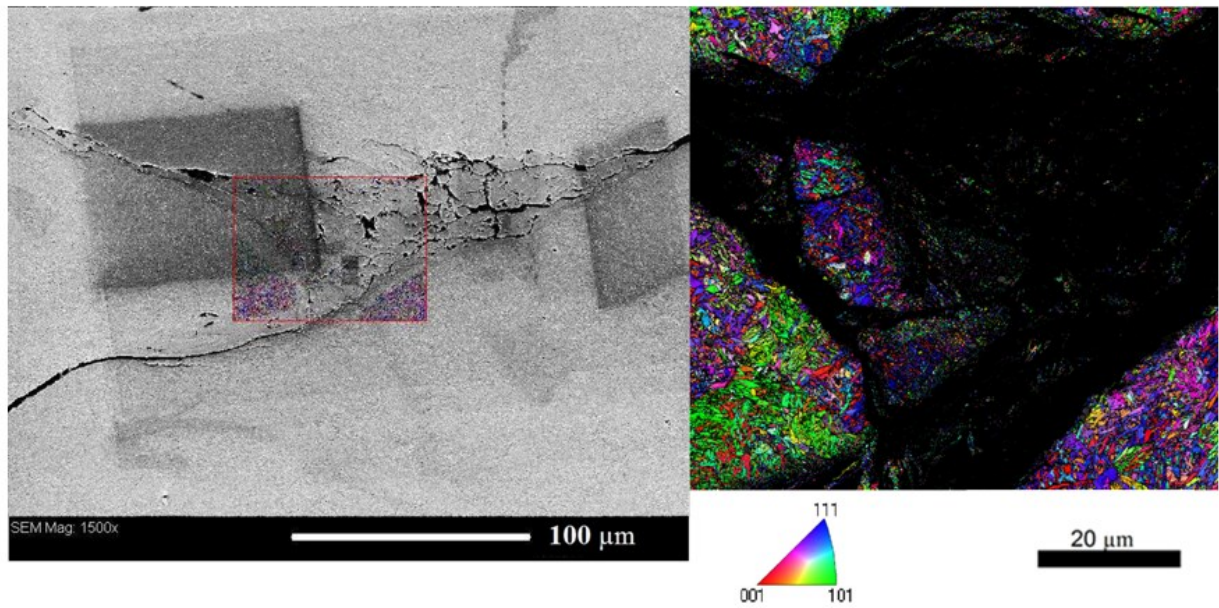
The pattern on the crack shown in Figure 32 *a*) might had been an indication that the crack was extending along prior austenite grain boundaries, thus an EBSD test was conducted with a step size of 0.05 μm, however no significant results were obtained due to heavy plastic deformations and a considerable decrease in grain size as shown in Figure 33.

**Figure 33** Overlay of EBSD results on top of a SEM image (left) and EBSD results corresponding to an iron BCC matrix (right) region shown in Figure 32 *a*)
