### A case study of St. Christopher in Maria Church, Nisse

# Application of shearography and the percussion method for the structural inspection of wall paintings: a case study of St. Christopher in the Mariakerk, Nisse

Valentina Gatto\*<sup>a</sup>, Andrei G. Anisimov<sup>b</sup>, Wouter Lettinga<sup>b</sup>, Nan Tao<sup>b</sup>, Merel Lantman<sup>a</sup>,  
Roger M. Groves<sup>b</sup>

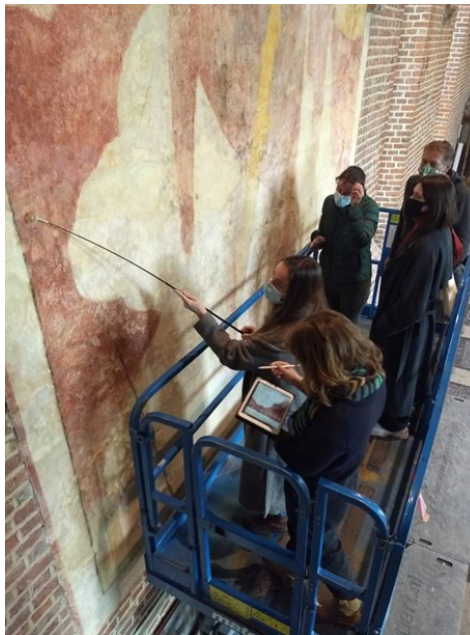
Figure 2. Percussion testing in Maria Church, wall painting depicting St. Christopher.

The percussion tests were executed in a collective approach, in order to reduce biases and subjective inclinations (Figure 2). After the tapping or the rolling of an area had occurred, the generated acoustic reactions were discussed and subsequently mapped (Figure 4 (a)). It can be easily observed that the implementation of the two percussion methods, despite involving the same mechanism of interpretation and collection of data, gave somewhat different results (Figure 4 (a)). It can be stated that the percussion method involving the tapping of a nail resulted in identifying more areas with delaminations than the percussion methods involving the rolling of the acoustically isolated plastic ball. In overall, some similarities in the results obtained were observed, especially in areas surrounding the wooden lintel, part of the door underlying the wall painting of St. Christopher (left and right side on the lower part of the wall painting in Figure 4 (a)).

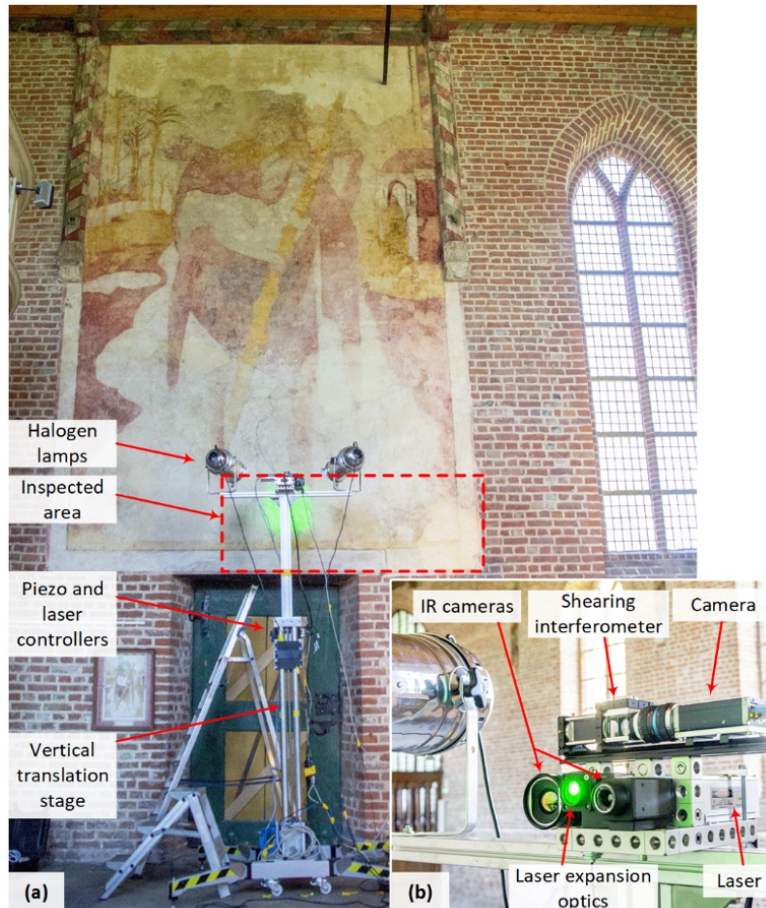
Figure 3. Testing campaign at the Maria church: (a) the overview of the shearography instrument mounted on a translation stage and the inspected area, (b) shearography instrument with a Michelson interferometer and IR cameras.

During the inspection, the shearography instrument was mounted on a motorised rigid platform (Figure 3 (a)) that provided scanning in the vertical direction. The horizontal scanning was performed manually. The individual field of view was approx.  $400 \times 335 \text{ mm}^2$  (green square illuminated by the laser in Figure 3 (a)). Two halogen lamps of 1000 W each were used for the heat excitation of the painting and its internal structure. Two infrared (IR) cameras (A615 and A65 both by FLIR) measured the surface temperature during heating and cooling.
