Explosion Hazards of Aluminum Finishing Operations

Jérôme Taveau ^{a,b}, Simone Hochgreb ^c, Saul Lemkowitz ^d, Dirk Roekaerts ^{b,e}

Abstract

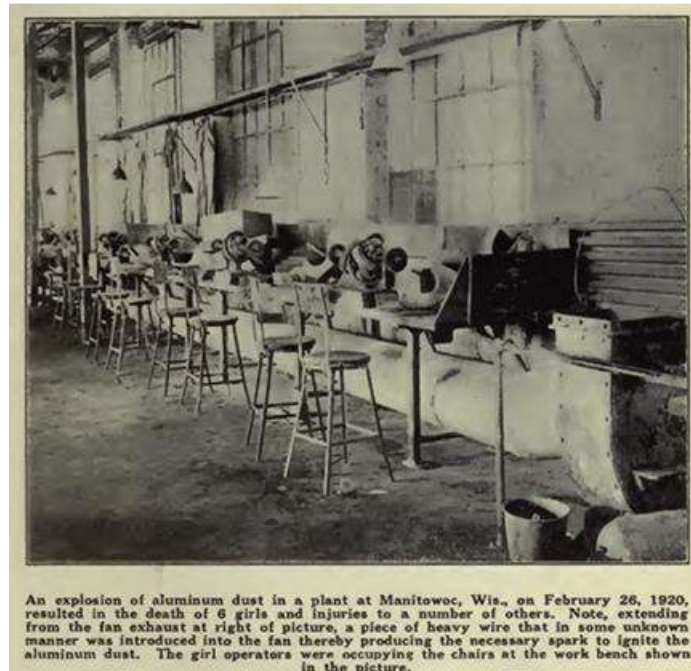
One of the first documented aluminum dust deflagration was reported by Price and Brown (1922) in the USA. The accident took place in the polishing workshop of a manufacturing plant located in Manitowoc, Wisconsin, on February 26th, 1920. Aluminum dust was drawn away from the polishers into a suction system which discharged into the open air. A heavy piece of steel wire fell into the exhaust pipe and struck the fan, striking sparks which ignited the dust. The explosion propagated back through the suction system and into the room (Figure 2), causing an explosion which was so violent that it was heard at least two miles from the plant, killing six operators.

Figure 2. Picture of the manufacturing plant located in Manitowoc, Wisconsin (Price & Brown, 1922) showing the work stations

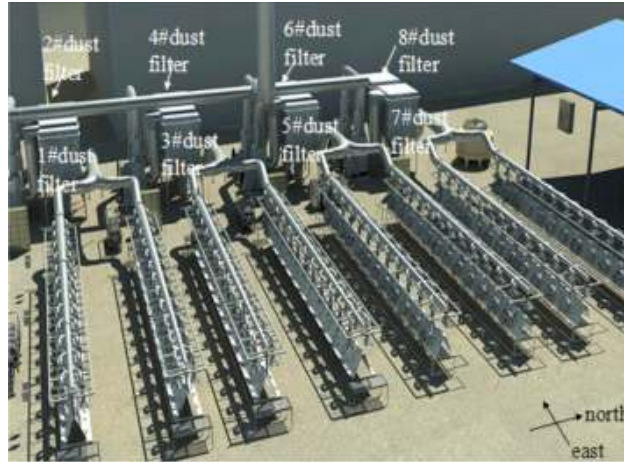
On August 2nd, 2014, an aluminum dust deflagration took place in an automotive parts factory of Jiangsu province, killing 146 people and injuring 114 people (Li et al., 2016). The explosion was heard several kilometers away, and shattered glass up to 500 meters away (Figures 7).

Figure 7a: Production lines with work stations (Li et al., 2016)
