Safety and Health Concerns for the Users of a Playground, Built with Reused Rotor Blades from a Dismantled Wind Turbine

2020

Sustainability

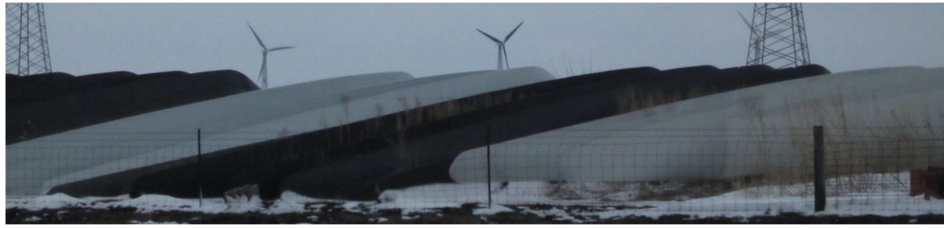
Figure 1. Rotor blades stored on a field before being transformed in components for the playground ('03.02.12-Wind Turbine Blades' by 'kristinefull' is licensed under CC BY-SA 2.0).

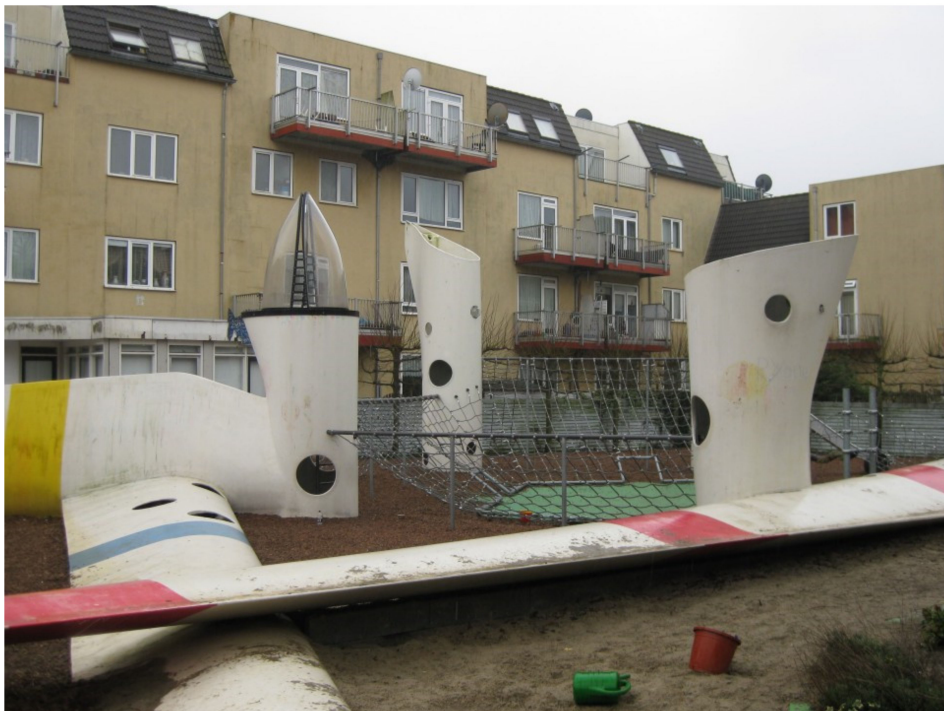
Figure 2. The “Wikado” playground, composed of rotor blades painted in white with coloured stripes (Photo by Carolyn Butterworth, 2011).

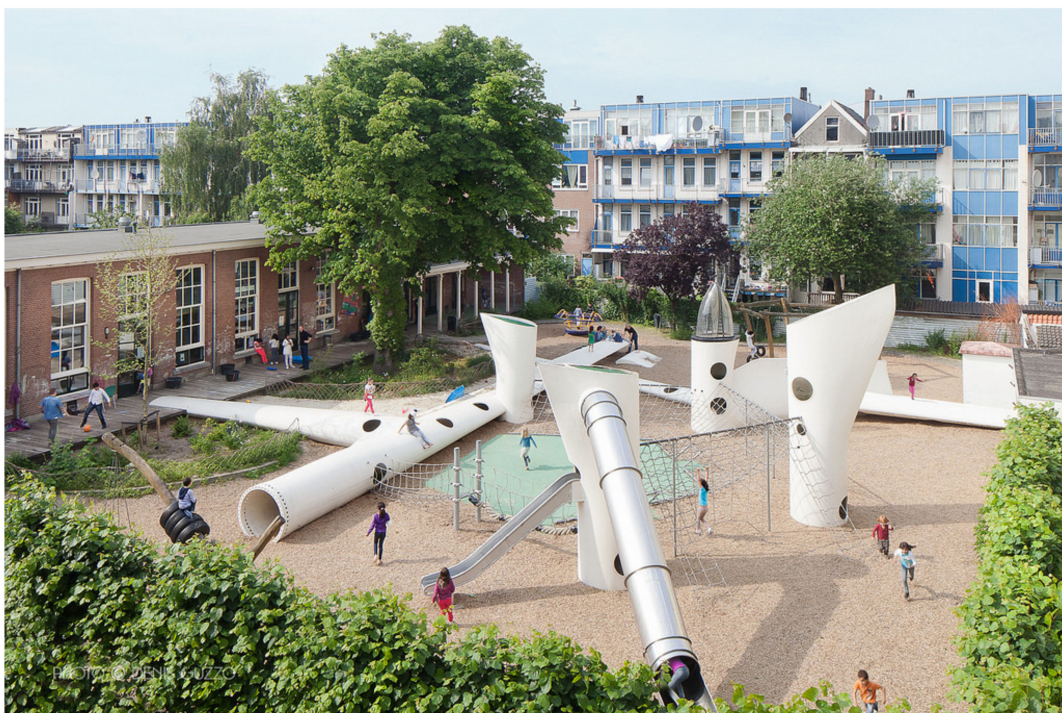
Figure 3. The playground Wikado after the application of the new external layer of coating and paint in 2012. Most of the components of the playground are reused rotor blades, such as the four towers, and the six parts lying horizontally. (Photo by Denis Guzzo, 2014).

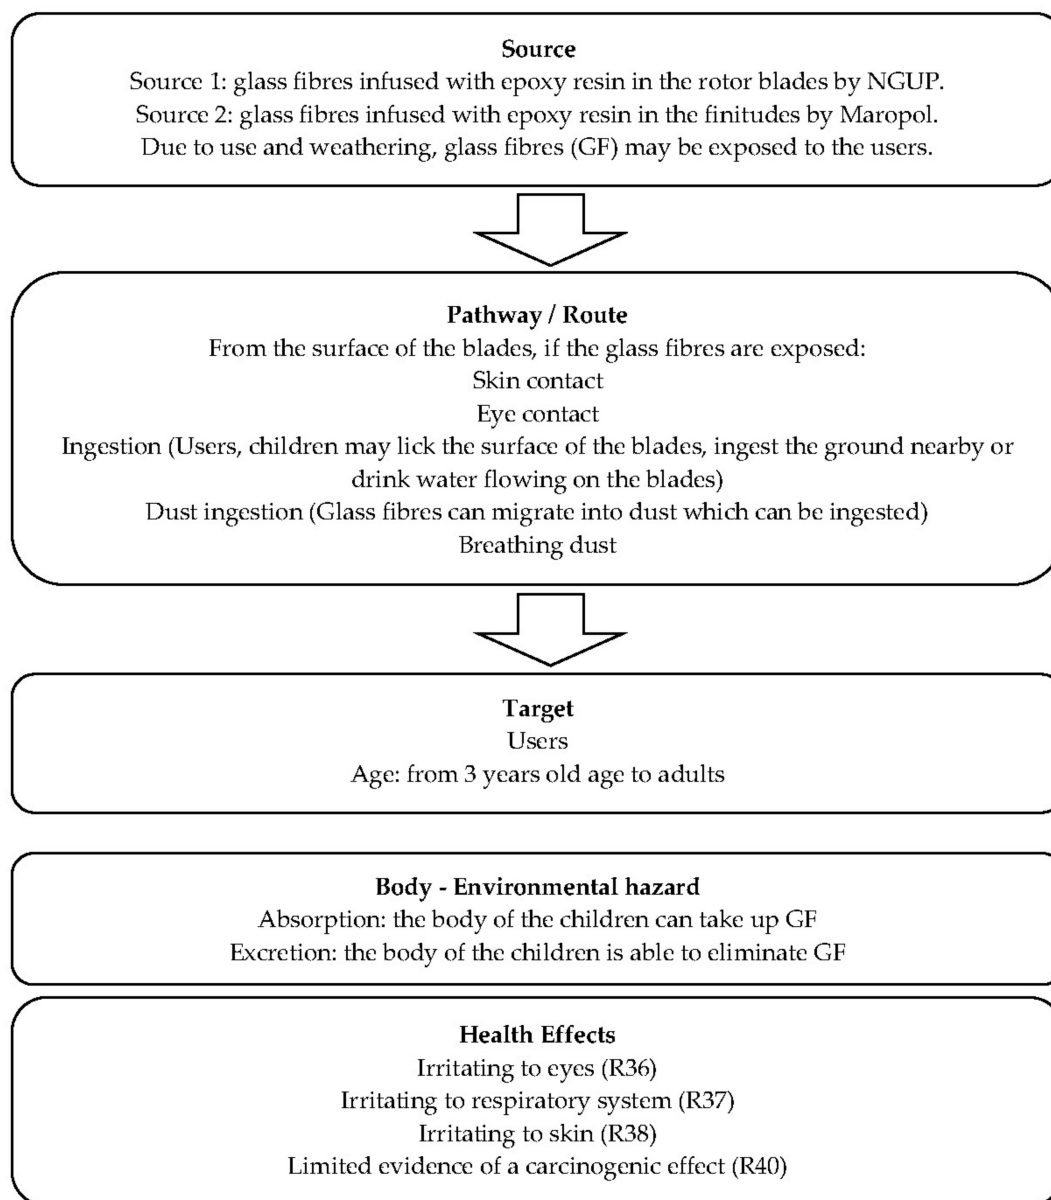
Following this formula, it was possible to trace a conceptual model (Figure 13) of glass fibres representing a health risk when exposed to the users [11–14]. The risk assessment model was derived from literature regarding Human Health Risk Assessment and human exposure to chemicals [11,12].

Figure 13. Conceptual model of risk assessment regarding glass fibres.

The primary risk for the users of the playground is the contact with the exposed glass fibres that are sharp and able to cut the skin. If the glass fibres were exposed massively, the playground users could inhale or eat thin parts of them. The human skin could absorb particles of glass fibres, causing an irritation known as fibreglass dermatitis (an article entitled “Fiberglass Dermatitis” stated that “the most frequent health hazards due to glass-fibre exposure are represented by skin lesions, commonly known as fibreglass dermatitis. The basic pathogenetic mechanism of fibreglass dermatitis is represented by penetration of fine, sharp particles into the skin causing mechanical irritation. It is

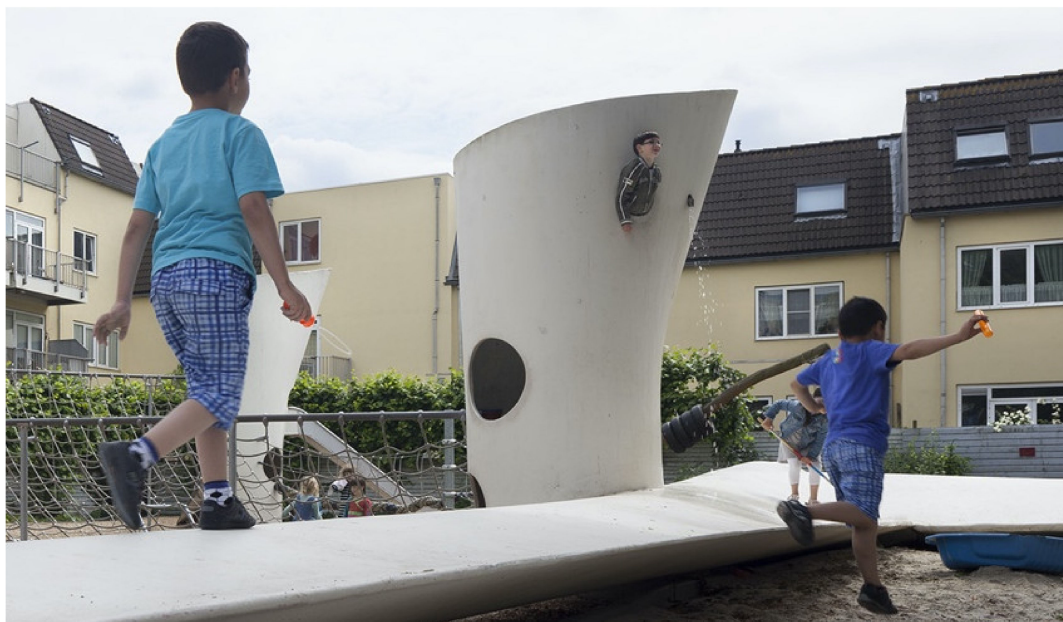
Figure 21. Water flowing on the blade, from the fountain located on top of the tower (Photo by Dennis Guzzo, 2014).

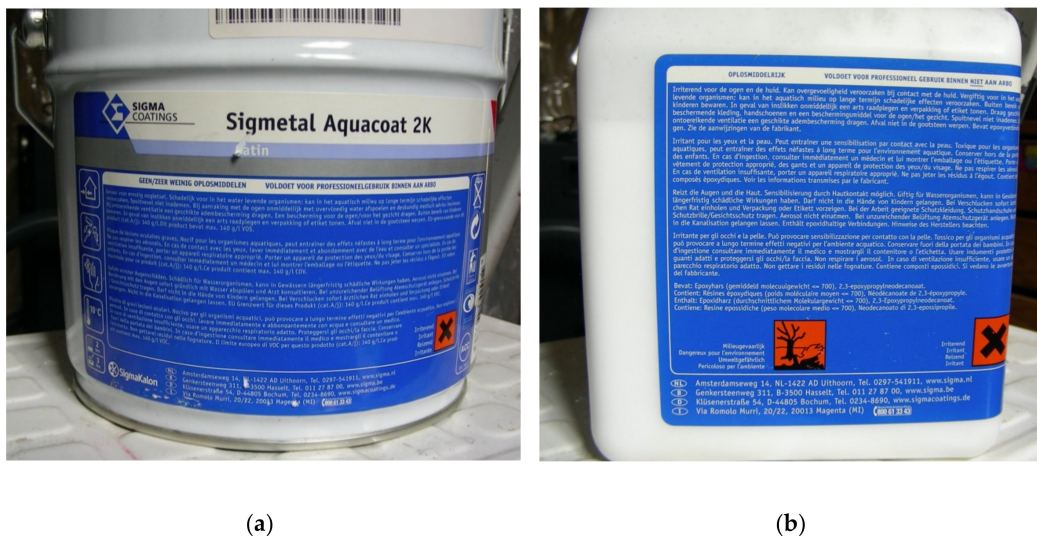
Regarding the possible human health concerns for the users, the yellow drops of Wikado could contain epoxy resin. This is because the epoxy resin was present in the original rotor blades by NGUP, in the finitude made by Maropol (type THV 500 and 600), and in the hardener of the painting applied

by the caretaker. He used three quarters paint and a quarter hardener composed of epoxy resin and 2,3-epoxypropyl neodecanoate (Figure 28a,b).

Figure 28. (a) Paint used by the caretaker; (b) hardener applied by the caretaker (Photos by Piero Medici, 2011).
