Fieldwork Report

Multidisciplinary Project

Hanoi, Vietnam

October 2013

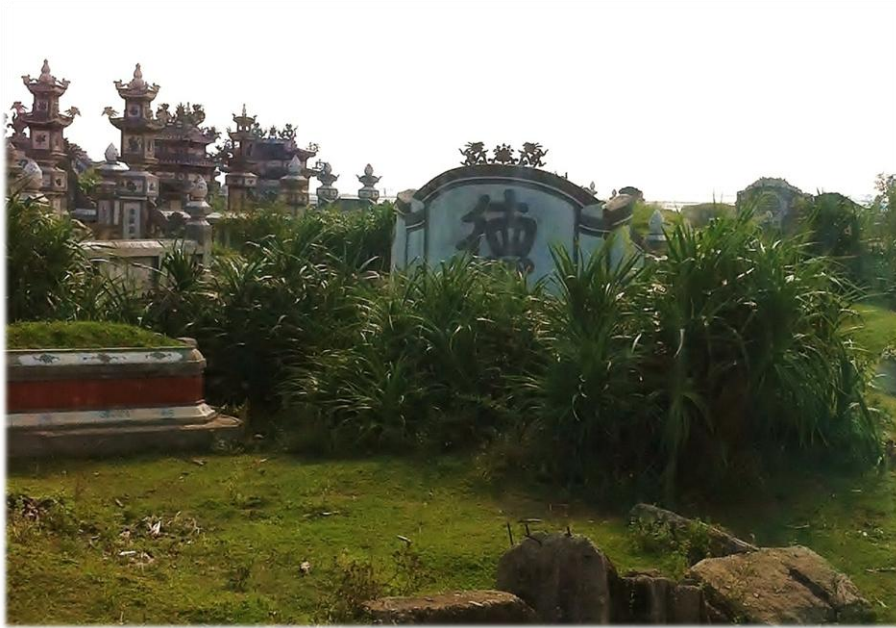
The lagoon has some main functions, of which the most important are rice paddies and shrimp farms. A use of land that was not expected on forehand was the enormous confiscation of land area by tombs. Almost all of the families in the region have a family grave, which results in an endless sight of tombs in the lagoon (Figure 3).

Figure 3: Photo with some examples of tombs present in the lagoon. The whole lagoon is filled with this kind of structures.

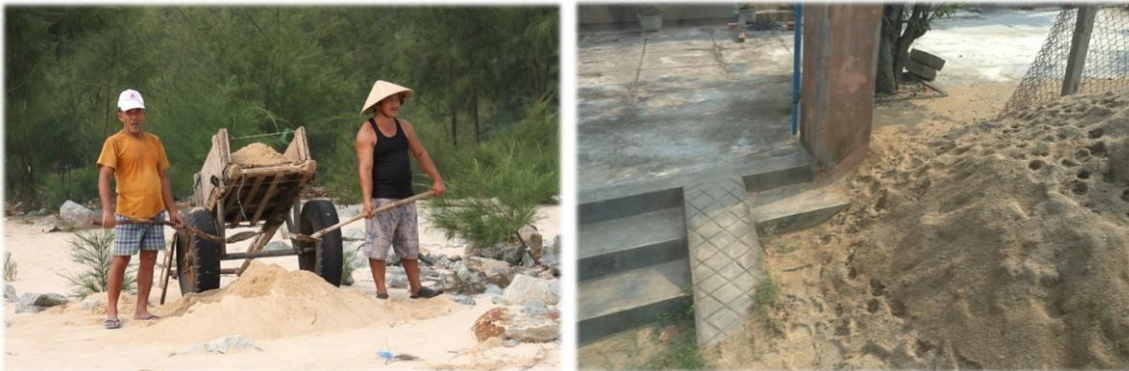
- Sand from the whole coastal system is used for construction works: every family has a hump of sand in front the house (Figure 4);
- Presence of a lot of litter: plastics, shoes, paper, crates etc. (Figure 5);
- Use of plastics for the construction of small sand dams;
- All constructions made (dams, houses, farms etc.) are improvised with materials present in the surroundings, and as an understatement not so firm;
- A lot of constructions wrecked during previous flooding were still standing in the area;
- At the time of visiting severe swell waves were hitting the coast, causing wave in the order of 2 meters high.

Figure 4: Small scale sand-excitation of the beach. Almost all of the houses in the village have their own pile of sand, excavated from or the sand dunes or the beach.

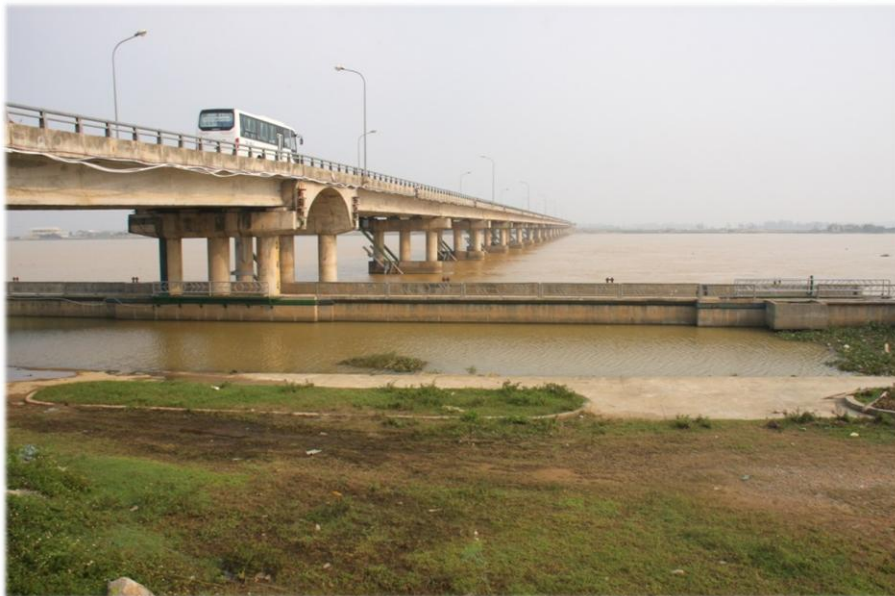
Build for stopping salt intrusion, this dam consists of 15 gates which can be closed to stop salt wedges moving upstream (Figure 6). Beside the gates a ship lock is present (dimensions 8 x 31.5 meters, with a height at that moment of about 9 metres) to maintain navigation possibilities during the dry season. Since the dam is not that high, only small ships can pass, which restricts the development of a harbour upstream.

- The river near the dam was about 500 meter wide, 7 meter deep and had a flow velocity of order 0.4 m/s;
- Some housing near the dam is placed on quite low land, which will be flooded regularly. In addition, the distance to the lagoon is only order 50 meters;
- The electricity supply towards the dams consists of 'open' wires, just hanging besides the road, and doesn't look like it is quite reliable.

Figure 6: Thao Long dam, build to prevent salt intrusion. In front the ship lock can be seen, in the back the 15 gates with hydraulic arms.

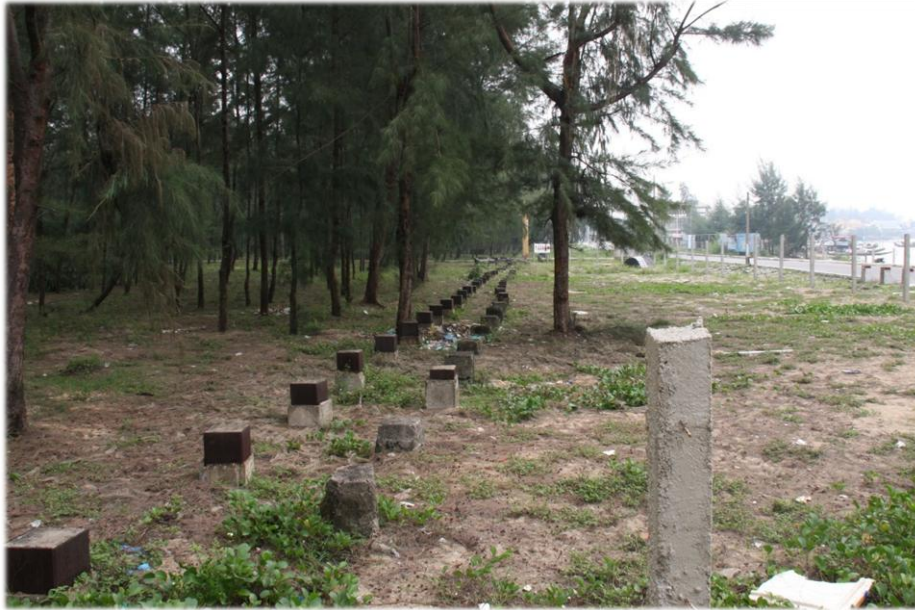
This old Hoa Duan breach (600 meter wide) was closed in 2000, after it opened in 1999 during the severe flooding. First a line of piles with rocks was constructed (Figure 11), after which sand was placed. Nowadays the constructed dam is designed at overtopping, without breaching, but it is still a weak spot in the whole sand barrier system.

Figure 11: The pile row in the Hoa Duan inlet, which served as a basis for closing the breach.

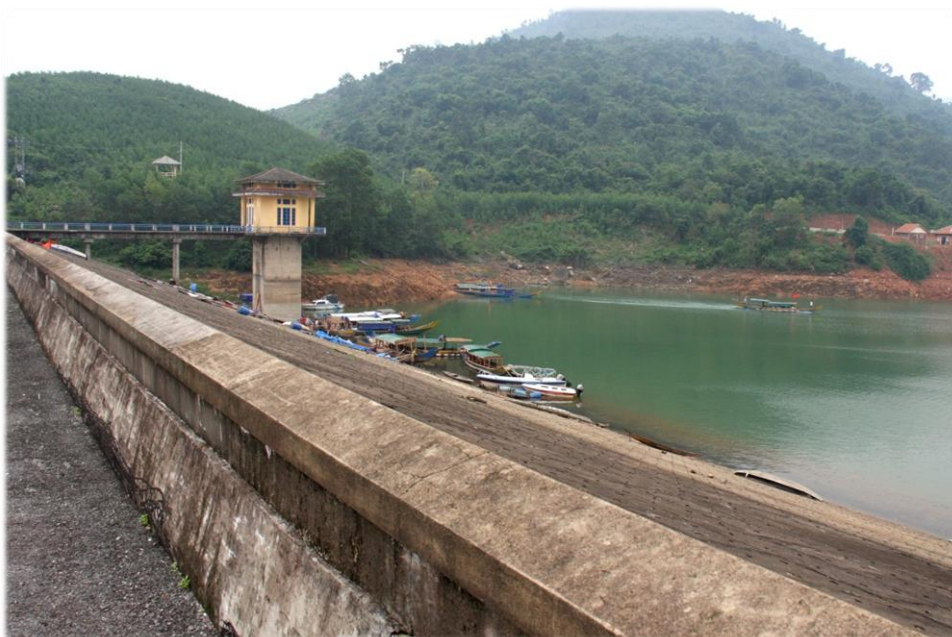
The Truoi reservoir consists of a large storage area and three separate dams, with a possibility for hydropower in the middle dam. The water level can vary about 5 meters (Figure 15), but stays about 15 meters below the top of the reservoir dam. Beside waterpower the lake is also used for recreation and touristic tours towards the Buddhist encampments in the centre of the storage area. In addition, the dam is used as a small scale wharf by construction boats on the lower side of the reservoir.

Figure 15: Maximum water level of the reservoir is indicated by the top of the red clay. The small wharf can be seen under the reservoir dam.

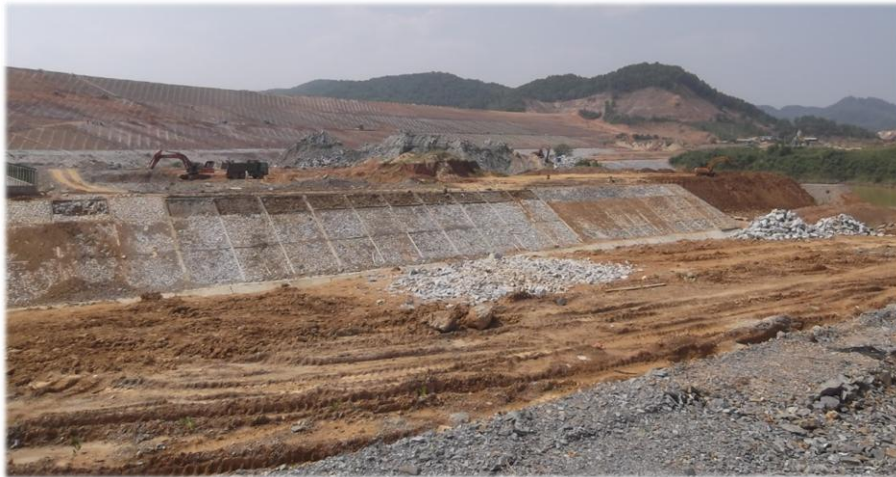
Figure 20: Ta Trach dam, with construction works in front of it.

Different from what was expected from the previous literature study, the Ta Trach dam appeared to be still under construction. The main dam, of about 300 meters, is already finished, but the spillway is still being constructed. The constructions for hydropower were already in place, as well as the electricity buildings to connect the dam to the power net.

The water level in the reservoir behind the dam appeared to have already stood a few meters higher than during the visit, probably with the purpose of a test. This could be concluded by the large amount of branches and other debris high on the reservoir banks. Some bank erosion could already be seen directly behind the dam, and the soil was very loose, eroding into the reservoir by the slightest of movements.

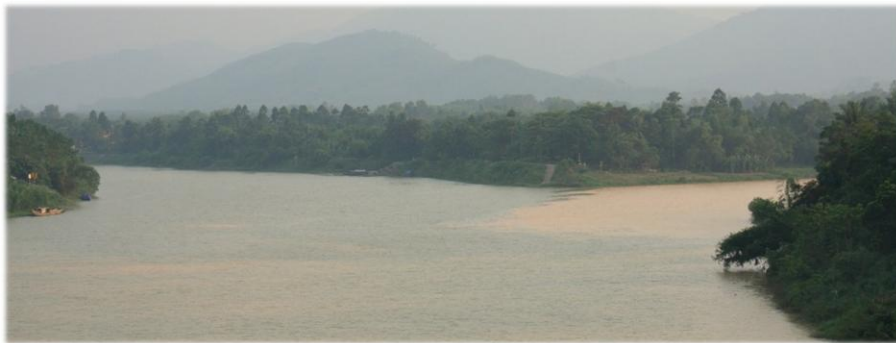
Figure 22: Confluence Ta Trach (left) rivers and Huu Trach (right).

At the confluence it could be clearly seen that, at least in this time of the year, most of the suspended sediment in the Huong river originates from the Huu Trach branch, see Figure 22.

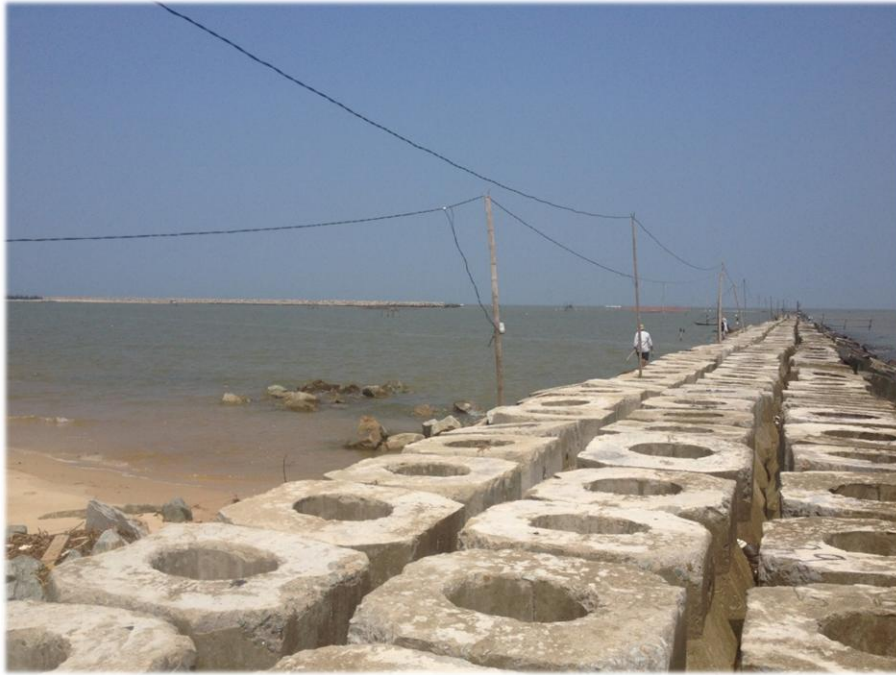
The water in between the two constructions has contact with the sea, because a piece of 200 meter of Tetrapods breakwaters is constructed at a few meters below MSL. This results in a basin with some exchange of seawater. The effect is that relatively small fish will live in this basin, which local fisherman try to catch. The sheltered environment is presented in Figure 31.

Figure 31: Sheltered environment on the left is suitable for fishery.

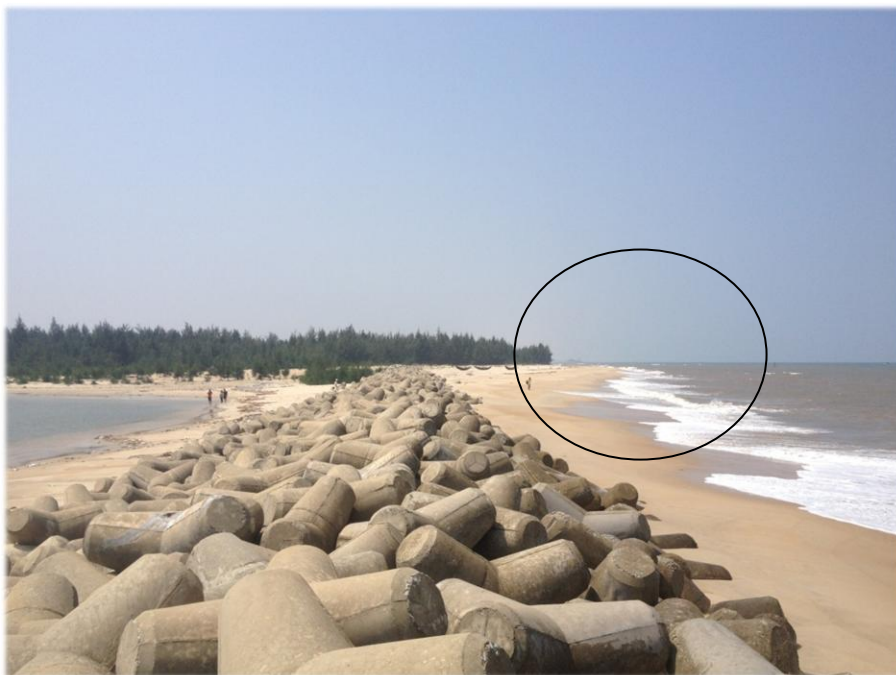
The northern breakwater is relatively stable with about four layers of regularly placed Tetrapod armour units. Near the coastline a lot of accretion can be observed, with whole layers of Tetrapods covered by sand. More interesting is the process and shape of this accretion. This can be explained based on the coastline orientation. The accretion is shown in Figure 32.

Figure 32: Sedimentation process which will eventually result in large area accreted land.

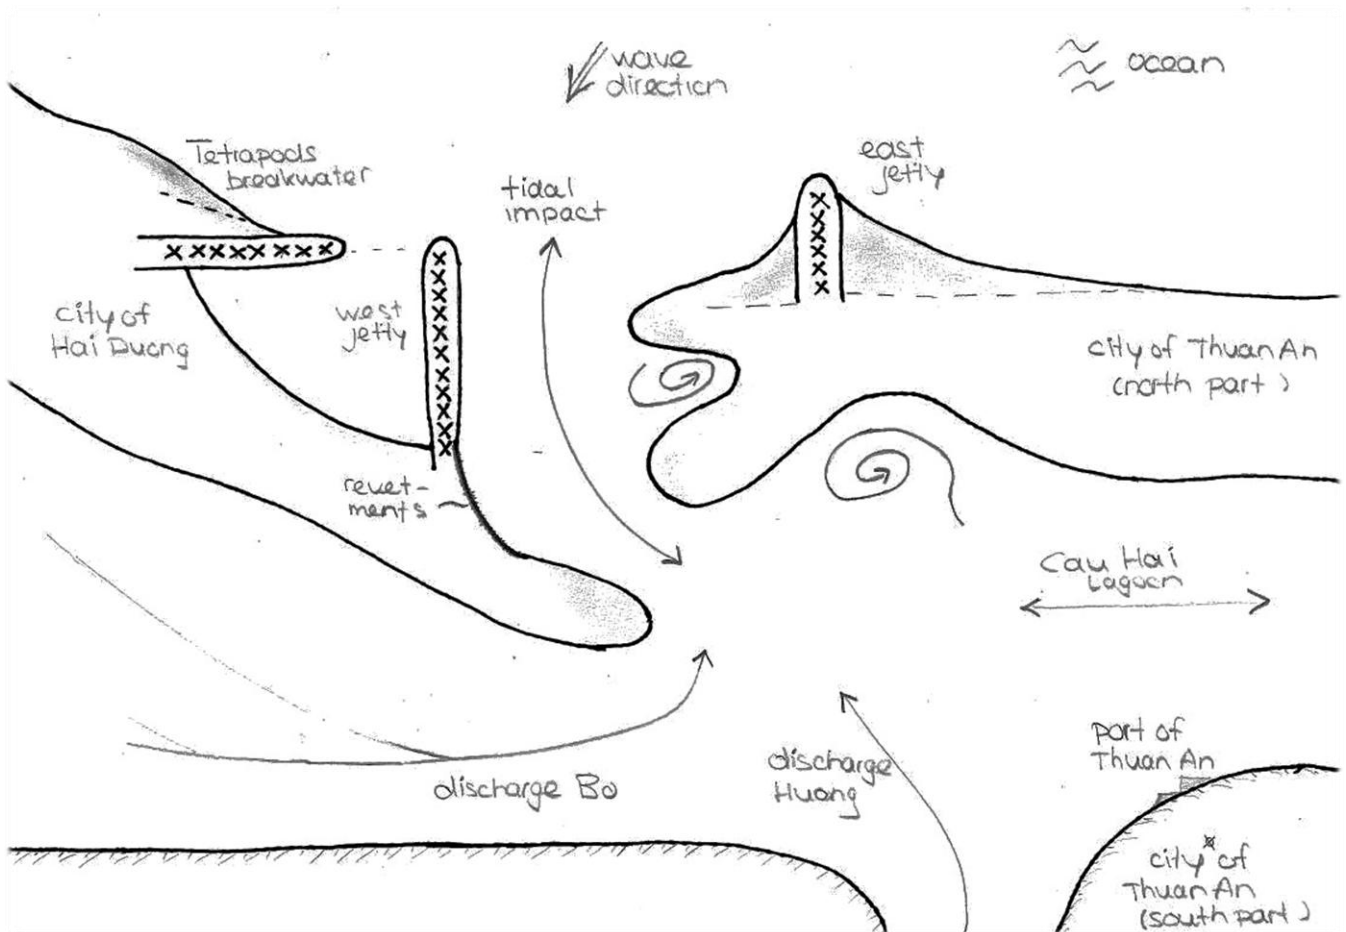
Figure 35: Sketch of processes in the Thuan An inlet. The jetties and breakwaters are indicated with the crosses, accretion with black spikkles.

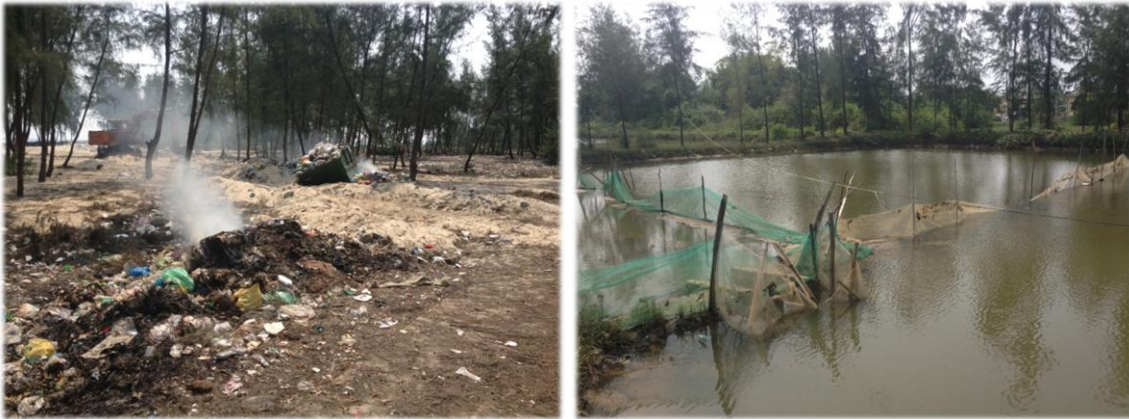
The revetments on the east side of the sand barrier have been constructed to protect the shrimp farms behind it. However, at the moment these farms have been abandoned. On the remaining land people are burning their waste and cutting branches from trees for personal use. In the past the revetments were constructed with concrete slabs. This eventually failed, because of fact that sand eroded under the slabs. Now, only loose stones are used, which works adequately. The revetment is presented in Figure 30. At the most southeast part of the sand barrier a spit is growing.

Figure 36: Burning of garbage (left) and an abandoned shimp farm (right) behind the revetments.

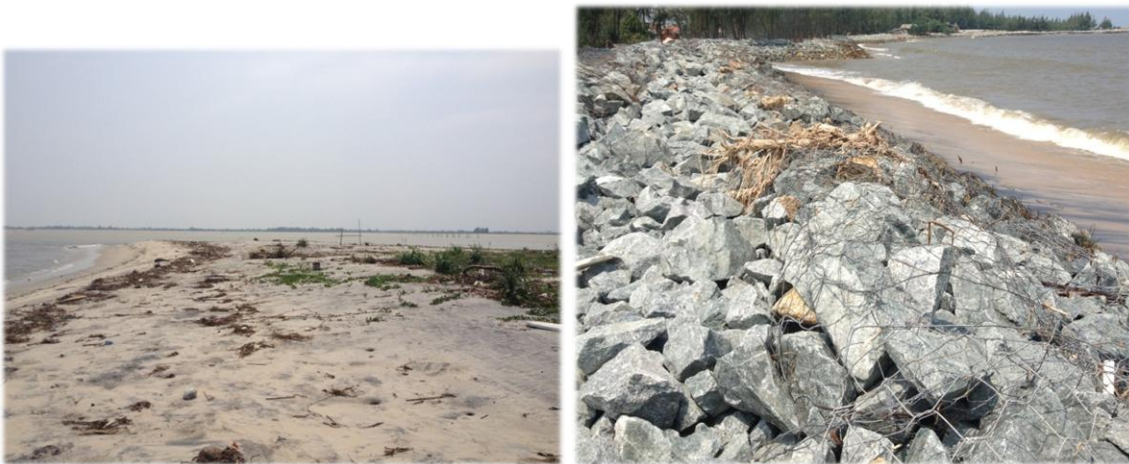
Figure 37: Sand spit growing (left) and the revetment (right) at the west-barrier.
