Non-Destructive Testing for Detection, Localization and Quantification of Damage on Composite Structures for Composite Repair Applications

Accepted author manuscript

Proceedings of the 10th International Symposium on NDT in Aerospace

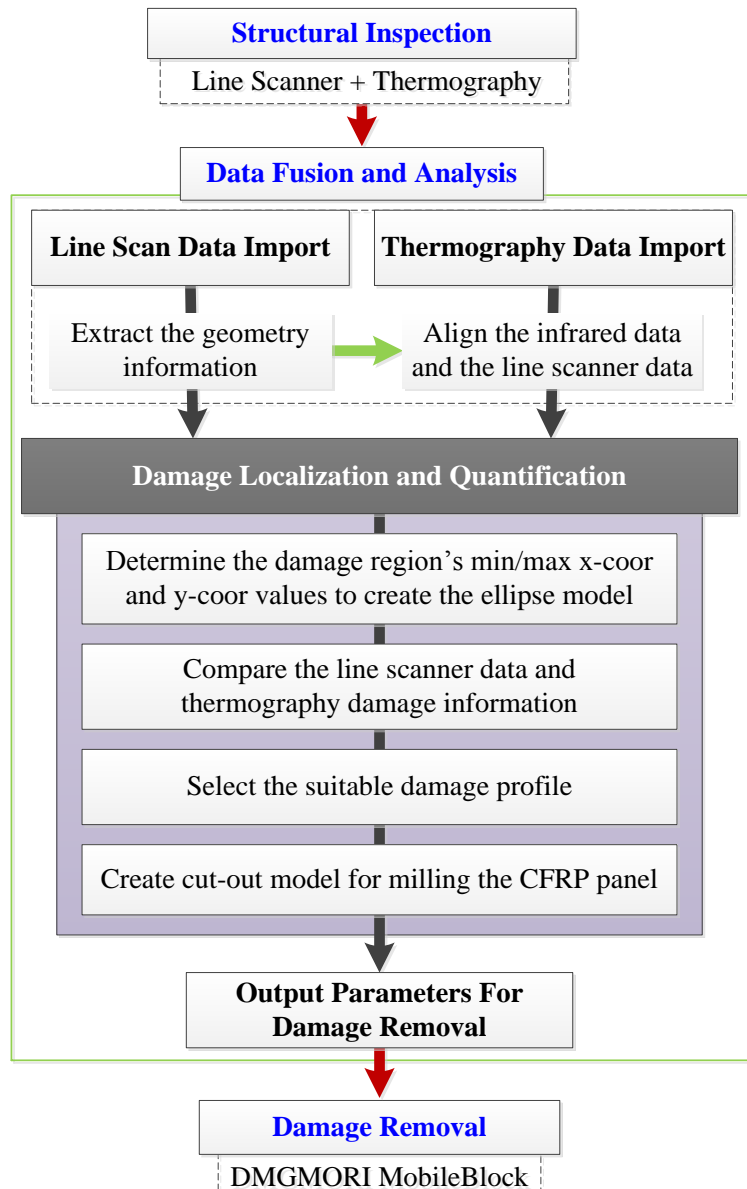
Fig. 5. Overview of the damage detection and localization algorithm.

The data acquired after the structural inspection was imported to the automated damage detection and localization algorithm for; 1) data pre-processing of the laser line scanner PCD data and infrared image, 2) damage detection and quantification and 3) providing the geometry and location of the scarf repair as input to the milling process. An overview of the algorithm is illustrated in Fig. 5. The first step of the algorithm involves pre-processing of the data acquired using the laser line scanner and thermographic inspection, in which; 1) the algorithm determines the geometry information of the curved CFRP panel based on the data acquired using the laser line scanner, 2) the panel's geometry data is used to reconstruct the 3D model of the curved CFRP panel, and 3) subsequently, the reconstructed model of the CFRP panel is then used to transform the pixel information of the infrared image to the coordinate system of the PCD of the CFRP panel obtained by the laser line scanner.

The laser line scanner and infrared image PCDs were analyzed independently to determine the damaged area. The damage length on the PCD obtained using the laser line scanner was determined by analyzing the gradient change in the z-axis by scanning the PCD in the x-direction and y-direction at x-interval and y-interval, respectively. The infrared image analysis for damage determination was also done by analyzing the pixel data by scanning the PCD in the x-direction and y-direction at specified intervals. After the damage localization procedure, the damaged areas are enclosed using an ellipse, which is

created using the minimum and maximum x-values and y-values of the damage region. The ellipse covering the damaged area of the laser line scanner PCD and the infrared image PCD are compared to check if they are in agreement.

Finally, the damage region determined based on the results obtained from the laser line scanner and thermography image analysis is used for modeling the cut-out for milling the CFRP panel. The cut-out profile is modeled so that the size of the ellipse at the bottom of the panel is 15 mm apart from the detected damage. Additionally, a commonly used scarf ratio [12], 1:20, was selected for modeling the cut-out profile for bonded repair applications. Finally, the milling profile parameters are output in .stl format by the algorithm. In the last step, the output parameters of the scarf profile are used as an input for damage removal using the MobileBlock.

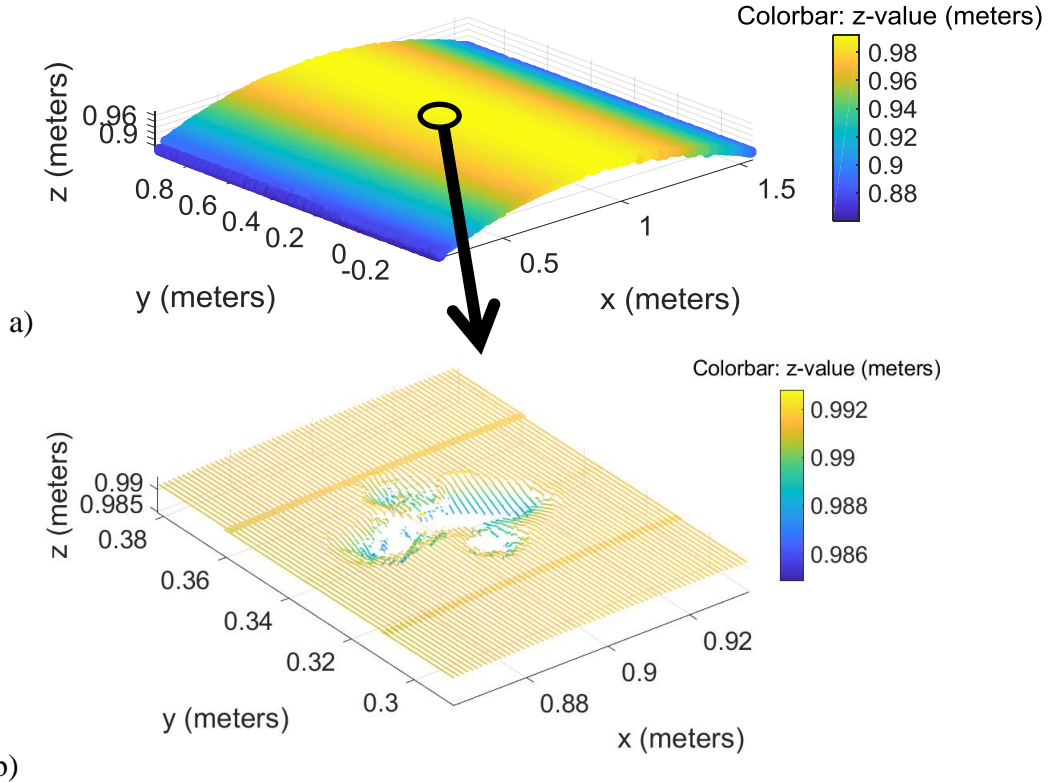
Fig. 6. a) Visualization of the PCD of the entire CFRP panel acquired by the laser line scanner and b) close-up of the damage region.

The PCD acquired after the entire panel was scanned using the laser line scanner is presented in Fig. 6 (a). The damage information on the PCD is represented by deviations in

the z-value and missing point cloud elements, as shown in Fig. 6 (b). The infrared image acquired through the thermographic inspection is presented in Fig. 7. The white and the black regions, corresponding to hottest and coldest region, can be seen on the infrared image because of the uneven distribution of temperature due to the presence of the damage. These two data sets were imported to the automated damage localization and quantification algorithms for further analysis.
