02 - SITE ANALYSIS

Site Analysis

Author	
Tutors	
Graduation Studio

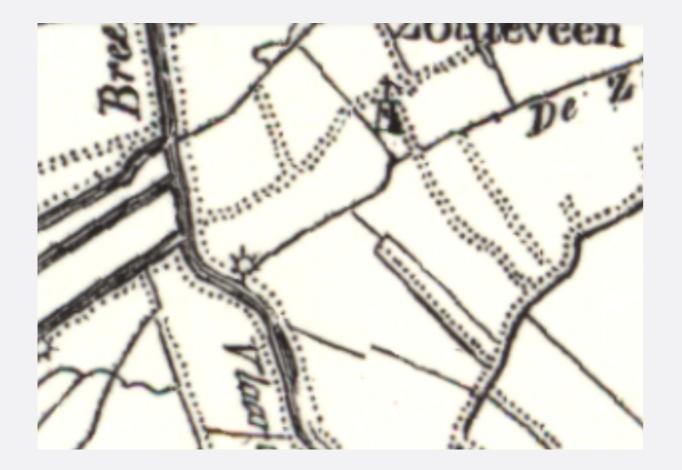
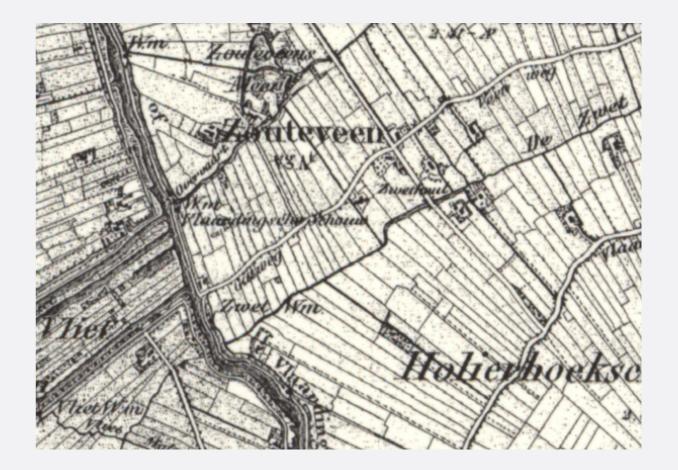
The original drawing dating from 1815 doesn't show a lot of information yet. The water (black lines) and some roads (dotted lines) are indicated, and seem to match the way the infrastructure is layed nowadays. At the crossing of the Zweth and the Vlaardingervaart a windpump is located.

The next chart in 1850 is already more detailed, now also showing the polder structure, buildings and names more clearly. A windmill is placed more towards the North, but still connected to the Zweth. There also is a windmill at the Slinksloot and the Vliet.

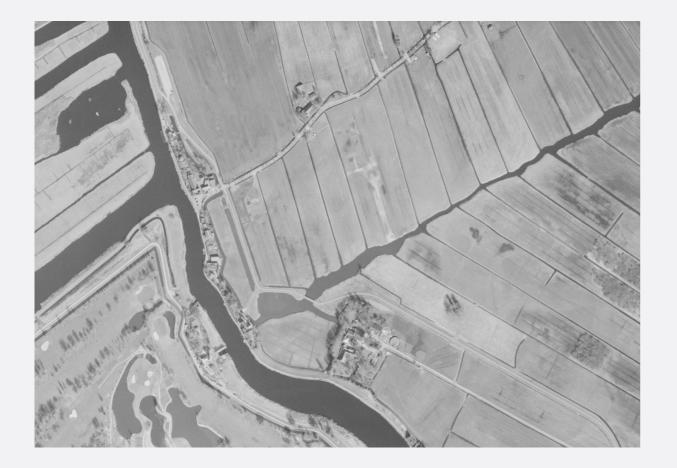
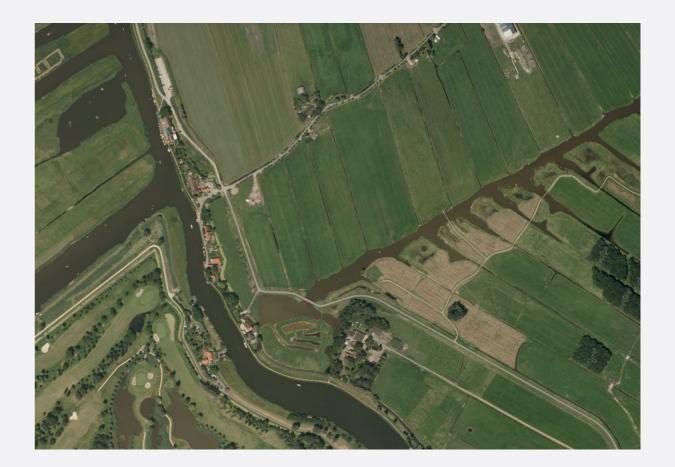
2008

The first images that were taken by satellite were infrared, meaning that they are black and white images. This however highlights the higher and lower areas, especially in the polder area.

In this first colour image, a change in landscape is visible, the straight edges of the peat landscape left of the Zweth became more irregular, as if it was eaten by the water.

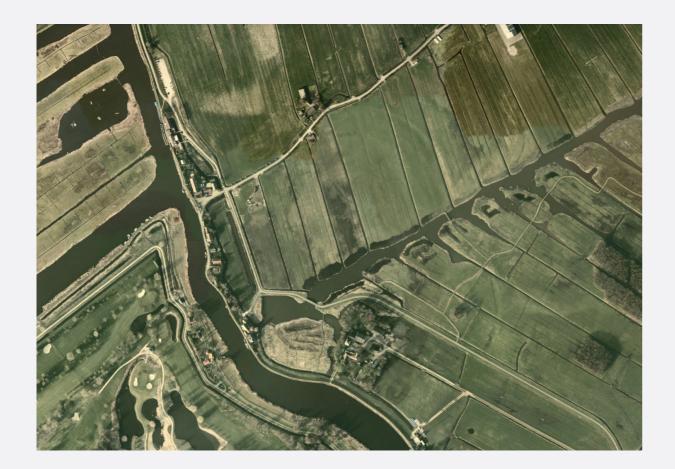
2012

This year a dike-dwelling is being built on the left (south) side of the Zweth, when comparing to the situation a year later, the temporary road is the most noticeable change in the landscape. Besides this building the satellite image also indicates the higher (lighter green) and lower (darker green) areas in the landscape.

Compared to the image on the left, the new dike-dwelling is now finished and the temporary road has been removed, indicating that the dwelling is not accessible by car.

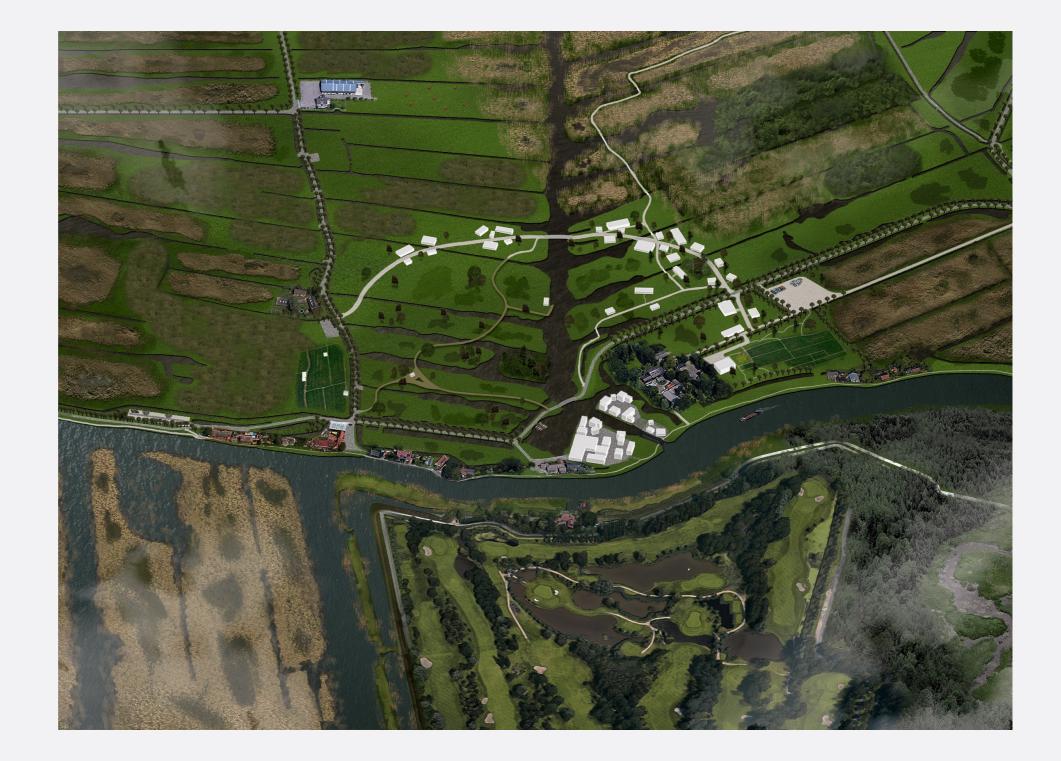
As seen on the image on this page the site as we know it will drastically change. The illustration shows the new National Productive Park Midden-Delfland around the year 2100. The polder has been transformed and most of the grassland has made a place for new ways of cultivation, like cattail, reed, elephant grass, and flax.

The water level has risen, so that large parts of the polder area at now almost level with water and show signs of flooding. The water of the Zweth has expanded into the existing blocks of cultivated polder landscape and is now the primary means of transpiration of goods from the polder to the city.

The new ways of production in combination with the transportation of these goods lead to a new settlement, that will take the form of a resourcebased community. Goods will arrive at the transshipment point connecting the Zweth to the Vlaardingervaart to be processed and transported further.

Farmers, seasonal workers, a care farm, and other inhabitants will settle on a tidal inversion ridge, keeping dry feet whilst still enjoying the rural landscape.

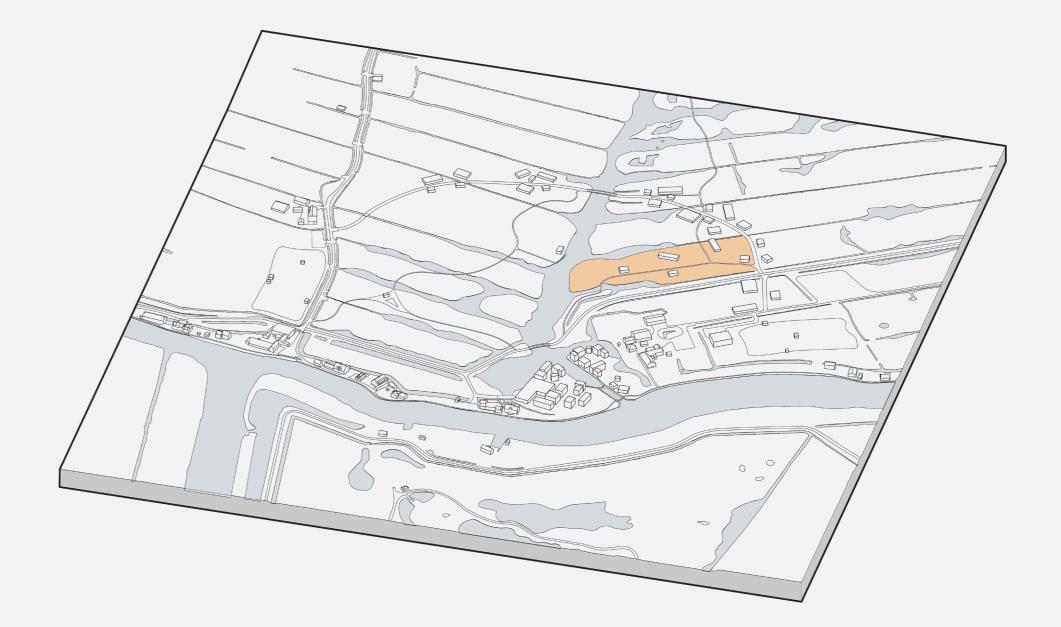
Selected Site

The site that has been selected for the development of the design project has many features, mentioned in the introduction of this chapter. It has multiple types of soil conditions, varying from clay to peat to sand, and therefore has varying heights, which will result in parts of the location being flooded. This location can therefore be an example of how to deal with multiple conditions in one plot.

The selected site covers in total an area of 10.750 m² in other words 1.7 soccer fields. The area makes up 6% of the total masterplan area, covering 173.375 m². The ratio of dry- versus wetlands is roughly 1 to 3. According to the masterplan (illustrated in figure 25), buildings can be built on the dry land completing the ribbon development, but also on the peatlands towards the Zweth.

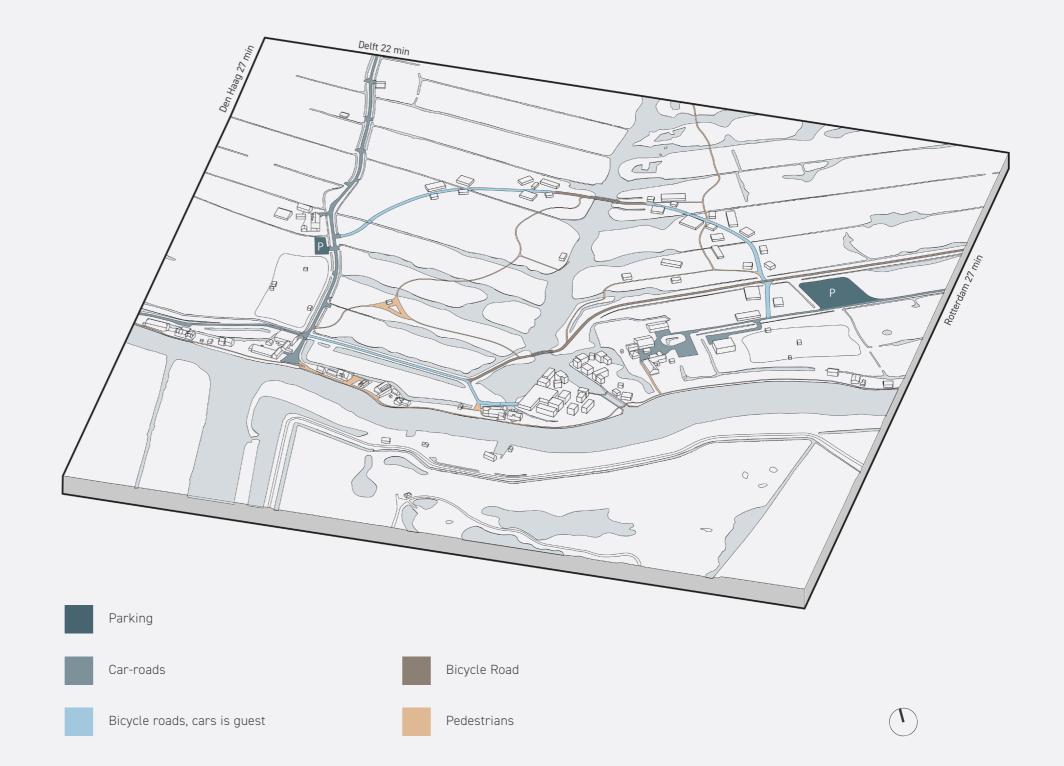
Although the site looks quite remote on the render and has floodings on some occasions, the location is relatively easy to reach. Probably the least accessible mode of transport for the location is the car, just like it is now, the car cannot reach further into the area than its edges. New parking lots are added in the masterplan on both sides of the ring, which are accessible by car in case of emergency, moving, or other actions that need a motorized vehicle close to the built environment. From the location all surrounding city centers are reachable within 30 minutes.

Cyclists can utilize almost all roads in the plan except the one running along the Vlaardingervaart and the central area left of the Zweth. Pedestrians have access to all roads on the site, as well as the car roads, which are 60 km/h and low intensity.

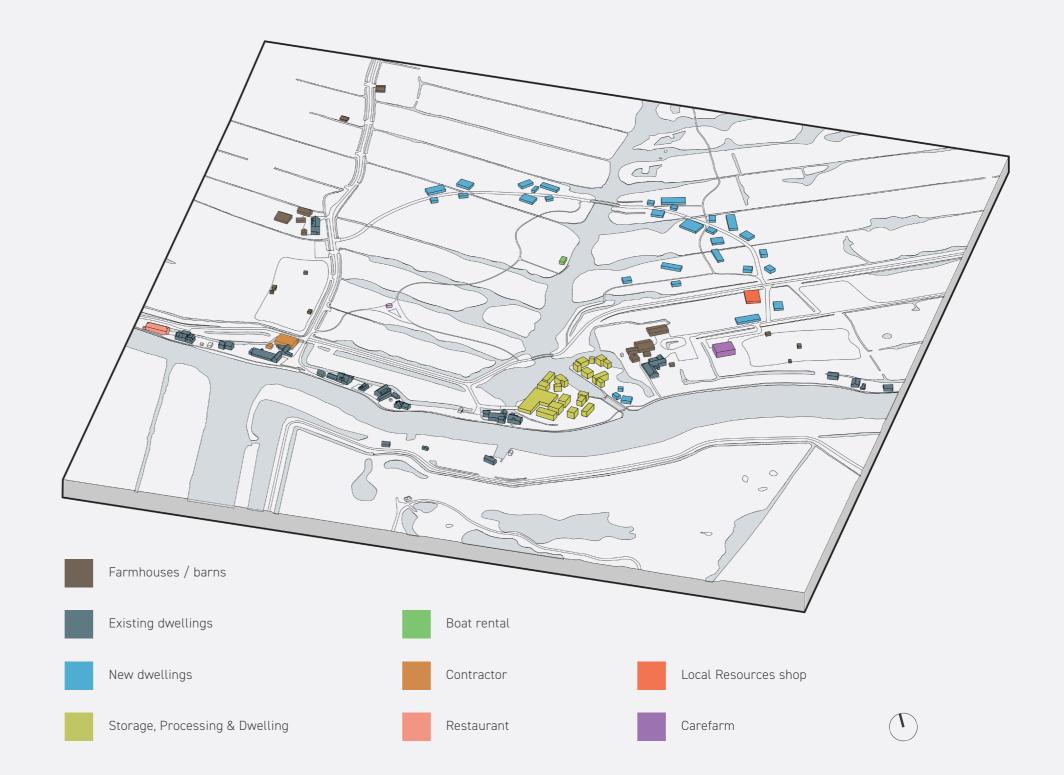
Building functions

Currently, the predominant function of buildings in the area is dwelling, which has been the case for a long time and also will stay the same in the masterplan. More dwellings are added on top of the already existing ones, which will all be kept as is. Dwellings are added on the ring, which will stay dry during floodings, as well as near the lock in combination with storage and processing of local resources.

Farming is another important function around the plot but will be less intensified in the future. This is why the farmhouses and barns are kept as is. To stimulate recitation in the area a boat/sub rental is added in the central middle of the ring and a local resource shop finds its place next to the busy cycling road.

Finally, a care farm is added to the master plan, with an additional community garden bordering it on the remaining higher ground. Care could especially be a good function to combine with the dwelling since the location is relatively remote and calm.

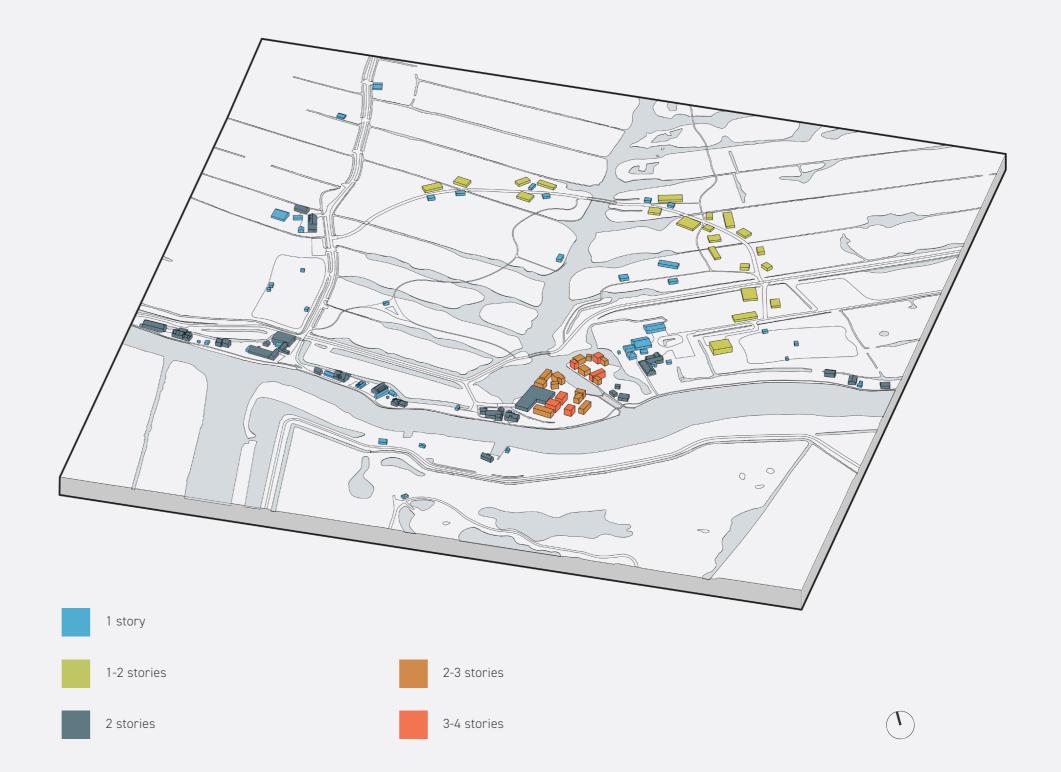
Building heights

As to be expected with rural landscapes the buildings are not that tall. Most of the current dwellings have a building height of 2 stories. Additionally, the farms and sheds most of the time just have one story that is slightly higher than the average story of a dwelling.

The newly added buildings join this tradition of low building heights, which is especially the case on the outer ring, which will have building heights of 1 to 2 stories. The more intensively used and denser transshipment area around the lock will have slightly taller buildings varying from 2 to 4 stories, depending on their placement on or off the dyke.

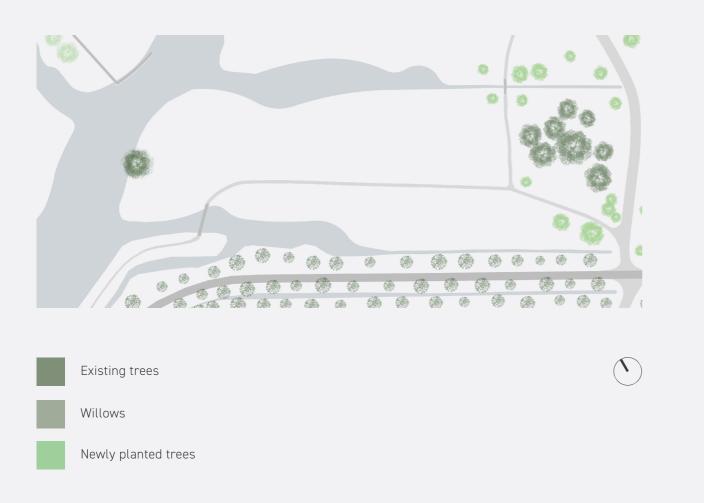
Paths

On the plot itself is a group of trees, which has been there since at least 1877 (see also the map on page 29) Furthermore, new trees are planted on the tidal-inversion ridge in the masterplan to shelter the newly built structures. The bicycle road is lined with willow trees, which also function as a production of willow branches, that are stored and processed in the transshipment point. The surface level is almost completely covered with grass, except the roads.
