## Image analysis for classification of damaged and undamaged areas on composite structures

Shrestha, Pratik; Groves, Roger M.

Nondestructive Characterization and Monitoring of Advanced Materials, Aerospace, Civil Infrastructure, and Transportation XIII

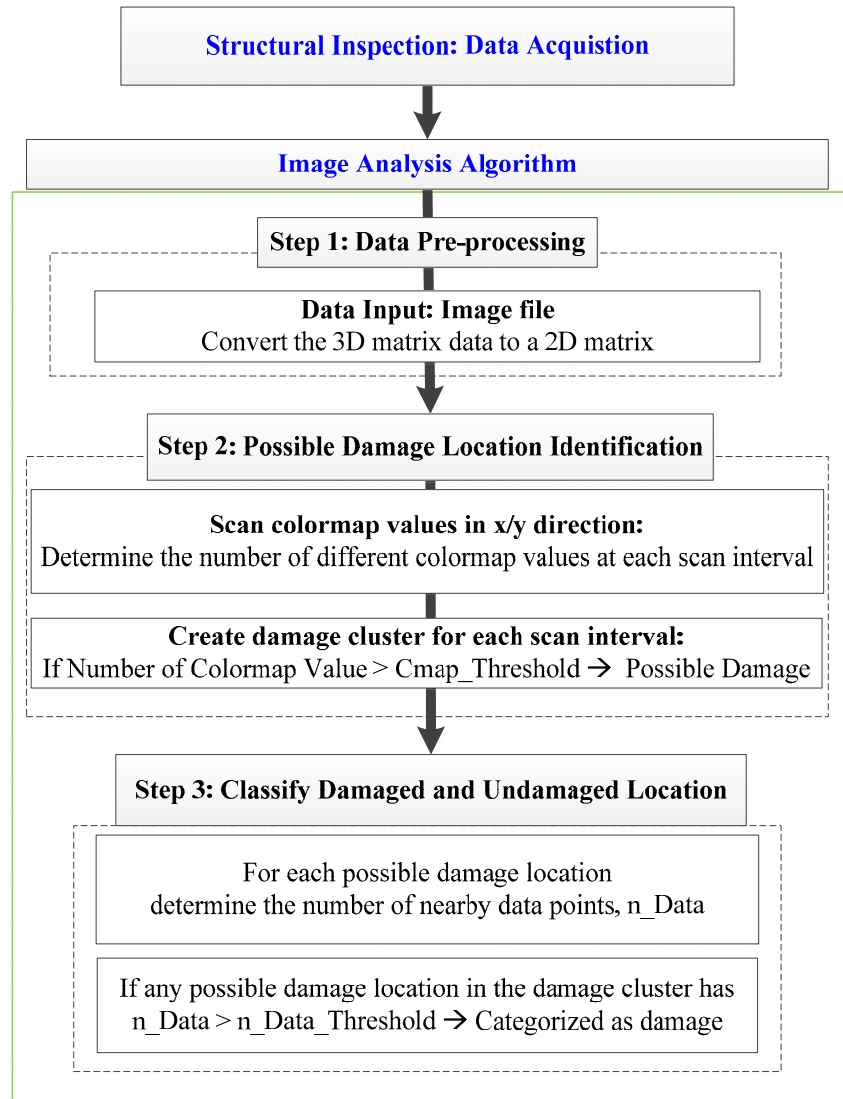
Figure 2. Overview of image processing algorithm for damage analysis.

In this section, an image analysis algorithm that extracts a number of colormap value features from a grayscale image acquired using a portable thermographic inspection for automated damage assessment is presented. In the image analysis algorithm, three key tasks are performed to determine the location and size of the damage on the CFRP panel: a) data pre-processing, b) possible damage location identification and c) classification of the damaged and undamaged region. The overview of the algorithm is presented in Figure 2.

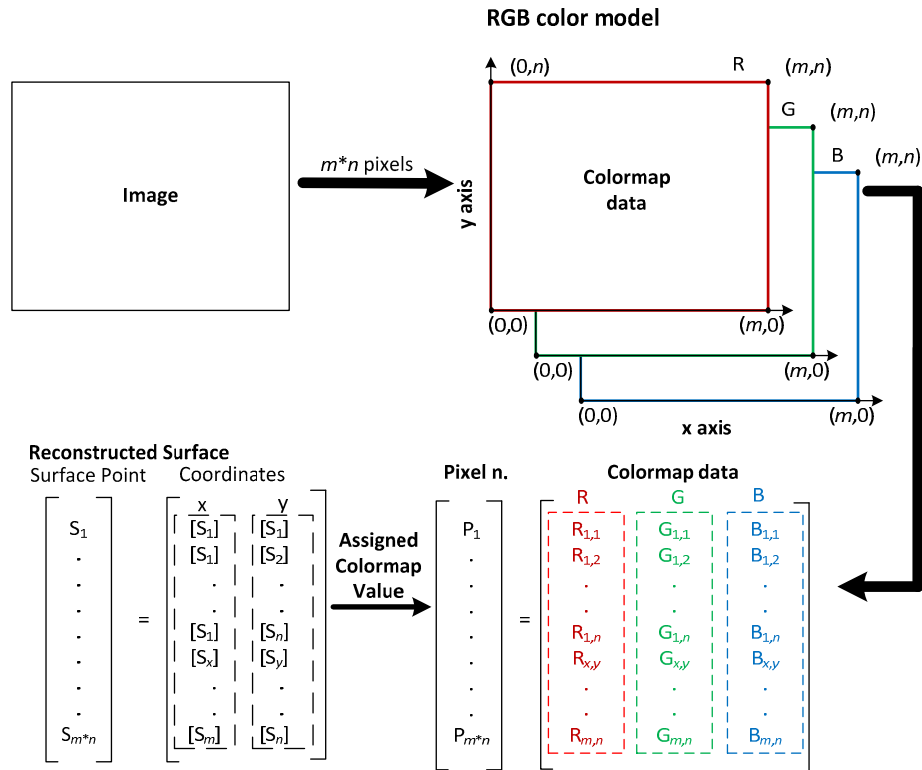
Figure 3. Illustration of data pre-processing procedure.

The first step of the image analysis algorithm involves data pre-processing of the  $m \times n \times 3$  matrix. In this step, a new matrix is created that consists of the property of each pixel such as RGB colormap values and the coordinates values. The 2D matrix containing the colormap data,  $P[R_{x,y}, G_{x,y}, B_{x,y}]$ , is constructed by transforming the image components stored in 3D matrix; where  $x = 1$  to  $m$ , and  $y = 1$  to  $n$ . Subsequently, a size marker with a known dimension was used to calculate the size of the test panel in SI units and a matrix containing the  $x$ -coordinates and  $y$ -coordinates of each pixel is created. Since the image used is 2D the  $z$ -component data of each pixel is not known, therefore, in the present algorithm, the  $z$ -coordinate of each point is assigned with an equal value. Finally, each surface point,  $[S_x, S_y]$ , is assigned with the corresponding colormap value,  $P[R_{x,y}, G_{x,y}, B_{x,y}]$ . The data pre-processing process is illustrated in Figure 3.

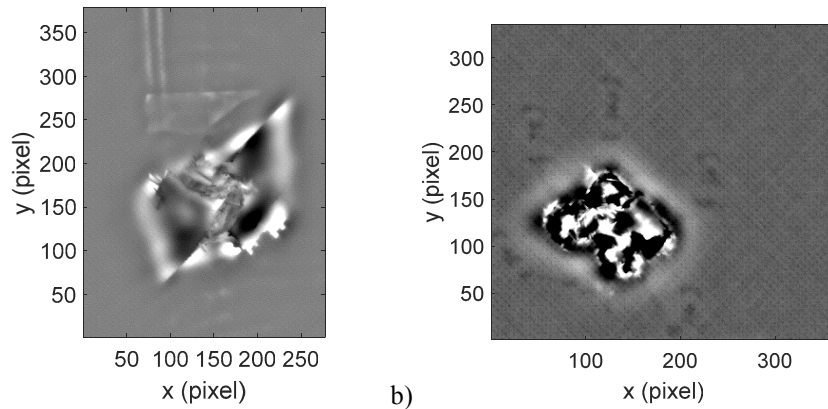
Figure 4. a) Case A: training dataset and b) Case B: test dataset.

In this section, the results of the image analysis algorithm developed for automated damage monitoring are presented. The damaged CFRP panel was inspected using NDTherm NT and the grayscale infrared images were obtained. The infrared images of two datasets with the impact damage are shown in Figure 4. These datasets were used to train and test the damage localization and quantification algorithm.

First, the Case A image data, with  $277 \times 378$  pixels, was used for training the algorithm to identify the presence of damage visible on the mid-region of the image. The image data was first pre-processed to convert the  $277 \times 378 \times 3$  3D matrix to a  $104706 \times 3$  2D matrix. A size marker was used to determine the size of the image from pixel to SI unit. The size of Case A was determined to be  $103.4 \text{ mm} \times 141.0 \text{ mm}$ . Subsequently, the pre-processed data was analyzed to determine the number of different colormap values in the x-direction and y-direction, as shown in Figure 5. This feature extraction process significantly reduced the volume of data required for damage analysis. In total, 664 clusters were created and from each cluster, a single feature, the number of colormap values present in the cluster, were obtained for the damage analysis in the next step of the algorithm.

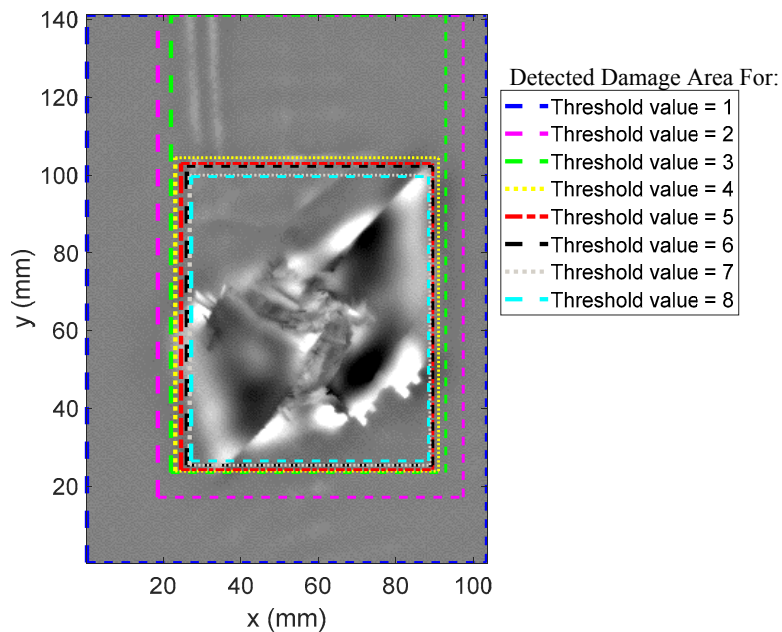
Figure 6. Case A: Damage area detection for Cmap\_Threshold value of 1 to 8.

The area detected as damage for  $C_{map\_Threshold}$  value of 1 to 8 is presented in Figure 6. Since the minimum number of detected colormap value is 2, the lowest threshold value of 1 resulted in the entire panel being classified as damaged. By increasing the threshold value it can be seen that the size of the detected damage area is reduced.  $C_{map\_Threshold}$  of 2 and 3 resulted in the damage length in x-direction and y-direction to be within the range of 70.0 mm and 124.0 mm, respectively. When the  $C_{map\_Threshold}$  of 2 or 3 was selected, the damage length in the y-direction is found to be longer in the y-direction due to detection of the two vertical lines located on the upper left quadrant of the image. The vertical lines correspond to visible surface features that are present on the structure. Whereas, with  $C_{map\_Threshold}$  between 4 and 8 the damage region was correctly identified. The damage area was determined to be  $67.9 \text{ mm} \times 80.6 \text{ mm}$  with  $C_{map\_Threshold} = 4$ , and increasing the threshold value resulted in decrease in the size of the detected damage area. Using  $C_{map\_Threshold} = 8$ , the damaged area was determined to be  $61.2 \text{ mm} \times 73.1 \text{ mm}$ . From the  $C_{map\_Threshold}$  parametric study,  $C_{map\_Threshold}$  value higher than 2 was found to be suitable for correct identification of the damage region for Case A dataset. Proper  $C_{map\_Threshold}$  selection is important for accurate damage size detection; if it is too small then it can result in overestimation of the damage size and if it is too high then it

can lead to underestimation of the damage size. Based on the results obtained from training dataset, the Cmap\_Threshold was set to 5.
