Combined Acoustic and Optic Characterization of Damage Mechanisms in Internally Pressurized Composite Pressure Vessels

MSc Thesis

Aerospace Engineering

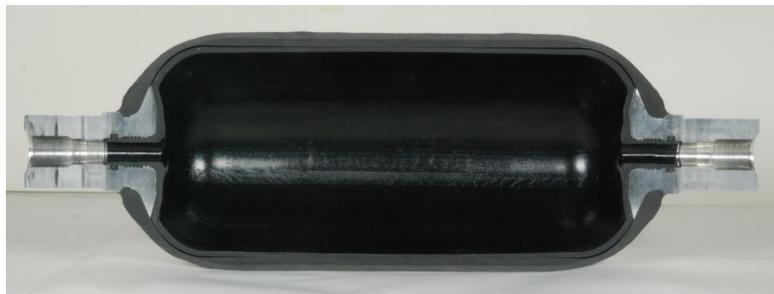
Figure 2.1: Section of a CPV.

In Figure 2.1 is represented a section of one of the sub-scale vessels used for the current investigation. The three forming parts can be easily identified. This vessel is a type IV and presents a polymeric liner which is not contributing to support the internal pressure. 99% of the load is carried by the fibers of overwrapping material, while the matrix is responsible for the remaining 1% [6, 10]. Vessels of this type are used in the automotive industry for portable light weight applications. All the existing vessel types are represented in Figure

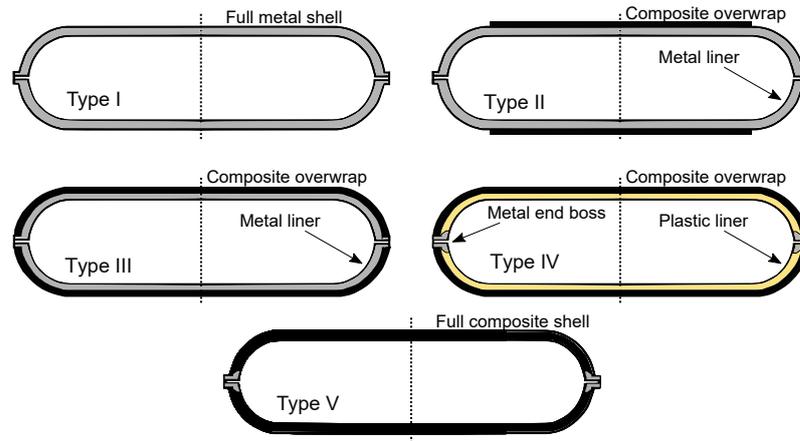
Figure 2.2: Vessel types [9].

Vessels of type I are completely metallic (generally steel) and are mainly used in the chemical industry. Types II have a reinforcement in the cylindrical section which is made of continuous filaments impregnated in resin. These are mainly used when high pressures are needed in stationary applications. Type III vessels, also known as composite overwrapped pressure vessels (COPVs), have a metallic liner, which has a sealing purpose. In this case, it also partially contributes to withstand the loads. Tanks of type III and IV are used in the automotive industries due to their low weight. Type V vessels do not have a liner, but only overwrapping material [9, 11].

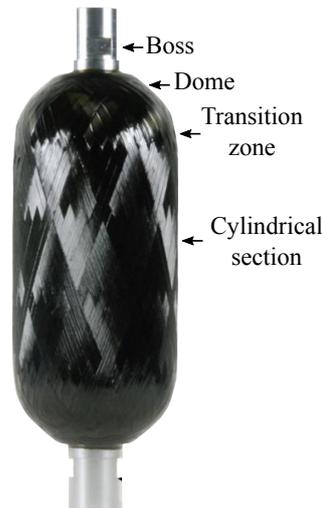
Figure 2.3: Vessel sections nomenclature.

Cylindrical vessels are the most common but not the only existing ones. Another example are spherical vessels. They have the lowest membrane stress on the walls when compared to vessels with same weight and different shapes [9]. Their main disadvantage is the significant volume, which makes them not suitable for all the situations. For these applications (being automotive one of those), cylindrical vessels are used. The side heads have semi-spherical or domed shapes to reduce stress concentrations. The pressure vessels of the current investigation have the latter configuration. It is possible to identify three sections of the vessel according to their geometry: cylindrical, domes and transition zones. The latter ones are the areas that link the cylindrical section with the dome regions, as shown in Figure 2.3. This nomenclature will be used in the present thesis.

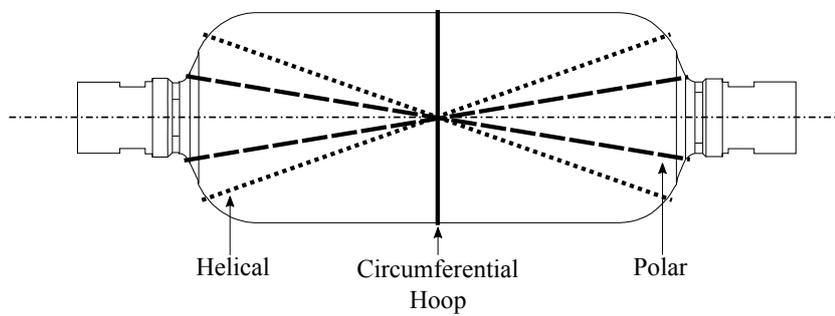
Figure 2.4: Layer types.

The overwrapping material of the CPVs is formed by continuous filaments (mainly carbon or glass fibers) impregnated in a resin (usually epoxy). The filaments are united in tows of variable bandwidths and wrapped around the liner. This manufacturing technique is called filament winding. It is possible to wind three types of layers, which vary according to their orientation [10]. These layers are shown in Figure 2.4 and are circumferentials (or hoops), helicals and polars. Circumferential or hoop layers are theoretically wound at 90° with respect to the vessel longitudinal axis. A slightly smaller angle is usually chosen, to avoid the perfect overlapping of the tows. They are wound only in the cylindrical section of the vessel and are responsible to carry the tangential loads. Helical layers are wrapped around the entire length of the vessel with an angle between 0° and 90° . They withstand both axial and tangential stresses in a percentage that depends on the winding angle. Parnas and Katirci [12] have theoretically evaluated that it is possible to build a thick vessel using only a single orientation of these layers, without hoops. The optimal winding angle is between 52.1° and 54.1° according to the materials used. Polar layers are a particular case of helicals: they are wound with the lowest possible angle, thus from pole to pole [13]. They are mainly used for carrying axial loads due to their configuration.

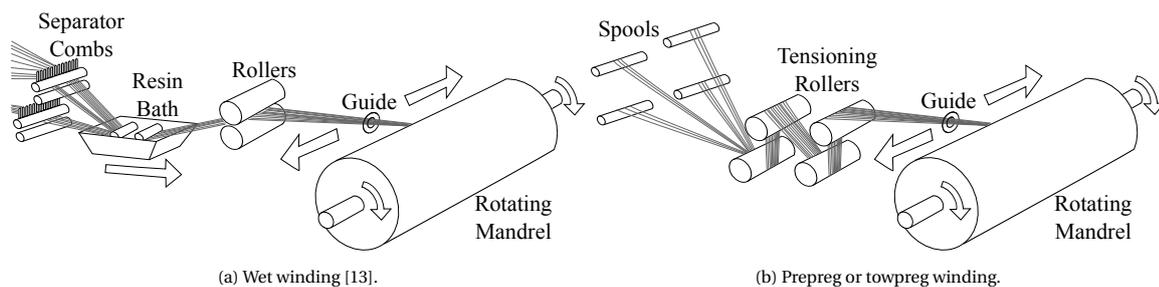
Figure 2.5: Wet winding and prepreg or towpreg winding techniques.

consists on the deposition of the fibers on a rotating mandrel which usually also displaces longitudinally. In some cases it only rotates and the rollers and the guide (shown in Figure 2.5) move horizontally. For types III and IV tanks, the metallic or plastic liner replaces the mandrel, thus the fibers are laid directly on it. The most used winding techniques are two: wet and prepreg winding [13], represented in Figure 2.5. Their differences depend on the fibers and resin used. In the wet winding technique, the fibers and the resin come separately

and are merged during the winding (Figure 2.5a). The fibers get impregnated passing through a resin bath just before being placed. In Figure 2.5b, prepreg or towpreg winding is represented, in which the resin bath is absent. The fibers come already pre-impregnated in form of spools, thus the impregnation phase is not needed. This allows a controlled resin content in opposition of wet winding. In the latter, the resin content is strongly dependent on the resin bath. Towpreg winding also has a higher placing rate making the total process faster. In wet winding the resin excess that does not stick on the fibers gets deposited on the floor and on the rollers. A constant cleaning process is thus required, while it is unnecessary when using towpregs. The main disadvantages of prepreg winding are the costs of the material and the need to store them in freezers.

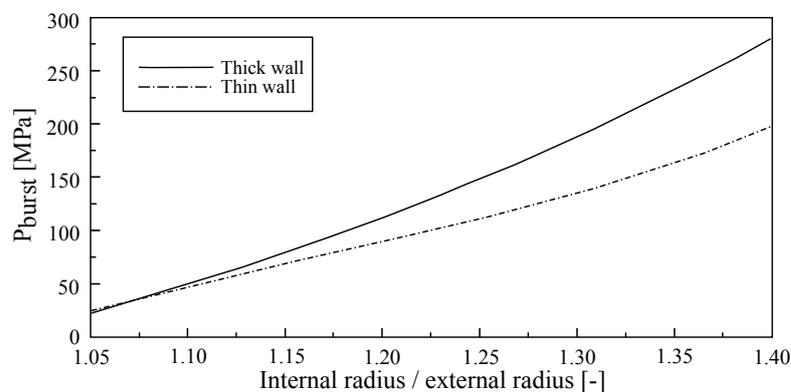
Figure 2.6: Calculated burst pressures for increasing wall thickness [12].

It is well known that composite materials are anisotropic, thus the previously described method has some limitations when applied on CPVs. These can be overcome with classical lamination theory (CLT). The plane-stress assumption makes it applicable only on thin structures and neglects the out-of-plane stresses. Perfect bonding between the layers is assumed, which results in continuous displacements through the thickness. The Kirchhoff-Love assumptions of deformation are also valid. The first one states that each straight line normal to the mid-plane stays normal and straight after deformation. The second that the laminate thickness is unchanged after the deformation. This method can be used to calculate the stresses along the vessel length to which failure criteria can be applied. This makes possible to obtain information regarding for example, critical pressure for interfiber-fracture [26] or burst pressures [12]. The CLT results could be inaccurate if applied to the CPVs used in the automotive field. Due to the important pressure they must withstand, they usually have thick walls. For this reason, the thin wall assumption of the CLT could be incorrect. Parnas and Katirci [12] used CLT and a plane-strain model to predict the burst pressure of CPVs with different wall thicknesses. As shown in Figure 2.6, the two methods provide similar results until the ratio between external and internal radii of the cylinder of the vessel is below 1.1. When this ratio increases, the predictions deviate from one another, and the CLT is highly conservative.

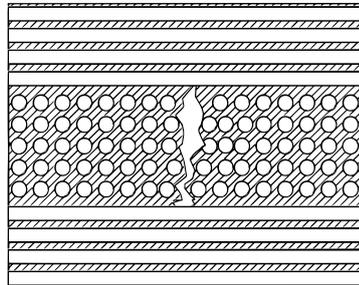
Figure 2.7: Representation of interfiber-fracture in the 90° plies [30].

Matrix cracking or interfiber-fracture is another damage mechanism that characterizes composite materials. It takes place when a crack gets formed in the resin. It is defined as “[...] formation of cracks in the matrix region between the fibers and along the interface between fiber and matrix” [30]. When it forms, it usually runs through the entire thickness of the ply and it quickly propagates through the laminate unless it gets stopped, for example, by a change in layers orientation [31]. An example is represented in Figure 2.7. Cracks usually

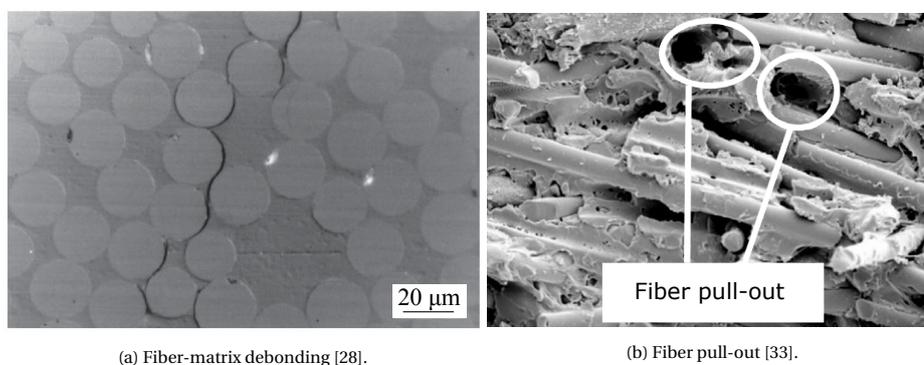
(a) Fiber-matrix debonding [28].

(b) Fiber pull-out [33].

Figure 2.8: Fiber-matrix debonding and fiber pull-out.

Matrix-fiber debonding is a damage mechanism characterized by the failure of the adhesion between the two elements. An example is shown in Figure 2.8a. This failure mechanism is very detrimental for the structure, because the interface between fibers and resin is responsible for transferring the loads [28]. When the debonding takes place in multiple adjacent fibers, it can evolve and form IFF [29].

Fiber pull-out is a particular case of fiber-matrix debonding. It happens when the matrix-fiber adhesion is completely lost and the fiber gets pulled out of its socket in the resin. An example is shown in Figure 2.8b.

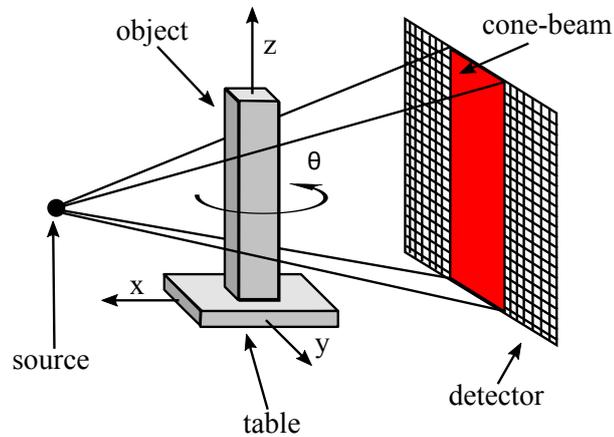
Figure 2.9: Representation of a CT station [30].

One of the most used non-destructive inspection (NDI) methods is computer tomography (CT) which allows to have a 3D visualization of the structure. Multiple measurements from different angles are taken with x-rays and combined in a second step. A representation of a CT station is shown in Figure 2.9. Each picture taken

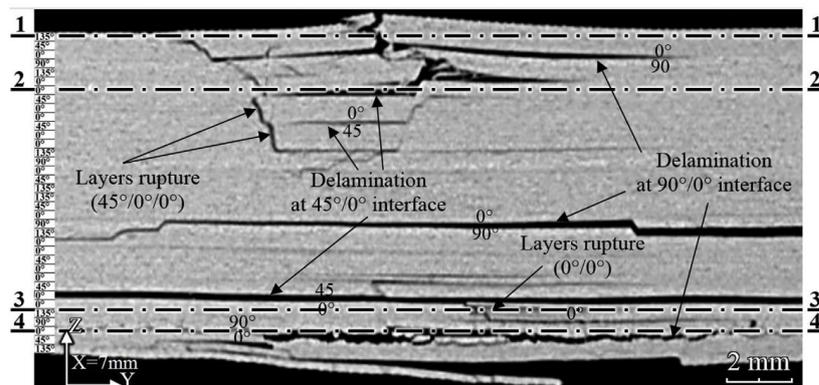
Figure 2.10: Cross sectional view of a tested specimen with different damage mechanisms obtained with CT [40].

CT has been extensively used as NDI technique applied to composite materials [37–42]. It is suitable to detect different damage mechanisms and laminate characteristics, such as porosity [30, 41, 42]. An example is represented in Figure 2.10. Here matrix cracking and delaminations can be detected. If the damage size is

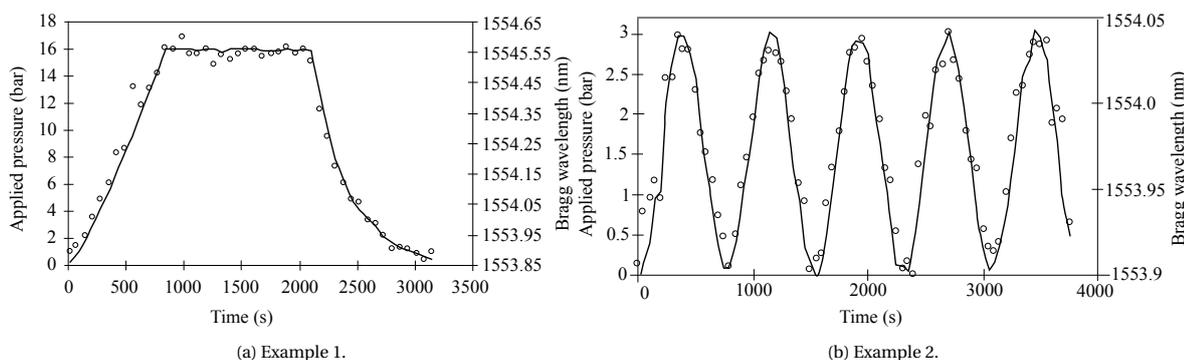
Figure 2.11: Comparison between pressure profile and FBG data [44].

FBG systems use optical fibers to measure parameters such as strains and displacements. The optic fibers are usually embedded in the structures during manufacturing and provide punctual information. The embedment in CPVs can be challenging when wet winding is used [43]. The sensors tend to move due to the low viscosity of the resin and can easily get damaged when tension is applied to the fibers during winding. When they are placed on the surface, they provide accurate results. The outputs have been compared, for example, to the applied pressure profile [44] (Figure 2.11) or to strain gauges results. Some errors might arise if there is a misalignment between the location of the FBG and ESG sensors [45].

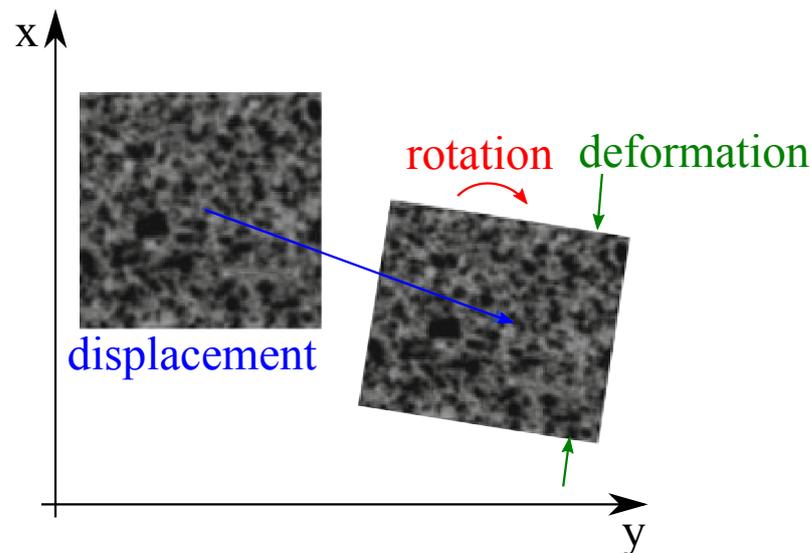
Figure 2.12: Facets in their original and deformed state [30].

DIC is a contactless optical technique that provides full-field deformation of a structure or an object. It was developed in 1982 by Peters and Ranson. They compared small areas of pictures of unloaded and loaded structures using ultrasonic waves [48]. The technique progressed with Sutton and other researchers that started using pictures optically recorded [49]. DIC analysis consists in the comparison of consecutive pictures taken during the loading or unloading of a structure. The measured area is divided into smaller parts called facets or subsets. The comparison is accomplished measuring the changes in the stochastic pattern previously applied on the surface. An example can be seen in Figure 2.12. The strains are later calculated

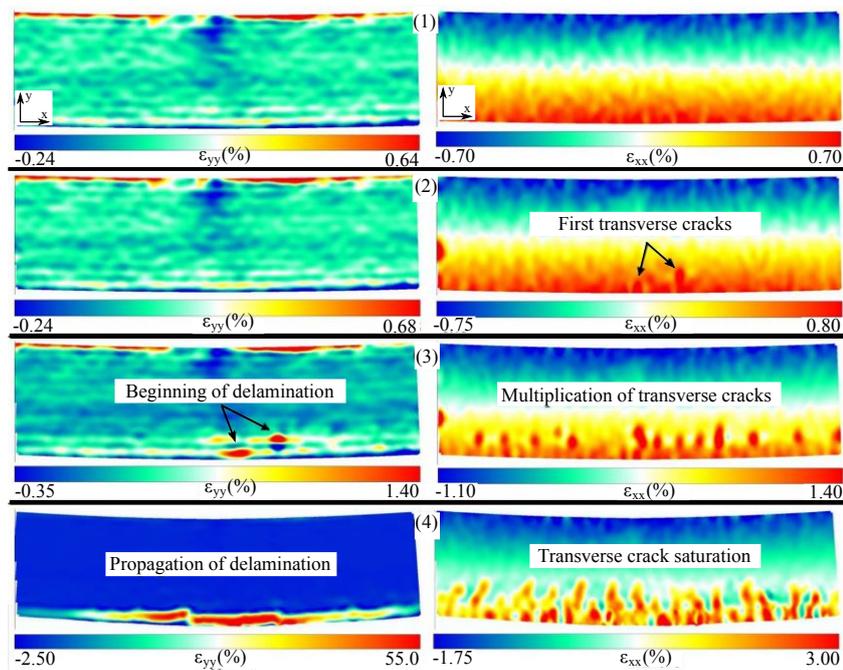
Figure 2.13: Progression of a delamination and formation and saturation of matrix cracking detected using DIC [39].

DIC has been used to detect and differentiate damage also at laminate level. Djabali et al. [39, 40] used it to collect strain data in thick specimens subjected to three point-bending tests. Figure 2.13 shows the strains through the thickness of the specimen at increasing bending loads. It is possible to detect the formation and propagation of the delamination (left side) as well as of transverse cracks (right side). This is an interesting outcome for the thesis investigation. However, it must be considered that filament wound structures like CPVs are closed structures. The visualization of the laminate through the thickness is not possible.

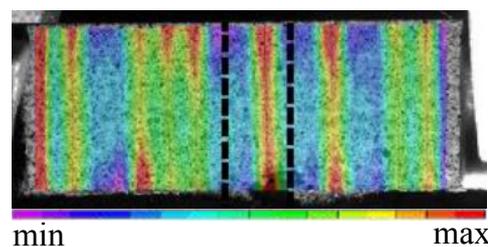
Figure 2.14: Detection of matrix cracking using 2D DIC [55].

The possibility to detect damage formation analyzing the surface of the specimen must be studied. Tensile tests on laminates with multiple layups have been performed by Oz et al. [55] using 2D DIC. They confirmed the detectability of some types of damage but this was highly layup-dependent. When matrix cracking was formed on the top surface (for example testing a specimen with layup $[(90^\circ)_2/(-45^\circ)_2/(0^\circ)_2/(45^\circ)_2]_s$), it was possible to detect the IFF taking place in the top layers. This is shown in Figure 2.14. When the 90° layers were positioned at a different depth in the laminate (for example in layup $[(-45^\circ)_2/(0^\circ)_2/(45^\circ)_2/(90^\circ)_2]_s$), it was not possible to visualize IFF with DIC. Delaminations between the 90° and the 45° plies could be observed ana-

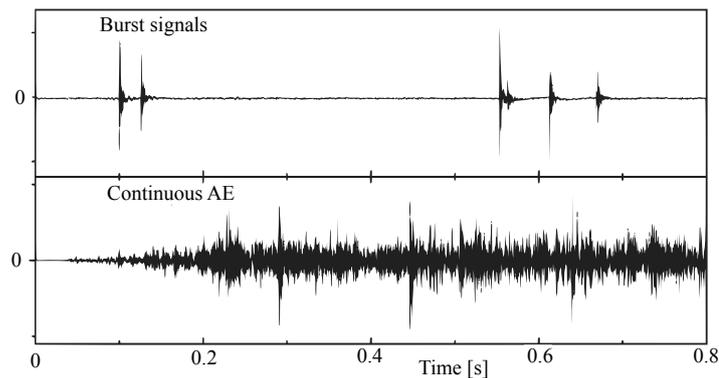
Figure 2.15: Burst and continuous type AE [62].

Acoustic emissions can be distinguished into two types: continuous and burst or transient, as shown in Figure 2.15. Burst emissions take place when damage is formed. They have recognizable characteristics that can be attributed to a specific source type. Emissions of continuous type correspond to a superposition and merge of single burst signals. They usually take place when the damage progression in the material is fast or are caused by friction of already existing fracture surfaces. When multiple waves overlap it is not possible to identify useful parameters to characterize the source [30, 59, 61]. An acoustic emission of burst type is rep-

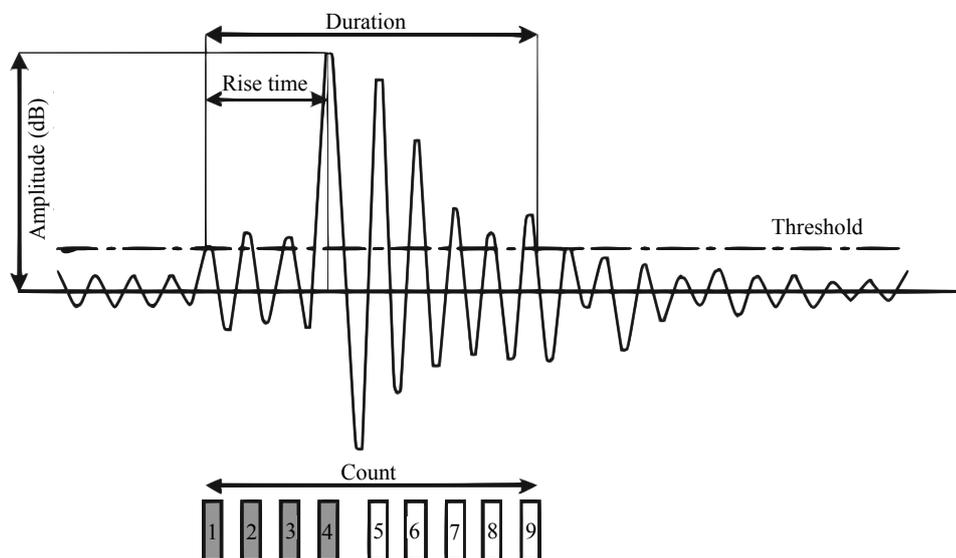
Figure 2.16: Acoustic emission features [62].

resented in Figure 2.16 and it is characterized by multiple features that have been defined in a standard, the ASTM E1316 [57].

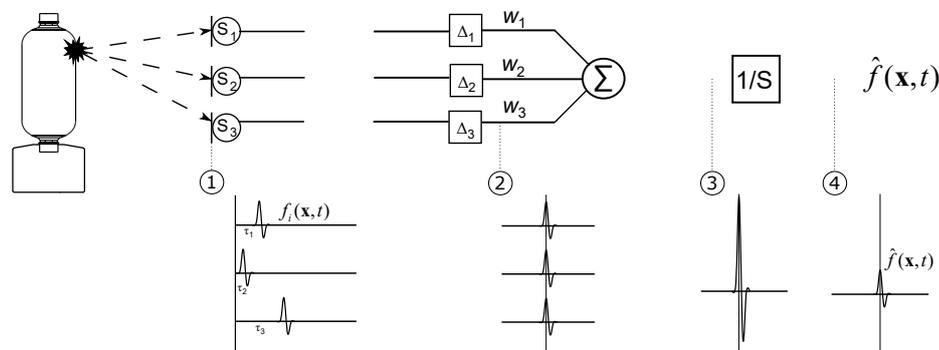
Figure 2.19: Delay-and-sum beamforming principle in time domain[42].

Nebe et al. [8] also performed pressurization tests on a type IV CPV. To gather the acoustic data they did not use piezoelectric transducers but sound pressure sensors. A delay-and-sum beamforming algorithm has been implemented to post-process the data. This technique gives the possibility to analyze the acoustic of a scene, giving as result a visual map in which the acoustic sources are identified [80]. This system is completely contactless. The acoustic of the scene is recorded through multiple sensors, positioned in a predefined layout. The location of the acoustic source can be defined analyzing the runtime delays of the wave with respect to each sensor [80]. A representation of the working principle of the delay-and-sum beamforming in time domain is shown in Figure 2.19. It can be explained as follows:

1. When the acoustic source is produced it reaches the sensors with different paths. The sensors detect the signals at different times, with a delay that depends on the covered distance. The absolute run time can be calculated taking into account the distance of a sensor (r_i) and the speed of sound in air (c) with equation:

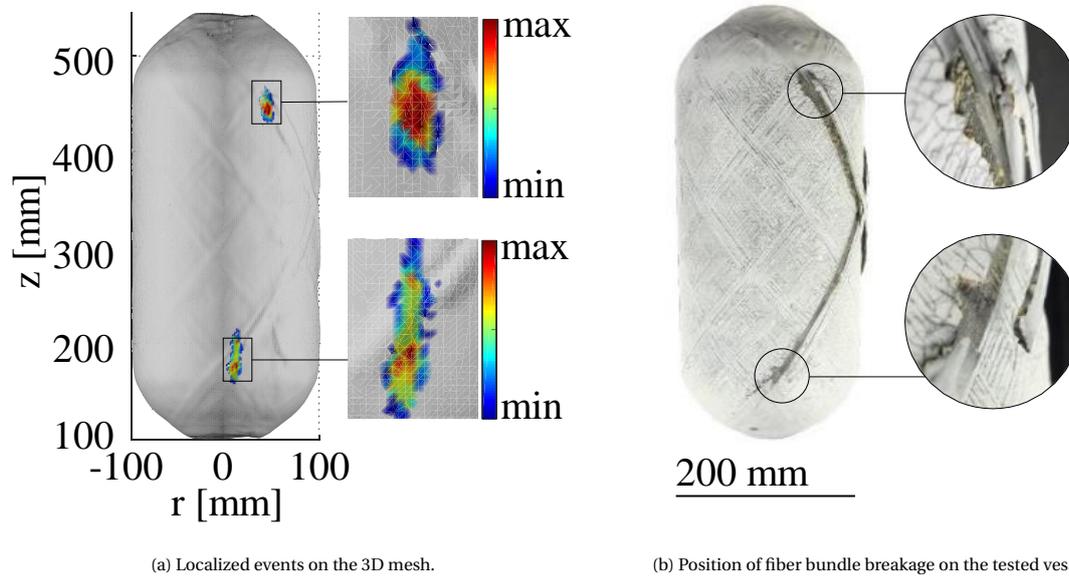
Figure 2.20: Localized and actual position of the fiber bundle breakage [8].

at the end of the test. They were reaching sound pressure amplitudes above 100 dB. They were localized by the beamforming algorithm at the top and bottom of the cylinder, close to the transition zones. They observed the tested vessel and found that the events corresponded to fiber bundle breakage of the outermost helical layer. They also showed that the accuracy of the localization was high, as it can be observed in Figure 2.20.

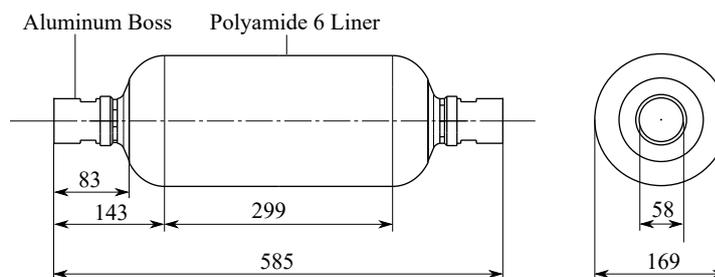
Figure 3.1: Liner dimensions.

The CPVs used for the current investigation are formed by composite materials wrapped around a polymeric liner, made of polyamide 6. The liner is manufactured by an external company using injection molding. It has a cylindrical section and two half-ellipsoidal domes at the sides to which aluminum bosses are attached. The storage volume in the unpressurized state is 8.6 L and its dimensions can be seen in Figure 3.1. The over-

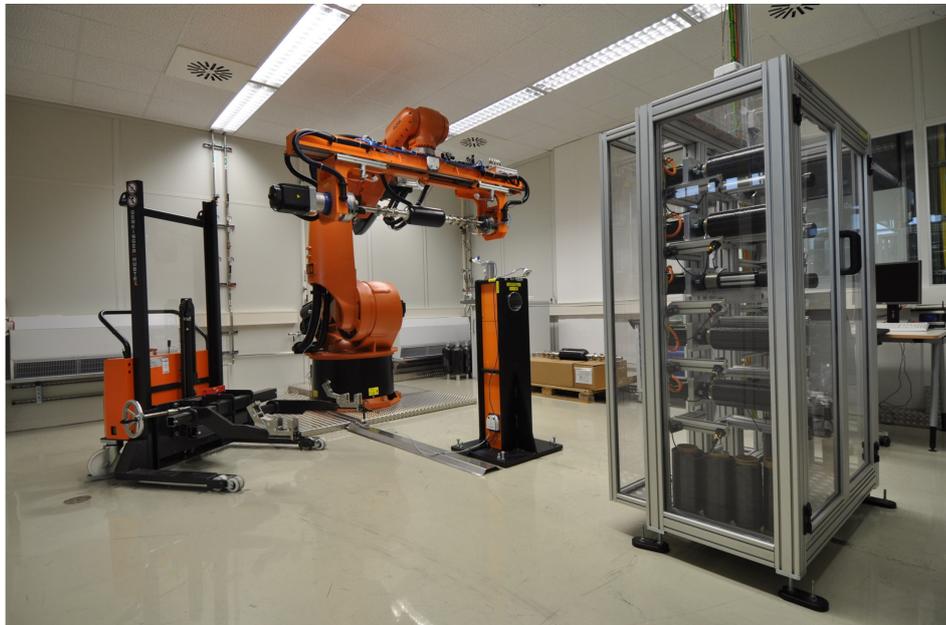
Figure 3.2: Manufacturing setup.

The manufacturing technique used to produce the CPVs is filament winding and in particular prepreg winding. The manufacturing is performed using a six-axis robot (KUKA Roboter GmbH, Augsburg, Germany). The liner is clamped in the robot and acts as mandrel for the winding process. It rotates and displaces in the three directions. A pressure of 1.5 bar is applied during the winding to avoid liner deformation and buckling. The wrapping material is positioned in a cabinet. Four bobbins are used simultaneously for each CPV. They are clamped on rotating cylinders which are linked to a tensioning system that works creating a torque on the bobbin itself. A tension level can be set to each tow. The four tows pass through a predefined layout of rollers which allows the proper placing of the tows with respect to each other. They are then linked on the eyelet, where the final band that will be applied on the mandrel is formed. The manufacturing setup used can be seen in Figure 3.2.

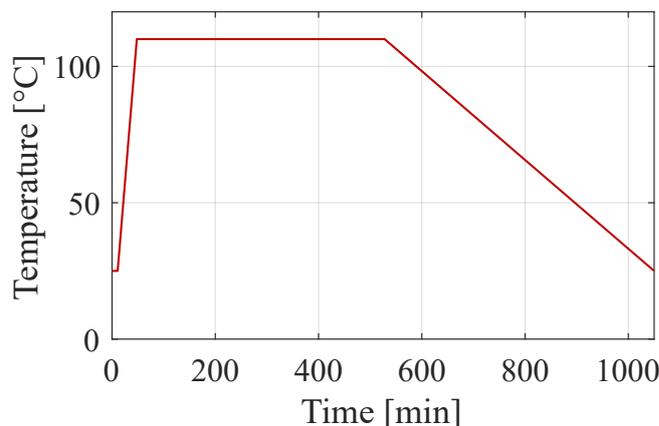
Figure 3.3: Curing cycle.

The two kinds of layers used during the manufacturing process are helicals and circumferentials, which are defined through the orientation of the fibers, as described in Paragraph 2.1.2. The circumferential layers are wrapped only in the cylindrical section, while the helicals along the entire geometry of the vessel. In the transition zone, the hoops layers are tapered to avoid the formation of a gap between the top and bottom blocks of helicals. The circumferential layers are wrapped with a tension of 20 N, while the helicals with 50 N. Depending on the layout, the winding time varies from 2.5 to 3 hours. When the process is finished, the vessel is placed in an oven for curing, horizontally oriented. During the curing process, an internal pressure of 2 bar is applied to avoid the shrinking of the liner. The vessel is clamped at the bosses to a mechanism that allows the rotation of the vessel along its longitudinal axis for the entire process. This is made to have constant heating in all the sides and to avoid resin rich areas at the bottom due to gravity. The rotation is at an angular speed of 10 rpm. The curing cycle of the vessel is decided taking into account the manufacturer's specification curing cycle and the thickness profile of the CPV and it is set at 110 ° C for 8 hours. The heating phase from room temperature to the curing temperature happens in 60 minutes, while the cooling needs other 8 hours. The

curing cycle of the vessel can be seen in Figure 3.3.

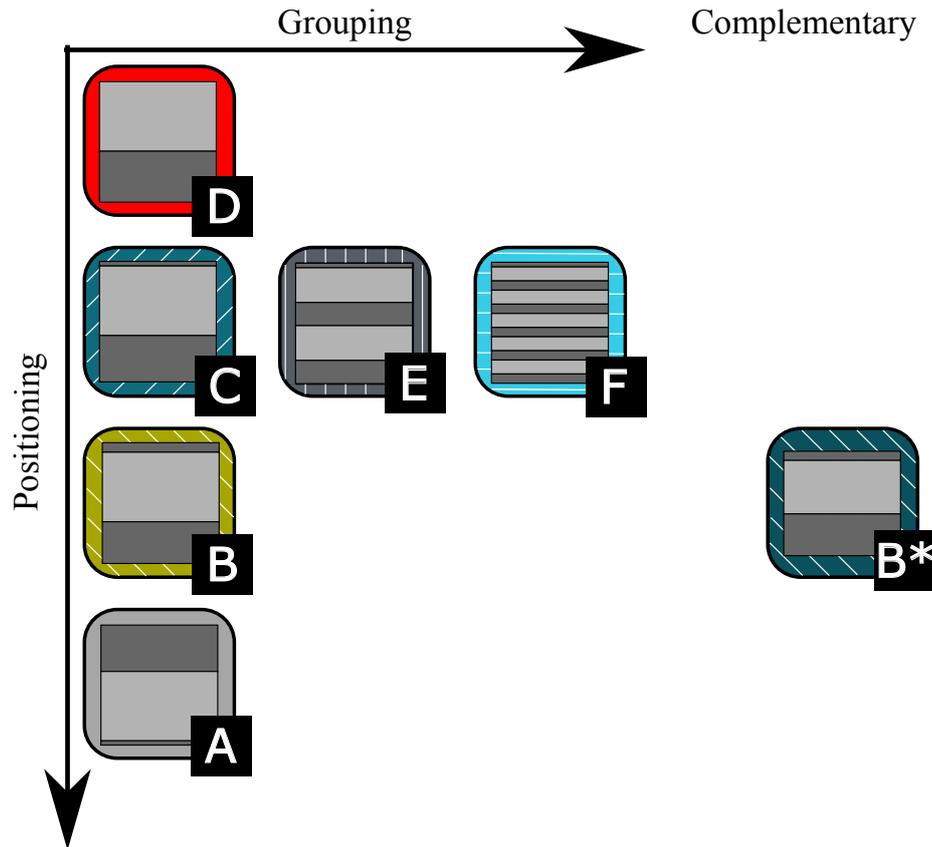
Figure 3.4: Nomenclature of the layups of the investigation.

Figure 3.4 shows a pictorial representation of the stacking sequences of the vessels analyzed in the current project. The nomenclature is provided in the black box below each layup. The dark gray corresponds to the helical layers, while the light gray to the circumferentials. The background color and pattern will be used in some future figures and/or graphs to identify the stacking sequences. All the layups (except B*) are characterized by the same number of hoops and helicals positioned and grouped differently. Layups A to D are characterized by a single block of hoops in which only its position through the laminate thickness is changed. Layups C, E and F differ on the amount of groups their hoops are divided in, being respectively one, two and five. Layup B* is a particular case of layup B, characterized by seven less hoops.

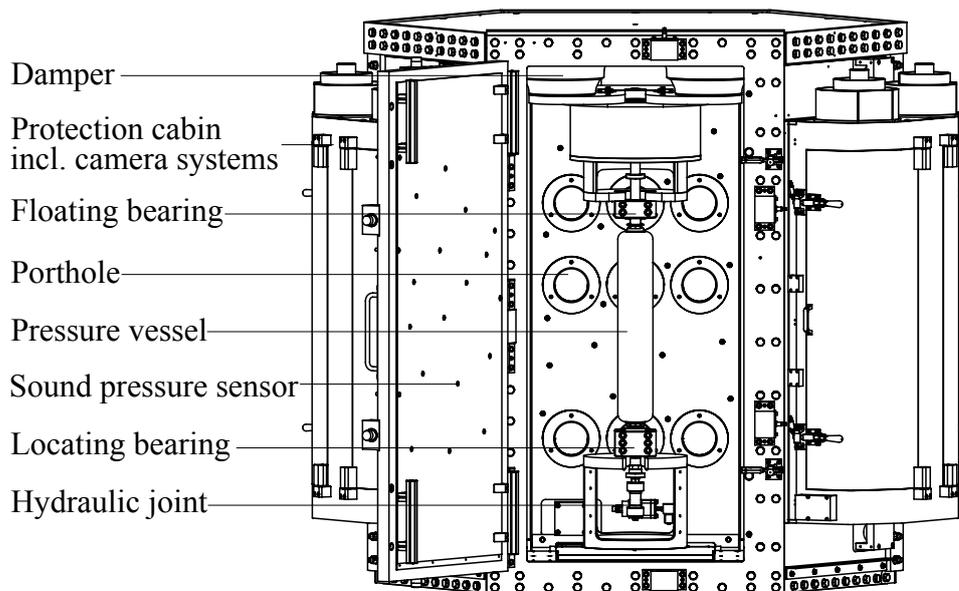
Figure 3.5: Testing facility in the Daimler plant, Untertürkheim, Germany [8].

The testing facility used for the investigations is situated in Untertürkheim, in the Daimler AG plant in Germany. This testing chamber, visible in Figure 3.5 has been designed to perform burst tests on pressure vessels. It has a hexagonal shape made of 70 mm thick steel walls. For pressurizing the vessel, a hydraulic pump is used and it can provide variable pressure rates. The pressure data is acquired with a sampling frequency of 1 kHz. In order to perform a test, the vessel is clamped at the upper and lower boss through a floating locating bearing arrangement. The bottom locating bearing is fixed and allows the attachment of the vessel to the hydraulic joint. The top boss is clamped in a floating bearing that allows the vessel to axially displace when pressurized. In addition, on three of the sides of the chamber, arranged every 120° along the circumference,

cameras are placed inside protection cabins. The cameras can take pictures through round portholes and are protected with 82.5 mm thick acrylic glasses. Three stereo cameras are positioned in each cabin, at three height levels: bottom, middle and top. In total nine stereo systems with 18 cameras can be used. Each camera has a resolution of 1624 x 1234 pixels and the maximum frame rate is 10 frames per second (fps). The cameras can be used to perform a 3D digital image correlation analysis of the vessel during the pressurization, as well as to obtain a 3D model of the vessel through stripe light projection. This is possible due to the presence of a projector in the porthole in between two cameras. In addition, 120 sound pressure sensors for recording acoustic events are positioned inside the chamber on the six lateral walls. The sound pressure sensors are arranged in such a way that minimizes aliasing effects. In total 20 sensors are installed in each wall and they all have a unique identification number. The sensors can record acoustic signals with a sampling frequency of 48, 96 or 192 kHz. This must be chosen accordingly to the length of the file to record, due to limited amount of memory. The sensors are used to record acoustic events and through the usage of a time domain delay-and-sum beamforming algorithm, it is possible to localize acoustic events. For the localization, the software NoiseImage (gfai tech GmbH, Berlin, Germany) is used.

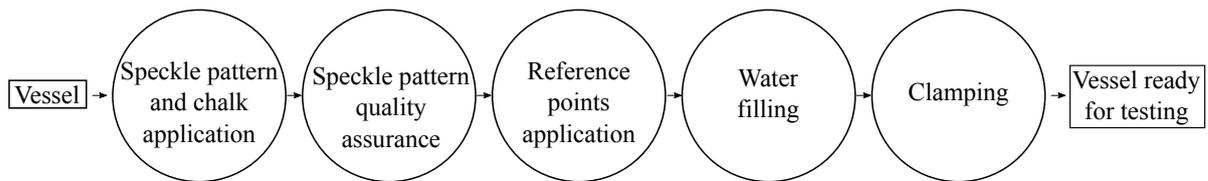
Figure 3.6: Steps for the preparation of the vessel.

Before being tested a vessel is subjected to five main operations. Three of them are needed for the optical data acquisition, the fourth one is the filling of the vessel (to avoid the presence of air during the testing) and the last one is the clamping in the locating bearing in the burst chamber. The steps for the vessel preparation can be visualized in Figure 3.6.

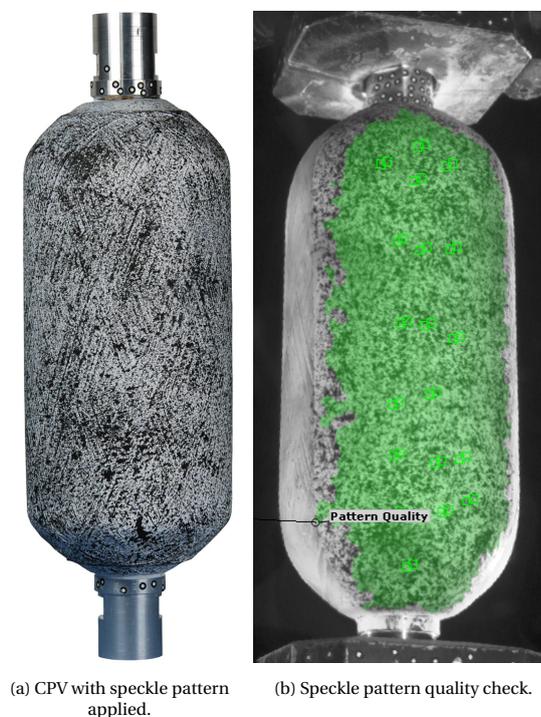
Figure 3.7: Example of speckle pattern on a CPV and quality check.

The first step consists in the creation of a speckled pattern on the CPV. The CPV is first sprayed with a water-based white paint and let dry for approximately one hour. Then, the speckled pattern is applied with a brush. The brush is first dipped into black paint and then the excess color is removed. Afterwards, the brush is tapped on the vessel surface, paying attention not to slide it. The black paint must be randomly applied and the pattern unique. The pattern should not be neither too sparse or too dense and the size of the speckles depends on the cameras resolution, the measuring volume and the distance of the vessel [51]. After the paint is applied on the entire surface, it must dry for at least 2 hours. An example of a CPV with the speckle pattern

applied can be seen in Figure 3.7a. The brush and the paints are provided by GOM (GOM GmbH, Braunschweig, Germany).

The next step consists in the quality assurance of the applied speckle pattern. The vessel must be clamped in the same position it will be placed during the testing. Pictures from each stereo system must be taken and imported in the post-processing software GOM Correlate Professional. The built in function “Pattern Quality” must be activated and it will automatically show the quality of the speckle pattern, being green a good pattern, yellow an acceptable one and red corresponding to low quality. If the quality is not high enough, the software will not be able to perform DIC in the area. An example of an excellent pattern quality can be seen in Figure 3.7b.

After the speckle pattern application and check, another step must be done to gather more information during the testing. In order to track the axial deformation of the entire vessel, it is necessary to apply some reference points that the software for the post-processing is able to recognize. These points are also provided by GOM and are attached at the top and bottom bosses, as it can be seen in Figure 3.7.

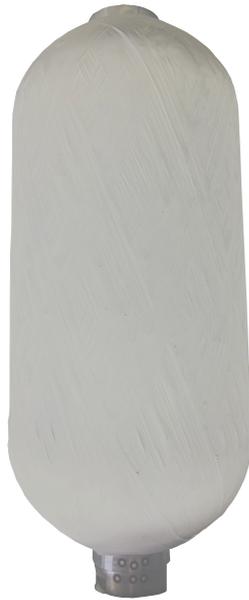
Figure 3.8: Example of vessel with chalk powder.

vessels has been prepared with chalk powder. The powder is sprayed on the vessel and let dry for 20 minutes. An example of vessel with chalk powder applied can be seen in Figure 3.8. When superficial damage is cre-

ated, the chalk flies off, making the crack detectable. During the testing it is possible to see from which areas of the vessel the chalk is detaching and whether it can be linked to certain acoustic emissions.

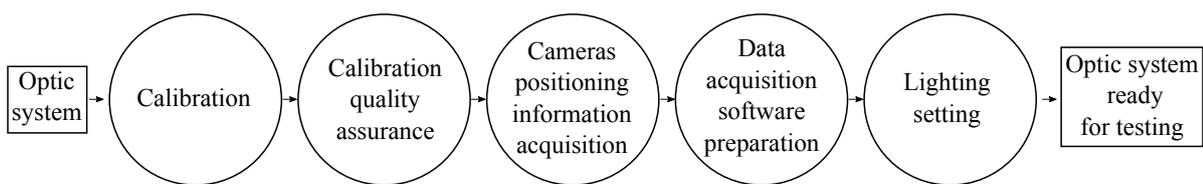
Figure 3.9: Steps for the preparation of the optic system.

Before the test, the optical system itself must be prepared. The process consists in five operations, shown in Figure 3.9. They are: calibration of the cameras and checking, acquisition of information regarding the positioning of each sensor, preparation of the data acquisition software and setting of the correct lighting.

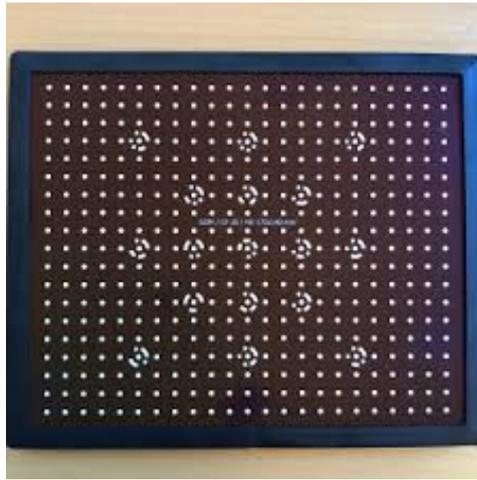
Figure 3.10: Calibration panel.

The calibration is needed to determine geometrical parameters such as position and orientation of each camera of the stereo system and to define the intrinsic and extrinsic camera parameters [51]. This must be done for each couple of cameras used during the test and it is necessary for the post-processing of the data. For the current case, the calibration is performed using a calibration panel and the software ARAMIS, both provided by GOM. The calibration plate has many white dots on black background and 17 special symbols positioned with a certain layout in the panel. The panel used can be seen in Figure 3.10. To perform the calibration, it must be positioned in front of the cameras and rotated following 13 steps provided by GOM. For each step, a picture must be taken from both cameras. When the acquisition phase is finished, the pictures are loaded in the ARAMIS software, together with the panel code. The software will localize in each picture where the special symbols are positioned and will provide a calibration file. The quality of the calibration file is given checking the parameter “Intersection Deviation”. This parameter expresses the difference between where

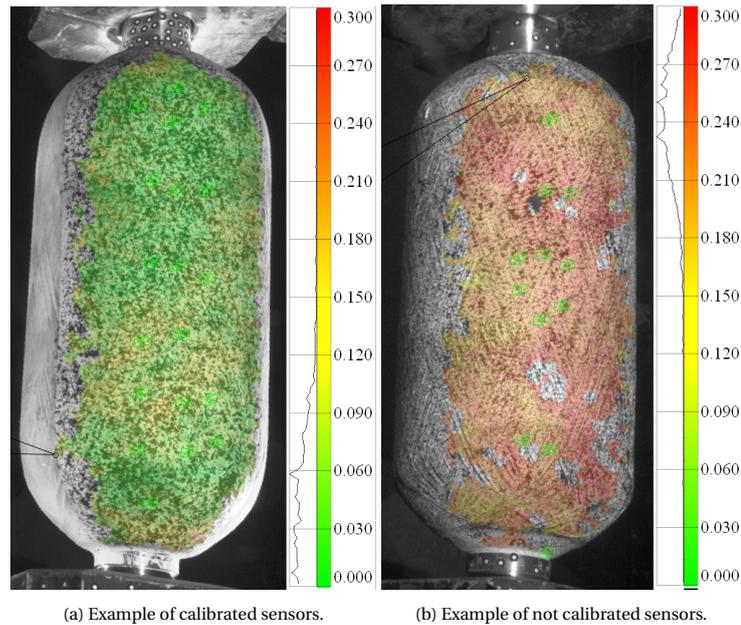
Figure 3.11: Calibrated and not calibrated sensors.

one camera expects a certain point with respect to where it really is. It is a pure number that multiplied by the pixel size, indicates how much of a pixel size the deviation is. The ARAMIS software considers a system not calibrated when the intersection deviation is higher than 0.3, thus when it is slightly less than a third of a pixel. With the current cameras and settings the pixel size is $4\ \mu\text{m}$. Figure 3.11 shows an example of a calibrated (3.11a) and a not calibrated optical system (3.11b).

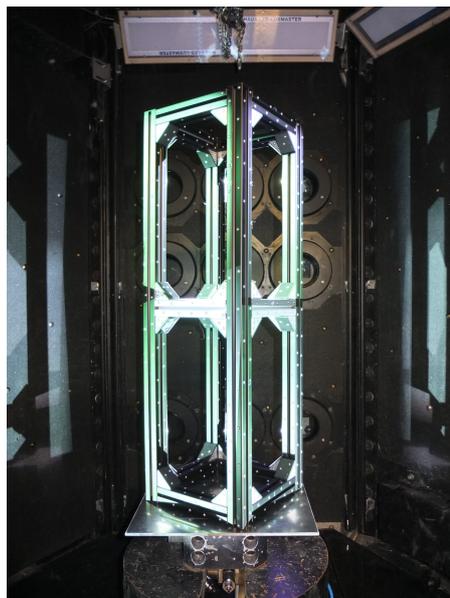
Figure 3.12: Calibration body.

Since multiple stereo-cameras are used simultaneously, to get global knowledge on the pressure vessel it is necessary to merge the information of all the systems. In particular, it is needed to correctly position the deformation data calculated by each stereo system in the 3D space and with respect to each other. This is done using a calibration body provided by the company GOM. The calibration body has a shape of a cuboid, with a known distribution of reference points and identification markers. The calibration body used for the case is shown in Figure 3.12. The position of each of the reference points is recorded in a digital file. To perform the multi-sensor positioning, it is necessary to place the calibration body where the specimen will be tested. Then a picture must be taken from each stereo camera system. The pictures must be loaded in the software ARAMIS, together with the digital file with the reference points position. The software will recognize

the reference points on the pictures and correlate them with the ones in the digital files. It will then move the pictures in the 3D space to their real position.

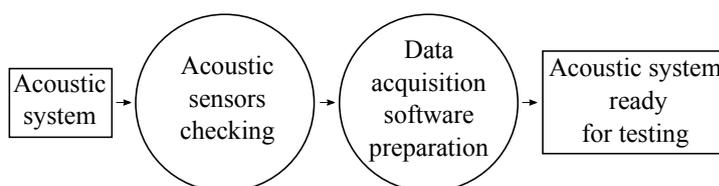
Figure 3.13: Steps for the preparation of the acoustic system.

The acoustic system must also be prepared before starting the acquisition of data. The needed steps can be seen in Figure 3.13.

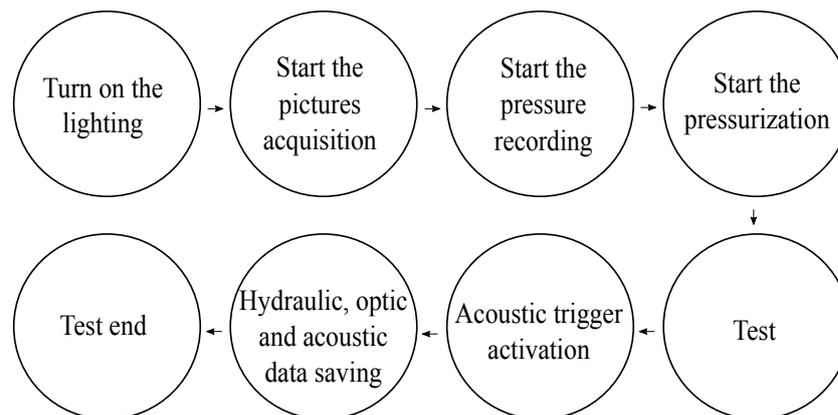
Figure 3.14: Data acquisition process.

When the vessel and the systems are ready, the test can start and the data acquisition with it. The steps to be done are shown, in order, in Figure 3.14.

First, the projectors must be turned on and few minutes are needed in order to project the predefined light. Then the GoPro recording can be activated, as well as the pictures and the pressure recording. Afterwards, the pressurization can begin, thus the test is performed. Finally, the acoustic trigger is activated. Before the ending of the test, the data coming from all the systems (hydraulic, optic and acoustic) must be saved.

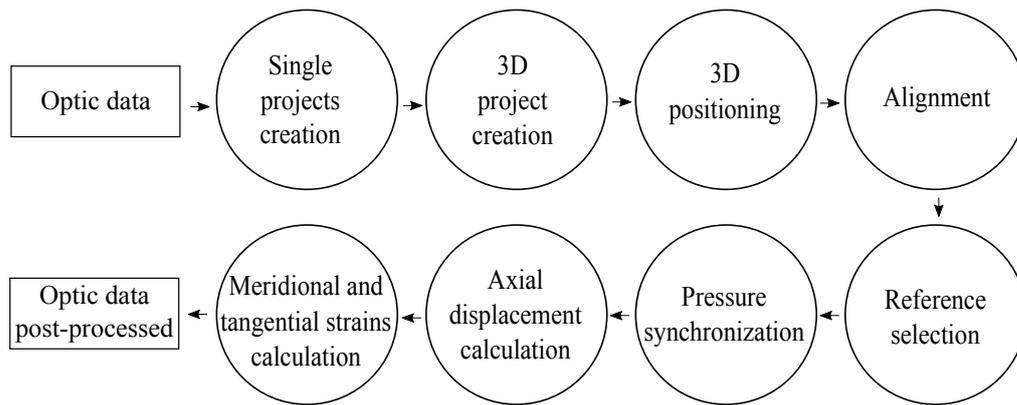
Figure 3.15: Steps for the processing of the optic data.

For the post-processing of the optical data the software GOM Correlate Professional is used. The main steps needed to carry on the analysis are shown in Figure 3.15. Each of them is described in detail.

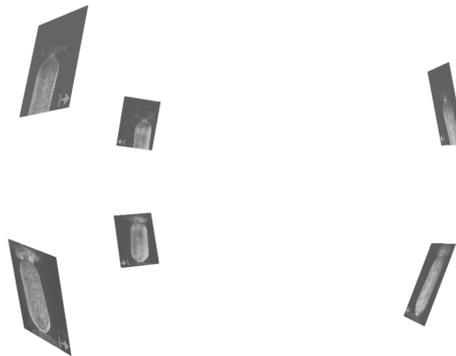
Figure 3.16: Pictures of six stereo-systems positioned.

When creating the 3D project, the pictures of the different stereo systems are randomly positioned in the 3D space. To move them to the exact location, the imported pictures of the calibration body are used. The file containing the position of each of the reference points is also needed for the process. The software will recognize the reference points on the pictures and correlate them with the ones in the file. Then, it will move the pictures in the 3D space in their correct position, as it can be seen in Figure 3.16.

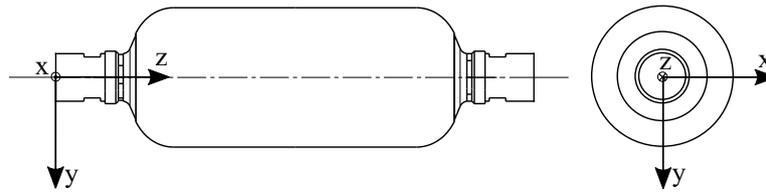
Figure 3.17: Global coordinate system.

The next step corresponds to the alignment. It consists in the positioning and rotation of the global coordinate system in order to place it in the correct location. For this case, the chosen coordinate system is shown in Figure 3.17: the origin is located at the end of the bottom boss, in its center. The z coordinate corresponds with the vessel longitudinal axis of symmetry. The x and y axes are both in the radial direction with respect to the vessel.

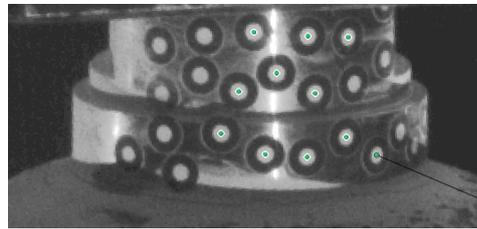
Figure 3.18: Example of a point component taken from the boss of a CPV.

The reference points attached at the top boss are needed to track the axial displacement of the vessel. Point components must be created in the software selecting the stickers attached on the surface. Afterwards, the position of the point components at each recorded stage is calculated and the displacement from the reference stage is obtained. The displacements are calculated in the 3 directions decided with the alignment, thus in the global coordinate system. An example of a point component can be seen in Figure 3.18.

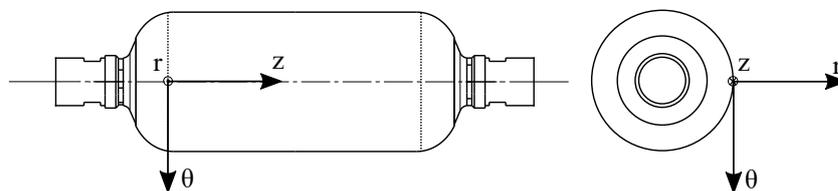
Figure 3.19: Local coordinate system.

Surface components are the tools responsible of evaluating the strains. The components are created on a speckled surface. Each of them is formed by facets, which are groups of pixels. For this case, a facet is a square with 19 pixels in each side. Depending on how these facets displace and rotate, strains can be calculated with respect to the unpressurized state, taken as reference. Contrarily to the displacements obtained from the point components, the strains are calculated in local coordinate systems. Each point of the surface component is the origin of its own local reference system. The three directions are tangential, meridional and through the thickness and can be seen in Figure 3.19. The 'z' local axis is oriented in the meridional direction of the vessel, tangent to its surface; ' θ ' is perpendicular to 'z' and it is also tangential to the vessel surface; the through the thickness axis 'r' is perpendicular to the other two axis, thus perpendicular to the vessel surface, pointing outwards.

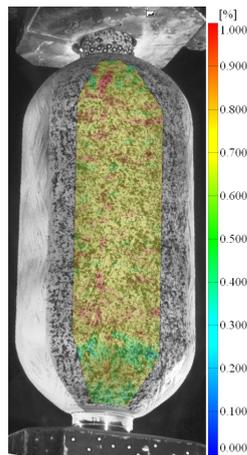
Figure 3.20: Full-field strain measurement of outer meridional strain.

The surface strains can be easily visualized in the software using a color map, as shown in Figure 3.20.

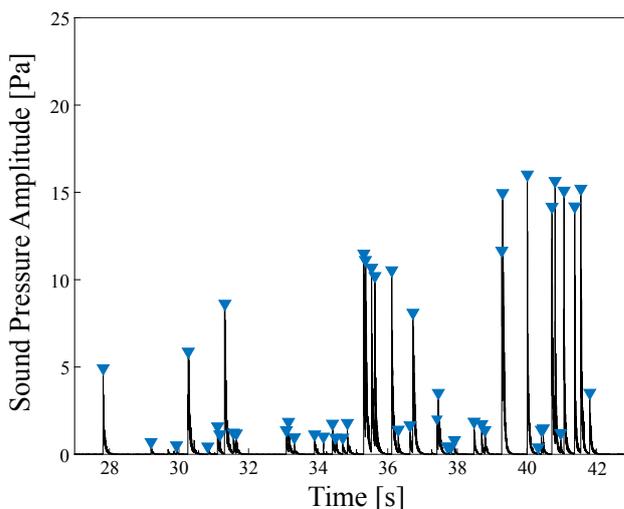
Figure 3.24: Example of peaks detected by the PeakFinder tool.

An example of output given from the `PeakFinder` tool is shown in Figure 3.24. Each detected peak is indicated with a blue marker.

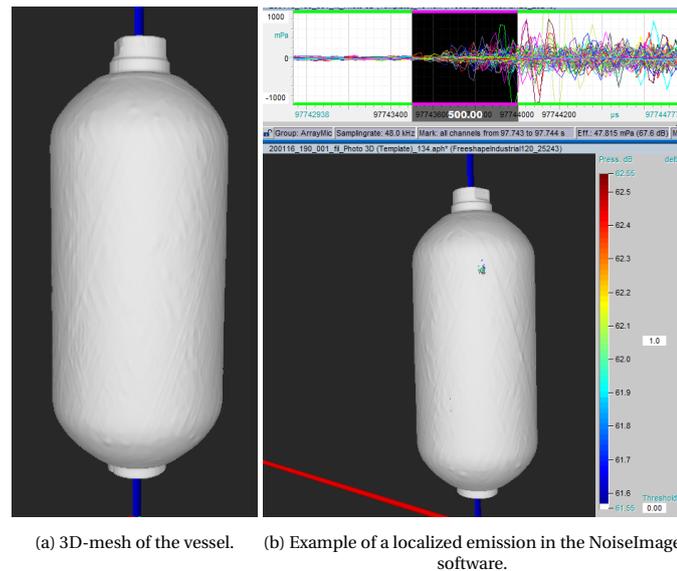
Figure 3.25: Vessel mesh and emission localization example.

After the emissions have been identified, it is necessary to localize them. This is performed using the software NoiseImage, which contains a delay-and-sum beamforming algorithm for the localization of acoustic emissions. In order to localize an emission, it is first necessary to import in the software the 3D-mesh of the vessel. This is produced scanning the vessel from all the stereo-cameras using the stripe light projection method. The scans are then merged to form the full 3D-mesh, as it can be seen in Figure 3.25a. Once the 3D-mesh is loaded in the software, the localization can start. Each acoustic emission detected with the PeakFinder tool is manually beamformed. Each peak is selected and the algorithm automatically provides the location of the acoustic source on the 3D-mesh, as it can be seen in Figure 3.25b.
