Combined Acoustic and Optic Characterization of Damage Mechanisms in Internally Pressurized Composite Pressure Vessels

MSc Thesis

Aerospace Engineering

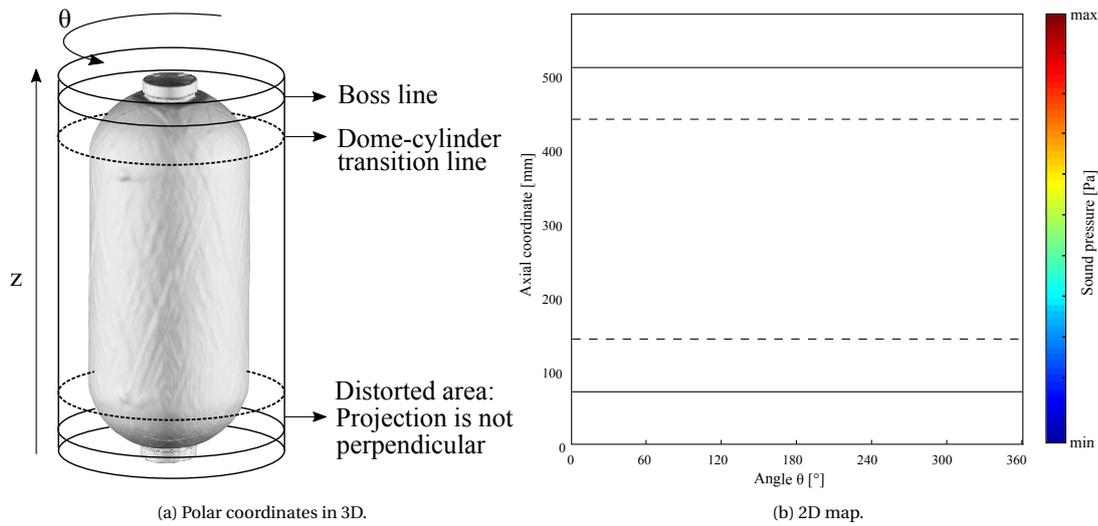
Figure 3.26: Transformation of 3D map into 2D.

The most damaged areas can be identified mapping all the localized emissions. This process cannot be done with the software NoiseImage, thus a MATLAB code has been written for the purpose. In order to easily visualize the entire vessel, a 2D map is created. The first step corresponds to the transformation of the cartesian coordinates (x , y and z) of each emission in polar coordinates (r , z and θ). Secondly, the radial coordinate is neglected and the 3D map is transformed in 2D, as shown in Figure 3.26. Due to this process the domes areas get distorted. To further simplify the visualization, bosses, domes and cylindrical sections are marked with different lines. The bosses are marked with solid lines and the cylindrical section with dotted lines, as shown in Figure 3.26. The domes are the areas in between a solid and a dotted line.

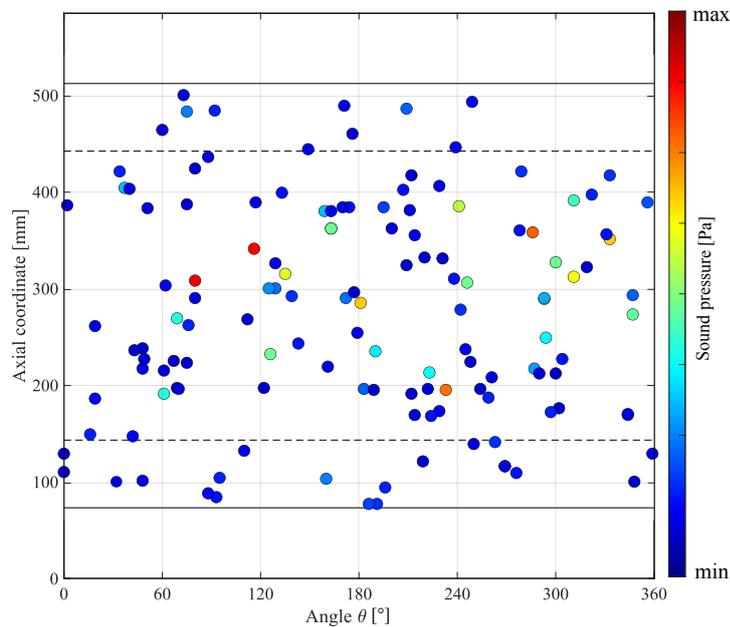
Figure 3.27: Example of representation of the acoustic emissions in a 2D map.

After the creation of the 2D map, the emissions are plotted. Each emission is represented with a circular marker. The color of the marker is correlated to the maximum sound pressure amplitude of the emission. An example of a 2D map representation with acoustic emissions can be seen in Figure 3.27. This visualization is useful to understand which are the most damaged areas of the vessel. However, it does not provide knowledge regarding the damage progression during the pressurization. Since the acoustic and hydraulic files have already been synchronized, the previous plot can be easily modified. The tangential coordinate (θ) of the acoustic emission is neglected, while its axial coordinate is kept and plot with respect to the internal hydraulic pressure. Also for this case the emissions have been represented with circular markers and their color depends on their maximum sound pressure amplitude. An example of this representation can be seen in Figure 3.28.

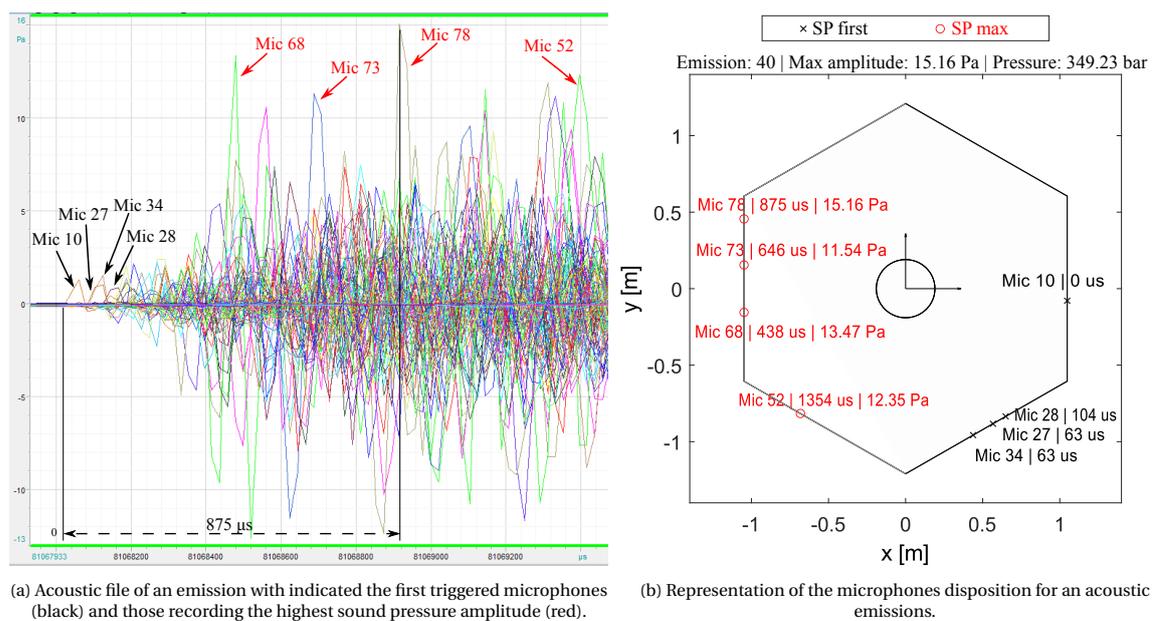
tion regarding the time, the amplitude of each peak and the microphones identification numbers are stored. Then, the first four microphones triggered are detected and their identification number is noted. The first microphones triggered are defined as the first four microphones which record a sound pressure amplitude higher than 0.3 Pa. The time interval between the start of the emission and the four maximum peaks is calculated. The identification number of these sensors is also stored. For a better understanding, an example is provided. Figure 3.29a shows the acoustic file of a certain emission: each line corresponds to one sensor. The microphones which record the maximum sound pressure amplitude are indicated with a red arrow, while the first triggered microphones with a black one. The delay of the maximum peak with respect to the emission start is indicated with a dotted arrow. When all the information is gathered, the results are plotted. An example can be seen in Figure 3.29b. The hexagonal shape is a representation of the testing chamber, being each side one of the lateral walls. The circle at the center represents the CPV. The black cross markers represent the first triggered microphones and the red circles the ones recording the maximum sound pressure amplitude. Each marker is positioned on the wall where the corresponding microphone belongs to and it is labeled with the acoustic sensor identification code and the delay with respect to the first microphone triggered. For the red markers it is also shown the maximum sound pressure amplitude recorded by that sensor.

(a) Acoustic file of an emission with indicated the first triggered microphones (black) and those recording the highest sound pressure amplitude (red).

(b) Representation of the microphones disposition for an acoustic emissions.

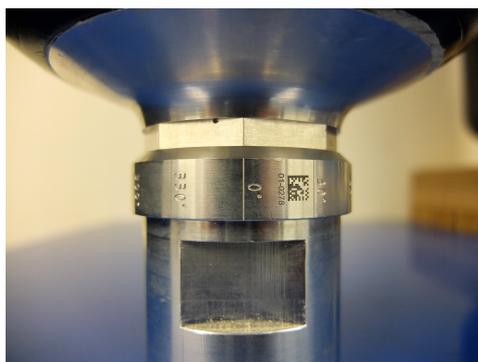
Figure 3.30: Angle scale in the boss of the CPV.

Known the coordinates of the emissions, they need to be localized on the vessel. This is possible because in the lower boss of each vessel it is present a scale with angles from 0° to 360°, as shown in Figure 3.30. The angles of the 2D-map are synchronized with those present on the boss. The axial coordinate is measured using a measuring tape. After the chosen emissions are marked on the CPV, specimens must be cut. The vessel is

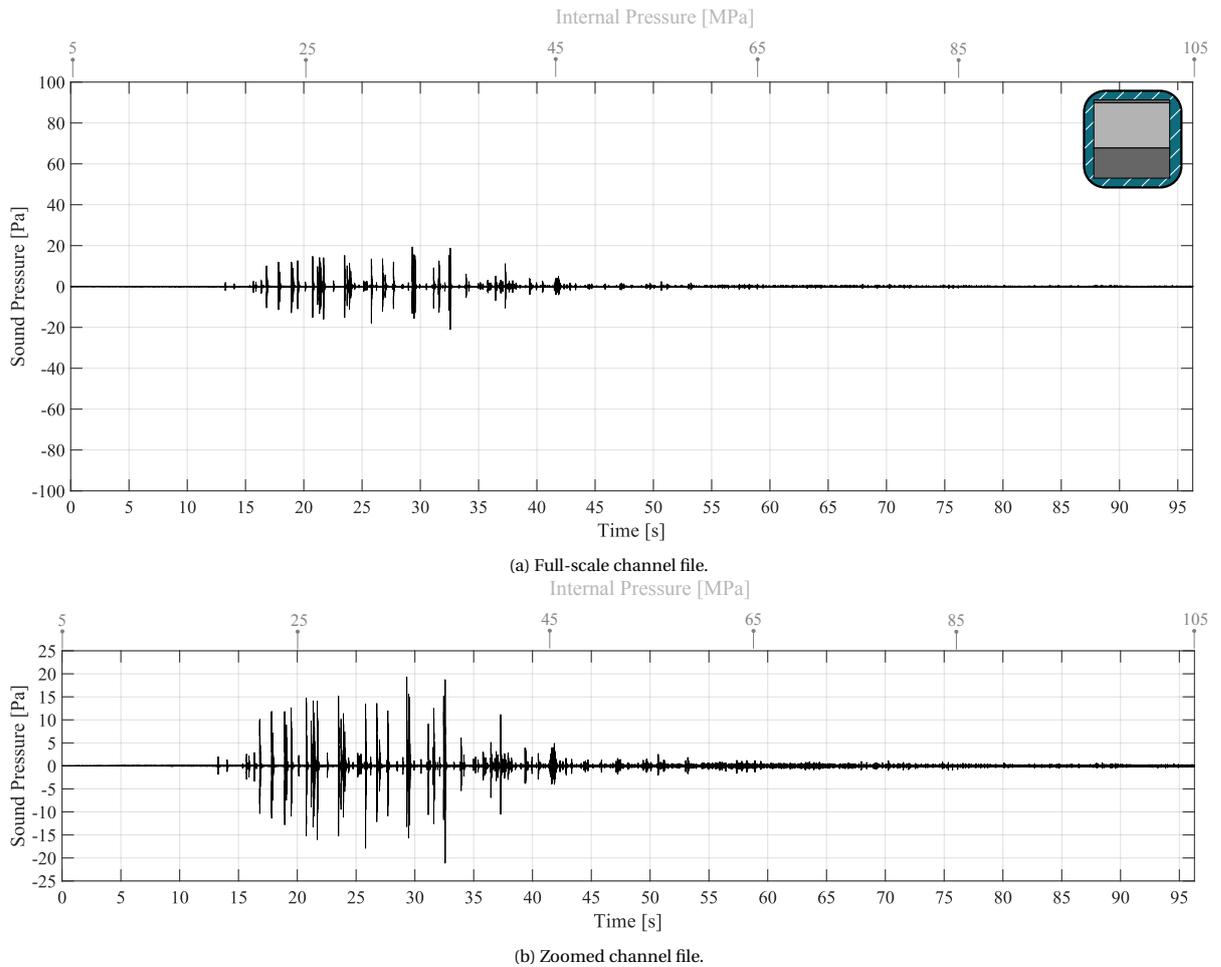
Figure 4.1: Acoustic file of vessel C in the hydraulic pressure range 5-105 MPa.

Figure 4.1 shows the acoustic channel file of one vessel of this layup. In particular, the sound pressure amplitude is plotted with respect to time in the hydraulic pressure range 5-105 MPa. Figure 4.1b is a zoom of Figure 4.1a and gives more detailed information regarding the acoustic behavior of this layup. In the top part of the graphs it is displayed the internal hydraulic pressure. It is not possible to directly plot the acoustic with respect to the hydraulic pressure due to some small non-linearities in the latter one. As it can be seen from Figure 4.1, at the beginning of the pressurization the vessel does not produce any detectable emission. After about 15 seconds (corresponding to an internal pressure of about 20 MPa), few peaks below 5 Pa are recorded, followed for the next 20 seconds by emissions above 10 Pa, reaching a maximum sound pressure of 19.47 Pa. For the next 10 seconds, until 45 MPa, emissions up to 5 Pa are recorded, followed by an important amount

of small amplitude peaks, usually below 1 Pa, that are present until the end of the pressurization. The maximum sound pressure amplitude (A_{max}) recorded for the vessel is 19.47 Pa and the first emission detected corresponds to the hydraulic pressure of 18.1 MPa. In total, in the predefined pressure range, 51 peaks are detected. They are identified using threshold I. Due to the low pressure stages at which they take place, they could be caused by matrix cracking in the 90° plies [42, 79, 82], thus the hoops. The variables of all the tested vessels of the current layup are shown in Table 4.1, together with their averages and standard deviations. As

4.3a with Figure 4.1a it is possible to notice that layup F produces acoustic emissions of lower amplitude. Figure 4.3b is a zoom of Figure 4.3a. The first 20 seconds of the pressurization are characterized by the absence of significant acoustic emissions. They are followed by other 20 seconds (until just before 45 MPa) in which few peaks can be observed but none detectable by the PeakFinder tool because characterized by sound pressure amplitude below 0.3 Pa. From an internal pressure of about 43 MPa, emissions with amplitude above 0.5 Pa can be detected, until reaching a maximum of 2.18 Pa. After this maximum peak, some more peaks above 0.5 Pa can be seen until reaching second 65, at about 72 MPa. Afterwards, up to the end of the pressurization, a significant amount of low amplitude emissions (with sound pressure below 0.5 Pa) can be observed. The maximum sound pressure amplitude (A_{max}) recorded for this vessel is 2.18 Pa. If compared to the maximum of layup C (19.47 Pa), it can be noticed that it is consistently lower. If these peaks are caused by IFF in the hoops, the difference in sound pressure amplitude could be explained by the fracture surface size [42, 68]. In layup F, the crack size is one fifth with respect to C, due to the presence of helical layers every six hoops. The first emission detected corresponds to the hydraulic pressure of 43.0 MPa and it is the only detected peak in

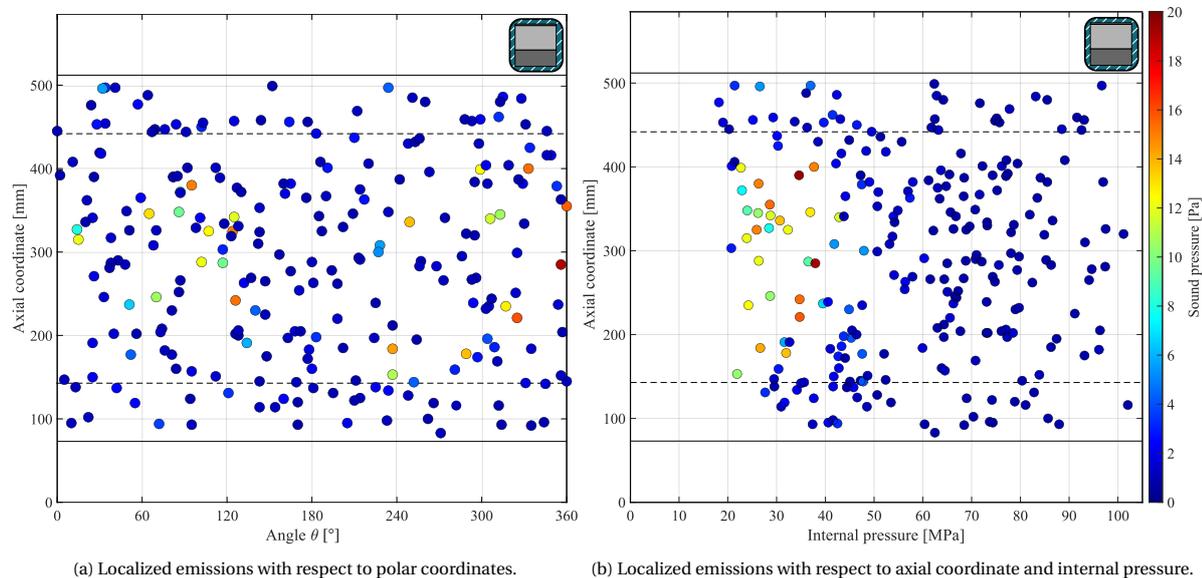
Figure 4.2: Localized emissions plots for layout C.

Figure 4.2 shows the localized emissions for this vessel. In particular Figure 4.2a displays the position of the emissions with respect to the axial and tangential coordinate. It can be noticed that all the peaks with higher amplitudes (above 8 Pa) are localized in the cylindrical section. This fact helps to reinforce the hypothesis that these emissions correspond to IFF in the hoop layers, since they are only wound in the cylindrical section and not in the domes. The fact that they have such a high amplitude could be related to the important size of the fracture surface [68]. In fact, once a crack is created, it progresses until it finds a crack stopper, such as a change in layer orientation [31]. In the current case, the cracks could easily develop through the 30 hoop layers and get stopped by the top and bottom blocks of helicals.

Figure 4.2b shows the axial position of the emissions with respect to the internal hydraulic pressure. It can be noticed that all the emissions with higher amplitude occur at low pressure stages, from 20 to 40 MPa. The rest of the pressurization is characterized by peaks of sound pressure amplitude below 6 Pa. As explained in Paragraph 2.4.2, when the amplitude is low it might be that either the fracture surface created is very small or that the damage takes place in depth in the laminate. With the current information it is not possible to define which case corresponds to the current situation. In the pressure range 20 - 40 MPa, some low amplitude emissions also occur, mainly localized in the transition zone. They could be caused by matrix cracking taking place in that area. In that zone, the hoops are tapered towards the dome. During the curing and the manufacturing process, the tows could laterally slide due to the tension applied. This could lead to the formation of small gaps that get filled with resin. These resin rich gaps could crack and cause AEs. The pressure range 40 to 50 MPa is characterized by low amplitude emissions localized through the entire height of the vessel. In the next 10 MPa only few emissions occur and they are mainly positioned in the cylindrical section. From the internal pressure of 60 MPa to the end of the test a significant amount of acoustic emissions has been localized, all characterized by a sound pressure amplitude below 2 Pa. The majority of the emissions are located in the cylindrical section and few in the domes. In the latter pressure range, nearly no emissions are localized in the transition zone. The presence or absence of these low amplitude emissions in some areas of the vessel cannot be explained with the few information provided. If those peaks are related to damage taking place on the surface, their occurrence might be related and explained with the superficial strain distributions, which are calculated with the DIC. This topic will be evaluated in detail in Paragraph 4.4.

In the same pressure range, some emissions of lower amplitude also occur, which have mainly been beamformed in the transition zones. As for the others, no superficial damage can be seen in Figure 4.22b, which is why it is concluded that the damage takes place on the inside of the laminate. Due to the low pressure stages at which it is happening, it might be related to matrix cracking [42, 79, 82] and since it is not visible, it must be in the internal layers. Few hoop layers are present in the transition zone, tapered towards the domes. Due to friction, fiber tension and to resin flow during curing, they might slightly slide. This could create small gaps between the bottom block of helicals and the outermost ones. Due to the compaction effect of the domes during the curing, this gap could be filled with resin and cause premature matrix cracking, which could be associated to these emissions. A similar trend can be observed in C (Figure 4.2b). Due to the similarity of the two layups, similar behaviors are expected.

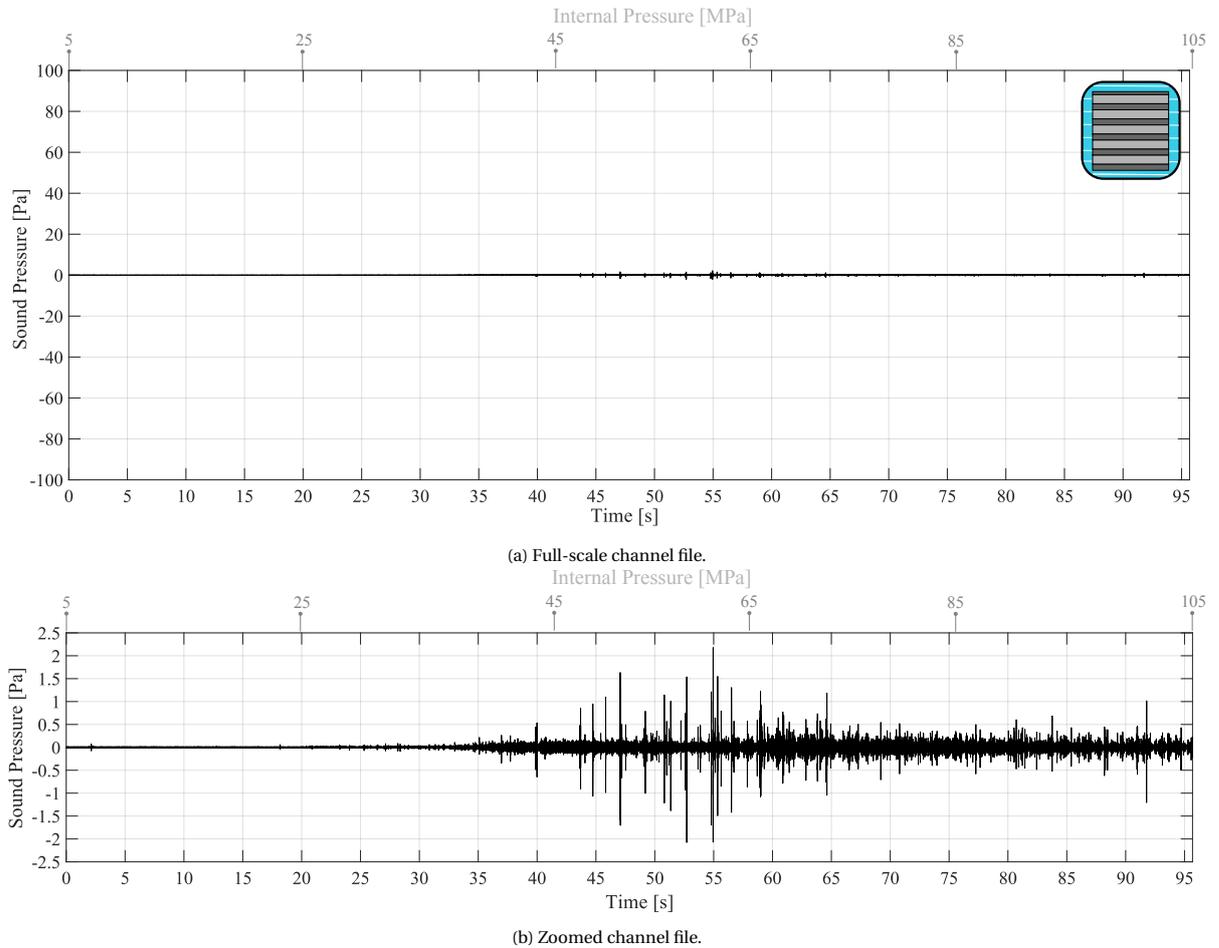
Figure 4.3: Acoustic file of vessel F in the hydraulic pressure range 5-105 MPa.

Figure 4.3 shows the acoustic file of the other pressurized vessel, in the range 5-105 MPa. Comparing Figure

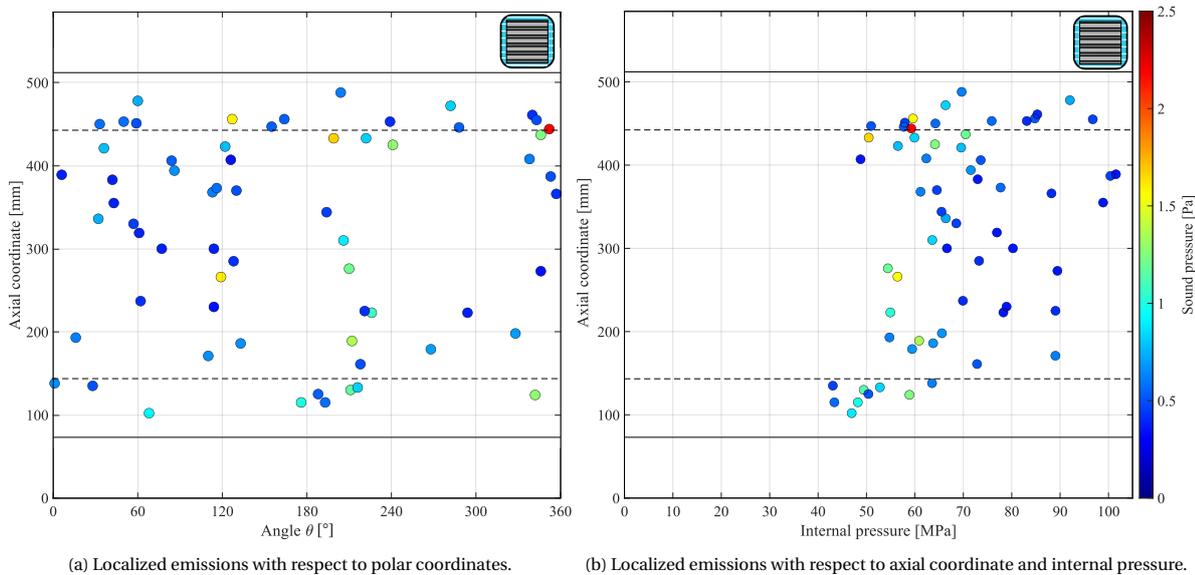
Figure 4.4: Localized emissions plots for layup F.

From Figure 4.4a it can be seen that emissions with sound pressure amplitude above 0.8 Pa are distributed in both the cylindrical section and transition zones. This means that these emissions cannot be uniquely associated with IFF in the hoop layers, since only few of them are wound in the transition zone due to tapering. Emissions with pressure amplitude below 0.8 Pa are mainly located in the cylindrical section. This follows the same trend observed in layup C.

Figure 4.4b shows the emissions with respect to the internal vessel pressure. It can be noticed that at pressure stages below 40 MPa, no emissions are present. The first localized are concentrated in the bottom dome-transition area. It was not clear why they were all concentrated in that area and no emissions could be found in the top transition. Due to vessel symmetry, it is expected that top and bottom transition zones and domes would behave similarly. The vessel has been visually analyzed and a ring with air bubbles (which can be associated to air inclusion) have been detected in the area, as shown in Figure 4.5. This increased superficial porosity could have been the cause of damage formation at low loads and as a consequence of presence of

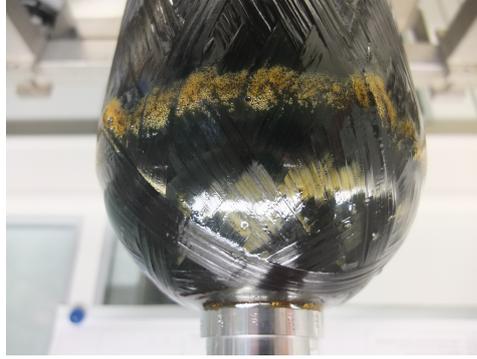
Figure 4.5: Presence of bubbles at the bottom transition zone of layup F

AEs. This hypothesis has been proven comparing pictures taken at pressure stages 40 and 50 MPa and look-

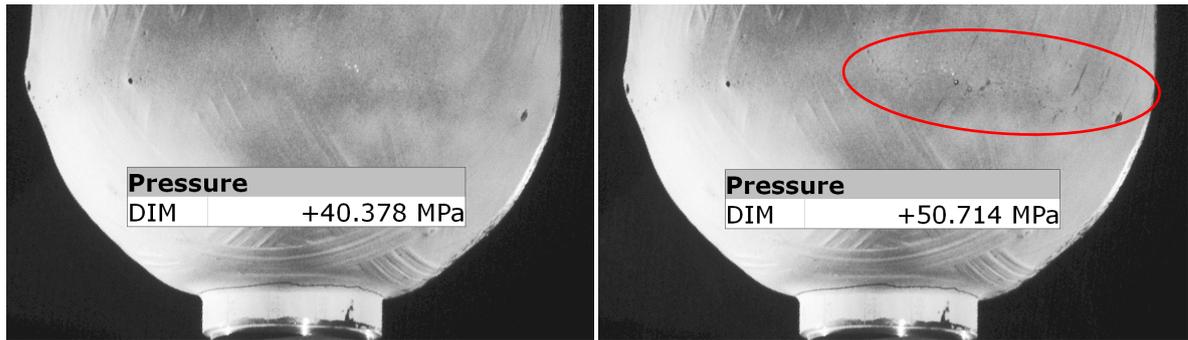
Figure 4.6: Bottom transition zone of layup F before and after the occurrence of the initial acoustic emissions.

ing at the chalk distribution in the area. In Figure 4.6, the picture on the left shows the transition zone of the vessel before the detection of the emissions at a pressure of about 40 MPa. Figure 4.6b shows the same area at a pressure stage of about 50 MPa, thus after those first peaks have taken place. In the red circle, some dark lines have appeared caused by the falling of the chalk dust. These emissions can be associated to superficial cracking of the matrix in the area. It was not clear what caused this small defect, since no problems during manufacturing and curing have been highlighted. Air inclusion in the transition zone is not a peculiar characteristic of layup F, otherwise it should have been found also in the top part and in other vessels with the same stacking sequence. Since this was not the case, it can be concluded that it was a defect. After these first

(a) Bottom transition zone without superficial damage at pressure stage 40.378 MPa.

(b) Bottom transition zone with visible superficial damage at pressure stage 50.714 MPa.

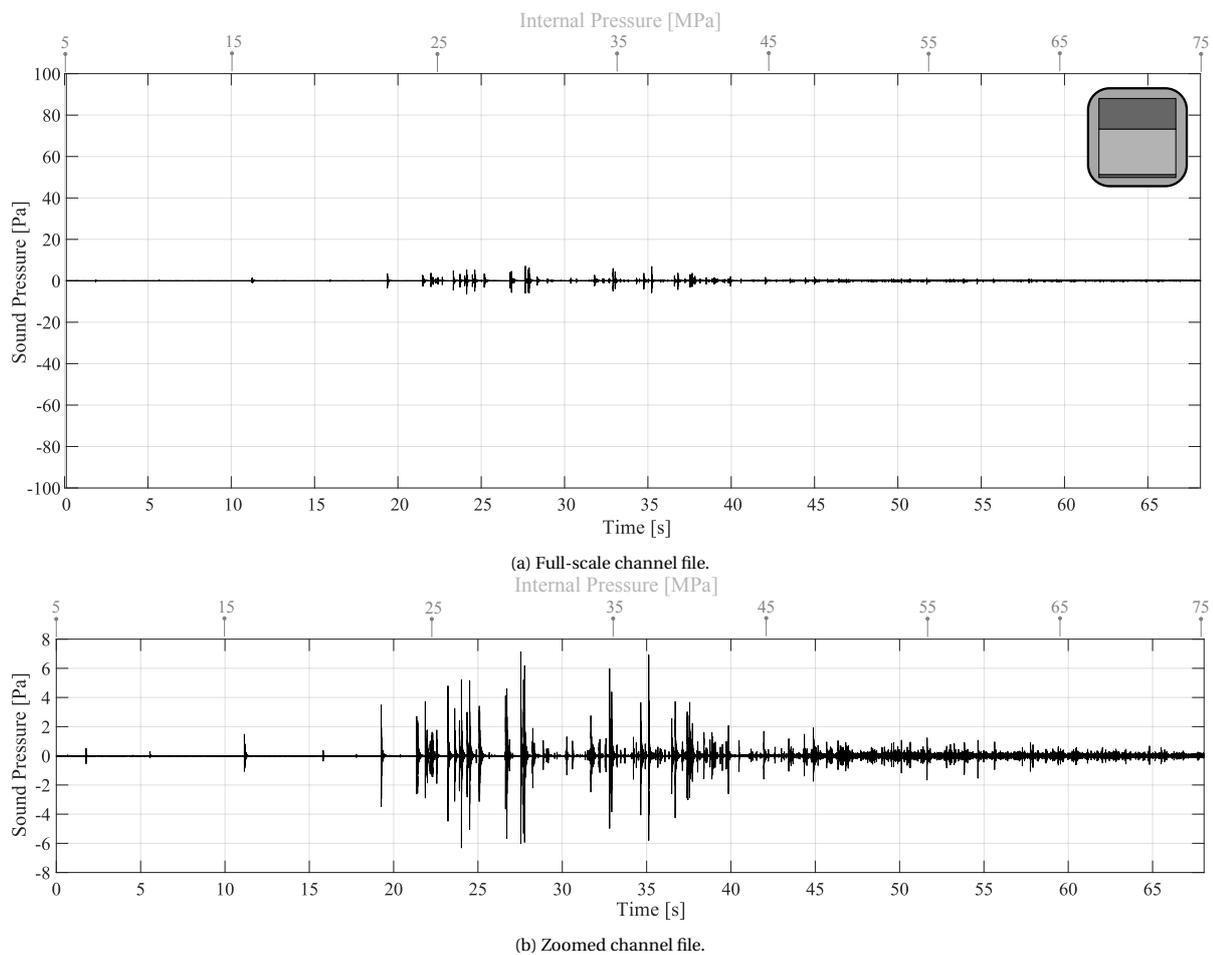
Figure 4.7: Acoustic file of vessel A in the hydraulic pressure range 5-75 MPa.

Figure 4.7 shows the acoustic channel file of layup A. The plot represents the sound pressure amplitude with respect to time in the hydraulic pressure interval between 5 to 75 MPa. The hydraulic pressure is present at the top of the graphs. Looking at Figure 4.7a it can be noticed that the acoustic behavior of this layup is in between

C and F in terms of sound pressure amplitudes. Figure 4.7b is a zoom of Figure 4.7a. At about second 11 (just above the hydraulic pressure of 15 MPa) a single emission is present. This has not been considered the first peak, because while performing the beamforming, it has been localized in the metal boss, as shown in Figure 4.8. This peak has been associated to an acoustic source caused by the hydraulic pump or any hydraulic valve. The first emission of the vessel is considered the one happening at second 19, which corresponds to the hydraulic pressure of 23.3 MPa. After second 20 it is possible to notice emissions with amplitudes above 3 Pa, with few peaks reaching 5 Pa. 7.05 Pa is the maximum amplitude recorded for the current vessel. In the range between second 35 and 40 (37 - 43 MPa) few more emission are present, but all with amplitudes below 5 Pa. Afterwards, the acoustic file is characterized by low amplitude acoustic emission, the high majority of them with a sound pressure below 1 Pa. The maximum sound pressure amplitude (A_{max}) recorded for this layup is 7.05 Pa. When comparing it to layup C, which has the same stacking sequence but in reverse order, it can be noticed that there is an important difference. For layup A it is 7.05 Pa and for C 19.47 Pa. If these emissions can be associated to IFF in the hoops, the difference can depend on the depth of the fracture in the laminate. Both stacking sequences have a single block with 30 hoops layers which are positioned at different heights in the laminate (deeper for A). The results obtained are in agreement with what found in literature [30, 82]. Drawing conclusions at this point is premature because only few data have been analyzed. The first detected emission for layup A takes place at a hydraulic pressure level of 23.3 MPa and the hits counted for the pressure range 5 - 75 MPa are 27. Table 4.3 shows the results of the other tested vessels of the current layup.

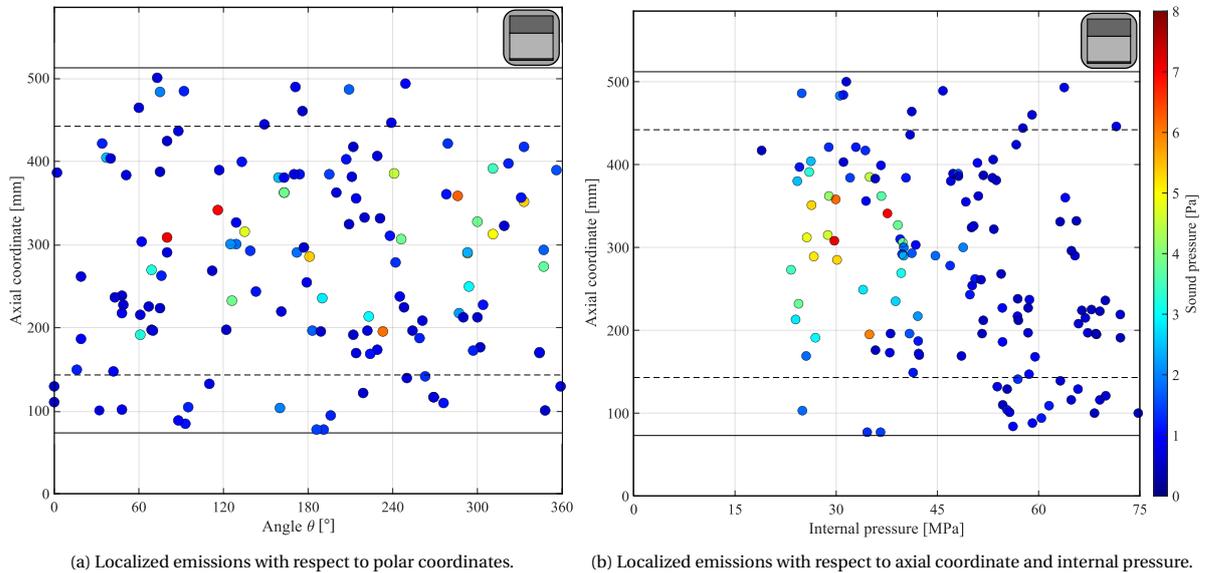
Figure 4.9: Localized emissions plots for layup A.

to threshold II. This allows the detection of emissions below 2 Pa. The results are shown in Figure 4.9. From

Figure 4.9a it can be noticed that all the higher amplitude acoustic emissions (above 3 Pa) are localized in the cylindrical section of the vessel. This fact further reinforces the hypothesis that the emissions with higher amplitude can be related to IFF in the hoop layers. The emissions with lower amplitudes are mainly localized in the cylindrical section but some of them can also be found in the domes.

From Figure 4.9b it can be noticed that the first emission occurs at a pressure level just below 20 MPa, and it is

followed by a significant amount of emissions with amplitude above 3 Pa, taking place in the pressure range 20 - 30 MPa. These emissions are all localized in the cylinder except two. The low loading state at which they take place further reinforces the fact that they can be associated to matrix cracking [42, 79, 82]. The pressure range between 30 and 40 MPa is characterized by high and low amplitude emissions, the majority localized in the cylindrical section. Proceeding with the pressurization, some low amplitude emissions are detected in the range 46 - 50 MPa and are localized in the cylindrical section. They are followed by other low amplitude emissions (below 1 Pa) that have been beamformed in both the cylindrical section and the domes. The low amplitude that characterizes these emissions could be associated either to small fracture surfaces or to a damage that takes place deep in the laminate and gets attenuated. This fact will be examined later in the research, when more data will be provided.

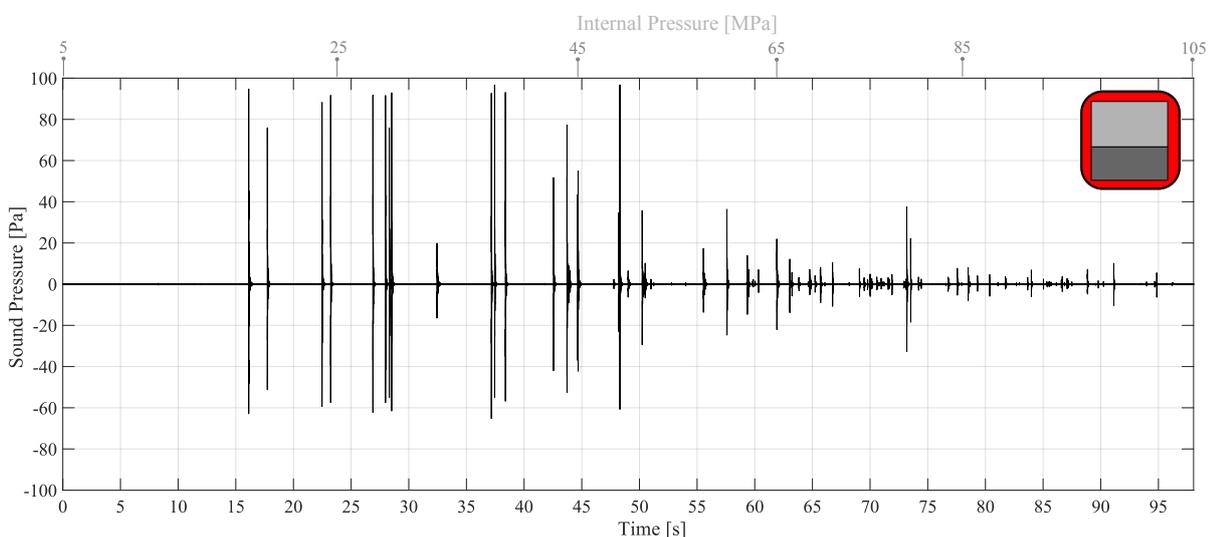
Figure 4.10: Acoustic file of vessel D in the hydraulic pressure range 5-105 MPa.

Layup D is a particular case because it is the only one of the current project without an helical ply as outermost layer. Its stacking sequence is $[(\pm 19.9^\circ)_{11} / (+88.5^\circ, -88.5^\circ)_{15}]$, thus it has 11 helicals on the inside with 30 circumferentials on top. Only one vessel of this layup has been manufactured and it has been subjected to pressurization test up to 105 MPa. Its acoustic file is shown in Figure 4.10.

This layup produces emissions characterized by a significantly high amplitude, some above 80 Pa. The first detected emission can be seen in Figure 4.10 at second 16, which corresponds to an internal pressure of 18.0 MPa. It is then followed by other very high amplitude peaks, until reaching second 47 (which corresponds to about 50 MPa). Emissions of lower amplitude (the majority below 10 Pa) can be detected later and up to the end of the pressurization. The parameters of this layup are summarized in Table 4.4. When lowering the

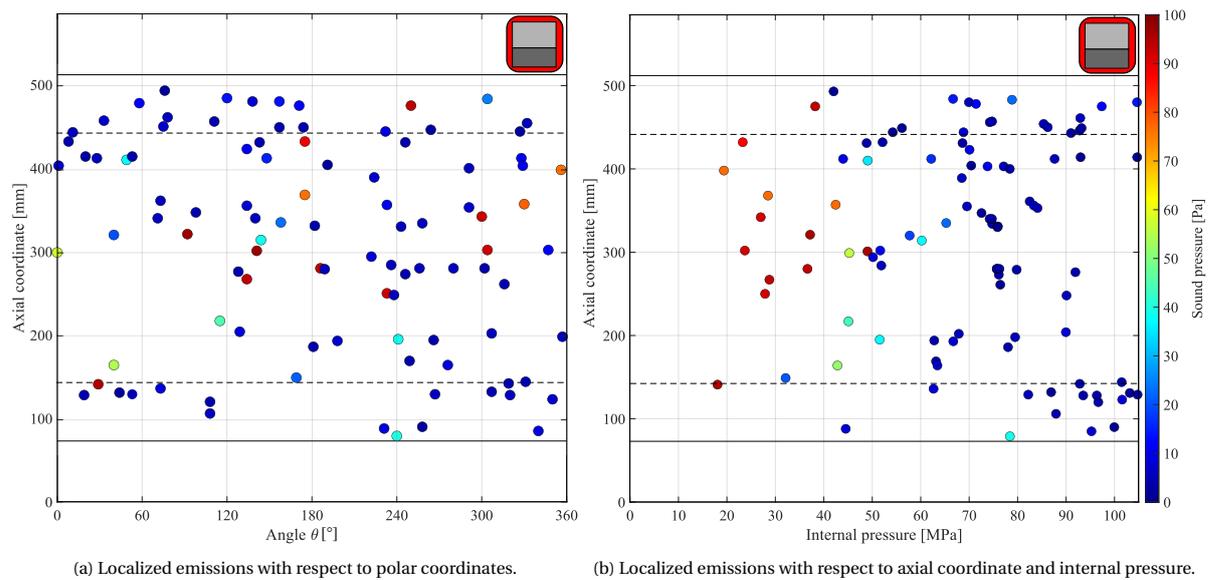
Figure 4.11: Localized emissions plots for layup D.

The position of the localized emissions can be seen in Figure 4.11. From Figure 4.11a it can be noticed that

also layup D follows the trend of the previously examined stacking sequences. All the emissions characterized by higher sound pressure amplitude have been localized in the cylindrical section (except two of them). Due to their significantly high amplitude, it might be hard to associate them to matrix cracking. Matrix cracking usually produces emissions of low amplitude, as shown in Figure 2.17. Fiber failure is associated to events with higher energy release [64, 66]. Looking at Figure 4.11b it can be observed that those emissions take place at early pressure stages (18 to 50 MPa). It is very unlikely that these modest loads could cause fiber failure, thus these significantly high peaks can most likely be associated to IFF in the hoop layers. The important amplitude of the emissions could be caused by the significant size of the fracture surface and to the fact that no helical layers are present on top of the hoops, thus there is no attenuation of the signal. The free boundary effect could also play a role in this configuration, as explained in Paragraph 2.4.2. Talreja and Veer Singh [28] have shown that when the 90° layers are superficial, more work is done during the crack opening by the tractions on the crack surfaces. This can be associated to a higher energy level, thus a higher amplitude of the produced acoustic emission. In the range 50 - 65 MPa some emissions of lower amplitude are present, localized in the cylinder and transition zones. They are followed by emissions (still of low amplitude) that are localized in the cylinder and upper domes, until reaching an internal pressure of 80 MPa. After this stage, the last emissions are mainly localized in the domes. With only the current information it is not clear to which damage mechanism they can be associated. More specific explanations could arise after studying the emissions more in detail as well as the superficial strains with the DIC.

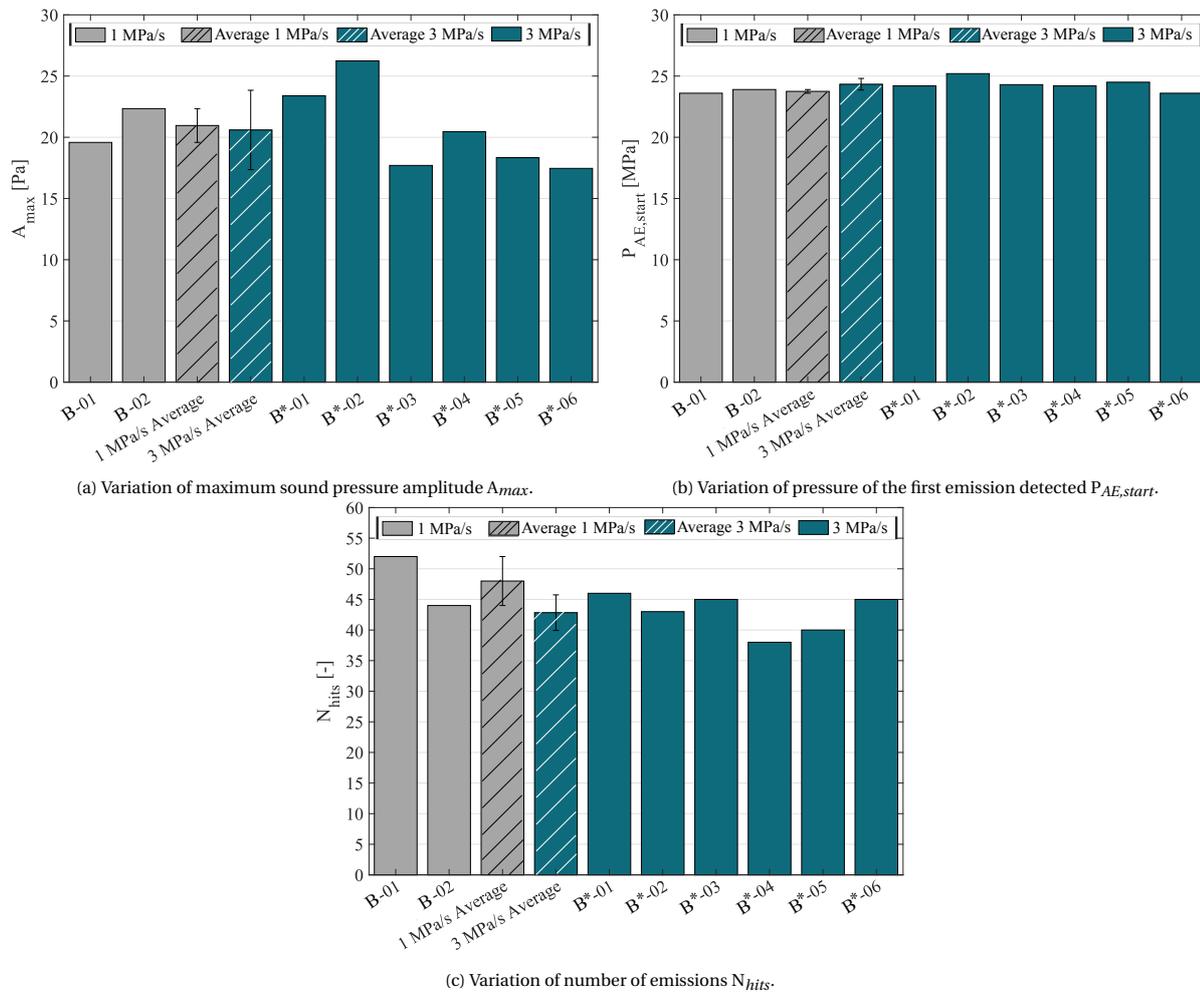
Vessels B-01 and B-02 (depicted in light gray) are the single vessels tested with a pressure rate of 1 MPa/s and the gray bars with black background lines correspond to their average. The single vessels tested with a pressure rate of 3 MPa are denoted with the symbol * and are in green, while their averages are represented in green with white lines in the background. Figure 4.12a shows the comparison of the maximum sound pressure amplitude. The averages of the maximum amplitudes for the two pressure rates are similar and the

Figure 4.12: Variation of A_{max} , $P_{AE,start}$ and N_{hits} with different hydraulic pressure rates of layout B.

Layup B is a particular case of layup C: it is the same but with one of the inner helical layers moved on the outside. Its stacking sequence is $[(\pm 19.9^\circ)_9 / (+88.5^\circ, -88.5^\circ)_{15} / (\pm 19.9^\circ)_2]$. Two vessels of this layup have been manufactured, one subjected to burst and the other to pressurization up to 105 MPa. Layup B has already been extensively used in the department for investigations, thus data of other six vessels are available. However, those have been tested with a different hydraulic pressure rate (3 MPa/s instead of 1 MPa/s). To understand whether and which data could be used for the current research, the three acoustic variables A_{max} , $P_{AE,start}$ and N_{hits} have been compared. Figure 4.12 shows the results of the comparison.

values of B-01 and B-02 are in the scatter region of the B vessels. It has been concluded that the data related to variable A_{max} of the vessels tested with pressure rate 3 MPa/s can be used in the present research. Same outcome was concluded for the hydraulic pressure of the first detected emission as it can be seen in Figure 4.12b. When comparing the amount of emissions (Figure 4.12c) a difference is observable. The average of the emissions of the vessels tested with lower pressure rate is higher than the other and the result of vessel B-01 is not in the scatter of the average of the vessels filled with the higher pressure rate. This outcome could be related to the fact that when testing with higher pressure rates some emissions might overlap, while when lowering it they are more distributed, thus in major number. The data regarding the variable N_{hits} of the vessels tested with pressure rate 3 MPa/s have not been used for the current research. The final results are reported in Table 4.5. The symbol * denotes the vessels tested with a pressure rate of 3 MPa/s. The data in gray in the column N_{hits} are not considered when calculating the average and the standard deviation.

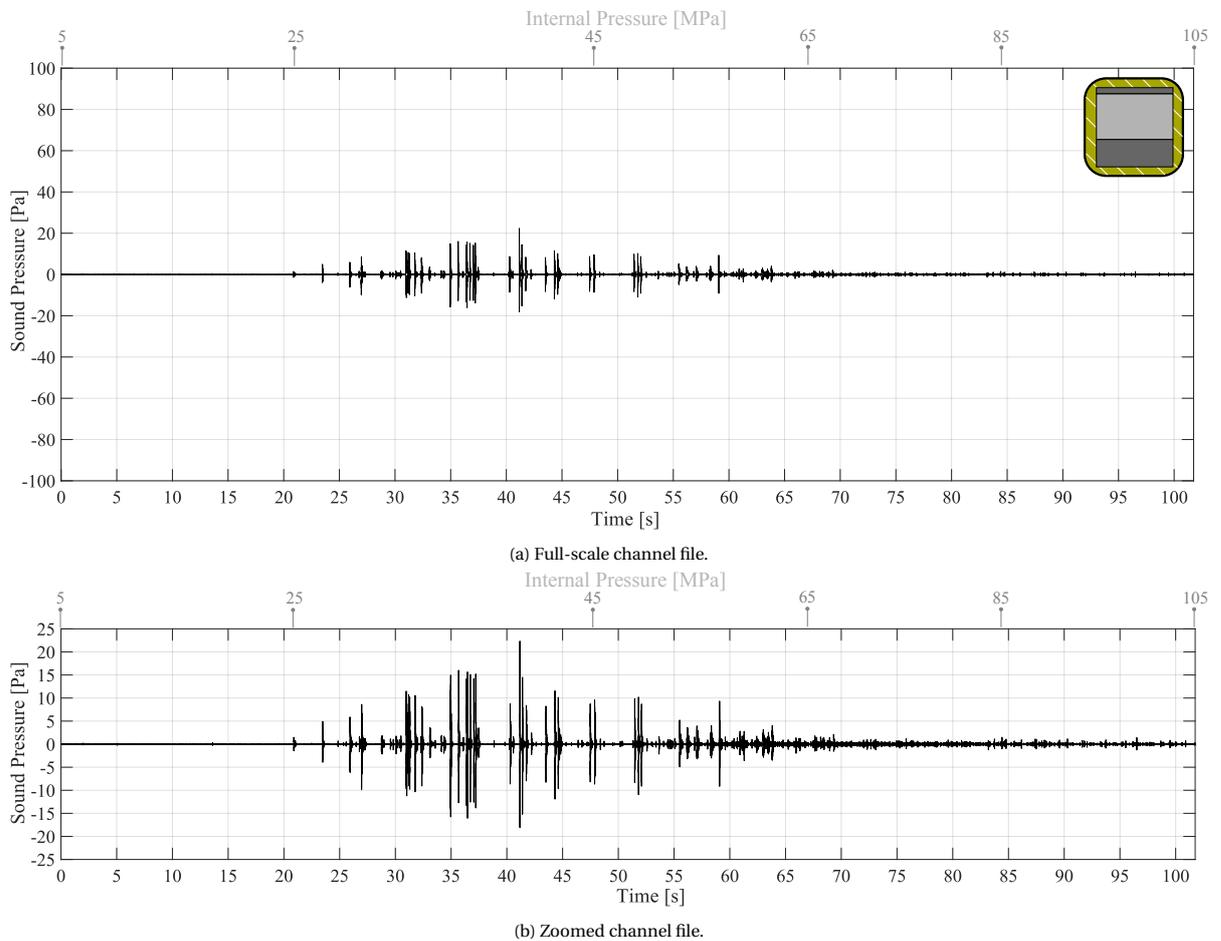
Figure 4.13: Acoustic file of vessel B in the hydraulic pressure range 5-105 MPa.

Figure 4.13 shows the acoustic file of the non-burst vessel, pressurized with a rate of 1 MPa/s up to 105 MPa. Looking at Figure 4.13a it can be noticed that the sound pressure amplitudes recorded are similar to those of layout C. This is expected due to the similarity of the two stacking sequences. In Figure 4.13b it is possible to see the acoustic behavior of this layout more in detail. The first 20 seconds of the channel do not present any detectable emission. From second 20, which corresponds to an internal pressure of about 25 MPa, peaks occur, with amplitudes below 10 Pa until second 31. In the next 8 seconds they reach a sound pressure of 15 Pa. The highest amplitude emission occurs at about second 41 and it has a sound pressure amplitude of 22.34 Pa. The range between second 40 and 58 is mainly characterized by peaks of 10 Pa or lower. After second 60 (about 55 MPa), an important amount of small amplitude peaks (below 1 Pa) are present and last until the end of the pressurization.

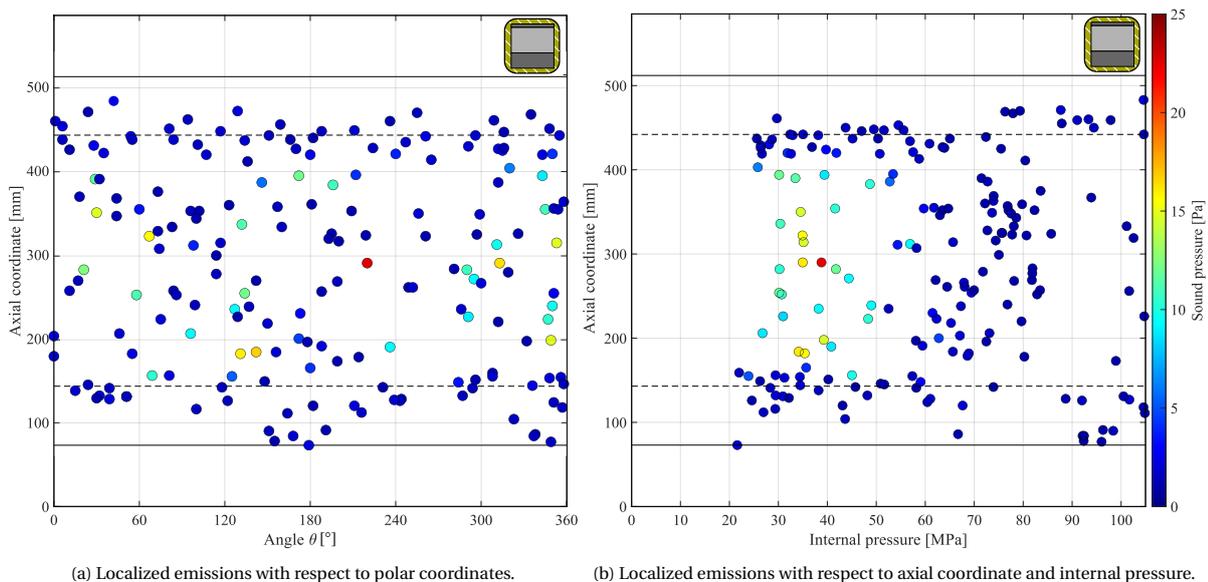
To get information of the peaks of smaller amplitude, it is necessary to lower the parameters for the `PeakFinder` tool to threshold II. After the post-processing, a total of 186 have been successfully beamformed. The results are shown in Figure 4.14. From Figure 4.14a it can be noticed that all the emissions with higher sound pressure amplitude (above 8 Pa) are localized in the cylindrical section. Due to the similarity in results and stacking sequence with layup C, it can be speculated that these emissions are correlated to IFF in the hoop layers. The high amplitude could be explained by the presence of the single block with 30 circumferential layers, which could create a fracture surface of significant size. Regarding the emissions with lower amplitude, a significant amount have been localized in the cylindrical section and transition zone, less in the domes. Due to their low

Figure 4.14: Localized emissions plots for layup B.

Figure 4.14b shows the emissions localized with respect to the hydraulic pressure at which they happen. The very first emissions take place in the pressure range between 20 and 25 MPa and are mainly located in the transition zones. This behavior has already been observed when analyzing layup C. It has been attributed to matrix cracking caused by resin rich gaps which are present where the hoops are tapered. The tows sliding during curing and the resin flow could be the cause of this mechanism. The hypothesis is further reinforced by the presence of this effect in layup C and the absence in all the others. The small amplitude of the emissions could be associated to the limited size of the fracture surfaces. These emissions are followed until pressure stage 50 MPa by two sets of peaks: those of higher amplitude (above 8 Pa) all beamformed in the cylinder and those with amplitudes below 5 Pa, localized mainly in the transition zones. The fact that the higher amplitude peaks take place at early pressure stages, reinforces the hypothesis that they could be related to matrix cracking [42, 79, 82]. The pressure range 50 - 60 MPa is characterized by few emissions but it is followed by a significant amount of low amplitude emissions localized in the cylindrical section. From pressure stage 85 MPa on, only few emissions are localized and the majority of them are in the domes. The distribution of the emissions of low amplitude cannot be explained yet. However, if they are related to superficial damage it should be visible when analyzing the superficial strain data, calculated with DIC.

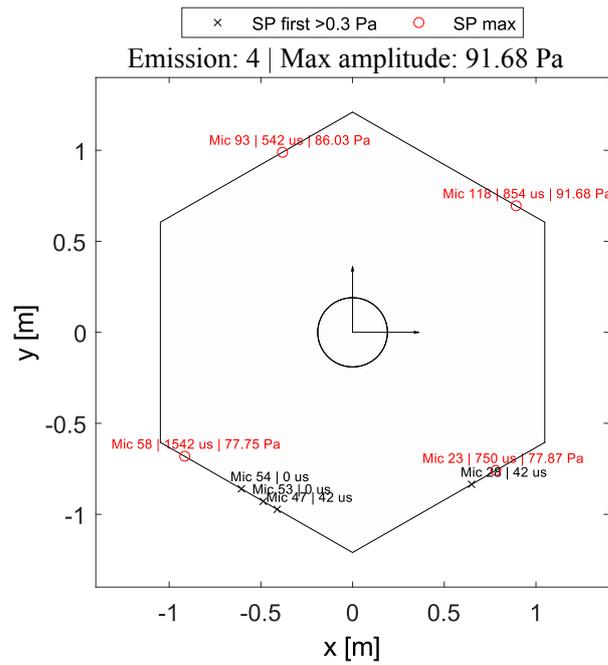
Figure 4.15: Example of microphones triggering for emission 4 of layup D.

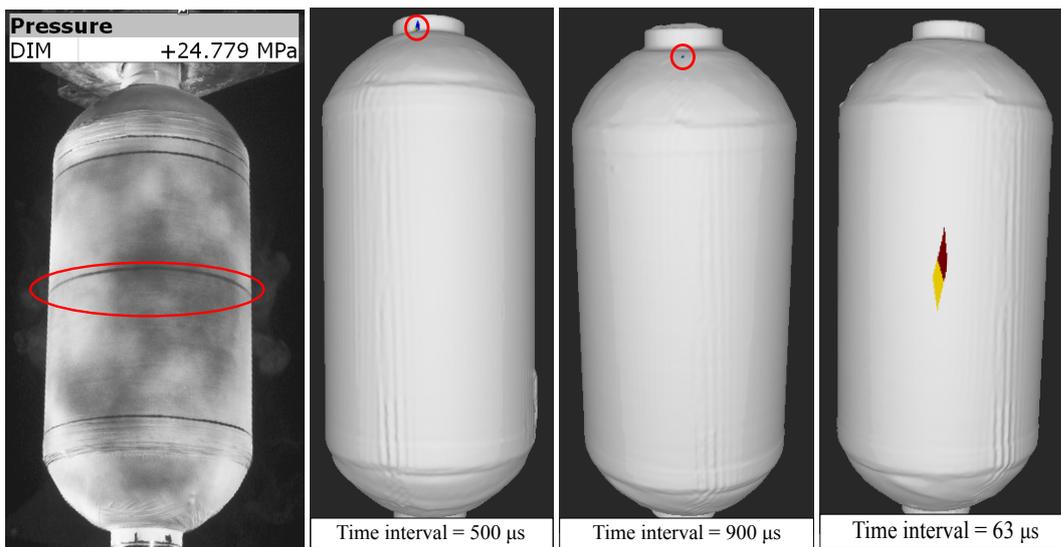
(a) IFF causing emission 4. (b) Beamforming of emission 4 with at time interval of 500 μ s. (c) Beamforming of emission 4 with at time interval of 900 μ s. (d) Beamforming of emission 4 with at time interval of 63 μ s.

Figure 4.16: Emission 4 of layout D: IFF location and beamforming with different time intervals.

Figure 4.16a shows the location of the IFF that caused emission 4, which corresponds to the center of the vessel. When using the predefined time interval ($500 \mu s$) during the beamforming process, the emissions of higher amplitude were not localized in the correct location, as shown in Figure 4.16b. Also increasing the time interval to, for example, $900 \mu s$ was not providing a correct location (Figure 4.16c). Looking at Figure 4.15 it can be noticed that the first microphones triggered are located close to each other, on two adjacent walls. This means that the fracture started on one point and quickly progressed into a ring. It was speculated that using a small interval during the beamforming, the emission could be considered as point source. In Figure 4.16d it is shown the beamforming of emission 4 with a time interval of $63 \mu s$. It can be noticed that its location is correct. For this reason, for the beamforming of the emissions of higher amplitude it has been

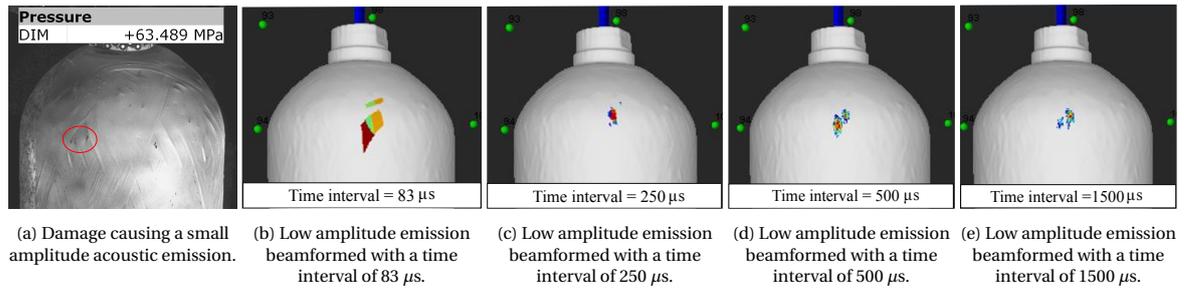
Figure 4.17: Same low amplitude emission beamformed with different time intervals.

Looking at the video of the pressurization of layout A, it was noticed that when the emissions of smaller amplitude were taking place, it was possible to see the chalk detaching from the vessel surface and dark marks were appearing. An example is shown in Figure 4.17a in the red circle. The emission associated to this damage has been beamformed and it was found a correlation in location. Since this kind of damage is located in a specific spot on the surface, the type of acoustic source related to it can be seen as punctual. This has been proven using different time intervals during the beamforming. Figures 4.17b, 4.17c, 4.17d and 4.17e show the emission localization with a time interval of respectively 83 μ s, 250 μ s, 500 μ s and 1500 μ s. It can be observed that the location is correct and it does not change.
