Combined Acoustic and Optic Characterization of Damage Mechanisms in Internally Pressurized Composite Pressure Vessels

MSc Thesis

Aerospace Engineering

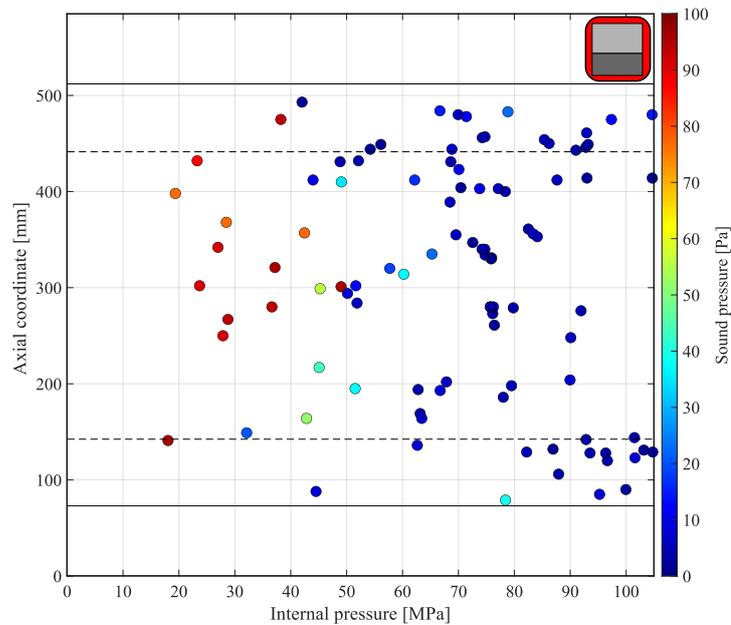
Figure 4.18: Acoustic file of vessel D in the hydraulic pressure range 5-105 MPa.

The first layup considered for damage identification is D, the one without a helical as outermost layer. Figure 4.18 has already been described in Paragraph 4.1.4, but it is reported here to make the understanding easier. It shows the relation between the axial position of the acoustic emissions, their sound pressure amplitude and the internal pressure at which they occur. Layup D is characterized by emissions of high sound pressure

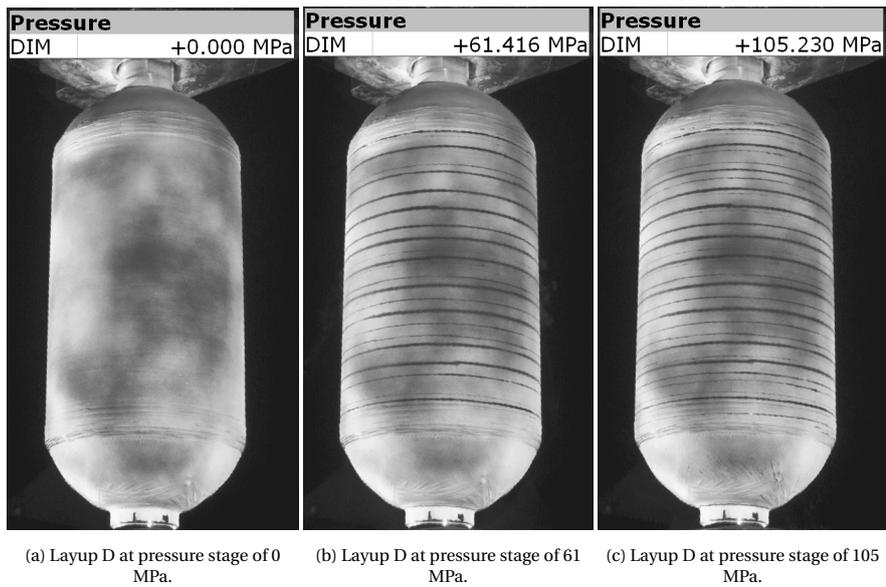
Figure 4.19: Layup D at different stages of the pressurization.

amplitude until pressure stage 60 MPa, followed by others of lower amplitude. Figure 4.19 shows the vessel at three different pressure stages: before the pressurization, after the occurrence of the emissions of higher amplitude and at the end of the pressurization. Figure 4.19a corresponds to the unpressurized stage and it is taken as reference. Figure 4.19b is captured at a pressure stage of 61 MPa. It is possible to notice that some chalk has fallen, due to the creation of damage. Rings in the cylindrical section are visible, only where the hoop layers are wound. Looking at Figure 4.18 it can be seen that the emissions with higher sound pressure amplitude are almost all localized in the cylindrical section. They can be associated to interfiber-fracture in the circumferential layers, as previously speculated. To further investigate the link, some of these emissions are analyzed more in detail. The hydraulic pressure at which one peak is detected is recorded and the emission peak is localized on the vessel. Then a picture of the vessel at the same pressure stage is taken and compared to the previous one. An example can be seen in Figure 4.20. The picture on the left is taken from the software NoiseImage and it corresponds to the result of the beamforming of emission 4. Figures 4.20b

The second part of the pressurization is characterized by emissions of lower amplitude, localized in the cylinder and dome region. Comparing Figure 4.19c with Figure 4.19b it can be noticed that there is a progression of damage. More chalk has fallen from the cylindrical section and few less marked rings have been created. The fact that the new lines are less visible than the previous ones could be related to the lower amplitude of the emissions and thus a smaller energy release. This could be linked to the superficiality of the damage. The same hypothesis could be developed when looking at the domes in Figure 4.19c. Some marks can be seen in these areas due to the fallen of the chalk powder at the end of the pressurization. The marks follow the direction of the wound layer. Also here the signs are not overly pronounced and can be associated to the emissions taking place at the end of the pressurization. Since in the domes there are no circumferential plies, there is a change in winding direction in each helical ply (one helical layer is wound at both $\pm 19.9^\circ$). The crack is stopped after just one layer, thus its fracture surface is limited. This could explain why the emissions localized in that area are characterized by lower sound pressure amplitude.

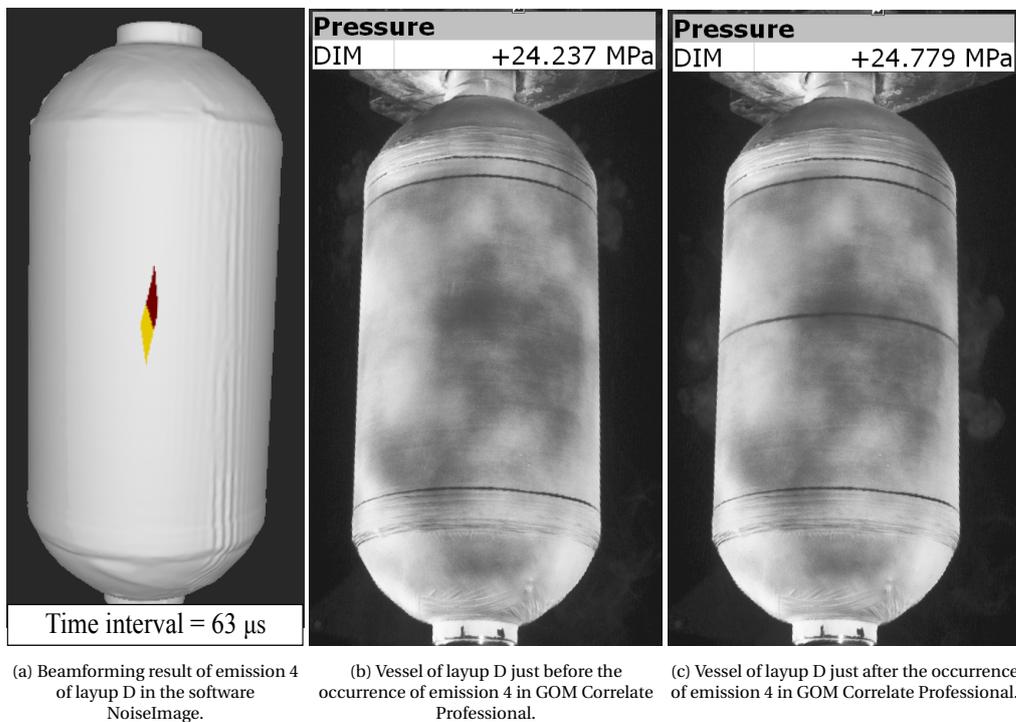
Figure 4.20: Beamformed emission and corresponding damage creation.

and 4.20c are taken respectively just before and after the pressure stage at which emission 4 occurred. It can be noticed that there is a correspondence between the location in which the emission is beamformed and the position in which the damage occurred. The same investigation has been performed for all the emissions that occurred in the pressure range between 18 and 61 MPa. For all the cases (except one) have been found similar results to those just described. The acoustic sources occurring in this pressure range reach a significant amplitude because the sound pressure of each event can be related to the energy released due to the damage formation and to the important fracture surface [30, 68]. Once the crack is started, it is free to develop and it is stopped only where there is a change in orientation [31], thus it runs through the entire block of hoop layers. The free boundary effect also plays a role in this layup, as explained in Paragraph 4.1.4. This is caused

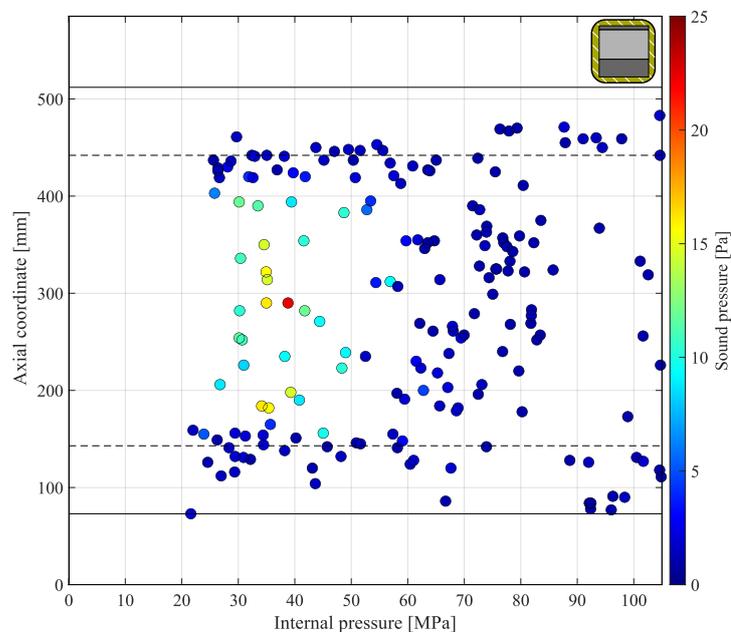
Figure 4.21: Acoustic file of vessel B in the hydraulic pressure range 5-105 MPa.

The acoustic behavior of layup B is reported in Figure 4.21. The first 50 MPa of the pressurization are char-

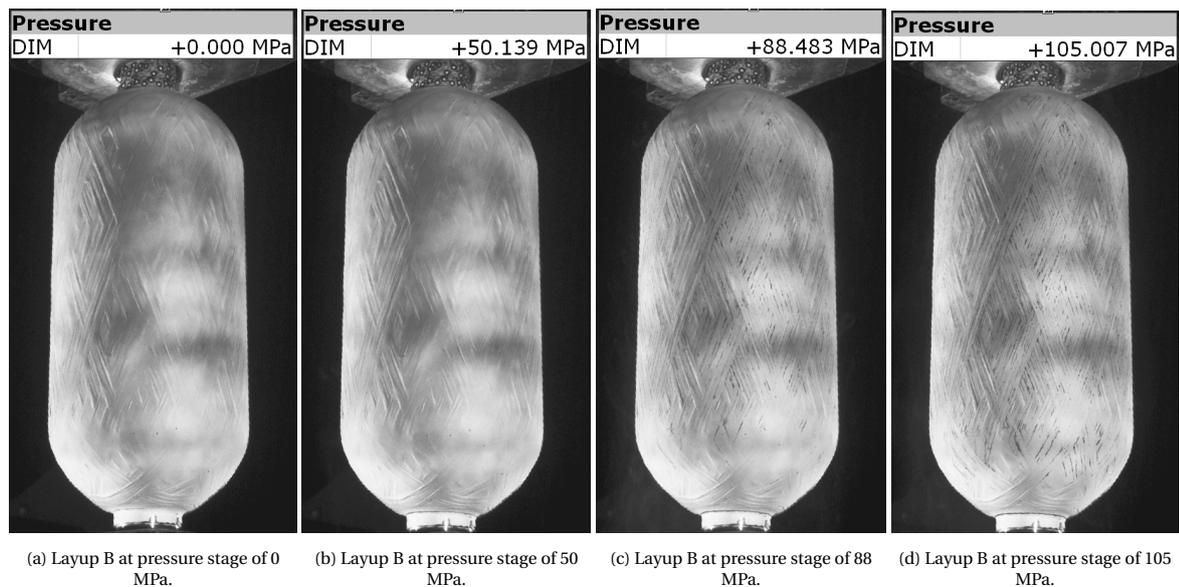
Figure 4.22: Layup B at different stages of the pressurization.

acterized by emissions mainly occurring in the cylindrical section and transition zone. Figure 4.22b is taken at a pressure stage of 50 MPa. No visible damage can be seen when comparing it to Figure 4.22a, which corresponds to the unpressurized stage. This means that damage is not superficial but it happens inside the laminate. As for layup D, the emissions of higher amplitude are all beamformed in the cylindrical section and take place at the beginning of the pressurization. It is likely the case that these emissions correspond to the same damage mechanism: IFF. This cannot be detected by visual inspection because the hoops are not the superficial plies. Two main differences can be noticed comparing these emissions with those of layup D. The latter reach a sound pressure amplitude which is 4 times higher (even if the amount of circumferential layers is identical) and that they start earlier, around 18 MPa instead of 26 MPa. Both differences could be explained by the presence of helical layers as outermost plies. When the crack is formed, the acoustic source is produced but its sound pressure is attenuated by the top helicals and lowered before reaching the acoustic sensors. The helical plies also restrict the separation of the two surfaces of the crack, reducing the work done in comparison with layup D in which the free boundary effect was taking place. This causes a lower energy

In the same pressure range, some emissions of lower amplitude also occur, which have mainly been beamformed in the transition zones. As for the others, no superficial damage can be seen in Figure 4.22b, which is why it is concluded that the damage takes place on the inside of the laminate. Due to the low pressure stages at which it is happening, it might be related to matrix cracking [42, 79, 82] and since it is not visible, it must be in the internal layers. Few hoop layers are present in the transition zone, tapered towards the domes. Due to friction, fiber tension and to resin flow during curing, they might slightly slide. This could create small gaps between the bottom block of helicals and the outermost ones. Due to the compaction effect of the domes during the curing, this gap could be filled with resin and cause premature matrix cracking, which could be associated to these emissions. A similar trend can be observed in C (Figure 4.2b). Due to the similarity of the two layups, similar behaviors are expected.

The pressure range between 50 and 88 MPa is characterized by acoustic emissions of amplitude below 5 Pa mainly localized in the cylindrical section. Figure 4.22c shows the vessel at pressure stage 88 MPa. It can be noticed that some chalk powder has fallen, in particular in the cylindrical section of the vessel. The emissions could be linked with matrix cracking in the top helical. To further prove this, as already done for layup D, some emissions have been beamformed and their pressure recorded. Pictures just before and after that pressure stage are compared in order to verify whether there is a link between the damage formed and the acoustic. An example is shown in Figure 4.23. In the red circle of Figure 4.23c it can be noticed that some chalk powder is missing if compared to the previous pressure stage, shown in Figure 4.23b. The position matches with the location in which the emission has been beamformed and this has been confirmed for multiple emissions. It can be concluded that the low amplitude emissions happening later in the pressurization can be associated with superficial damage, identified as matrix cracking. This damage is caused by the presence of external helical layers. This can be concluded by comparing the amount of detected emissions when changing the thresholds of the PeakFinder tool. Since the emissions taking place at higher pressure stages are all characterized by a low amplitude, they are not detected when the amplitude threshold is set to 2 Pa. They are identified when lowering the same parameter to 0.3 Pa. Table 4.6 shows the increase of detected emissions when lowering the parameters of the PeakFinder tool from threshold I to II. Layup A is in gray because its values are calculated in the pressure range 5 - 75 MPa, while the rest of the vessels in 5 - 105 MPa.

pening at late pressure levels are relatable to the presence of the superficial helical layers. The marks caused by the falling of the chalk are shaped as straight lines. These lines are oriented in the same direction of the helical tows and they are formed at the sides of each band. They also stop when there is an intersection of the bands. This damage could be caused by two effects. The first and most probable one is related to the tangential stresses that act towards the matrix and transversally to the tows which can cause a crack. The second could be linked to the Poisson effect. During the pressurization, the vessel axially deforms. This makes the fiber bands strain in the axial direction and contract transversally, causing some cracks in the matrix at the sides of the bands. Both the effects could explain why the marks are appearing at higher pressure stages and why they are located at the sides of the tows and shaped like straight lines, at least in the cylindrical section. It can be concluded that the emissions taking place in the pressure range 50 - 88 MPa can be associated to matrix cracking of the superficial helical. The same outcome has been concluded for the emissions taking place from 88 MPa until the end of the pressurization: they have mainly been beamformed in the domes. In Figure 4.22d it can be noticed that some chalk is missing in those areas.

superficial strains could be linked to the progression of matrix cracking in the top helicals. For layup B this type of damage was first detected in the cylindrical section and later in the transition zones and domes, as it was shown in Figure 4.22. This result is consistent with the strain distribution, being higher in the cylinder (Figure 4.35a). The opposite reasoning can be applied to layup F. The superficial marks are first appearing in the transition zones and later in the cylindrical section (Figure 4.28) in accordance to the location of the AEs. This is also in agreement with the superficial full-field meridional strains, shown in Figure 4.35d: the strain is higher in the transition zones. Considering layup A it is not easy to draw the same conclusions. Even if some low amplitude emissions have been localized in the domes and transition zones, they were not visible on the surface, as explained in Paragraph 4.2.4. It was concluded that the stress distributions could have played a role causing damage in the innermost helicals before the outermost ones. A research taking place simultaneously to the current investigation was studying the vessels from the analytical and optical point of view. It was observed that the strains in the transition zones were approximately constant all around the vessels for each configuration. This was not the case for layup A. When progressing with the pressurization, the transition zones presented few spots with significantly higher strains. An example is shown in Figure 4.36. The internal

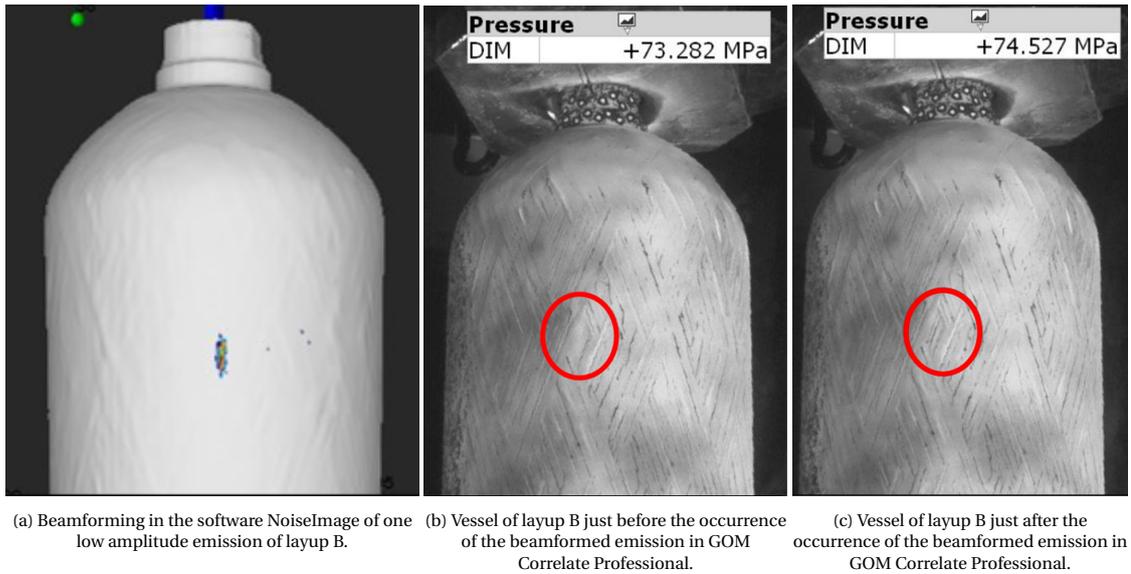
Figure 4.23: Beamformed emission and corresponding damage of an acoustic source of low pressure amplitude of layup B.

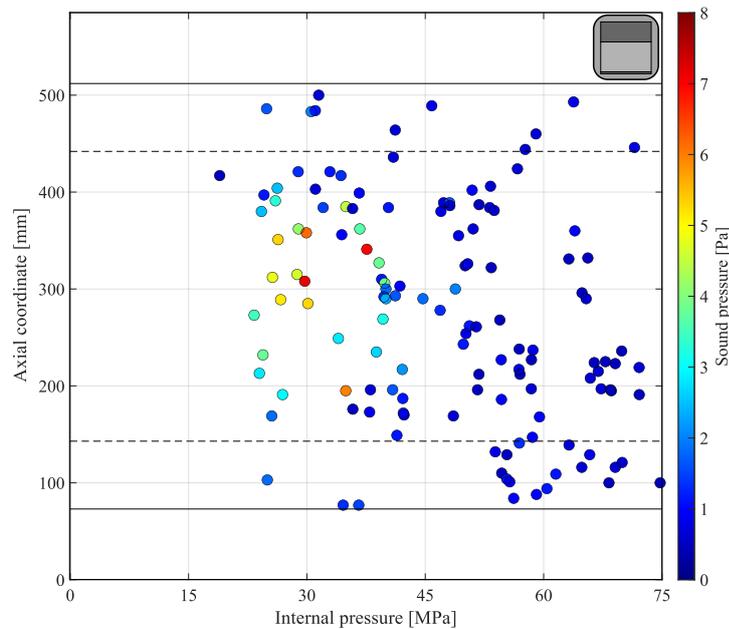
Figure 4.24: Acoustic file of vessel A in the hydraulic pressure range 5-75 MPa.

The next vessel analyzed is layup A and its emissions are shown in Figure 4.24. The peaks start just below 20 MPa and up to 40 MPa can be divided into two categories: those of higher amplitude, all localized in the cylindrical section and some of lower amplitude, located both in the dome and in the cylinder. When comparing Figure 4.25a and 4.25b, which correspond to the internal pressures of 0 and 40 MPa respectively, no differences can be noticed. This means that the damage is not superficial but it takes place internally in the layup. The same assumptions made in Paragraph 4.2.3 for layup B are valid and for the same reasoning they could be related to IFF in the hoop layers of the cylindrical section. There is an important difference between the two cases which is the sound pressure amplitude of the emissions. For layup B the maximum recorded pressure corresponds to 23.6 Pa while for layup A it is 7.05 Pa. As already speculated, this difference could

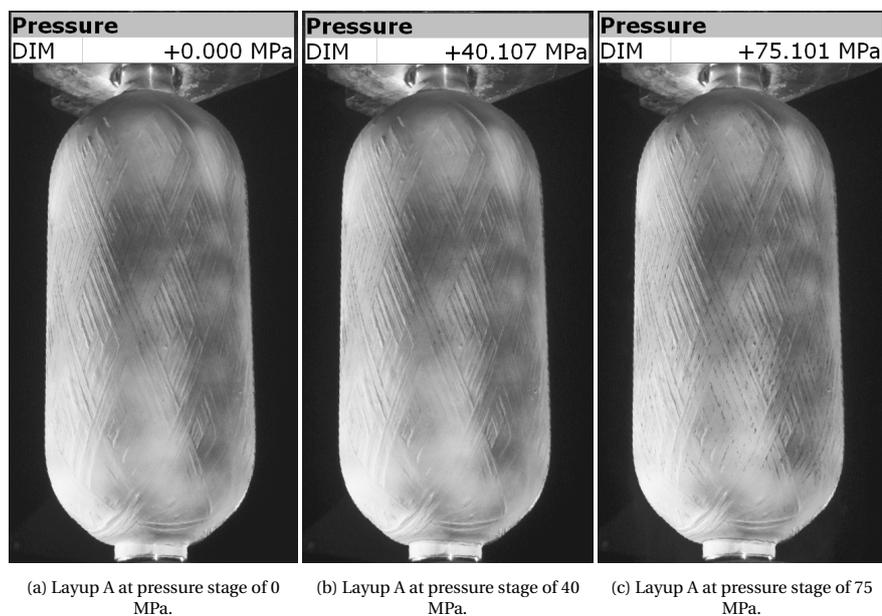
Figure 4.25: Layup A at different stages of the pressurization.

After pressure stage 40 MPa, the acoustics of layup A is characterized by peaks of low amplitude (below 2 Pa), mainly localized in the cylindrical section and transition zones. Figure 4.25c shows the vessel at the end of

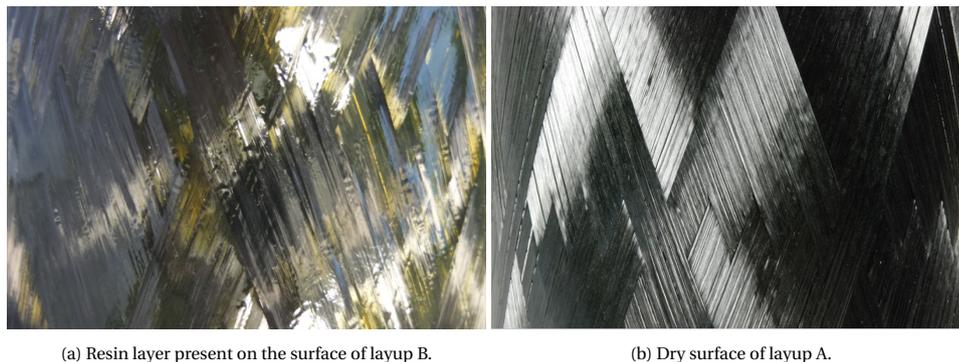
Figure 4.26: Surface comparison of layups B and A.

the pressurization. As for the previous layups, it is possible to see that some chalk has fallen from the vessel, leaving dark marks. The marks are shaped as straight lines and follow the direction of the tows, stopping where there is an intersection between bands, as for the previous layup. It can be concluded that those emissions correspond to matrix cracking in the superficial layer. It can be observed that the marks are not in large numbers when compared to the amount of emissions, particularly in the domes. This means that the emissions are not taking place superficially but most likely from the inner layers. This could be explained by the presence of 10 helical layers on the outer side. It might happen that not only the outermost layer cracks, but also the others. Due to the continuous change in direction, the cracks only go through single plies, thus they produce an acoustic emission but they cannot be seen on the surface of the vessel. This fact could be proven after having the results from the CT scans. Another factor that might play a role is layers compaction. It has been noticed that whenever the hoops are positioned above the helicals, they tend to compact the latter during curing. This causes air release and resin flow towards the surface. This results in a superficial resin layer as shown in Figure 4.26a. In layup A, the circumferentials are below the helicals, thus this effect is not present. This leaves a dry vessel surface, as visible in Figure 4.26b. Few emissions are also localized in the transition

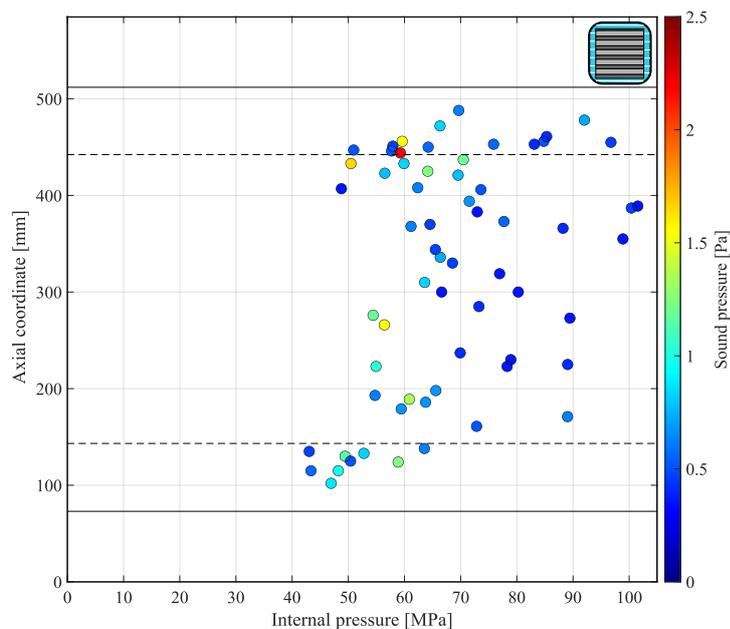
Figure 4.27: Acoustic file of vessel F in the hydraulic pressure range 5-105 MPa.

The acoustic behavior of layup F is shown in Figure 4.27. The first part of the pressurization, up to 50 MPa is characterized by emissions localized in the bottom transition zone and dome. These are caused by the presence of a ring with air inclusion in forms of bubbles in that area. This fact has already been explained extensively in Paragraph 4.1.2. Figure 4.28b shows the marks in the bottom transition zone related to those emissions in the red circle.

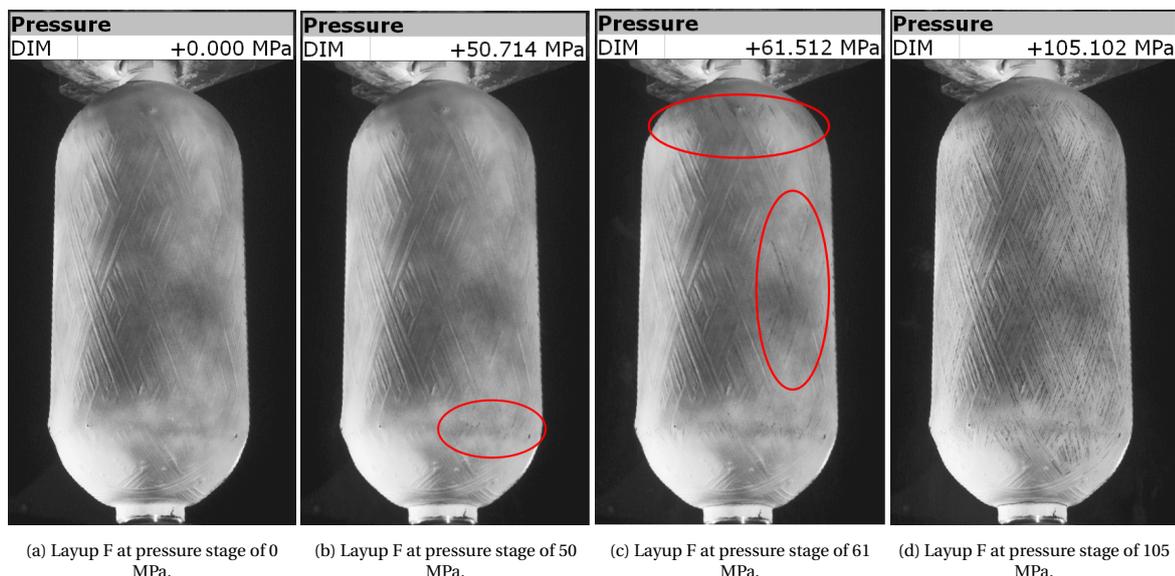
Figure 4.28: Layup F at different stages of the pressurization.

From the pressure stage 61 MPa to the end of the pressurization, some more emissions have been beam-formed. Figure 4.28d shows the vessel at the end of test. It can be seen that an important amount of chalk is fallen, leaving clear marks on the surface. The marks are similar to the ones of the other vessels and can be associated to matrix cracking in the superficial layers. Looking at Figure 4.27, it can be noticed that the emissions localized are fewer than those for the other layups and the visible marks are in greater number. This means that not all the emissions produced by the vessel are detected by the system. The minimum sound pressure amplitude detected by the system is 0.3 Pa and all the emissions below the threshold are not considered. A factor that can also play a role is the distance between the sound pressure sensors and the vessel. The sound pressure amplitude can be highly reduced when passing through the air. It can be concluded that the system used for the analysis is not able to detect all the acoustic emissions produced by the vessels. The reason why this fact is evident only in this layup is not clear. Since the damage considered is matrix cracking in the outermost helical, the superficial strains distribution might be a factor to take into account. This will

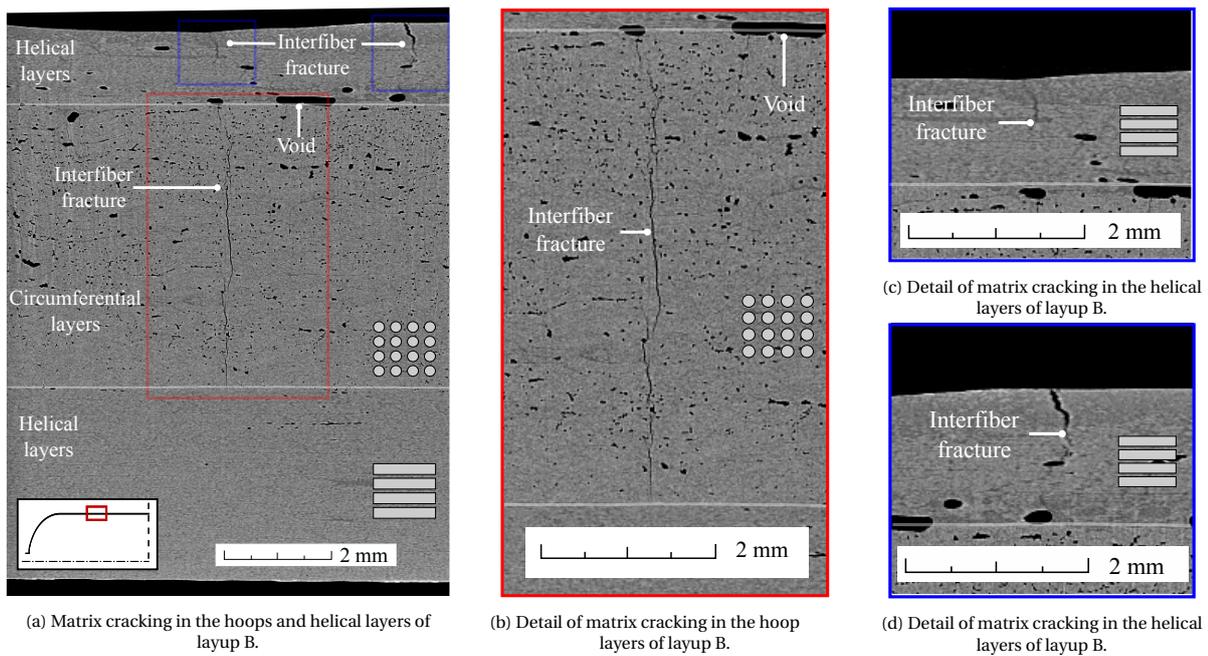
Figure 4.29: CT results of a specimen taken from a vessel with layup B after an EOL pressurization up to 105 MPa.

Figure 4.29 shows the scan of a specimen cut from a vessel with layup B, subjected to a pressurization up to 105 MPa. The specimen is taken from the cylindrical section, where a high amplitude emission has been beamformed. The three main blocks of layers can be seen in Figure 4.29a: the top one corresponds to two helical plies, followed by 30 circumferentials and ending with other nine helicals. In the middle of the picture in the red box it can be noticed a crack, located in the hoops. Figure 4.29b is a zoom of this crack. It runs through the entire block of circumferential layers and it is stopped where the helicals start, which is in agreement with what found in literature [31]. It can be concluded that the acoustic emissions of higher amplitude can be related to IFF in the hoop layers. It can also be observed that the change in orientation of the layers acts as a crack stopper.

In Figure 4.29a other cracks with a smaller length, located in the top helical layers are also present. They are marked with blue boxes and are shown in detail in Figure 4.29c and 4.29d. This scan proves that the low amplitude emissions visible as black marks on the surface of the vessel correspond to matrix cracking. Even though this damage is superficial, the fracture surface of the cracks is significantly small, from which the low amplitude of the emissions [68].

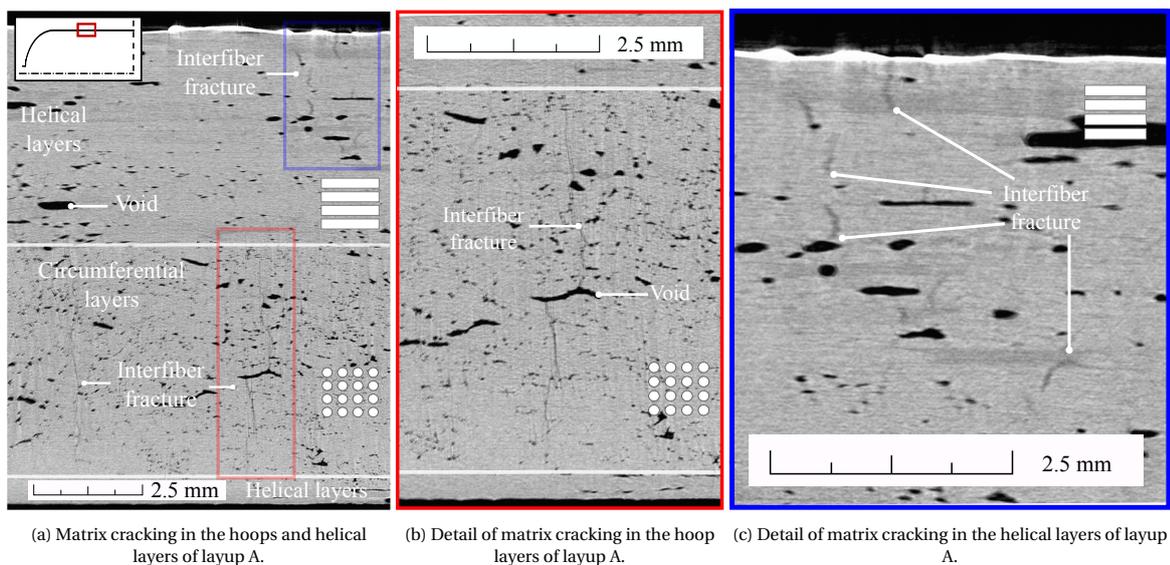
Figure 4.30: CT results of a specimen taken from a vessel with layup A after an EOL pressurization up to 75 MPa.

The next layup analyzed is A. After the pressurization test, some of the emissions with higher amplitude have been localized in the cylindrical section. Specimens from those areas have been cut and CT scanned. The results are shown in Figure 4.30. Figure 4.30a shows the full height of the laminate, in which it is possible to distinguish the top 10 helical layers, followed by the block of hoops and the bottom single helical. Figures 4.30b and 4.30c show a zoom on the cracks present in the hoops (red box) and top helical layers (blue box) respectively.

IFF in the hoop layers is present in the location where an emission of higher amplitude is detected, as for the previous case. The crack runs through the entire thickness of the block of hoops and stops only where there is a change in direction of the wound layers. In Figure 4.30b it is possible to observe that an important

amount of black spots are present. It is very likely that these black spots are voids and it is evident that the crack passes through them. The voids could be the cause of the crack formation in that area because they act as stress concentrations [29]. It can be concluded that also for layup A, the emissions with higher sound pressure amplitude can be associated with IFF in the hoop layers.

Figure 4.30c shows the outer block of helicals, which, for this layup, it is made by 10 plies. Multiple cracks can be observed, in many of the top helicals, all characterized by small length. The change in orientation of the helical layers acts as crack stopper. The cracks located on the surface of the vessel can be associated to the black marks visible at the end of the pressurization due to the detachment of the chalk. In Paragraph 4.2.4 it was shown that the emissions were in larger number than the visible marks. This could be explained by the fact that some of the detected emissions correspond to the damage taking place in the helicals below the superficial, shown in Figure 4.30c.

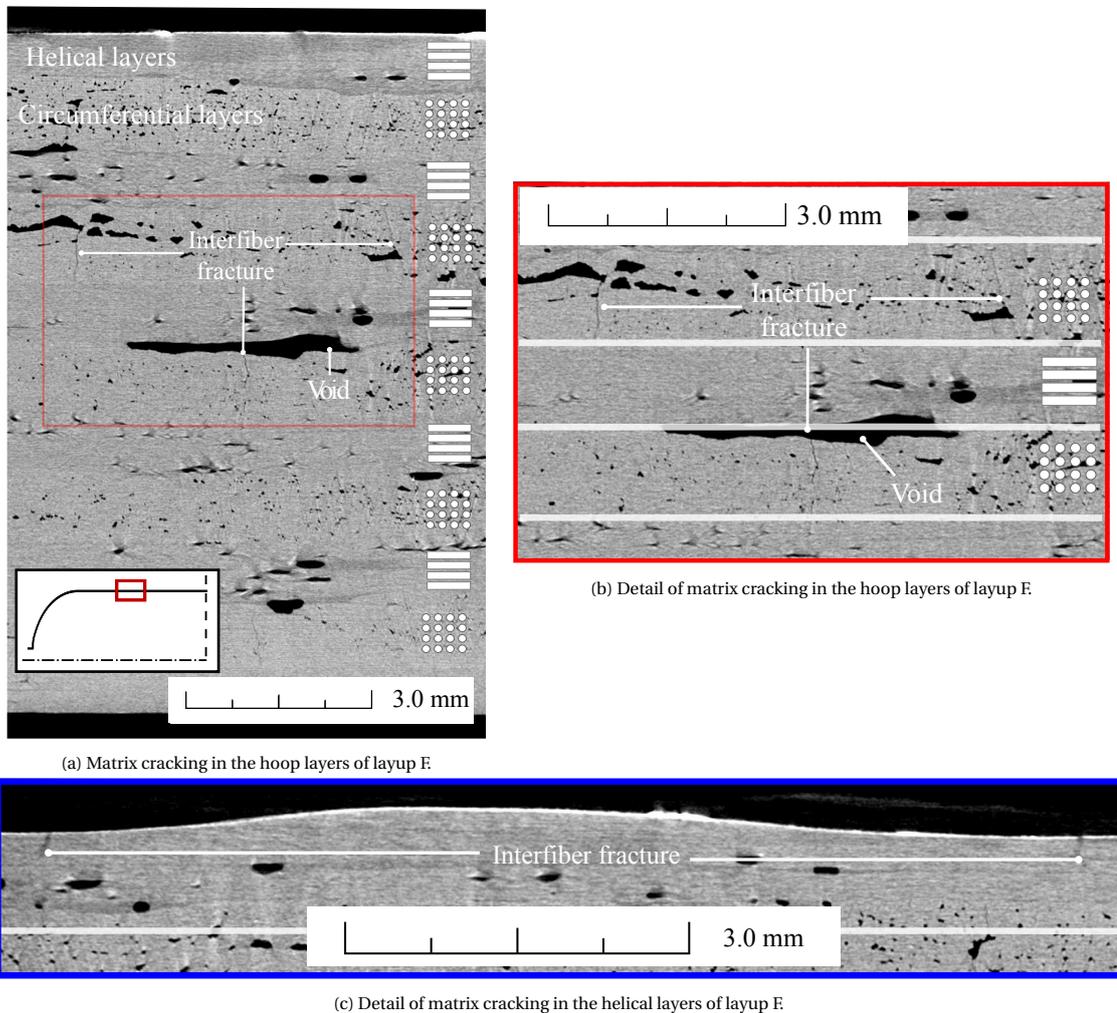
Figure 4.31: CT results of one specimen taken from a vessel of layup F after an EOL pressurization up to 105 MPa.

The last vessel scanned belongs to layup F, which has been pressurized up to 105 MPa. The results are shown in Figure 4.31 and belong to the same specimen (cut in a square of sides 10 mm by 10 mm) but at different widths and lengths.

Figure 4.31a shows the entire thickness of the laminate, where the different blocks of hoops and helicals can be observed. The cracks formed in the hoop layers stop whenever there is a change in orientation, thus the fracture goes only through six circumferential plies. Figure 4.31b is a zoom of the red box of of Figure 4.31a in which it is possible to have a better visualization of IFFs. The cracks are formed where there is at least one void, which could act as stress concentration [29]. Looking at Figure 4.31a and considering only the blocks of hoop layers, it can be noticed that the porosity increases when going from the innermost to the outermost blocks. This is most likely caused by a compaction effect. Since tension is applied on the tows while winding, the deeper the layers are positioned in the laminate, the more they get compressed. This compacts the plies and lets the air trapped during winding out. This effect reduces the amount of voids in the inner layers and as it can be seen in Figure 4.31a also the possibility of creation of IFF. In fact, more cracks can be found in the outer blocks of hoops than the inner ones.

Figure 4.31c is taken from the same cut specimen but at different widths and lengths and shows the outer helical layers. As for the other layups, it is possible to notice the presence of matrix cracking in the superficial

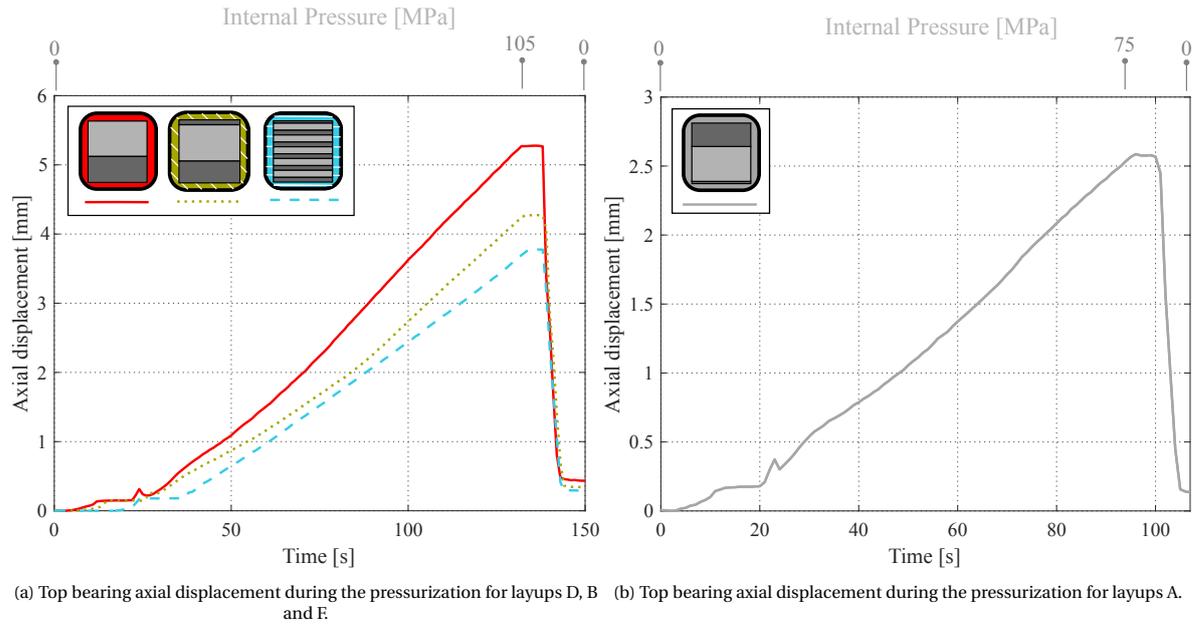
In Figure 4.32 it is possible to observe the axial displacement of the top bearing during the pressurization test. As explained in Paragraph 3.4.2, this is tracked thanks to the reference points that are glued on the top boss of the vessel before the test. This is the side clamped into the floating bearing, which is free to displace. In Figure 4.32a are shown layups D, B and F (which were pressurized up to 105 MPa), while in Figure 4.32b A (pressurized only up to 75 MPa). The first part of the curves is non-linear and has some peaks and plateaus. This can be linked to the non-linearities caused by the pump at the beginning of the pressurization. Afterwards, the pressure rate is reached by the pump and kept constant and the internal pressure increases. This can be seen in the second part of the graphs, where the axial displacement increases. When reaching 105 MPa (or 75 MPa for layup A), the pressure rate drops to 0 and the maximum pressure is kept constant for few seconds. The pump valve is then opened and this causes the rapid depressurization of the vessel, which corresponds to a fast decrease in axial displacement. At the end of the test, the internal pressure of the vessel is 0 MPa, but a residual axial displacement is left. The displacements are summarized in Table 4.7. The row containing the information regarding layup A is gray because this layup is pressurized up to a different pressure stage and the data cannot be directly compared. This residual displacement can be related to the formation of damage in the vessel, in particular to IFF in the hoop layers. It is calculated in the axial direction and could be connected to the cracks formed in the 90° plies. After the depressurization, the cracks might not close perfectly and a small gap between the sides might be left. Summing up the gaps of all the formed IFFs could lead to a measurable displacement. This hypothesis is further reinforced when analyzing N_{hits} , which corresponds to

Figure 4.32: Axial displacement of the top bearing during pressurization test.

the peaks detected with a sound pressure amplitude above 2 Pa. These emissions are associated with IFF in the hoops. It can be noticed that (except layup A) the more cracks in the hoops are detected and the higher is the residual axial displacement.

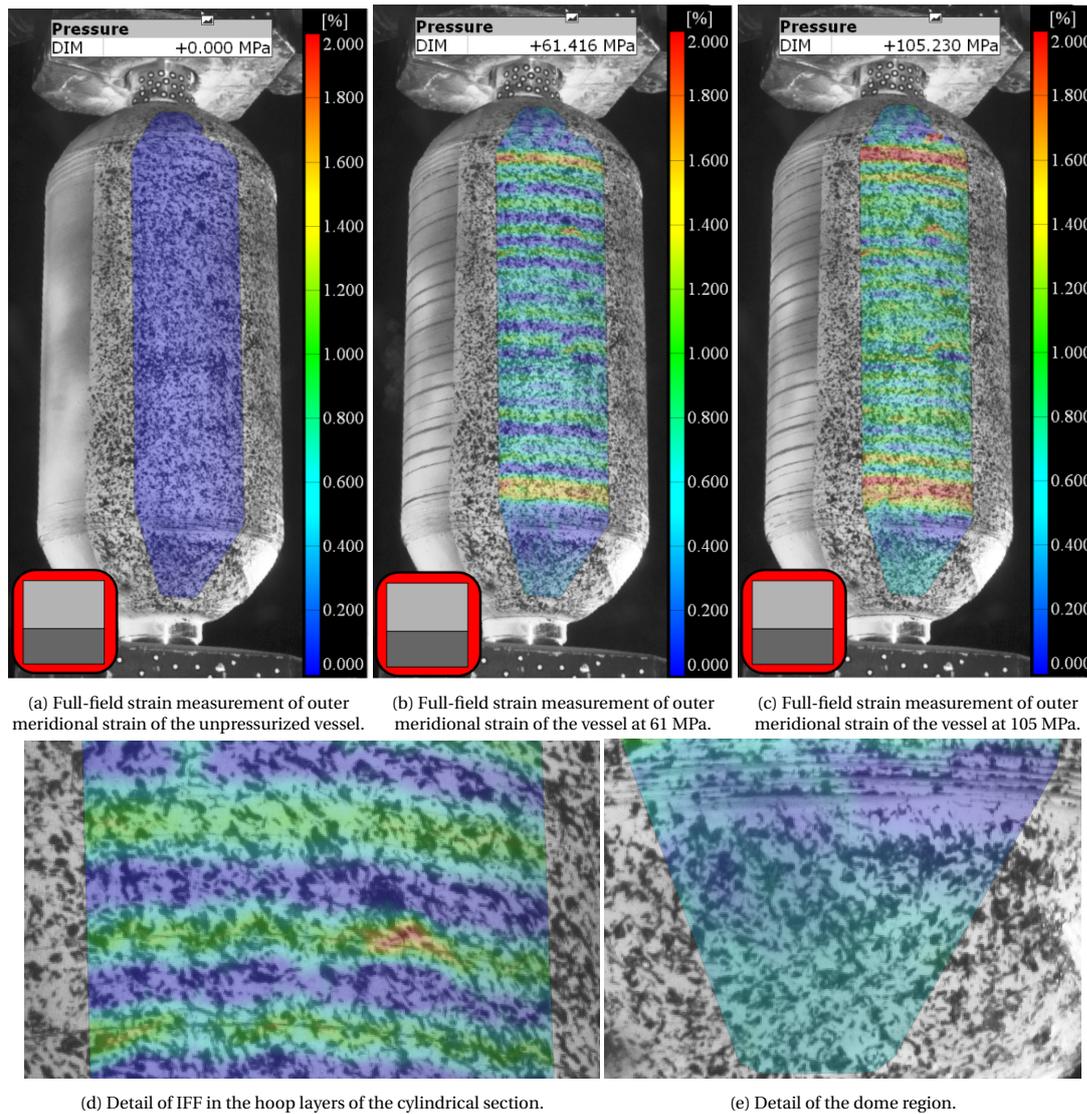
As explained in Paragraph 4.2.2, matrix cracking in the superficial helical is present in the domes for layup D at the end of the pressurization. Looking at Figure 4.33c it is possible to notice that the interested area is sub-

Figure 4.33: Full-field strain measurement of outer meridional strain of layout D at different pressure stages.

jected to a higher strain with respect to Figure 4.33b. Looking at the zoom of the area, represented in Figure 4.33e, it is not possible to detect the superficial crack, as it was with visual inspection. This could be caused by the optic system resolution and the small fracture surface created compared to the significant measuring volume. It can be concluded that for layout D it is possible to detect IFF the hoops layers using DIC, but not matrix cracking in the helicals visible in the domes.

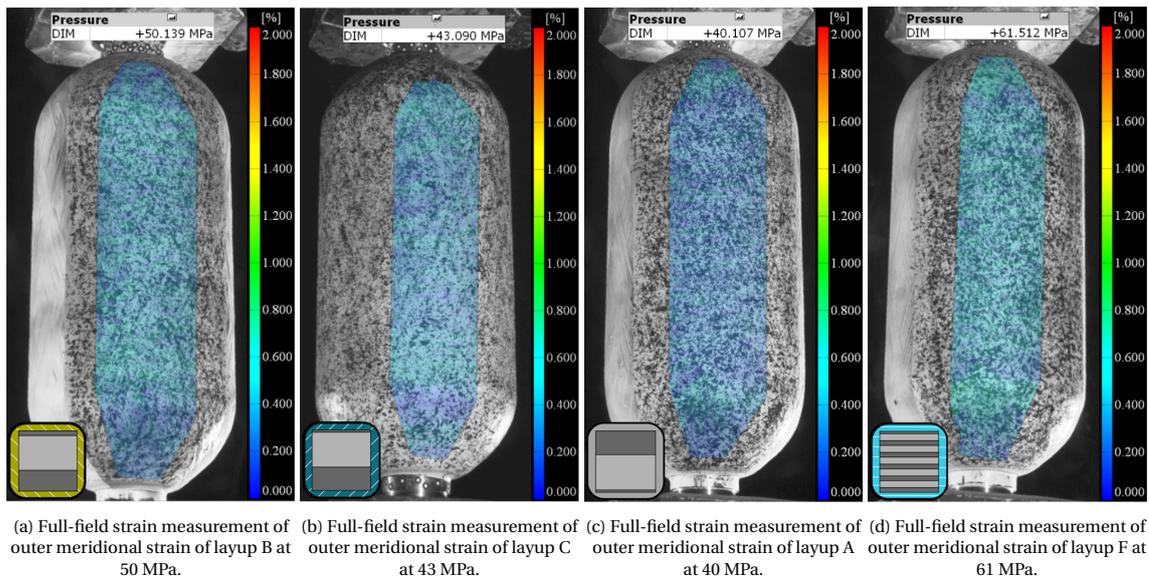
To prove whether IFF is always detectable using DIC, it is necessary to investigate the layouts which do not have the hoops as outermost layers. Figure 4.34 shows the full-field meridional strain of the other layouts, taken at a pressure stage matching with the end of IFF in the hoops formation. For all the cases the overall strain is higher than zero and each vessel presents a specific strain distribution. Layouts B and C are characterized by higher strain in the cylindrical section, while A and F in the transition zone. No layout shows any significant higher strains stripes in the cylindrical section that can be linked to IFF. It can be concluded that IFF in the hoops is not detectable for all the layouts using DIC.

Figure 4.34: Full-field strain measurement of outer meridional strain of layups B, C, A and F respectively after IFF formation.

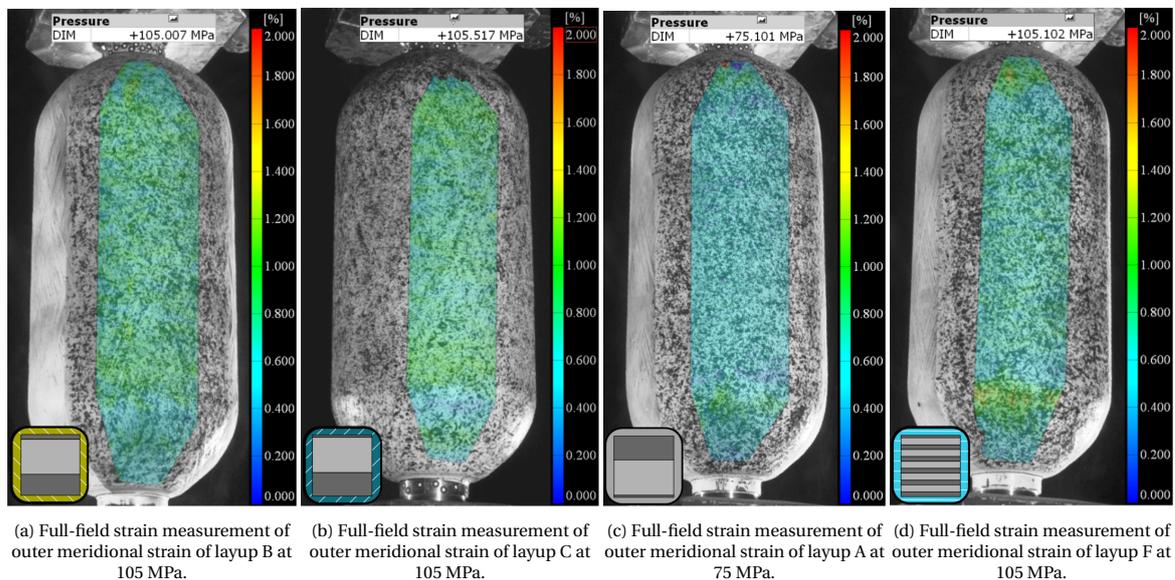
Figure 4.35 represents layouts B, C, A and F at the maximum internal pressure (75 MPa for A and 105 MPa for the others). As previously discussed for layout D, there is no possibility to detect the formation or to visualize matrix cracking taking place in the superficial helical layer with the DIC. For the identification of this type of damage, the best solution is using visual inspection combined with chalk powder. Information regarding the

Figure 4.35: Full-field strain measurement of outer meridional strain of layups B, C, A and F at the maximum internal pressure.

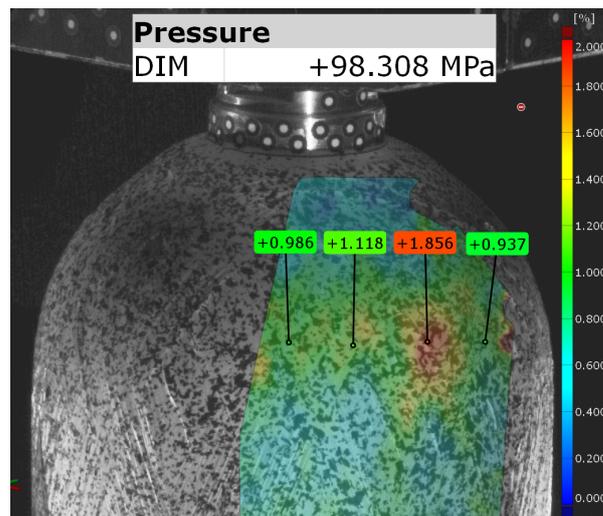
pressure is about 98 MPa and in the transition zone the red spot reaches a strain of 1.856 % while in the rest of the transition zone, it is about 0.9 - 1.1 %. In these areas, delaminations between the hoops and the helicals

Figure 4.36: High strain spot in the transition zone of layup A.

have been detected after CT analysis. This is in agreement with what found by Szebényi and Hliva [83]. In their studies, they recreated delaminations adding some foils in the layup. They showed that where the foils had been added, the DIC was detecting a local higher strain. The fact that the higher strains are caused by the formation of another damage mechanism might be the reason why no superficial damage is seen. From literature (Figure 2.17) it was shown that delaminations are usually associated to emissions with an amplitude in between that of IFF and fiber failure. In the current case, the emissions taking place in the domes at the later stages present low amplitudes. More research on the topic is needed to have a definitive explanation of the events.

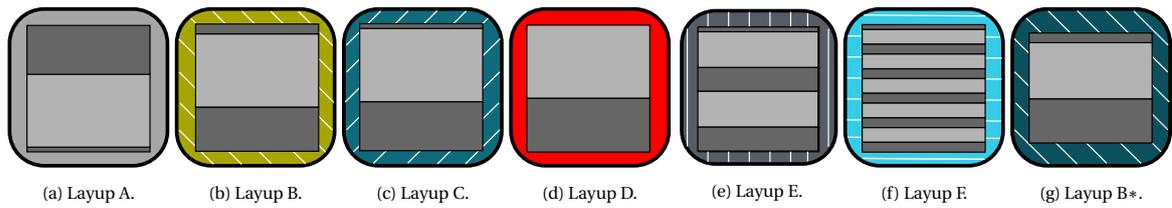
identical groups separated by helicals as shown in Figure 4.37e.

Figure 4.37: Pictorial representation of the seven layups of the investigation.

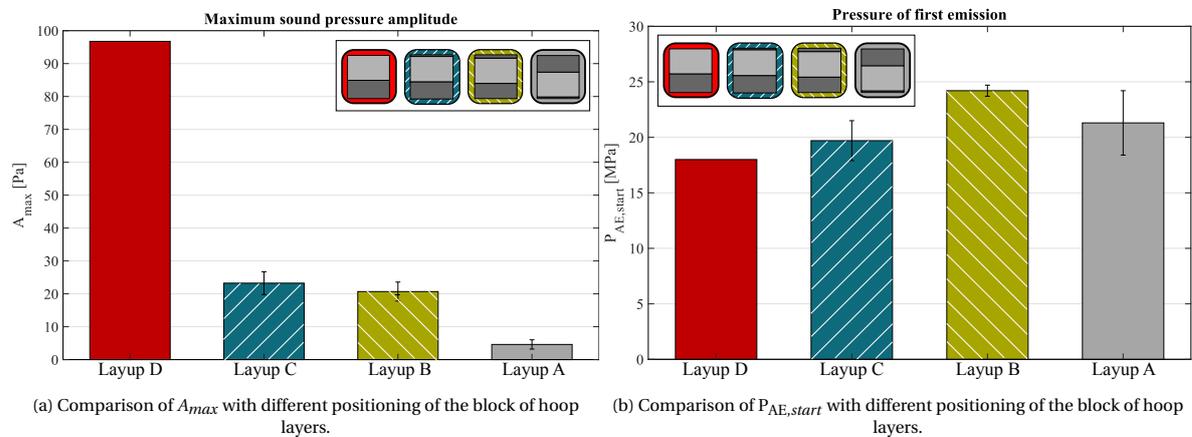
Figure 4.38: Comparison of A_{max} and $P_{AE,start}$ with different positioning of the block of hoop layers.

Looking at Figure 4.38a, it can be noticed that the maximum amplitude recorded is highly influenced by the location of the hoops. The more helical layers are positioned on top of the hoops, the lower is the maximum sound pressure amplitude recorded. This is in agreement with what found in literature at laminate level [30, 55]. It can be observed that there is a drop when passing from zero to one outer helical layer. This significant trend is not followed when moving another helical from the inside to the outside. In the latter case there is just a small decrease. A further drop in maximum amplitude is encountered when moving all the helicals except one. What causes such a high maximum amplitude for layup D are two effects, already presented in Paragraph 4.2.3. The first one is the attenuation caused by the presence of some layers wound above the crack. If this would be the only cause, a similar significantly high effect should be observed whenever adding another single layer. The main cause could be related to the possibility of the two sides of the crack to separate without restriction and to release an appreciable amount of energy. This is known as the free boundary

In Figure 4.38b it can be noticed that the hydraulic pressure at which the first emission takes place is slightly influenced by the positioning of the hoops. Considering D, C and B it can be observed that the more helicals are added on top of the block of hoops, the later the first emission is recorded. This could be explained by the fact that the top helical layers hold the hoops together and delay the cracks formation. If this was the only cause, $P_{AE,start}$ of layup A should be the highest, which is not the case. It must be considered that while layups D, C and B are similar in terms of stacking sequence: inner block of helicals, block of hoops and few or no helicals on top, layup A is significantly different, being the opposite of C. This must cause a completely different stress distribution through the thickness of the laminate that could be the reason why the trend is not followed. Due to the thick wall, the tangential stresses are higher in the inside of the vessel with respect to the surface. Since in layup A the hoops are positioned deeper in the laminate, they could crack earlier than the other configurations. Another variable that has been proven to influence the IFF formation is the presence of voids, as explained in Paragraph 4.3. In the department, some colleagues have investigated the porosity of the different layups. It was concluded that layups B and A have in the block of hoops in the cylindrical section a very similar void content percentage (respectively 2.19% and 2.03%). For this reason, the porosity should not play an important role in the formation of IFF in the hoops.
