Combined Acoustic and Optic Characterization of Damage Mechanisms in Internally Pressurized Composite Pressure Vessels

MSc Thesis

Aerospace Engineering

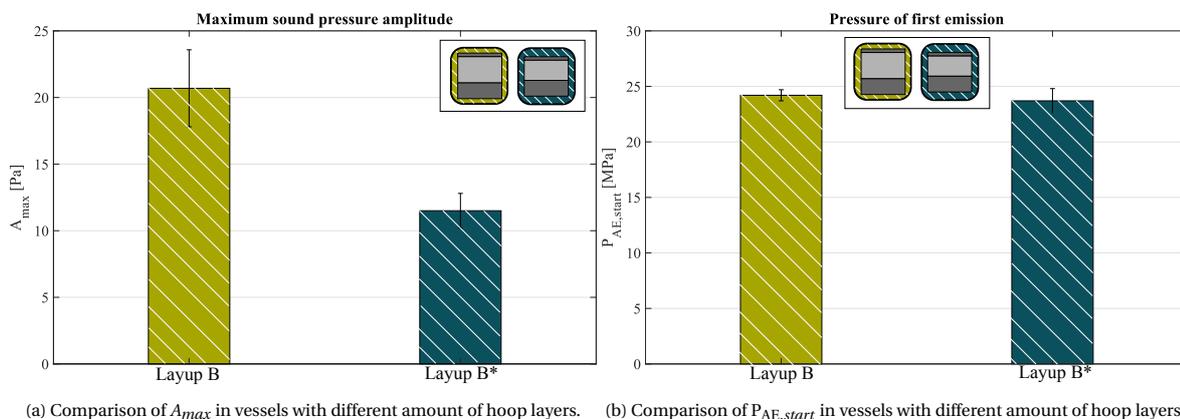
Figure 4.39: Comparison of A_{max} and $P_{AE,start}$ in vessels with different amount of hoop layers.

In Figure 4.39a it can be noticed that there is a difference in maximum sound pressure amplitude when changing the amount of stacked hoop layers. The less circumferential plies are stacked together, the lower is the amplitude of the AEs caused by IFF. More in detail, removing the 23% of hoops reduces the maximum sound pressure amplitude recorded of 44.4%. This fact can be linked to the length of the fracture surface created [30, 42, 68]. The shorter it is, the lower is the energy released.

Looking at Figure 4.39b, which shows the pressure at which the first emission is detected, it can be noticed that there is hardly a difference between the two layups. It could be concluded that the amount of hoop layers in the laminate (keeping the same positioning) does not influence the crack formation. This can be further proved comparing the amount of emissions detected (N_{hits}) in the two layups. This has already been investigated in the department in previous studies and it has been found that the emissions identified for layups B and B* are respectively (on average) 48 and 49 [42]. It could be concluded that the ratio between the num-

The next aspects analyzed are the effects of the grouping of the hoop layers. In particular, two scenarios are evaluated. The first one is represented in Figure 4.39 and it studies how A_{max} and $P_{AE,start}$ are affected when comparing two vessels in which the only difference is in the number of hoop layers. Layups B and B* are exactly the same except that B has 30 hoops while B* only 23. The second case will evaluate the differences when comparing vessels with the same amount of hoops and helicals but having them split in multiple smaller blocks.

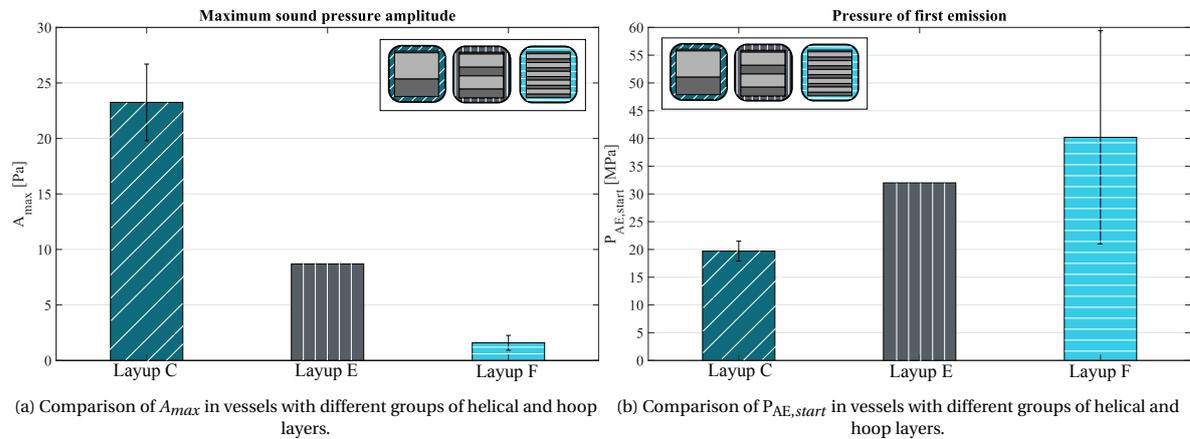
Figure 4.40: Comparison of A_{max} and $P_{AE,start}$ in vessels with different groups of helical and hoop layers.

In Figure 4.40a it can be noticed that the maximum sound pressure amplitude recorded is affected by the grouping. The same trend observed before is repeated: the less hoops are stacked in a block and the lower is the AE amplitude. When halving the amount of hoops in a block, the sound pressure amplitude drops of 62.6%. As for the previous case and similarly to what found in literature, this effect can be related to the size of the fracture surface and the energy release associated to it [30, 42, 68]. For layup F it is not clear whether the emission with maximum sound pressure amplitude corresponds to IFF in the hoops or in the outermost helical layer, as already explained in Paragraph 4.3.3. The data provided can be used to give a qualitative overview on how the grouping of the hoop layers affects the acoustics but not quantitative results.

In Figure 4.40b it is represented the pressure stage at which the first emission is detected. The standard deviation for layup F is significantly high. This is the case because for only three of the eight investigated vessels it was possible to detect AEs with the given threshold and for each only a single peak was identified. Furthermore, for one of the three vessels the hydraulic pressure was not recorded, reducing the comparison to only two. For all the other vessels, the amplitude of the acoustic emissions produced was below 2 Pa. Again, it must be taken into account that for layup F it is not clear whether these detected emissions correspond to IFF located in the hoop or helical layers. Looking at the values given in Figure 4.40b it can be noticed that there is a significant difference between the layups. The more the groups, the higher is the hydraulic pressure at which the first emission is detected. One hypothesis that has been speculated is that the first emission recorded does not correspond to the first IFF in the hoops created in the laminate. Considering layup E it could be the case that the emissions detected are most likely produced by IFF present in the outermost blocks of hoops. As already shown in Paragraph 4.5.1, the deeper in the laminate the crack is formed, the lower is the sound pressure amplitude produced. Since the amplitude is also depending on the amount of hoops stacked, it is most likely the case that the cracks formed in the innermost block cannot be detected by the system. It might be speculated that the innermost blocks of hoops crack earlier than the outermost. Due to the small fracture

The last comparison regards the different grouping of hoops and helicals. For the three considered vessels the ratio between them is the same as well as the amount of layers. The difference consists in the number of blocks of hoops created. In particular, layup C has only one group of 30 hoops, E has two of 15 and F has six blocks of five layers each. All the vessels have a single helical as outermost layer. Only one vessel of layup E has been tested, thus more specimens would be needed before drawing the final conclusions. However, since all the vessels of one layup follow a clear pattern regarding their acoustic behavior, it has been decided to insert it in the research. Regarding layup E, it must be taken into account that of the eight vessels analyzed, only three produced AEs with a sound pressure amplitude above 2 Pa. Furthermore, for all of them only a single hit has been detected and at different internal pressure. This factor might be a limit when analyzing $P_{AE,start}$ of this layup. It is also not possible to clarify whether the first detected emission in layup F corresponds to IFF taking place in the hoops or in the superficial helicals.

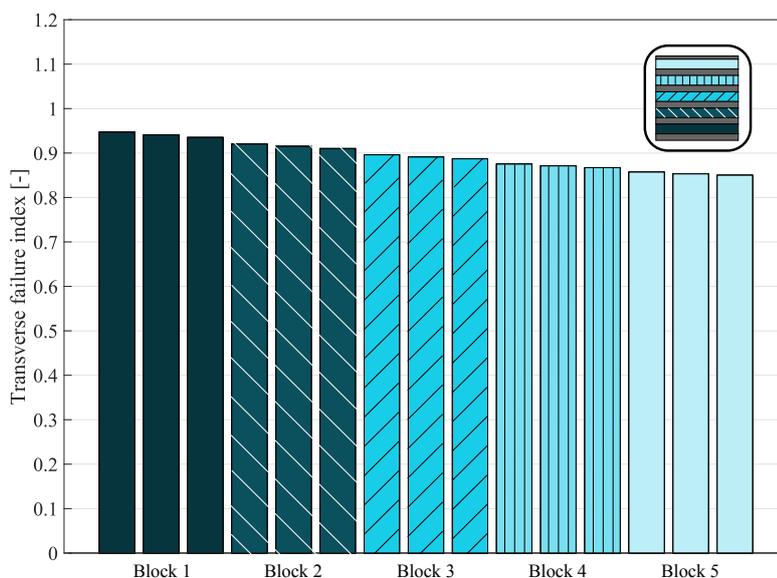
One study that is currently taking place in the department concerns the simulation of the layups. Even if this topic is not part of the current research, few results will be presented to verify whether the hypothesis can be validated. In the department, layup F has been simulated. Figure 4.41 shows the transverse failure index for each couple of hoop layers. The data are taken at a simulated hydraulic pressure of 35 MPa and at the axial symmetry plane of the vessel, so at half of the total length. This simulation is performed using a continuum shell formulation in the software Abaqus. Each vertical bar corresponds to a couple of hoop layers, thus each

Figure 4.41: Transverse failure index simulated for each couple of hoops of layup F with continuum shell approach.

block of hoops in the laminate is represented with three bars of the same color and pattern. As shown in the pictorial representation of the layup, block 1 corresponds to the innermost block of hoops while block 5 to the outermost. The helical layers are not represented. When the transverse failure index is equal to one, it means that the couple of hoops has failed, thus that matrix cracking has taken place. Comparing the indices it can be noticed that it is higher for the innermost plies and it decreases when moving outwards. This means that, according to this formulation, IFF will take place in the deeper blocks first and the superficial one last. This finding reinforces the hypothesis. In more recent times, the vessel has been simulated using a solid element formulation instead of the continuum shell approach. This new formulation is more effective when modeling thick structures such as the CPVs of the current investigation. The results of this method are shown in Figure 4.42. Also in this case, these data correspond to a simulated internal pressure of 35 MPa and the representation is the same of the case above. The trend is exactly the opposite which makes the results in conflict with the previous findings. These data show that the hoop layers that will fail first are the most external ones, which is in disagreement with the previously mentioned hypothesis. However, this method is the one giving most realistic data for thick structures. It can be concluded that it is most likely the case that the hypothesis is incorrect and that the delay in the recording of the first emission must be associated to other effects.

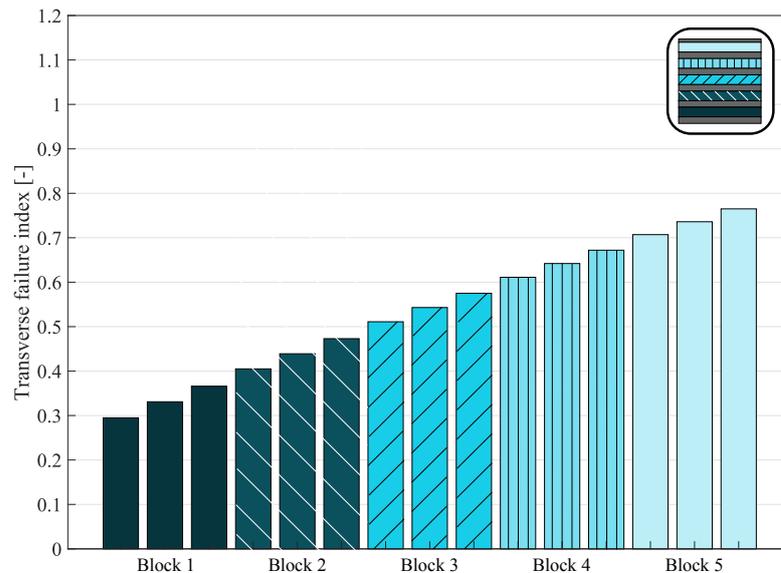
Figure 4.42: Transverse failure index simulated for each couple of hoops of layup F with solid elements.

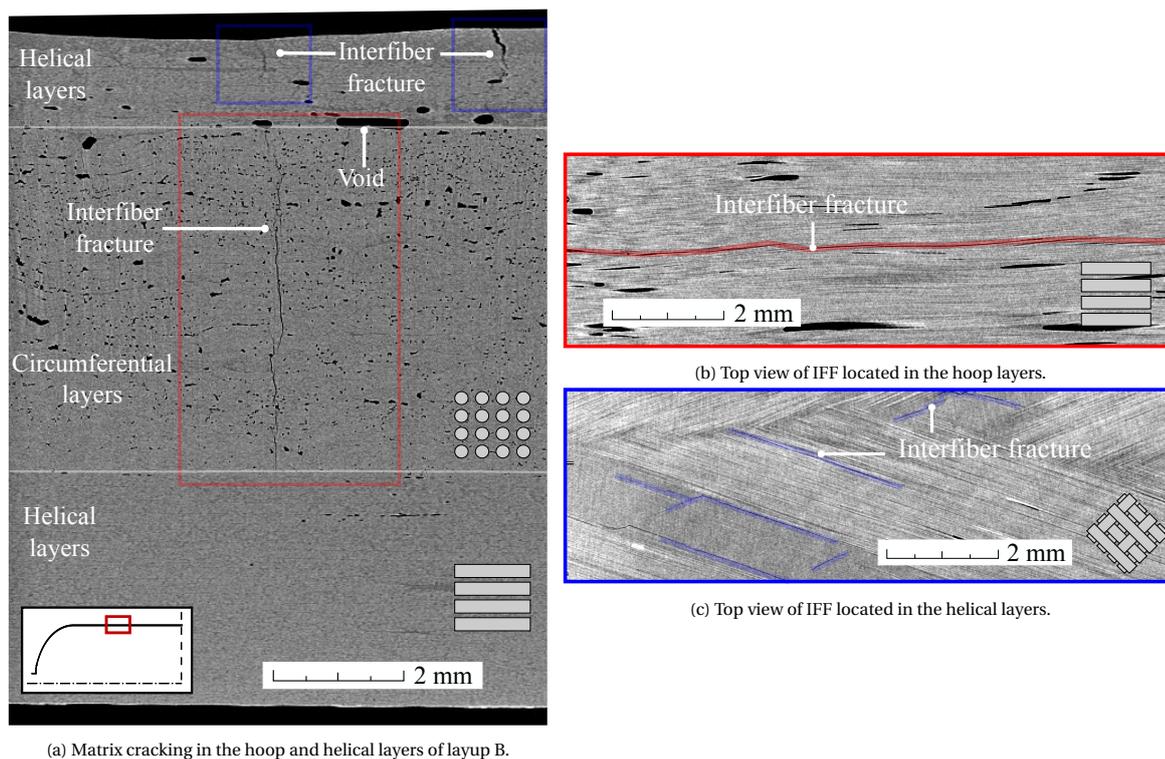
When internally pressurized during an EOL test, the CPVs examined in the current investigation are characterized by the formation of one damage mechanism: matrix cracking. An example can be seen in Figure 4.43a. In filament wound vessels, there is a difference in the characteristics of this damage according to the layer type in which it takes place. When a crack is formed in the helical layers, it tends to propagate in-plane and it gets stopped whenever the tow intersects another one. An example can be observed in Figure 4.43c. Since these layers are cross-ply, the tows intersect very often and for this reason the fracture created has limited length. This also reduces the possibility of the crack to propagate through the thickness of the lam-

Figure 4.43: CT results of a specimen after an EOL pressurization up to 105 MPa.

propagate both in-plane and through the thickness, as visible in Figures 4.43a and 4.43b. When they are formed, they quickly progress in-plane forming a complete ring around the vessel. This was evident observing layup D in which the hoops layers are the most external ones. This fact was also confirmed when analyzing the acoustic signal that this damage was creating. It was discovered that the microphones recording the maximum sound pressure amplitude of the emissions associated to this damage are positioned in different walls all around the testing chamber. The crack also grows through the thickness of the laminate. Since the hoops are wound with the same orientation, IFF can easily progress until where it encounters a helical ply, which acts as crack stopper [31]. This can be observed in Figure 4.43a. From the scans it is also possible to notice that the IFF located in the hoop layers is passing through at least one void in the majority of the cases. This could confirm what found in literature which states that the voids in a laminate could act stresses concentration that may cause the cracks formation [29]. Looking at layup E, it was possible to notice that the majority of the cracks in the hoop layers were located on the outer-most blocks. Due to compaction, the blocks positioned more internally in the layup presented a lower porosity and also less cracks. IFF in the hoop layers could be detected by the DIC analysis only in layup D in which the circumferential are the most external ones. This is the opposite of what stated above when considering IFF taking place in the helicals. This difference could be associated to the significant size of the fracture when compared to the measuring volume. Nevertheless, IFF in the hoops is not detected by the DIC when they are located below one or multiple helicals [55]. After the vessel depressurization, it is possible to understand whether IFF in the hoops has taken place, studying the residual axial displacement of the top boss thanks to DIC. After the vessel depressurization, a residual displacement can be measured. This can be linked to the closure of the cracks. After the depressurization the cracks might not close perfectly, leaving a small gap between the two sides. Summing all the gaps can lead to a measurable displacement. Acoustic emission analysis can provide more precise results. IFF that takes place in the hoops produces emissions which are usually characterized by higher amplitudes when compared to those located in the helicals. This is explained by the bigger size of the fracture surface which is associated to a higher energy release. Since the in-plane fracture size is comparable for all the layups (it forms a ring around the vessel), what causes differences is its progression through the thickness. It depends on both the amount of hoop layers stacked together and their position through the laminate. It was proven that vessels with more hoops stacked together produced emissions of higher amplitude when compared to those with less (e.g. layups B and B*). This confirms what studied at laminate level [30, 68] and what supposed by Torres Guijarro in the analysis of CPVs [42]. The AE sound pressure amplitude is also influenced by the position of the IFF through the laminate thickness: the deeper it takes place and the lower it will be due to attenuation. Also this fact proves what already discovered at laminate level [30, 55].

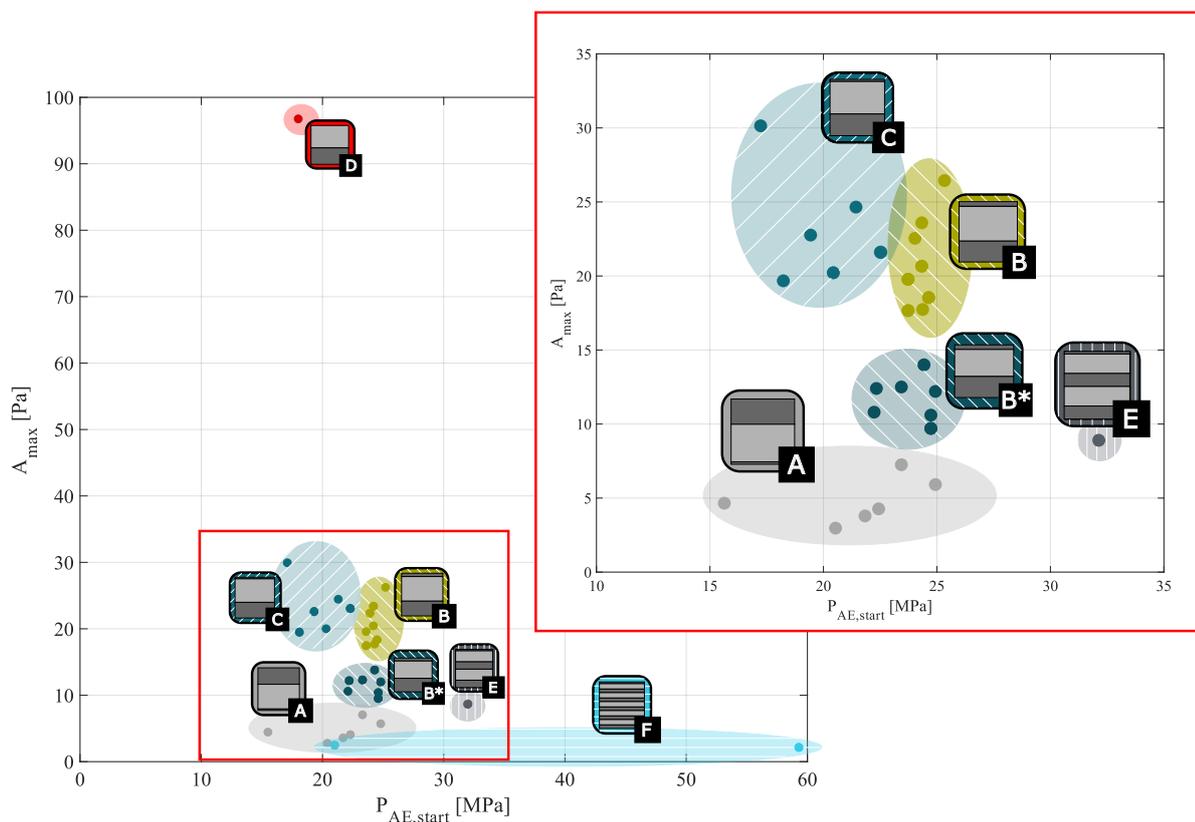
Another aspect that has been analyzed is the internal pressure at which the first emission is detected. This considers the emissions with a sound pressure amplitude above 2 Pa, according to the predefined thresholds (Threshold I). Figure 4.44 shows how this parameter and the maximum recorded amplitude vary according to the analyzed stacking sequences. Each mark corresponds to a specimen and those of the same color belong to the same stacking sequence. To make the understanding easier, the results of each layup are grouped in circles with shaded areas. It can be observed that the specimens of each stacking sequence are located in a specific area of the graph, which means that they all follow a pattern. This is true for all the layups except F. Its results are highly influenced by the threshold settings due to the low amplitude of the emissions that characterize this stacking sequence. The vertical axis of the graph represents A_{max} , while the horizontal $P_{AE,start}$. The majority of the layups are grouped in one area of the graph, except D which is positioned particularly far from the rest of the groups. It has a significantly higher maximum amplitude recorded. This is the case because it has the hoops in a single block and no helicals on top that can attenuate the acoustic wave. The free boundary effect also plays a role [28]. Layups B and C are similar with the difference that the latter has one helical moved towards the inside of the laminate. Their sound pressure amplitudes are similar (slightly higher for C), while the pressure of the first emission is not. This could be explained by the constraining effect of the top two helicals (layup B) that retard the crack formation when compared to C that has only one outer helical. Layup A is located at the bottom of the diagram, due to the deep position of the block of hoops that causes emissions of lower amplitudes. Layup B* is located just below B, in accordance to the consideration on the fracture surface size. Despite the seven less hoops, their $P_{AE,start}$ is similar. This shows that keeping the same stacking sequence but changing only the helicals to hoop ratio, the maximum sound pressure amplitude recorded is influenced but not the $P_{AE,start}$, at least for this case. Considering the layers grouping, keeping the helicals to hoops ratio and the number of layers unchanged, it can be noticed that both the variables are affected. In particular, a smaller fracture surface will produce emissions of lower amplitude and the

Figure 4.44: A_{max} and $P_{AE,start}$ of the totality of the analyzed vessels.

more groups are present, the later the first emission is detected by the system. It is not clear what causes the latter, but it was speculated that the in situ strength could play at least a side role. This effect is associated to “[...] the varying strength of a ply perpendicular to the fibers” [84]. The thicker these plies are and the lower is their in situ strength. This could lead to a premature crack formation. Nevertheless, if this was the only cause, a similar trend in $P_{AE,start}$ should take place when comparing layups B and B*, which is not the case. It can be concluded that this effect cannot be the only explanation. To explain the delay in detecting the first emission, it was speculated that the innermost block of hoops would have cracked first but due to the limited fracture surface and depth in the laminate, could not produce detectable emissions. For this reason, the first emissions identified are those produced by the outermost block that cracks later. Simulations performed by one colleague in the department showed that the transverse failure index in the hoop layers decreases when moving towards the inside of the laminate, invalidating the hypothesis. It is still not clarified the relation between grouping and the variable $P_{AE,start}$.
