Bondline thickness effects on damage tolerance of adhesive joints subjected to localized impact damages

Application to leading edge of wind turbine blades

Verma, Amrit Shankar; Vedvik, Nils Petter; Gao, Zhen; Castro, Saullo G.P.; Teuwen, Julie J.E.

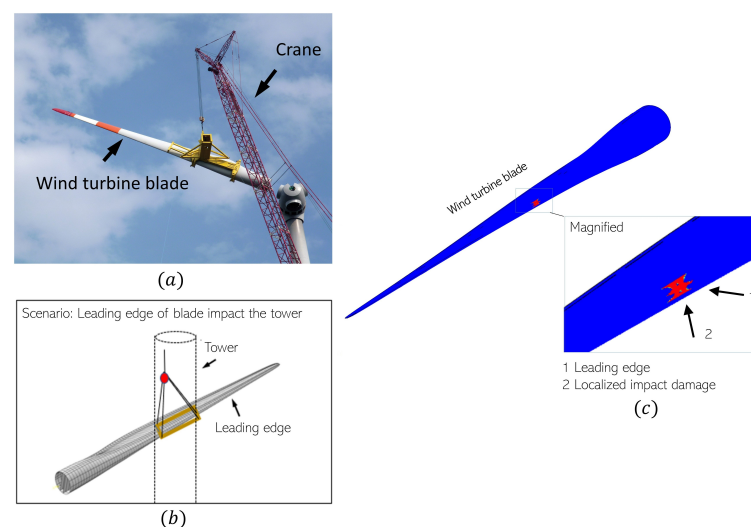
Figure 1. (a) Lifting phase of wind turbine blade [5]; (b) collision scenario [2]; (c) localized impact damage at adhesive joint of leading edge [2].

The recent trends in the offshore wind turbine industry include bigger turbines with large size rotor blades as they increase the rotor swept area and power production, and are thus profitable for the industry [1]. However, the increasing size of wind turbine blades creates complex challenges during their assembly and installation phases in the offshore environment [2,3]. One of the major issues is the risk of impact loads with the surrounding structures due to substantial dynamic motion responses existing during the lifting phase using offshore crane vessels; see Figure 1a. Verma et al. [2] identified different collision scenarios during blade installation. The study found that large pendulum motions during lifting can cause the leading edge of the blade to collide with the preassembled structure, such as the turbine tower (Figure 1b) [4]. Verma et al. [2] numerically investigated this collision scenario and it was found that the blade could hit the turbine tower with low velocity, causing localized damages at the leading edge of the adhesive joint (see Figure 1c).

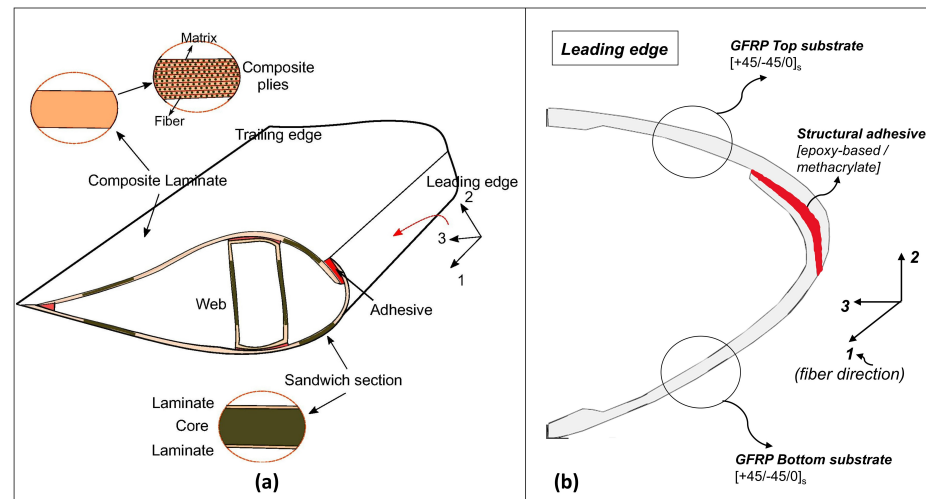
Figure 2. (a) Wind turbine blade cross section [9]. (b) Leading edge joint with top and bottom substrate with material orientation ($[+45/-45/0]_s$) (where 0-degree layer is along the blade span).

A typical composition of a wind turbine blade and their leading edges is presented in Figure 2a,b. It can be seen that the leading edges are primarily composed of adhesively bonded composite laminates made of Glass Fiber Reinforced Plastic (GFRP) materials and have plies with layup oriented in $([+45/-45/0]_s)$ material directions where a 0-degree layer is along the blade span. The main reasons for application of adhesive bonds over mechanical fastenings are their ability to facilitate in uniform stress distributions, and to

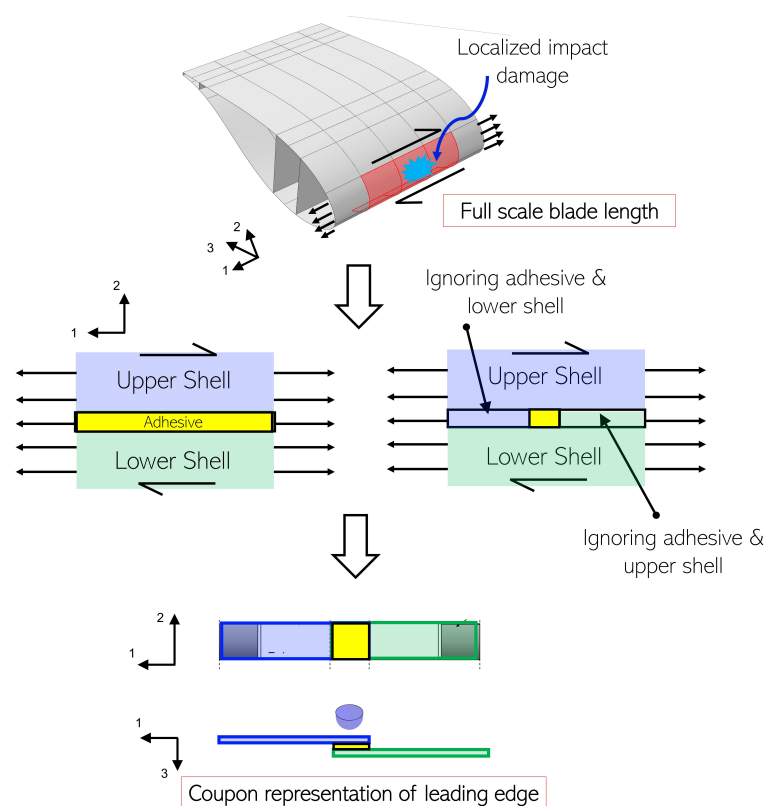
Figure 3. Single lap adhesive joint representation of leading edge at coupon scale.

The leading edge joint connects the upper and lower aerodynamic shells and sometimes a flange is used to redirect the peel stresses to shear stresses [11]. Typical loads on the leading edge of a wind turbine blade consisting of normal force and shear force is shown in Figure 3. Given that the dominant forces are in plane and directed along the adhesive, and can force the substrates to slide over one another, we used the shear mode as the benchmark loading condition and tensile single lap shear tests as benchmark testing for damage tolerance investigation. Note that the tensile single lap shear tests present challenges [41], especially due to paths that create an eccentric load, developing a combination of normal and bending forces in the adhesive zone referred to as peeling forces. Nevertheless, this mode of testing adhesive joints has been used extensively due to simplified geometry to check the performance of the adhesive joints in the state of shear. Furthermore, we represent the leading edge joint by a single lap adhesive joint. Figure 3 describes the assumptions made while making this choice, where we have ignored parts of the adhesive and laminates for our analysis. Similar simplification of leading edge joints has been performed in [42,43]. Note that we represent the blade’s true geometrical parameters like adhesive thickness, composite thickness, joint configuration, and composite layup at coupon scale. These details will further be discussed in Section 3.

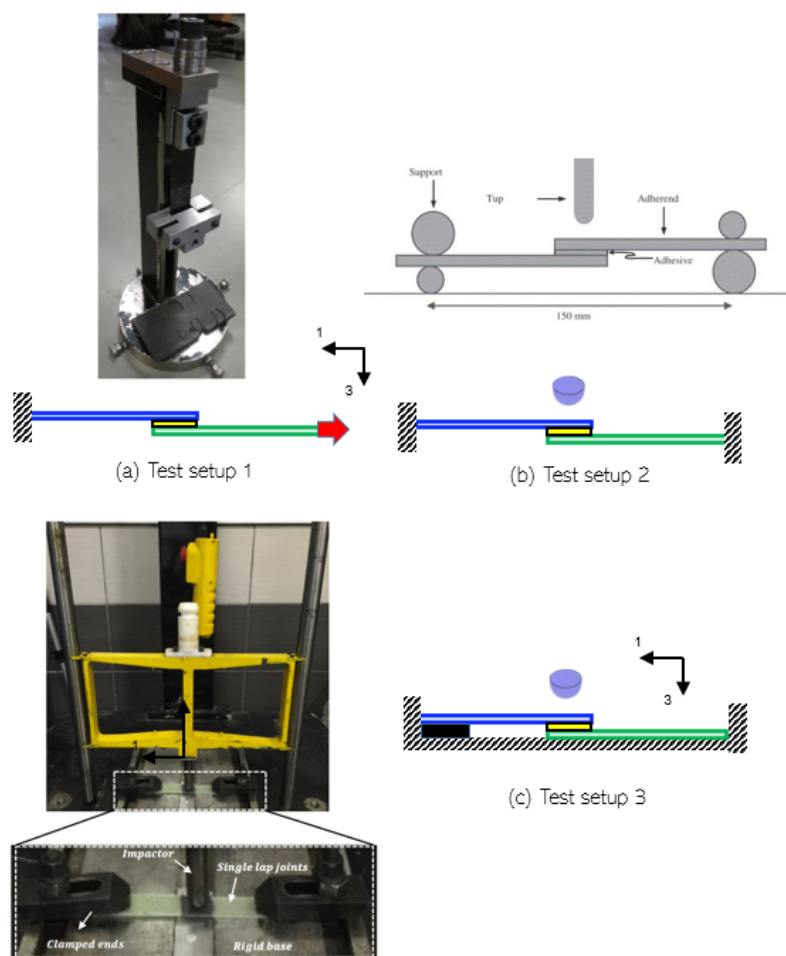
Figure 4. Different test setups used for testing adhesive joints under impact loads [51,56,59].

(1) Test setup 1: Under this test setup, boundary conditions include one end of the joint being rigidly fixed, whereas the other end is unconstrained in the direction of force (F) (see Figure 4a). An impactor is allowed to drop in such a way that it impacts the lower end of the fixture attached to the sample [44,45] (see Figure 4a). In other words, impact forces are imposed in the in-plane direction of the single lap joints in order to break the adhesive bond. This test setup is also referred to as in-plane dynamic testing with high strain rate, where the substrates of the joints are dominantly exposed to membrane forces. The test setup has been used extensively in the literature sources by [44,46–50] to investigate impact assessment on single lap joint. However, this test setup is contrary to the global impact scenario in our study applied to the leading edge of a wind turbine blade. Hence, this test setup was not considered suitable for the current study.

(2) Test setup 2: This test setup includes both ends of the sample being rigidly fixed, and a drop weight impact machine is used to apply impact energy in through the thickness direction of the sample (see Figure 4b). This configuration of loads is explicitly referred to as the transverse impact loading condition in the literature (perpendicular to the reinforcement direction) and has been utilized in [51–55]. The dominant mode of failure is governed by the membrane effects in the substrates, global deflection of the sample under impact-induced bending, as well as localized deformations. Hence, mixed loading and failure modes will likely cause a severe inconsistency when comparing three different bondline thicknesses. Therefore, this test setup was not considered suitable for the study.

(3) Test setup 3: The configuration of loads and BCs for this test setup is similar to Test setup 2, however, a rigid support base is present below the samples along with rigidly clamped ends (Figure 4c). In this way, the local impact damage on the adhesive joint is isolated by eliminating any significant membrane forces and global bending deformation. Furthermore, the flat rigid plate also satisfies the geometric stiffness inherently present in the blade system due to the curvature of the leading edge section. Hence, this test setup enables a consistent comparison of localized impact-induced effects on adhesive joints between different bondline thicknesses. The test setup has also been explored in the literature [56–58] for impact testing on adhesive joint, and was judged as the most suitable configuration for the present study.

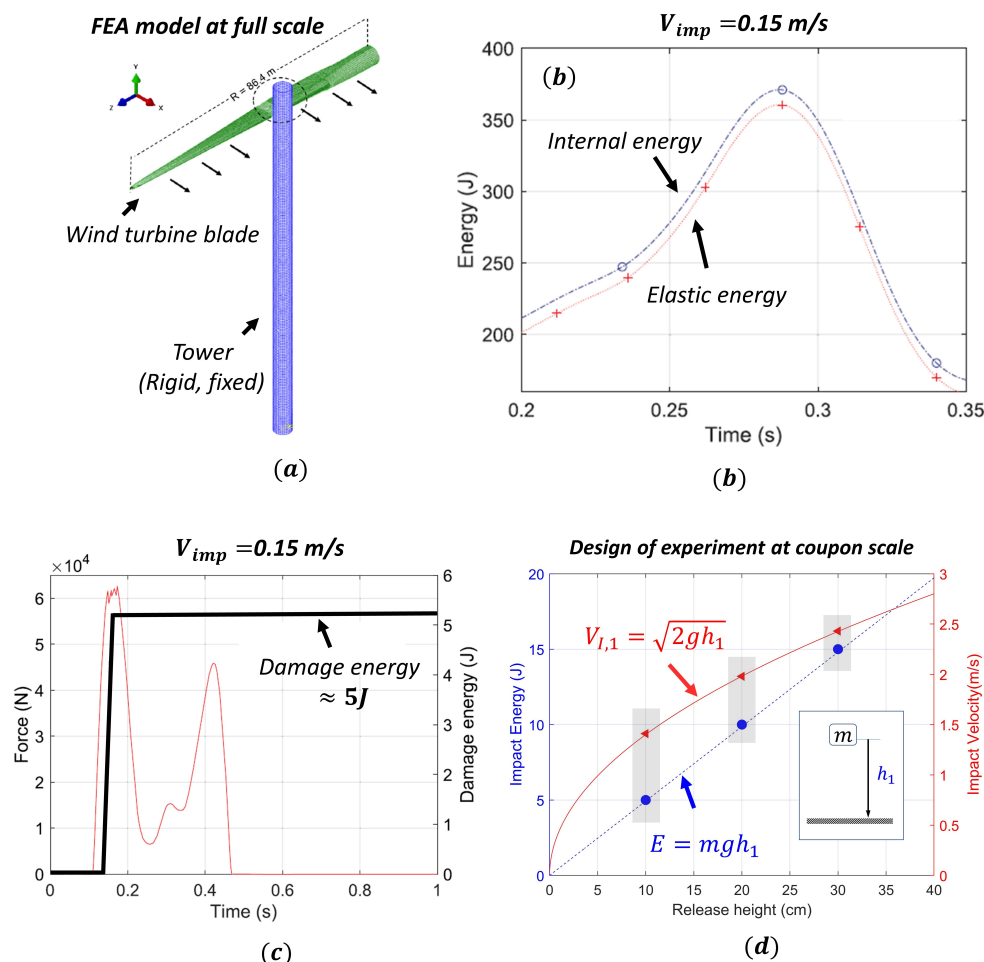
Figure 5. (a) Full scale Finite Element Model (FEA) model from [2], (b) comparison of internal energy and elastic energy in the blade [2], (c) magnitude of damage energy developed in full scale blade [2], and (d) coupon scale impact parameters.

impactor test setup for coupon scale investigation, the desired impact energy on the sample can be generated by releasing an impactor with mass (m) from a release height (h_1) onto the specimen. Figure 5d presents the desired release height as 10 cm, 20 cm, and 30 cm to achieve an impact energy of 5 J, 10 J, and 15 J using an impactor that has a mass of 5.1 kg. Furthermore, utilizing the impact kinematics, the impact velocity ($V_{I,1} = \sqrt{2gh_1}$) is obtained as 1.41 m/s, 1.98 m/s and 2.43 m/s, respectively.

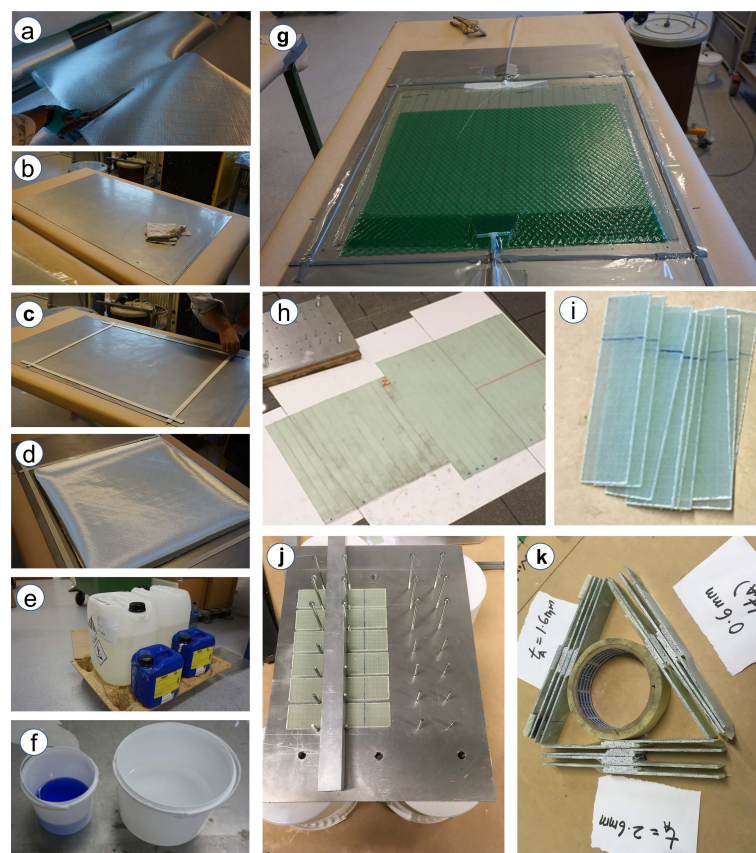
Figure 6. Step-by-step procedure (a–k) followed in experiment for preparing laminates and adhesive joints.

GFRP laminates are manufactured using vacuum infusion process, a standard manufacturing procedure followed in the wind turbine blade industry. The procedure for preparation of joints are summarized in Figure 6 and are also briefly explained in the sequence below. First, unidirectional (UD) and biaxial reinforcements from Saertex made of 3B's HiPer-tex W2020 glass fibers are cut in square sheets of size 60 cm \times 60 cm (Figure 5a) and are stacked on the mould to obtain a layup plan [+45/−45/0]_s. Note that before

stacking the reinforcements, the stacking mould is unstained with acetone and a release agent is used (Figure 6b). Then, the sealing tapes are applied on the mould (Figure 6c), and the desired sequence of reinforcement along with peel ply and flow meshes are stacked (Figure 6d). Momentive EPIKOTE-MGS135 epoxy resin and EPIKURE-MGS137 curing agent are mixed in a 3:1 ratio, and the mixture is used as the resin (Figure 6e,f). The mixed resin is then kept in the degassing chamber for removing any trapped air bubbles. Furthermore, the whole system is vacuum infused at a pressure of 0.8 bar (Figure 6g) and the prepared laminate has a final thickness of $2.2 \pm 2\%$ mm. The curing cycle of the laminate included keeping the prepared laminates at room temperature for 24 h followed by their post curing in the oven at $80\text{ }^{\circ}\text{C}$ for another 15 h. The prepared laminates are further cut into desired dimensions of size $100\text{ mm} \times 25\text{ mm}$ for their use as substrates in the SLJs (Figure 6h,i).

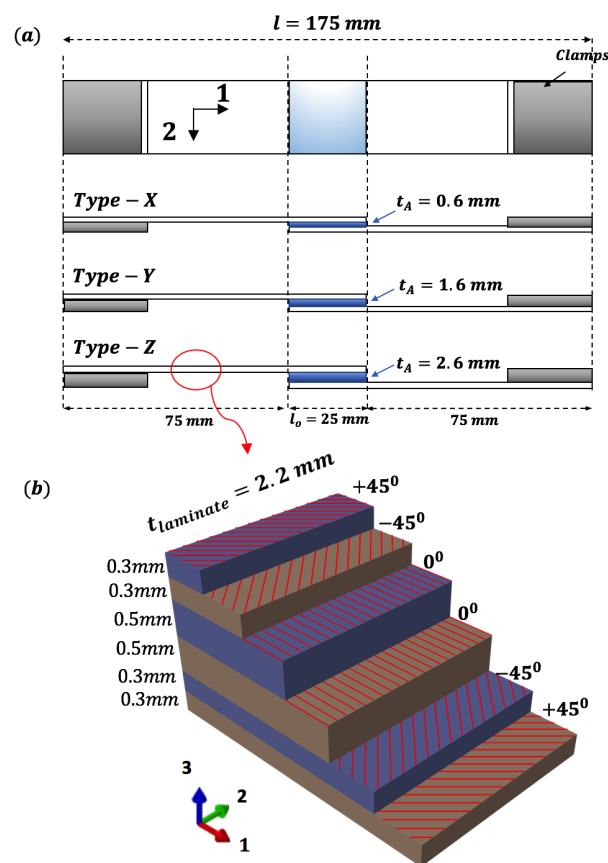
Figure 7. (a) Configuration of prepared adhesive joints and (b) layup of top and bottom substrate.

configurations used in the leading edge of a wind turbine blade. Figure 7a presents the configuration and dimensions of prepared adhesive joints. The total length of the joints is 175 mm, with an overlap length of 25 mm. The stacking sequence of substrate $[+45/-45/0]_s$ is also presented in Figure 7b. For each bondline thickness, there are 16 samples prepared, where 4 samples are tested under a lap shear test for measuring the intact failure load, and the remaining samples are used for damage tolerance investigation.

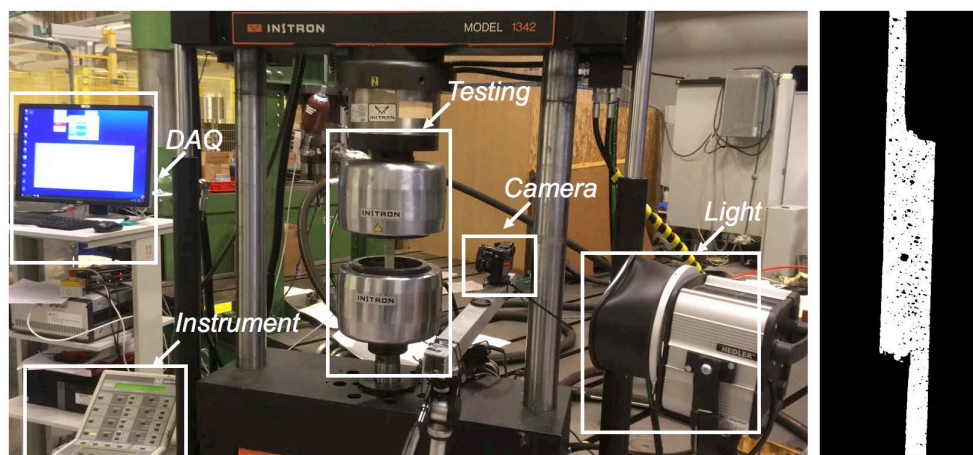
Figure 8. Setup for testing adhesive joints under lap shear (left) and through the thickness surface prepared for failure analysis (right).

The prepared single lap joints are tested in a universal testing machine (UTM) Instron model 1342, at a displacement rate of 1 mm/min. Figure 8a presents the test setup, where components such as data acquisition system (DAQ), operating instrument, camera, light, and samples are shown. In addition, the initial configuration of the joint along the thickness direction, which is used as a surface for image analysis of the failure process is shown in Figure 8b. The maximum force observed by the UTM machine is considered as the failure load of the intact samples. Note that all tests are carried out at room temperature ranging between 23 °C to 25 °C.

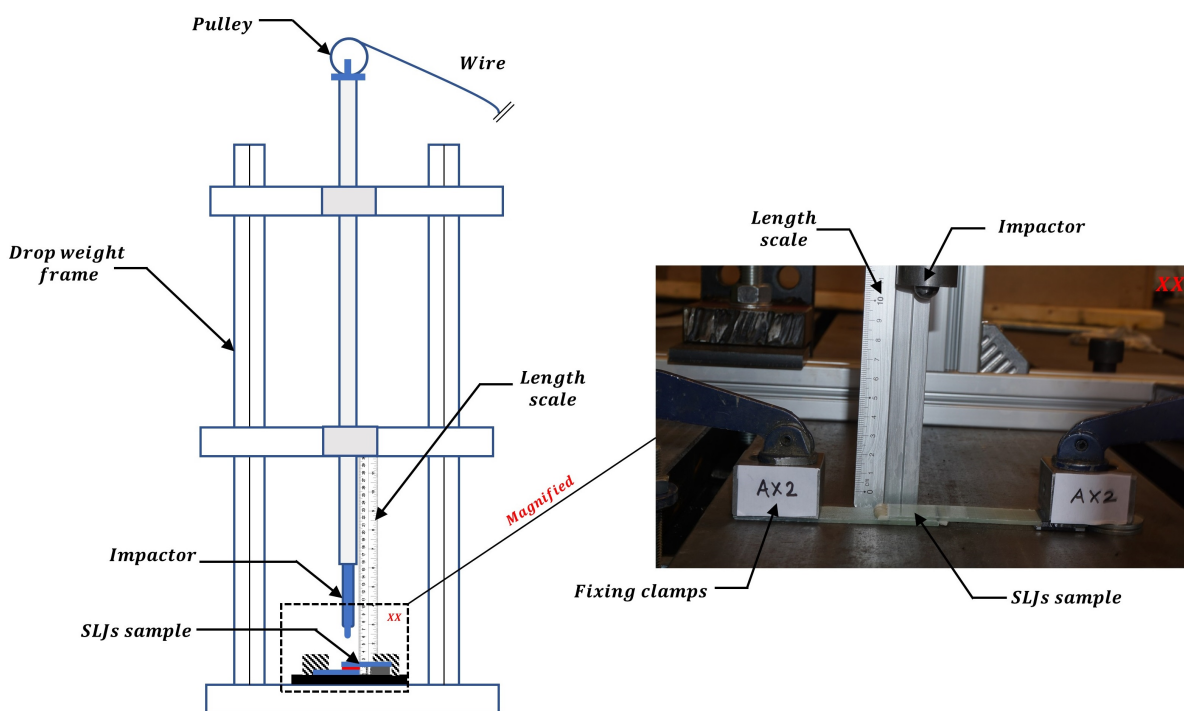
Figure 9. Test setup constructed for impact testing on single lap adhesive joints.

A special dedicated fixture for testing joints under impact loads is constructed for this study to replicate the boundary condition (see Figure 9). The test setup frame is assembled using strut profiles and connections from Bosch Rexroth AG [64], and the base of the setup is rigidly fixed to a steel base. A high-grade hollow steel cylinder is rigidly connected to the center of the frame (Figure 9), which acts as the guiding chamber for the impactor to fall on the sample. The impactor is a rigid steel cylinder having a mass of 5.1 kg and has an impactor diameter (ϕ_d) of 12.7 mm. One end of the impactor is attached with the fibre rope which runs through the pulley attached to the top of the hollow cylinder, and the rope is connected with the winch which controls the height of the impactor. A length scale is also attached with the setup which measures the release height and the rebound height of the impactor. In this way, the impact energies in the test are controlled.

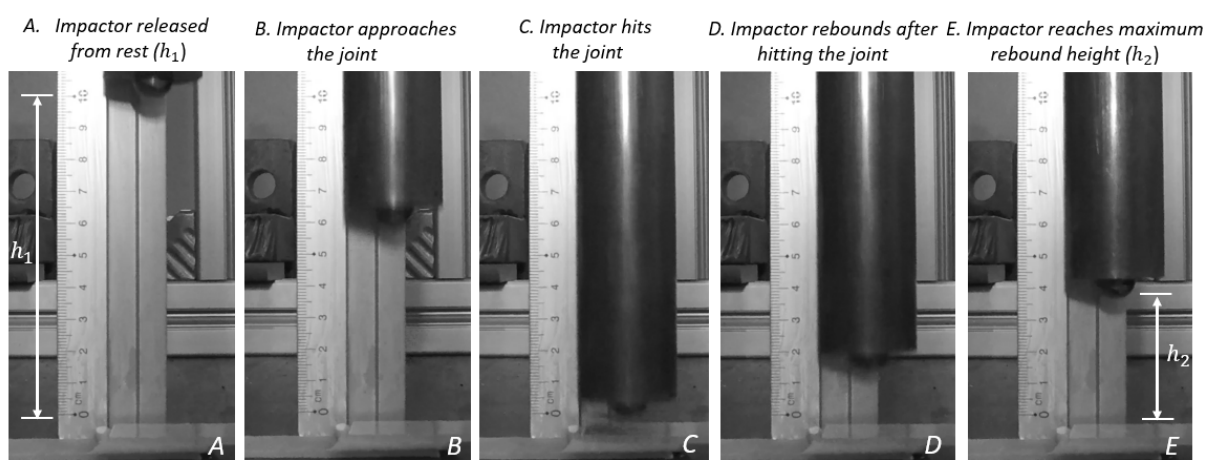
Figure 10. Different stages of impact event recorded by camera.

Impact kinematics were analyzed to describe the absorbed and elastic energies during the impact event. For this, we described the impact on adhesive joints into five sequential stages (Figure 10):

- Stage (A) Impactor released from rest at height (h_1);
- Stage (B) Impactor approaches the joint;
- Stage (C) Impactor hits the joint with velocity ($V_{I,1}$);
- Stage (D) Impactor rebounds after hitting the joint with rebound velocity ($V_{I,2}$);
- Stage (E) Impactor reaches the maximum rebound height (h_2).

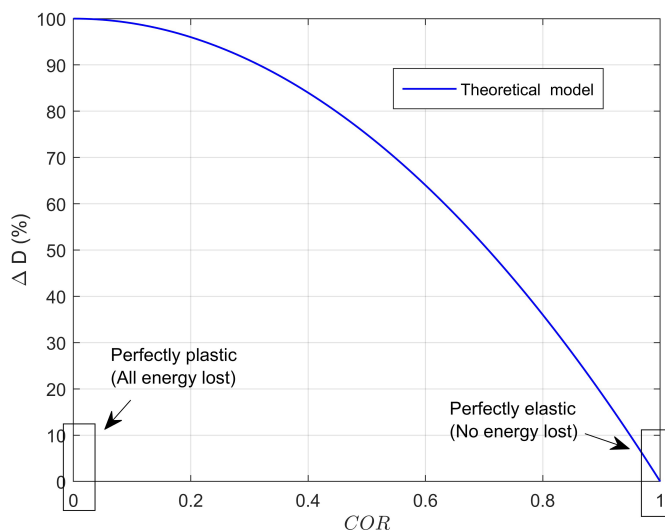
Figure 11. Description of impact kinematics: Theoretical $\% \Delta D - COR$ curve.

A $\% \Delta D - COR$ theoretical curve is presented in Figure 11, where it can be seen that the lower the value of COR , the larger the energy loss percentage $\% \Delta D$ in the system during the impact. Note that the elastic part of the impact event will cause a rebound of the impactor and is associated with energy stored due to elastic deformation [68]. On the other hand, the inelastic part of the impact will include energy losses in the system due to the conversion of kinetic energy of impact into thermal energy, sound, as well as localized deformation and damage of the softer material. In this study, we do not isolate the inelastic part of the impact and assume the energy loss during impact is absorbed by the specimens [68].

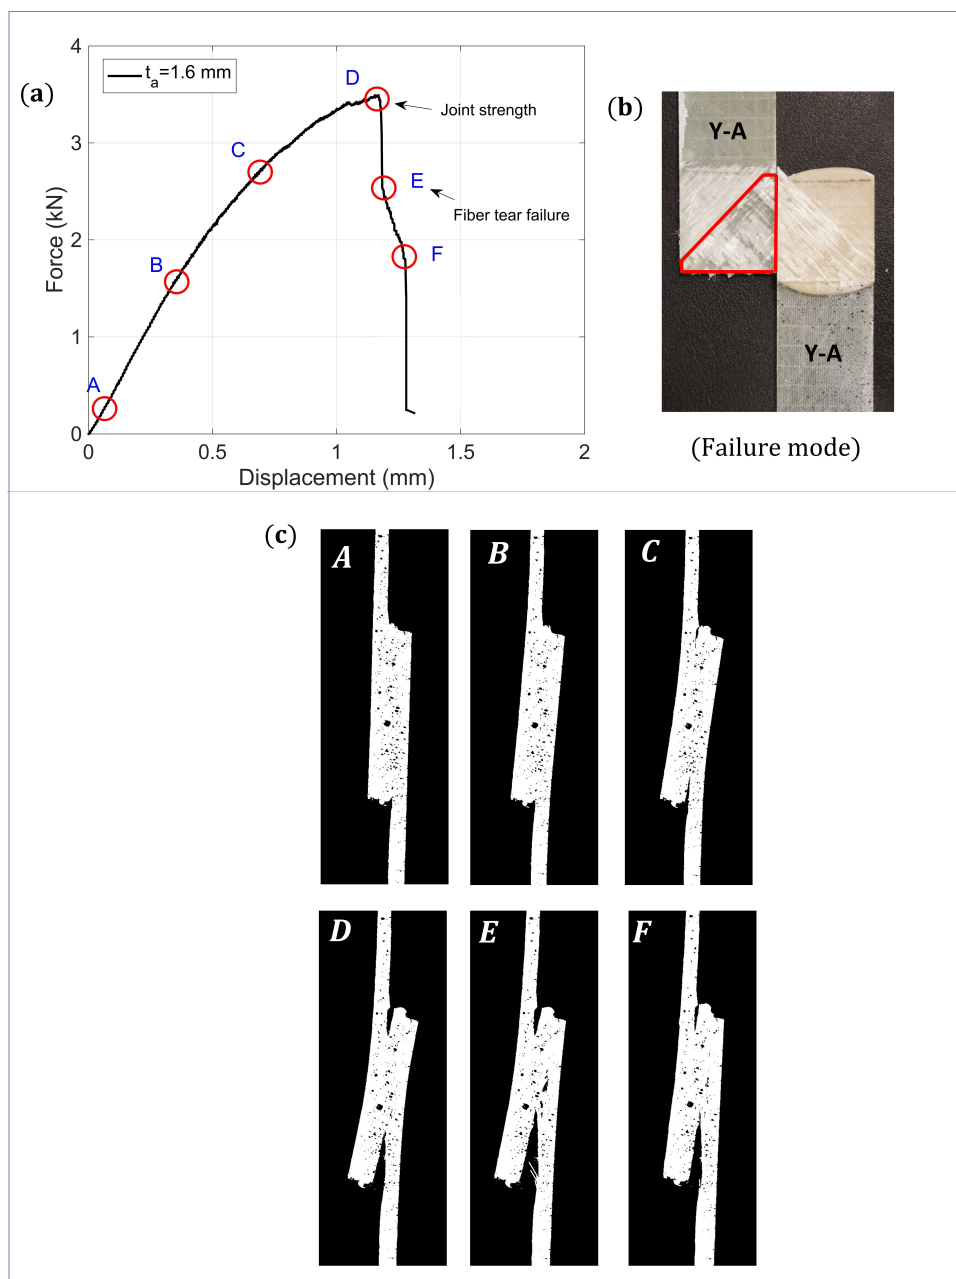
Figure 12. Tensile lap shear test results for intact joints: (a) Force-displacement history, (b) dominant failure mode, and (c) state of joint at different points A-H along the force-displacement history.

Figure 12a,b present the intact load displacement history and failure mode respectively for Type-Y samples ($t_a = 1.6$ mm) subjected to tensile lap shear tests. The figure shows that

the failure load of the sample is close to 3.5 kN, whereas the maximum failure displacement is around 1.35 mm. The failure mode is obtained in the form of fiber tear failure and partial delamination of the first ply of the bottom-most adherend at the adhesive-adherend interface. This is generally due to the fact that composite adherend's interlaminar tensile strength is lower than the peel strength of the structural adhesive, thereby causing a delamination of the bottommost ply. This failure mode is also consistent with the results obtained in the literature for SLJs made with GFRP substrates.

Figure 12a is also marked with different label pointers on the force-displacement curves, where each labeled point represents the deformation state of the sample at different time frames captured using a camera and presented in Figure 12c. It can be seen that the load curve exhibits linear behavior with increased displacement till point B. Furthermore, due to increased bending moment at increased displacement, the joints are exposed to both

tensile as well as bending mode of deformation (see state C,D). At point D, the maximum load is reached, and at this point, partial delamination of the bottom most ply has completely occurred at the adhesive-adherend interface due to high peel forces. This partial delamination further progresses into fiber tear failure at E, finally causing complete failure of the joint at F. The response behavior and failure mode is consistent for all the joint-types and for all the tested samples under tensile lap shear. Figure 13 summarizes the failure mode obtained under tensile lap shear tests for all the three different bondline thicknesses ($t_a = 0.6$ mm, 1.6 mm, and 2.6 mm) and for one representative sample. As seen from the figure, the dominant failure modes for all the cases include fiber tear failure and partial delamination of the first ply of the bottom-most adherend at the adhesive-adherend interface.

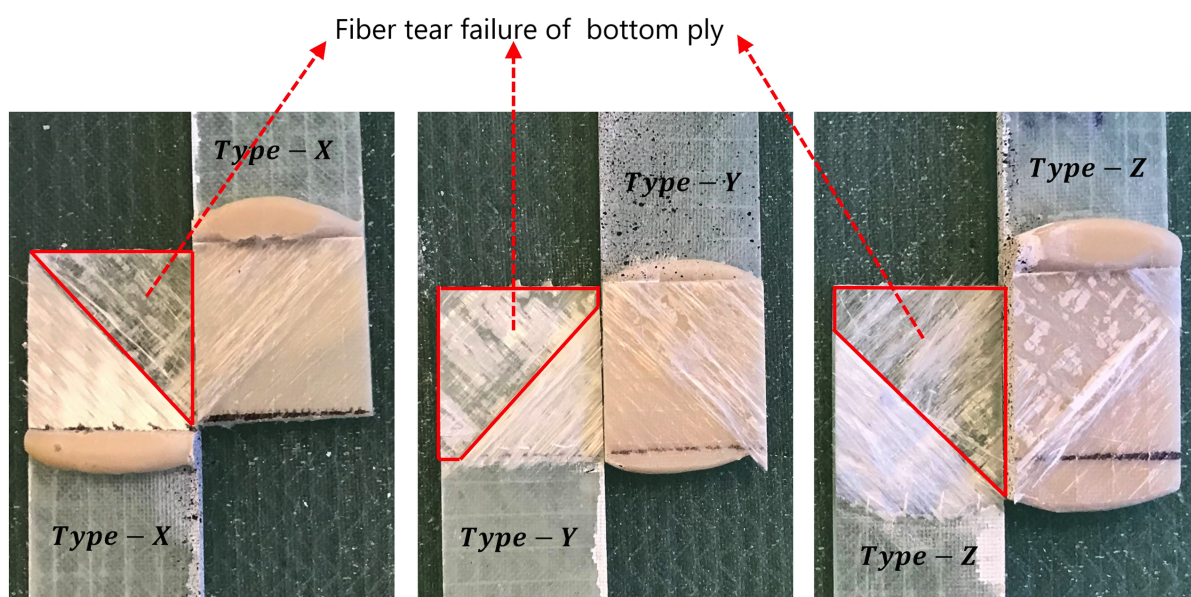
Figure 13. Failure mode subjected to tensile lap shear for joints with bondline thicknesses (0.6 mm, 1.6 mm, and 2.6 mm).

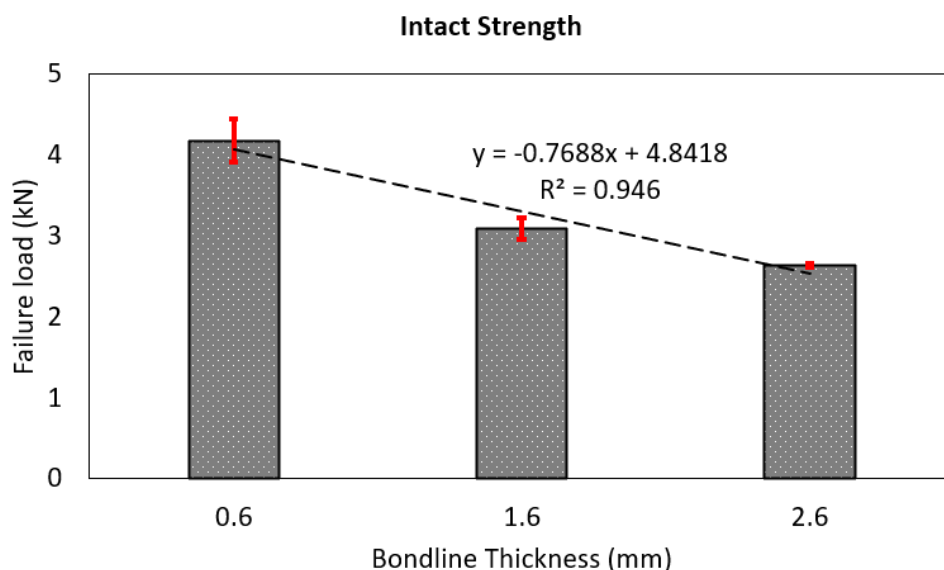
Figure 14. Comparison of intact failure loads with varying bondline thicknesses.

Figure 14 further compares the failure load for the joints with different bondline thicknesses under a tensile lap shear test. It is seen from the figure that the failure load is the highest for the joints with the least bondline thickness ($t_a = 0.6$ mm), whereas the failure load is the lowest for the joint with the largest bondline thickness ($t_a = 2.6$ mm). This is due to large bending moment developed due to eccentricity of the load application, and this effect increases with increasing bondline thickness. Overall, the failure load of the single lap joint reduces with increasing bondline thickness. This result is in agreement with the observation made in the published literature on the failure load of GFRP-based single lap joints subjected to tensile lap shear load [8]. A line of best fit is also drawn to confirm this correlation, which showed a negative slope and has an R^2 value close to 95% confirming our overall observations.

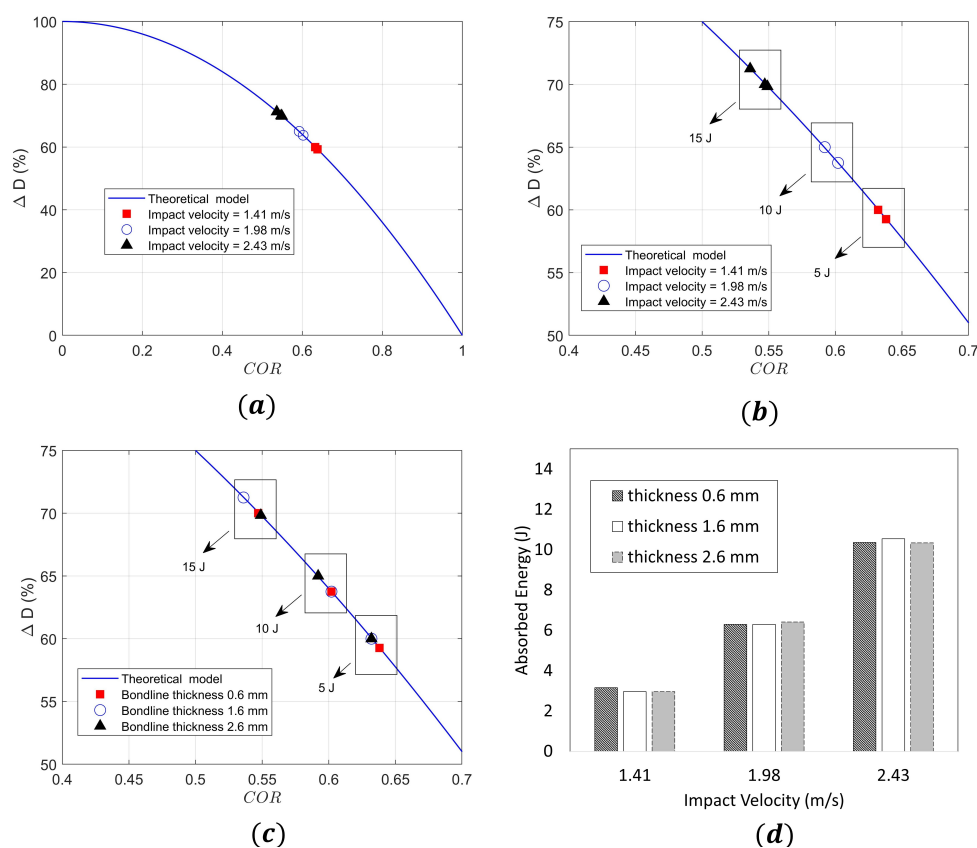
Figure 15. Description of impact kinematics: (a) $\% \Delta D - COR$ curves for different impact velocities, (b) magnified image showing variation of COR and $\% \Delta D$, (c) $\% \Delta D - COR$ curves for different bondline thicknesses, and (d) absorbed energy in the specimens for different impact velocities and bondline thicknesses.

In this section, impact kinematics describing elastic/absorbed energies together with damage assessment results under impact loads for the joints will be discussed. Figure 15a,b present the results for the impact kinematics where the $\% \Delta D - COR$ values from the experiment are presented for impact on joints with varying impact velocities and associated impact energies. The experimental values obtained are also overlapped with theoretical $\% \Delta D - COR$ curves in the figure.

It can be seen from the figure that the COR varies between 0.53 to 0.63 for all the cases, which implies that not all the kinetic energy of impact is absorbed in the specimen, thus implying that the impact kinematics belongs to an elastic plastic regime. Furthermore, the COR is found to decrease with increasing impact velocities which is similar to the trend observed in the literature [66]. This means that for higher impact energies, there are larger

percentage energy losses in the system during impact. For instance, the average percentage energy loss in the system for the case with an impact energy of 5 J is in the order of 60%, whereas average percentage energy loss in the system for 15 J impact energy is close to 70% (see Figure 15b). Figure 15c further presents the measured $\% \Delta D - COR$ values from the experiment for the impact of joints, now classified according to different bondline thicknesses. It can be seen from the figure, that for a given impact energy, there is a weaker dependence of COR on the bondline thickness compared to the impact velocity discussed before. This implies that for a given impact energy, COR and percentage of energy loss due to impact in the system do not vary significantly with bondline thicknesses. This can also be seen from Figure 15c,d, where for a given impact energy, the range of energy absorbed by the sample is similar for joints with varying bondline thicknesses. For instance, around 3 J of impact energy is absorbed by joints with bondline thicknesses of 0.6 mm, 1.6 mm, and 2.6 mm associated with an impact velocity of 1.41 m/s (5 J); 6 J of impact energy is absorbed for the impact velocity of 1.98 m/s (10 J), and 10.5 J of impact energy is absorbed for an impact velocity of 2.43 m/s (15 J) (Figure 15d).

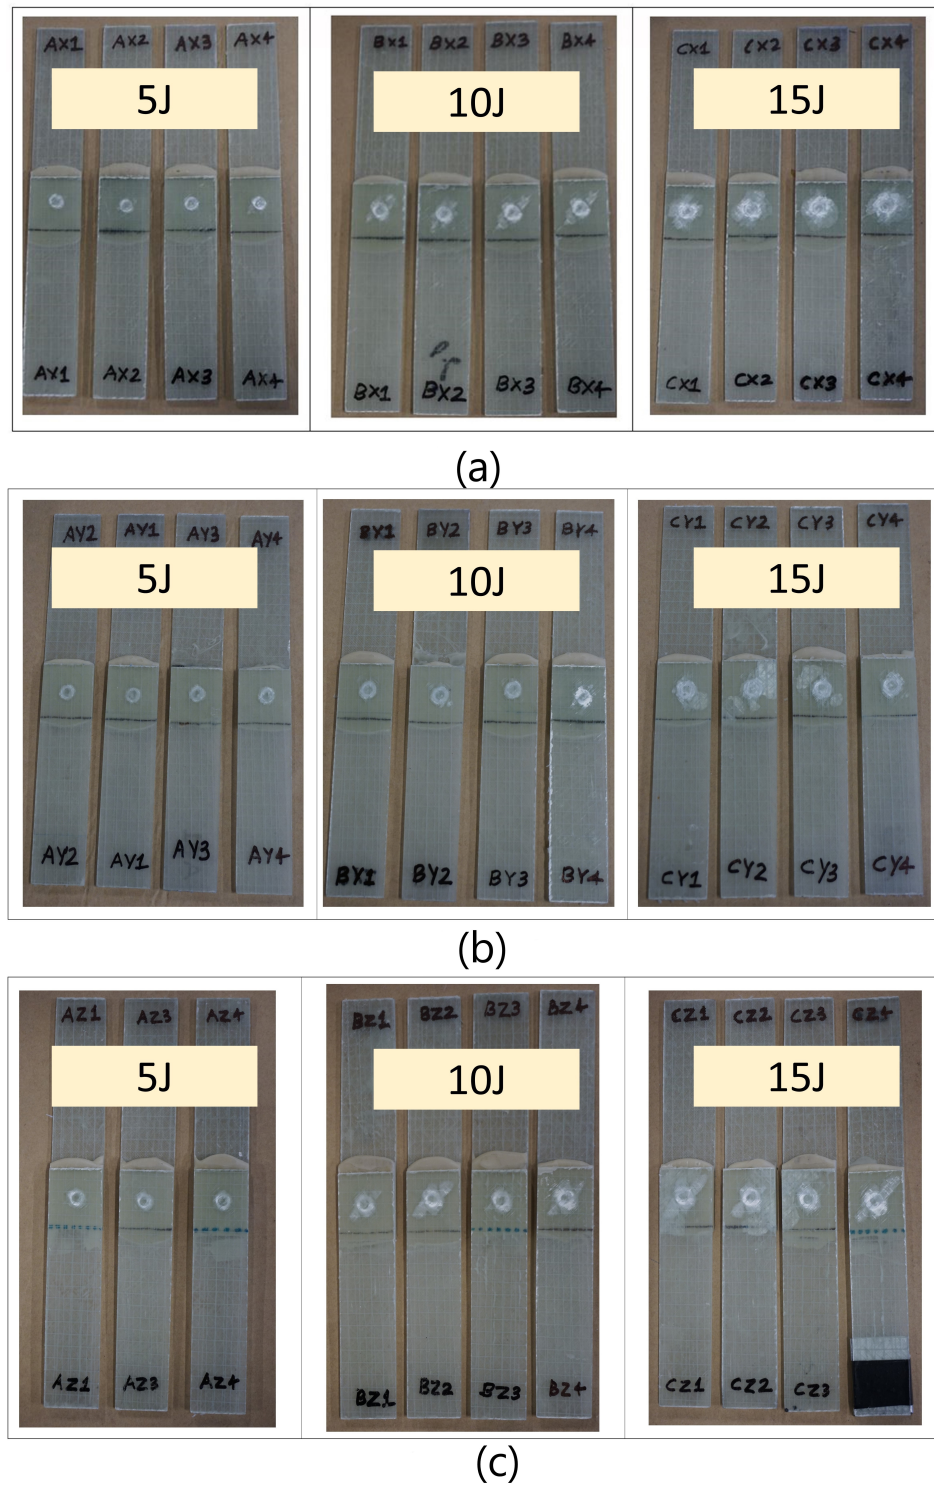
Figure 16. Damages in the joints subjected to different impact energies of 5 J, 10 J, and 15 J for bondline thickness: (a) 0.6 mm, (b) 1.6 mm, and (c) 2.6 mm.

Figure 16a–c present the damages obtained in the specimens due to impact loads. The damages shown here are for all the joints with bondline thicknesses ($t_a = 0.6$ mm, $t_a = 1.6$ mm, and $t_a = 2.6$ mm) respectively subjected to three different impact energies (5 J, 10 J, and 15 J). Note that we used an open-source image processing software, imagej [69], for quantifying the projected damage area due to impact loads (see Figures 17 and 18). The main focus of the damage assessment was not to quantify the damages through the thickness of the sample in detail, and we restricted our investigation to the overall projected area of damage.

As seen from Figures 16 and 17, the damages in the joints due to impact loads are found to be predominantly concentrated around the overlap adhesive zone, and explicitly around the impact point. However, for the largest impact energy of 15 J, the damages even extended to the joint edges for all the samples related to bondline thickness of $t_a = 2.6$ mm and one sample corresponding to the bondline thickness $t_a = 1.6$ mm (white area extended around the edges). These failure types and regions are critical locations of high peel stresses when subjected to tensile lap shear testing. Figure 18a,b further magnify and annotate different failure modes obtained for two different joints with varying bondline thicknesses and an impact energy of 15 J. As seen from these figures, the failure modes in the joint include matrix cracking, typical bean-shaped delamination pattern in the top composite adherend, as well as an impact-induced localized crater around the impact zone. The localized circular crater is one of the most important features found in all the joint types subjected to varying ranges of impact energies (see Figures 15–17). The depth of the localized crater was found to increase with increasing impact energy and to be the most critical for thin joints. This is because for thin joints, the localized crater caused plastic deformation in the layers of the top composite adherend, which extended until the bondline interface. This localized crater along the adhesive zone has been found in the literature [56,57] to cause mechanical locking effects that prevent relative movement of the adherend during the tensile lap shear testing, thereby affecting the overall strength and stiffness of the joint. For additional clarity and representation of these interlocking effects, a cross-sectional scan of one of the thin samples with a bondline thickness of 0.6 mm (cut lengthwise across the impact crater) is presented in Figure 19. We utilized an optical microscope Keyence VR-5000 for presenting this cross-sectional analysis. Figure 19 clearly describes that the mechanical locking effect, where the adhesive layer together with the top adherend's composite layers below the impact crater, has been found to undergo plastic deformation due to impact-induced compressive stresses.

In addition, as seen visually from Figures 16 and 17, the projected damage area on the impact surface increased with increasing impact energies for all the bondline thicknesses. This observation was further quantified in Figure 20a,b using image processing where the damage areas are presented for different bondline thicknesses ($t_a = 0.6$ mm, $t_a = 1.6$ mm, and $t_a = 2.6$ mm) subjected to impact energies (5 J, 10 J, and 15 J). It is found that for any given bondline thickness, the damage area increased with the increasing impact energy, thereby validating our visual observation. These results also agree with the results presented in Figure 15a,b where *COR* decreased with an increasing impact energy. For instance, for the adhesive joint with $t_a = 0.6$ mm, the damage area was around 42 mm², and this increased to more than 300 mm² for an impact energy of 15 J. Moreover, from Figure 20b, it was found that for a given impact energy, the adhesive joint with the thinnest bondline thickness had the least damage area, whereas the thickest joint had the largest damage area. This is an interesting observation as it was previously discussed that the absorbed energies were similar for joints with varying bondline thicknesses (see Figure 15c,d). This can also be seen from Figure 20c where the average projected damage area is plotted against absorbed energy for joints with different bondline thicknesses. The results clearly show that for the same level of absorbed energy, there is more projected damage area observed for thickest joints compared to joints with thin bondline thickness. All in all, thin joints exhibit the highest damage resistance to the projected damage area.

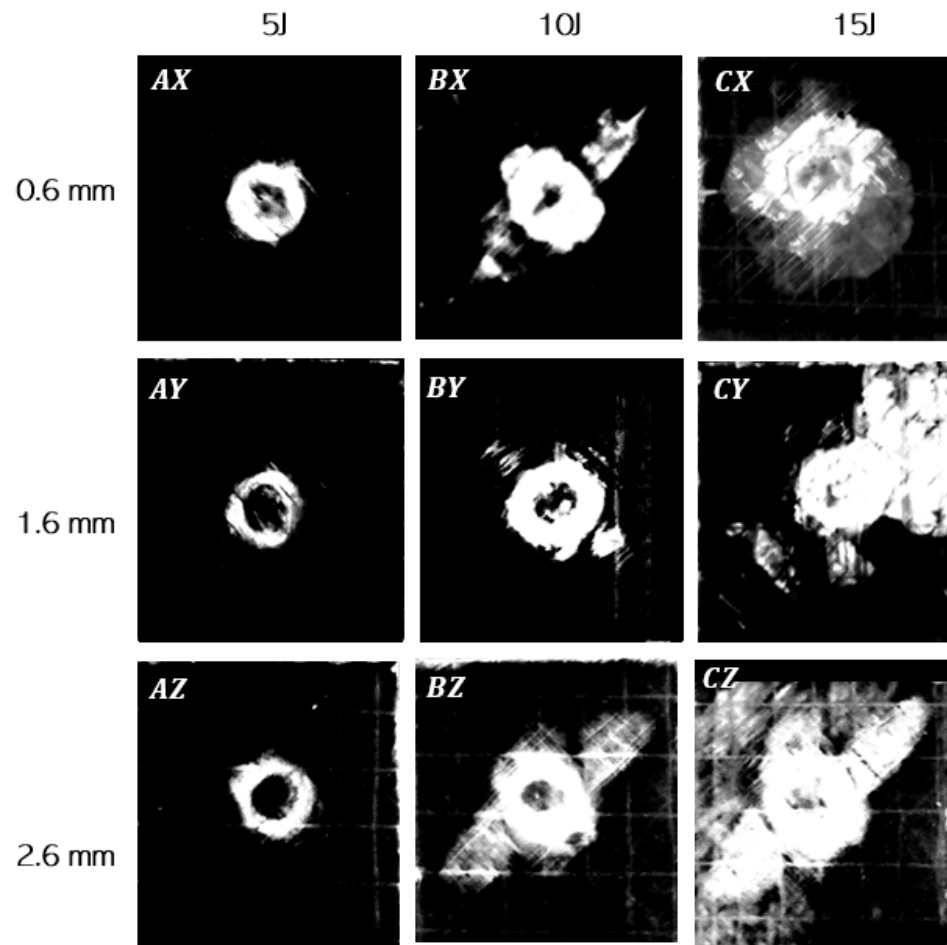
Figure 17. Projected damage area obtained in the joints with bondline thickness (0.6 mm, 1.6 mm, and 2.6 mm) and subjected to impact energy (5 J, 10 J, and 15 J).

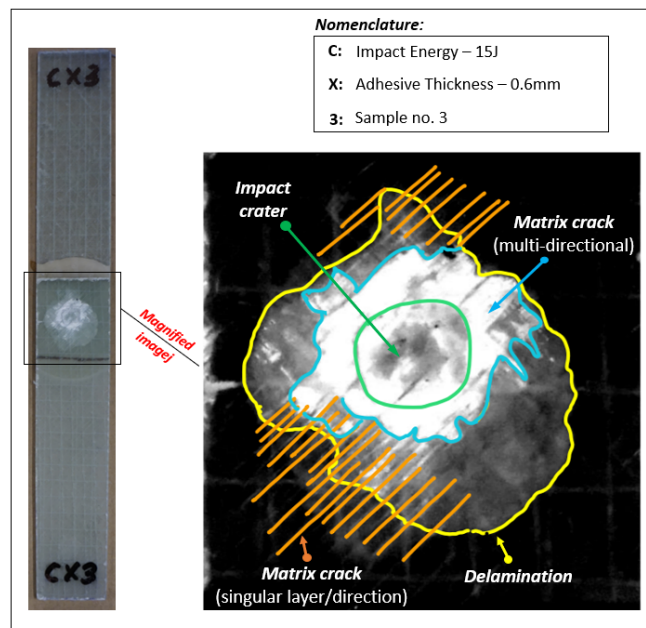
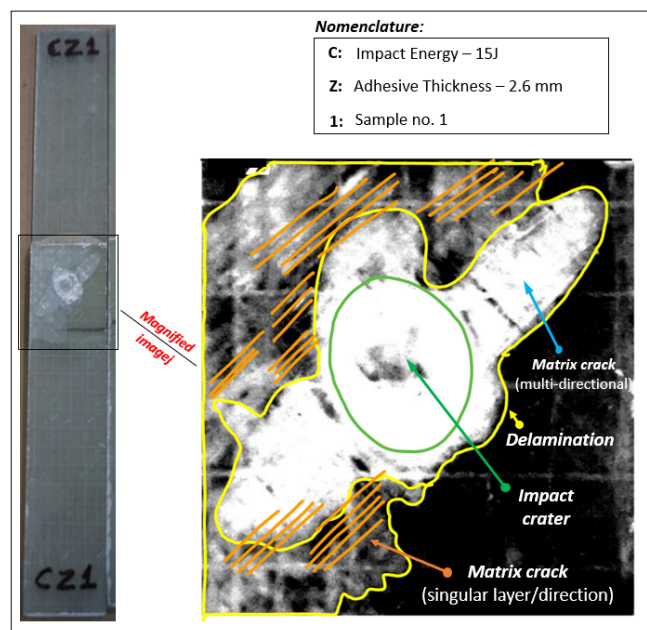
Figure 18. Different failure modes in the joints subjected to impact energy of 15 J for bondline thickness of (a) 0.6 mm and (b) 1.6 mm.

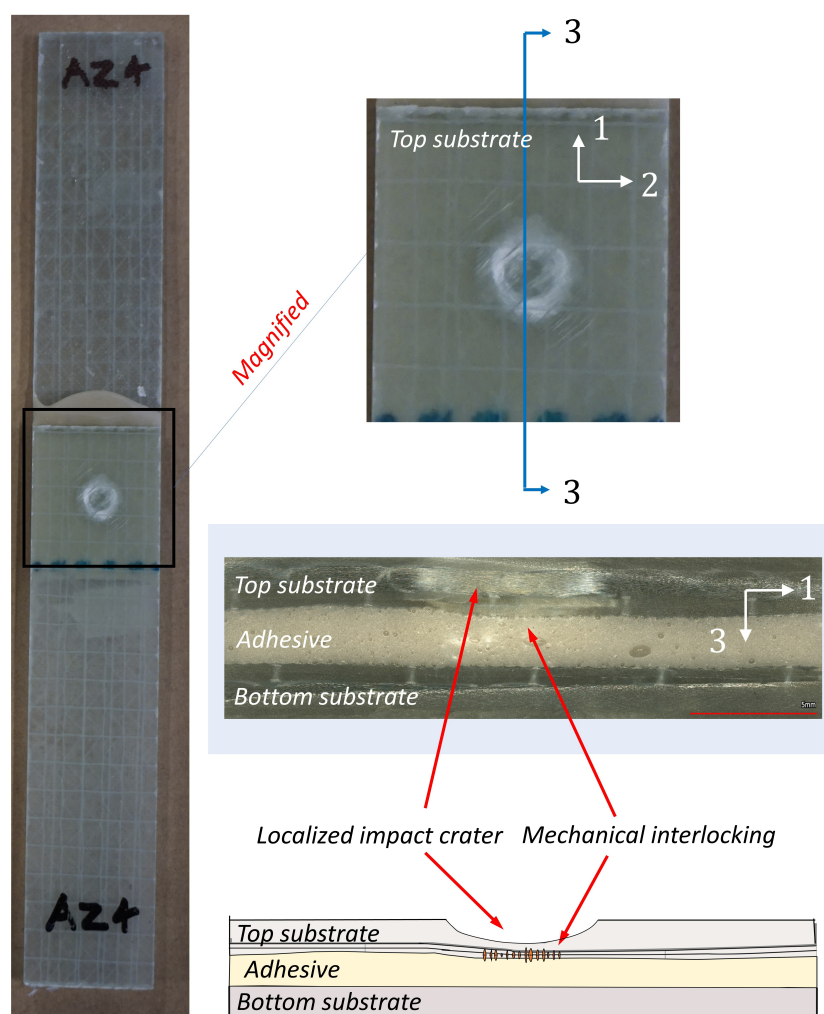
Figure 19. Cross-sectional scan of joint with bondline thickness of 0.6 mm subjected to 15 J of impact energy.

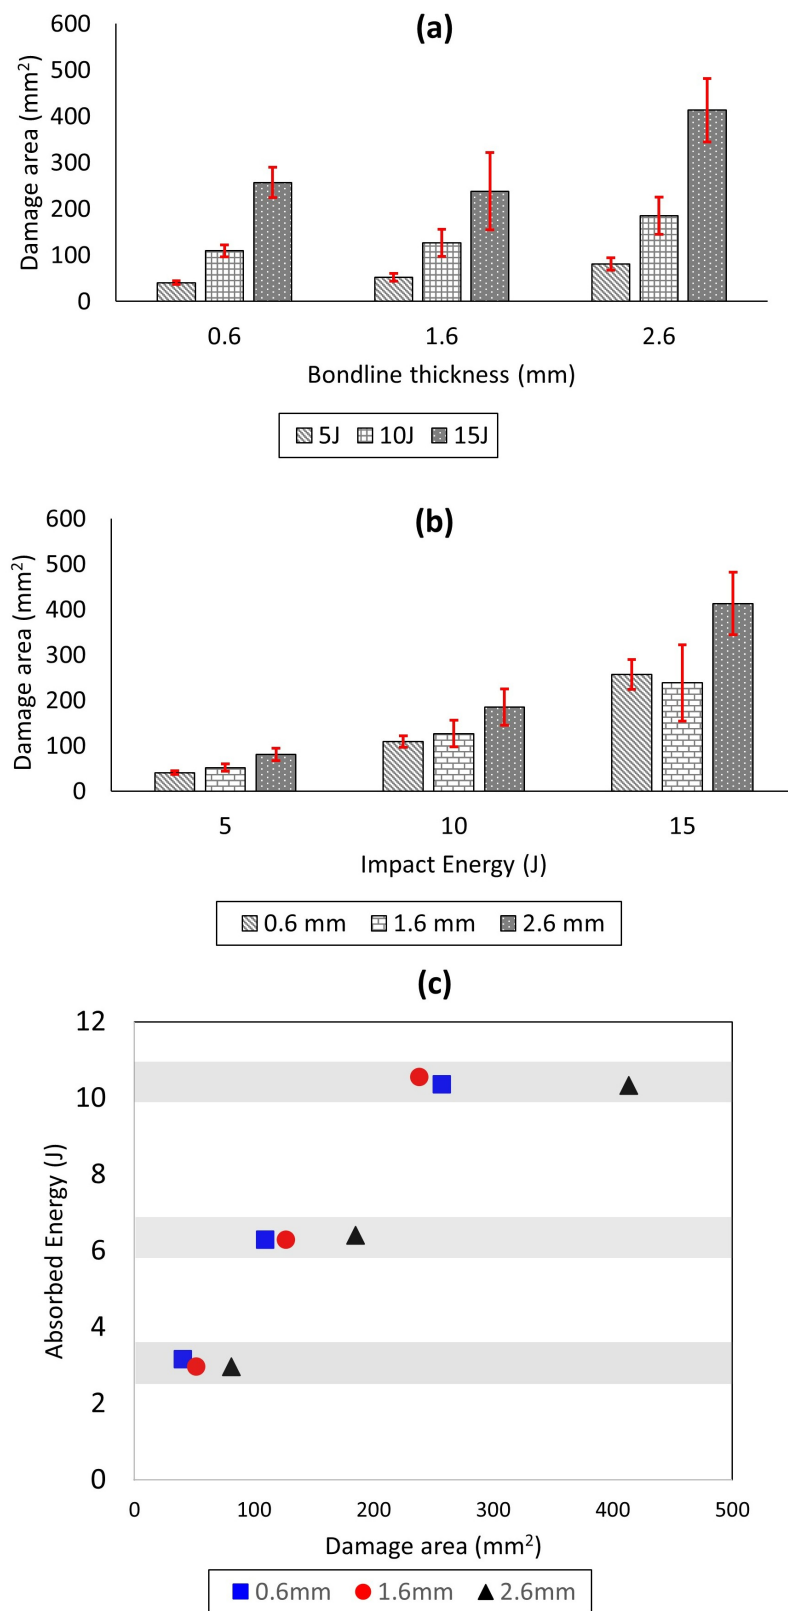
Figure 20. Comparison of impact-induced projected damage area in joints for different (a) bondline thicknesses, (b) impact energies, and (c) absorbed energies.
