Bondline thickness effects on damage tolerance of adhesive joints subjected to localized impact damages

Application to leading edge of wind turbine blades

Verma, Amrit Shankar; Vedvik, Nils Petter; Gao, Zhen; Castro, Saullo G.P.; Teuwen, Julie J.E.

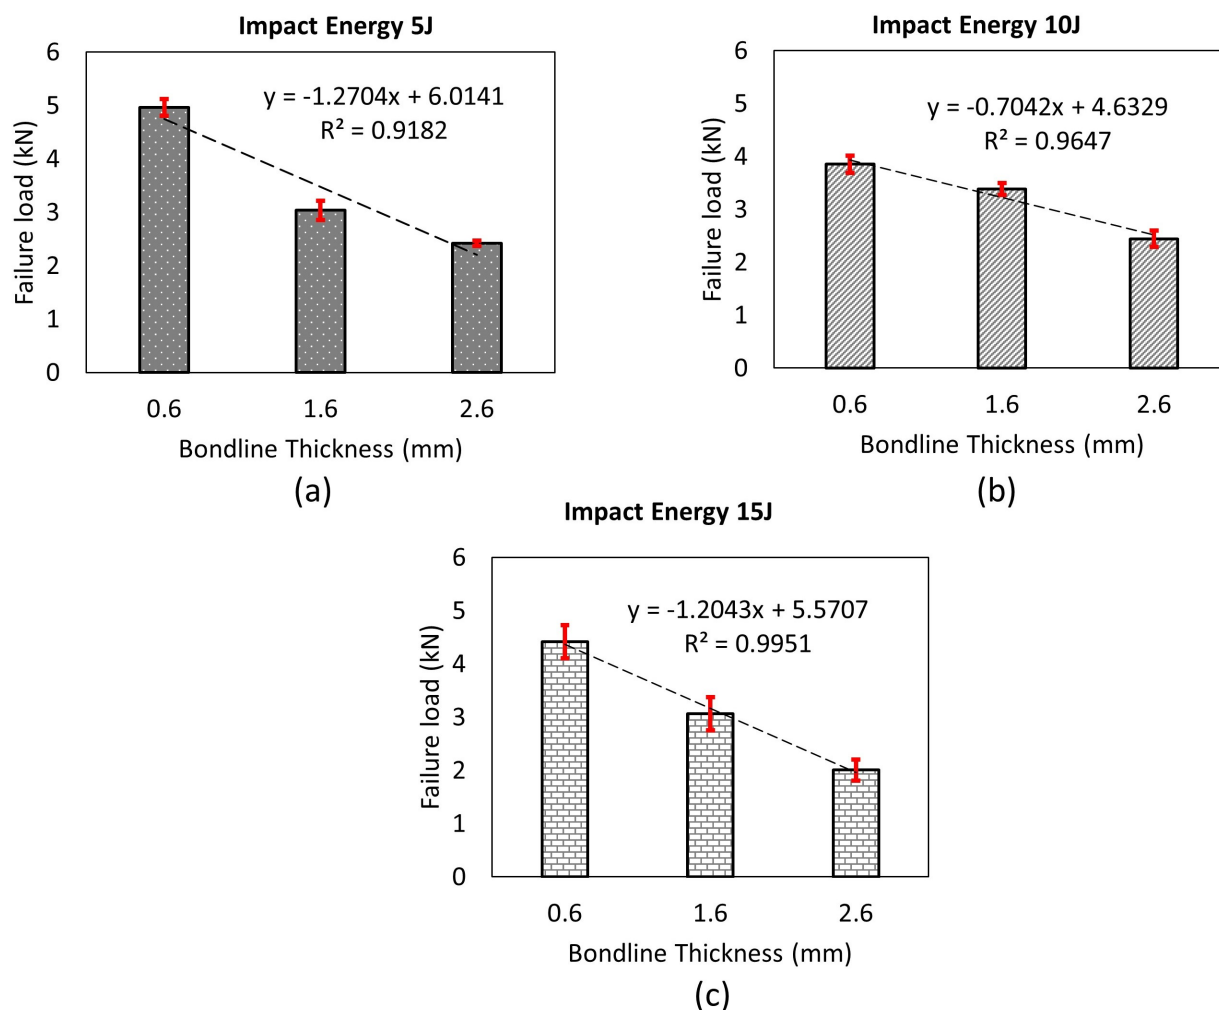
Figure 21. Comparison of post impact failure load of joints for different bondline thickness after being subjected to an impact energy of (a) 5 J, (b) 10 J, and (c) 15 J.

5. In the last part of the study, the impact-induced damaged samples were tested under tensile lap shear tests, and post-impact failure loads were compared with the intact failure loads. It was found that for a given impact energy, the largest failure load belongs to the joint with the thinnest bondline thickness. Therefore, similar to the static behavior of adhesive joints, the best performance of the joint after impact loads was given by the joint having the least bondline thickness.

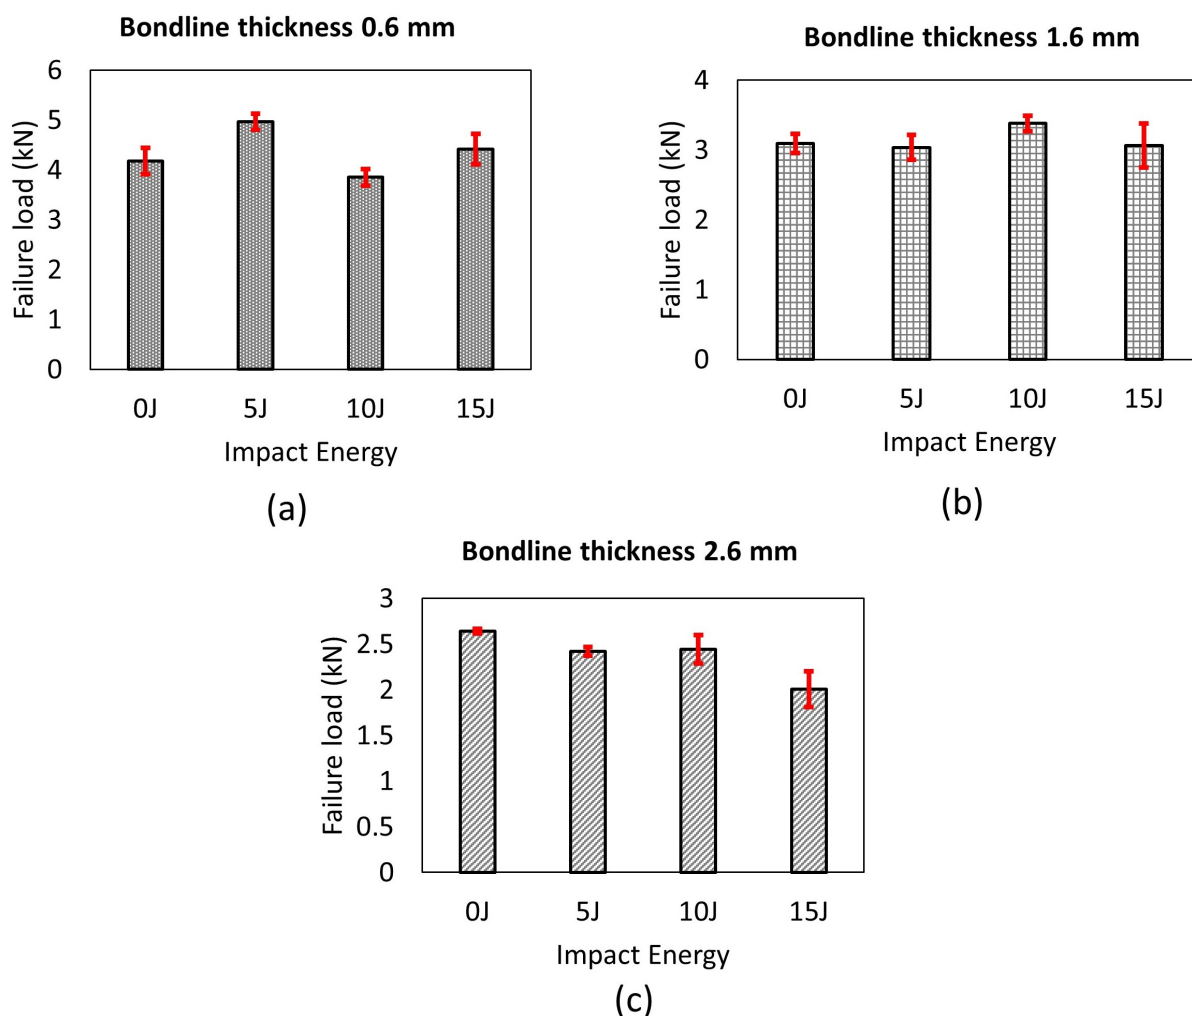
Figure 22. Comparison of post impact failure load of joints after being subjected to different impact energy: (a) Bondline thickness of 0.6 mm, (b) bondline thickness of 1.6 mm, and (c) bondline thickness of 2.6 mm.

Another important finding was that for all the cases, the impact loads did not significantly reduce the failure load of joints compared to their intact values as reported in [58] for Carbon-fiber-reinforced polymers (CFRP) based adhesive joints (see Figure 22a–c). Interestingly, for some of the cases, the failure load seems to have increased by 20% compared to the intact values (see Figure 22a,b). The increase in the failure load is attributed to the impact-induced mechanical locking effects reported through the cross sectional scanning of the damaged samples (see Figure 19). The mechanical interlocking is a well-known effect that tends to increase the loading capacity of the joints by enhancing adhesion area between adhesive and substrate [70–72]. This enhancement could be caused by an increase in the surface roughness at the adhesive adherend interface as more fracture energy is dissipated due to increased roughness [73]. For instance, in the work from [70,71], authors added multiwall carbon nanotubes (MWCNT) to epoxy adhesive to increase the loading capacity of joint; for example, this treatment increases surface roughness and area of adhesion at the bondline interface, thereby enhancing the mechanical locking effects. In the literature [56,57], the impact induced loads on the joint have also been found to develop similar effects that tend to increase post impact loading capacity of the joints. For further quantification, we also analyzed the line surface roughness data using the optical microscope (along the plane of joint thickness) for different locations (*A – F*) along the adhesive adherend interface (Figure 23). We present two surface roughness parameters: Maximum height of the profile (*Rz*) and root mean square roughness (*RMS*). The results indicate that there is an increase in the surface roughness at the adhesive adherend interface (below

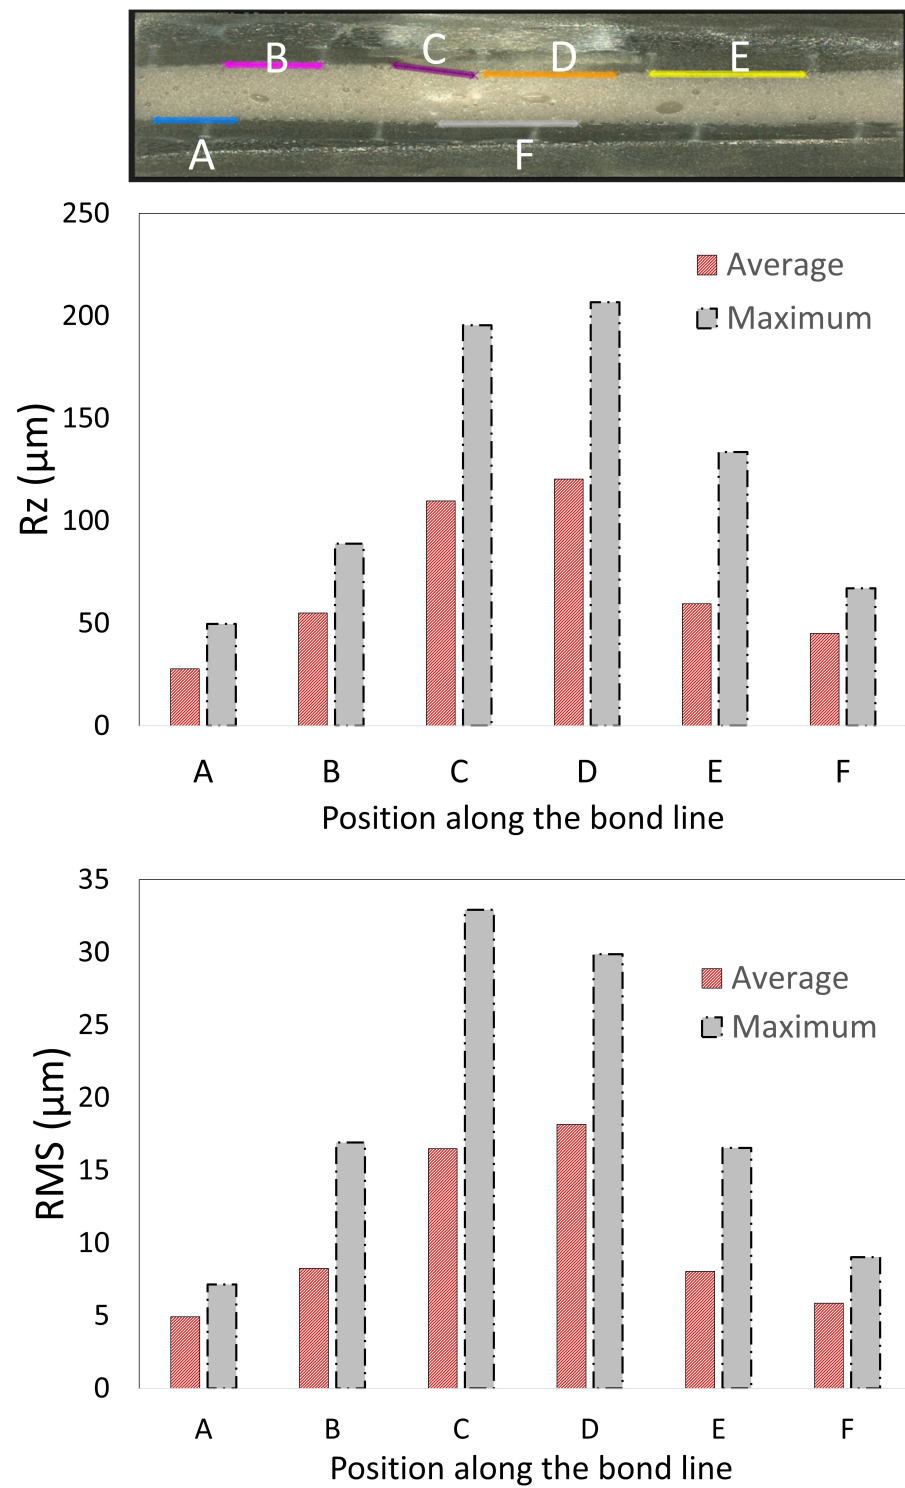
Figure 23. Comparison of surface roughness along the bondline interface for joint with a bondline thickness of 0.6 mm subjected to an impact energy of 15 J.

the region of impact crater, location C, D in Figure 23), which we believe enhanced the adhesion area and increased the failure loads.

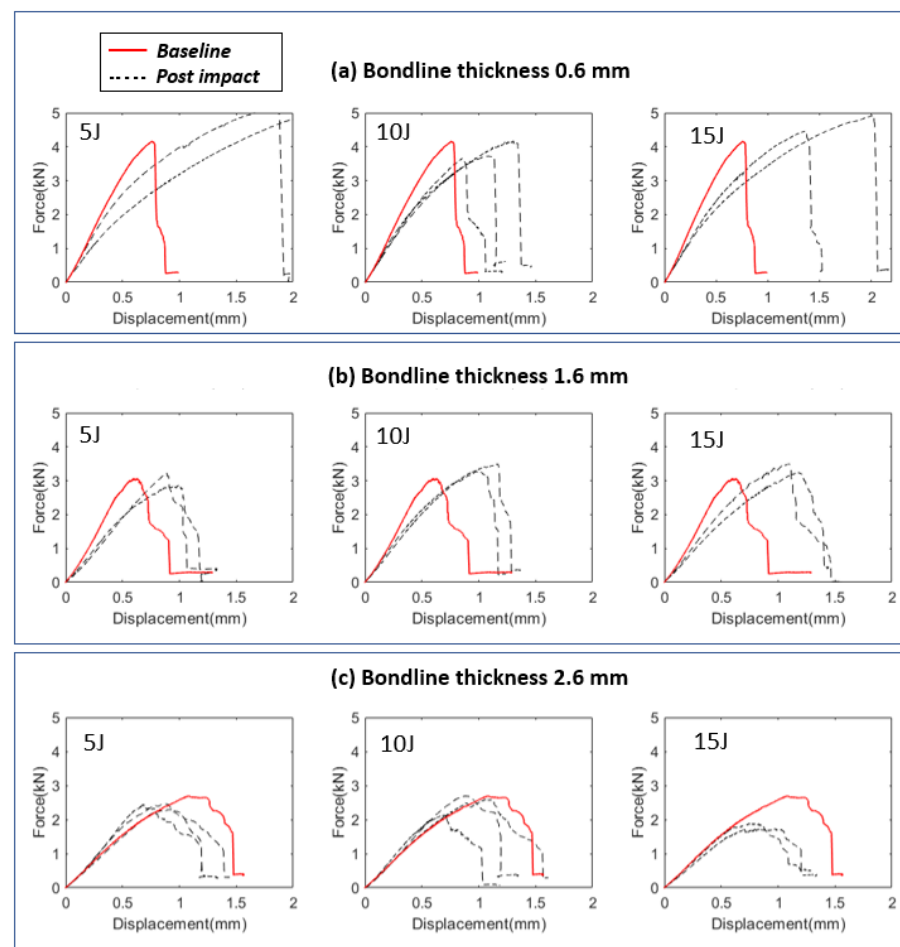
Figure 24. Comparison of post-impact load displacement history with intact load displacement history (baseline) for different bondline thicknesses and impact energies.

Figure 24 compares load displacement histories for intact and post-impact damaged samples subjected to lap shear tests. For thin joints, the slopes of the damaged samples were less steeper compared to the slopes of the intact joints. However, this was not the case for bondline thickness of 2.6 mm, as the slopes of the damaged samples were similar to the slopes of the intact samples, and there was a reduction in the failure load. Again, the difference in the damage tolerance behavior for different joint thicknesses was attributed to the fact that the mechanical locking effects due to the impact crater were less pronounced for the thickest joints, and the plastic deformation of composite layers did not extend till the adhesive zone. Therefore, the crater was mostly concentrated around the top adherend and damage progressed more towards the joint edges, increasing the projected damaged area. This observation implies that the projected damaged area, especially that extends towards the edges of the joint, is more detrimental to the failure load of the joint compared to the localized impact crater itself. Overall, mechanical locking effects together with projected damage area play a major role in the overall damage tolerance behavior of the adhesive joints with varying bondline thicknesses.
